Geotechnical Report

849 State Highway 1, Kaikoura

June 2023

Our ref: 9295

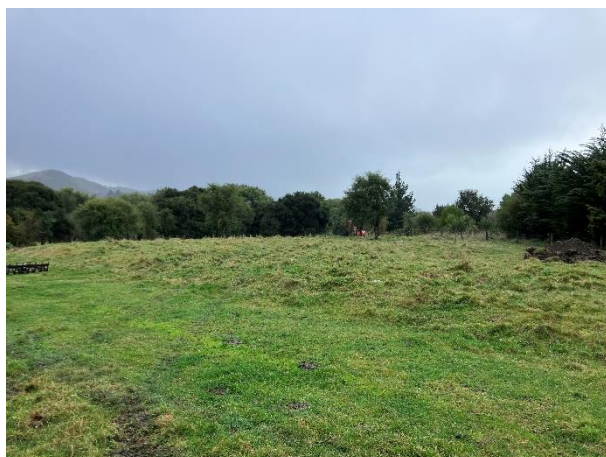
Photographs: 1 Looking from site access across proposed build site. 2 looking east, across shallow terrace to the north of build site (machine can be seen in both as reference).

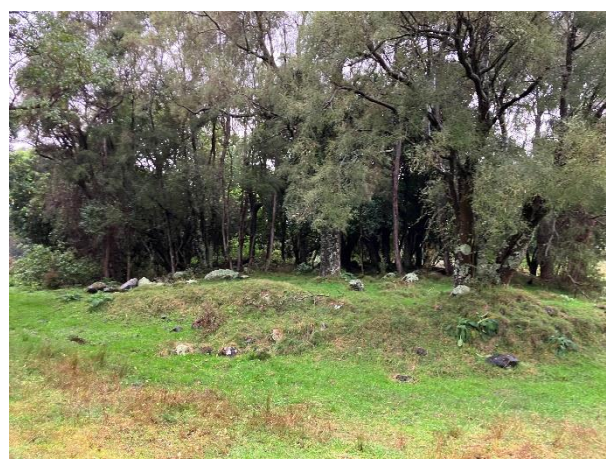
Photographs: 3 Looking towards bushes and trees typical at the site. 4 looking south from the banks of the Hapuku River towards site.

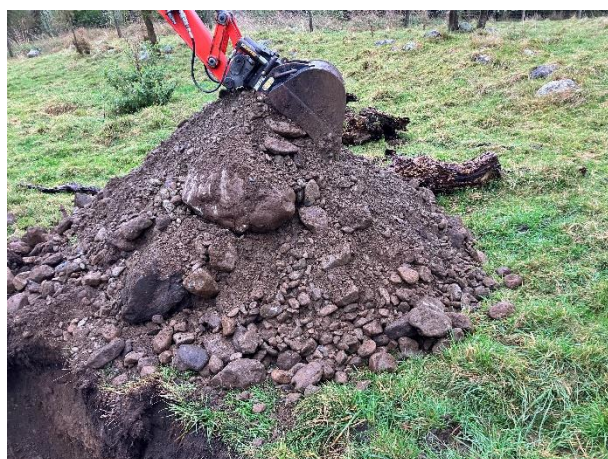
Photo:5 Spoil pile Trial pit 1. Photo 6 Trial pit 2 base.

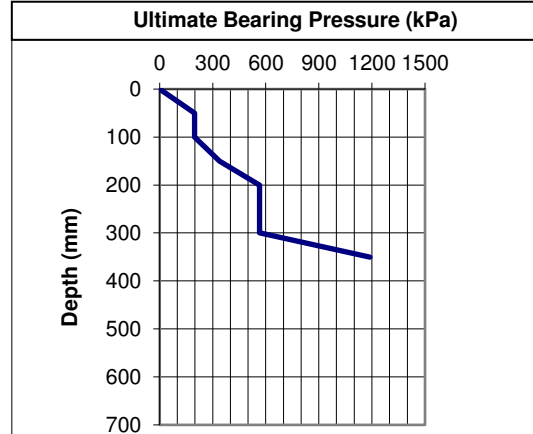
Test 1

No. of	e (mm/blow)	Soil bearing	Depth (mm)
START	0	0	0
1	50	198	50
1	50	198	100
2	25	339	150
4	13	565	200
4	13	565	250
4	13	565	300
10	5	1189	350
Refusal

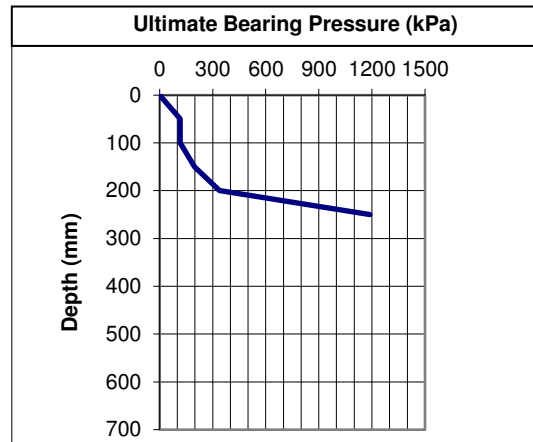
Test 2

No. of	e (mm/blow)	Soil bearing	Depth (mm)
START	0	0	0
0.5	100	115	50
0.5	100	115	100
1	50	198	150
2	25	339	200
10	5	1189	250
Refusal

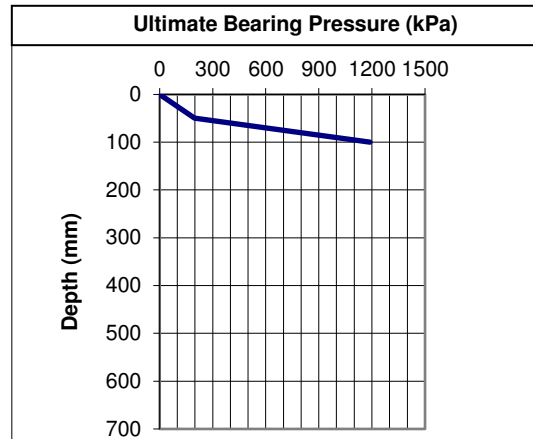
Test 3

No. of	e (mm/blow)	Soil bearing	Depth (mm)
START	0	0	0
1	50	198	50
10	5	1189	100
Refusal

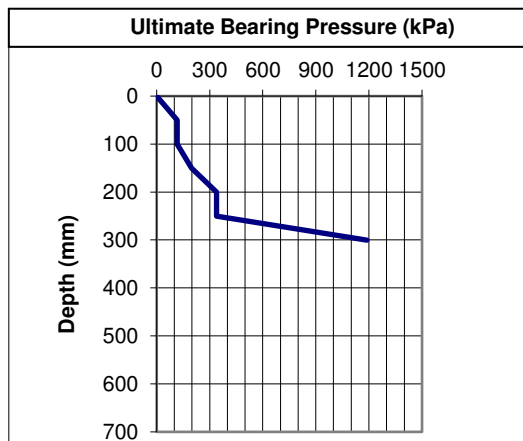
Test 4

No. of	e (mm/blow)	Soil bearing	Depth (mm)
START	0	0	0
0.5	100	115	50
0.5	100	115	100
1	50	198	150
2	25	339	200
2	25	339	250
10	5	1189	300
Refusal

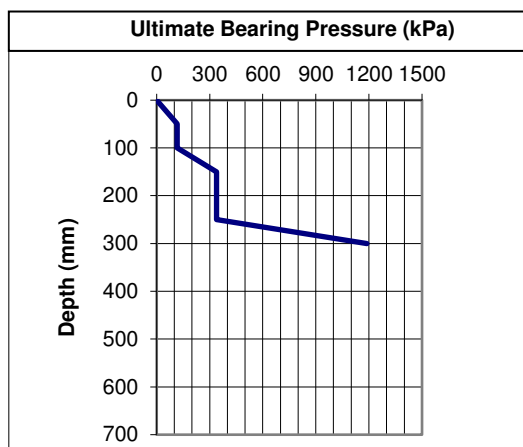
Test 5

No. of	e (mm/blow)	Soil bearing	Depth (mm)
START	0	0	0
0.5	100	115	50
0.5	100	115	100
2	25	339	150
2	25	339	200
2	25	339	250
10	5	1189	300
Refusal

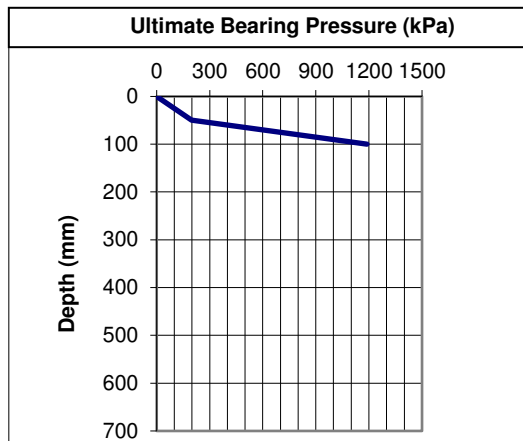
Test 6

No. of	e (mm/blow)	Soil bearing	Depth (mm)
START	0	0	0
1	50	198	50
10	5	1189	100
Refusal
