Re: New Zealand Steel Subdivision - Waiuku

Re: N.Z. Steel Subdivision in Sandspit Road - Waiuku

**RE: DWELLING @ 17 ELSIE DRIVE, WAIUKU**

**Progress as at 15 April 2002 - Monthly Report No. M/1998-0853/1**

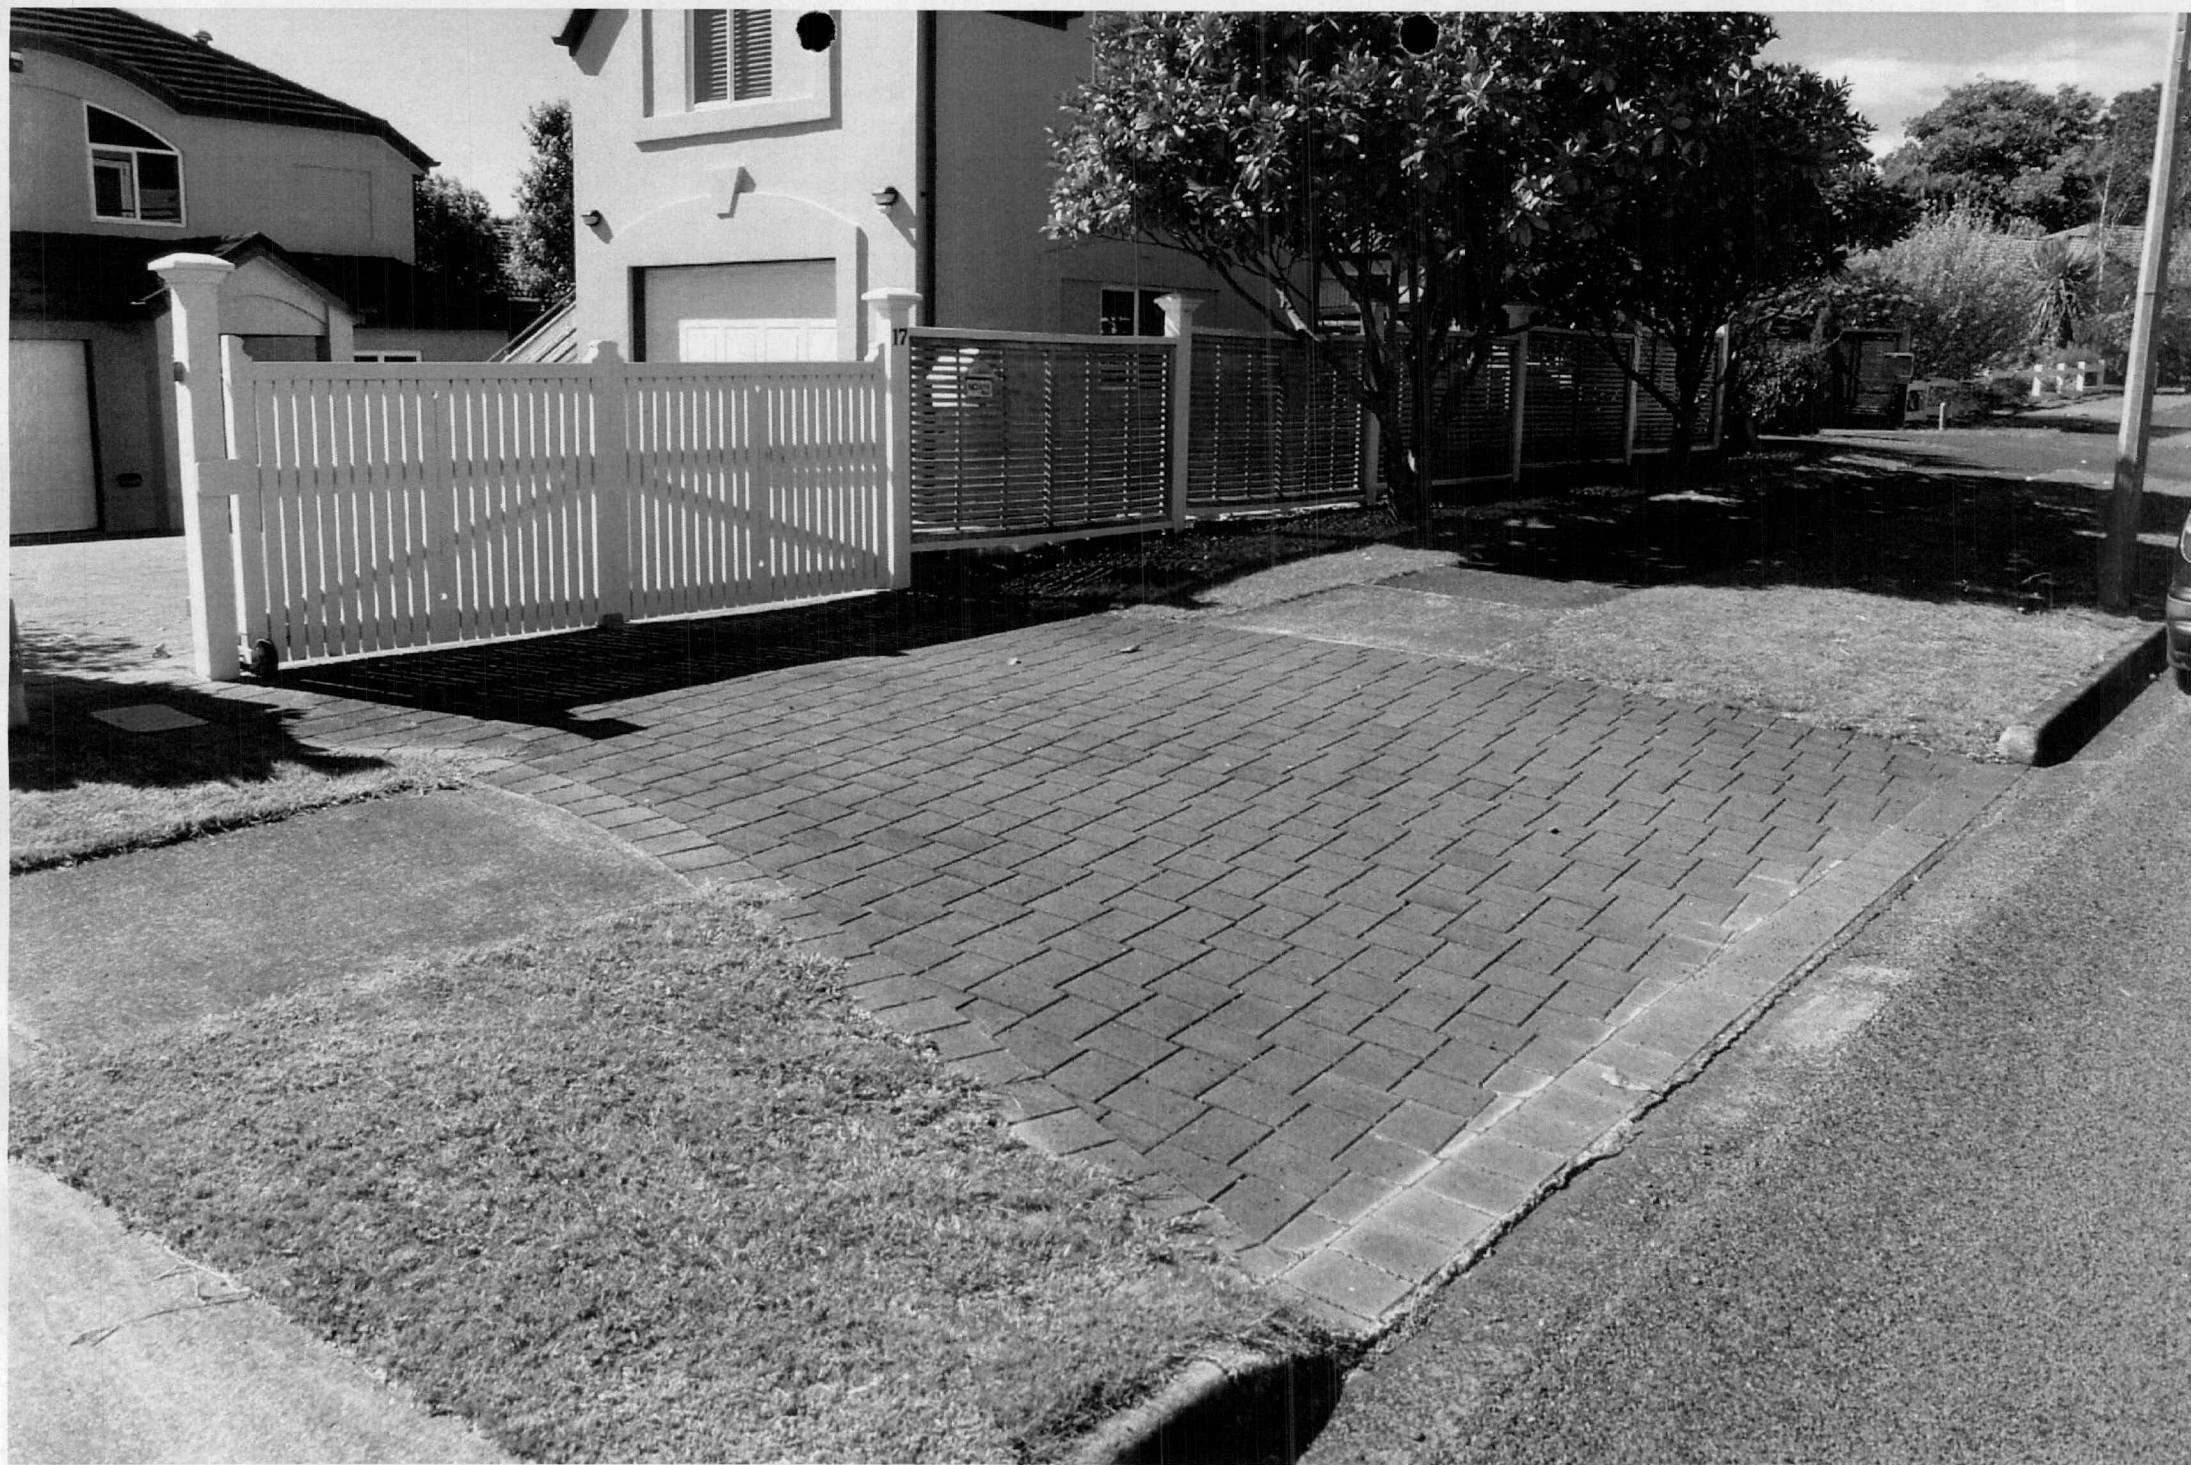
17 Elsie Drive Wairuku. PR 2400-510 Received 27-3-13.

Thank you for sending the photo of your driveway and footpath.

I have spoken to Jennifer Clark our staff member who wrote the note and she advised me that it means; upon your instruction Council (via Opus) has done the work and fixed the crossing. Therefore the money has been transferred into the footpath maintenance account.
