PROPERTY CHECK EXPRESS REPORT

| Property Inspected | 24B Larch Place, Casebrook, Christchurch |
| Inspection Date | 25 July 2025 |
| Scope of Report | Visual inspection of the buildings that are listed in this report for the purpose of a residential inspection in accordance with NZS4306: Residential Property Inspections. |

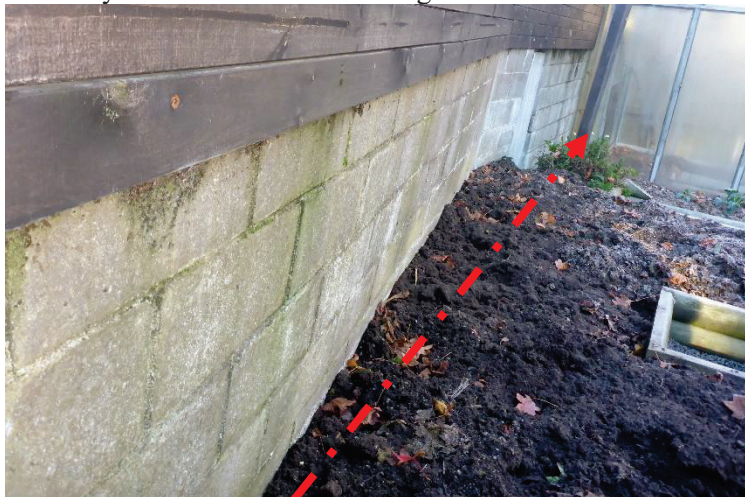
There may be a drain running underground along the east boundary. We recommend checking the title documents.

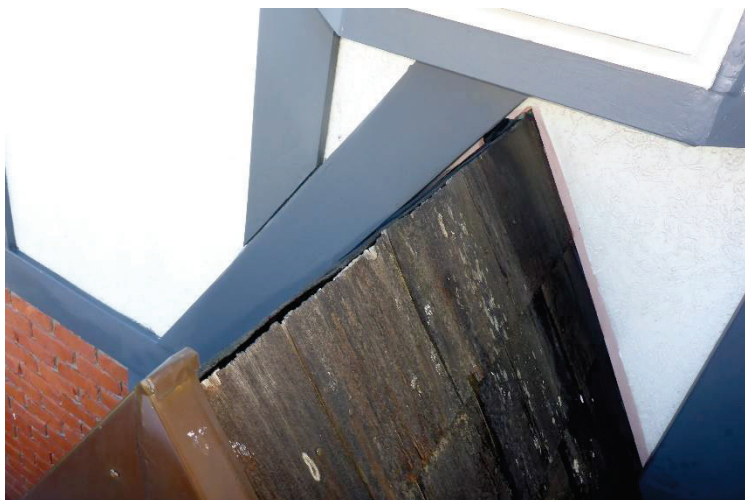
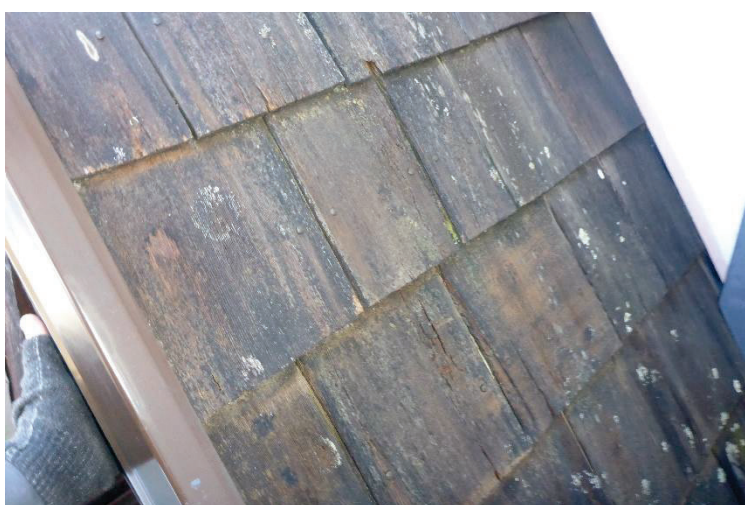
Some timber shingles over the main entrance are deteriorating and may need replacing in the near future.

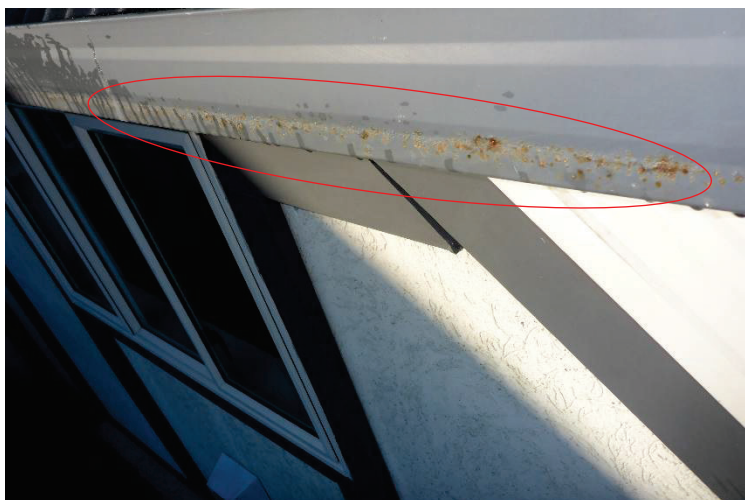
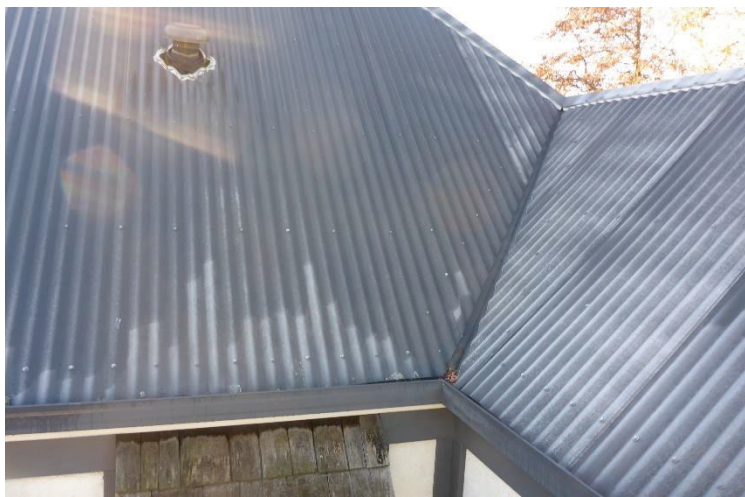
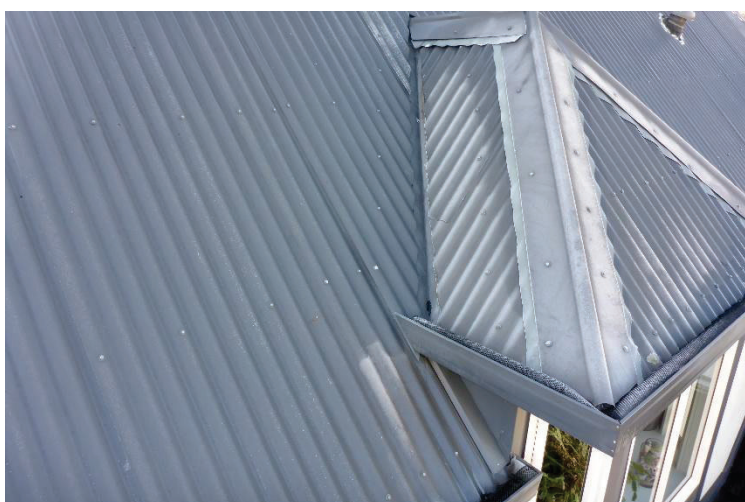
External Pre-Painted Steel Spouting

Spoutings to the upper level above the garage and the lower level north elevation near the dining room are corroding and may require replacement.

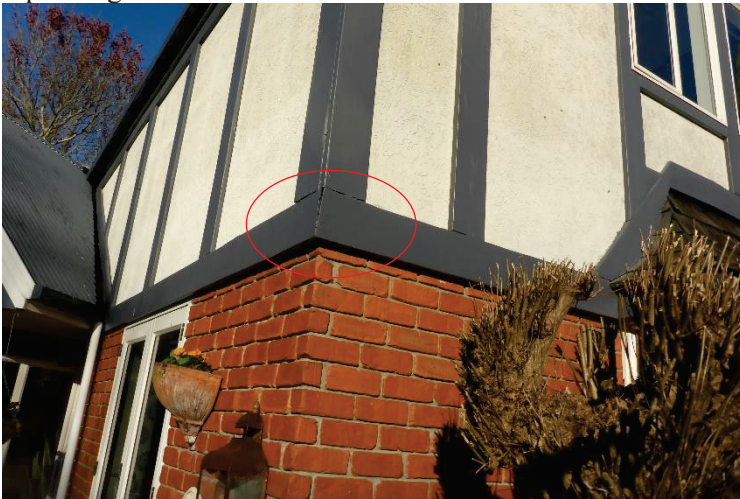
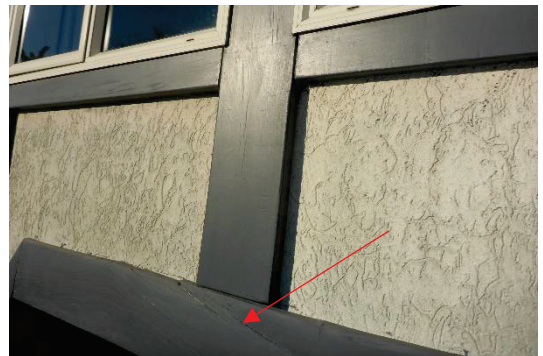
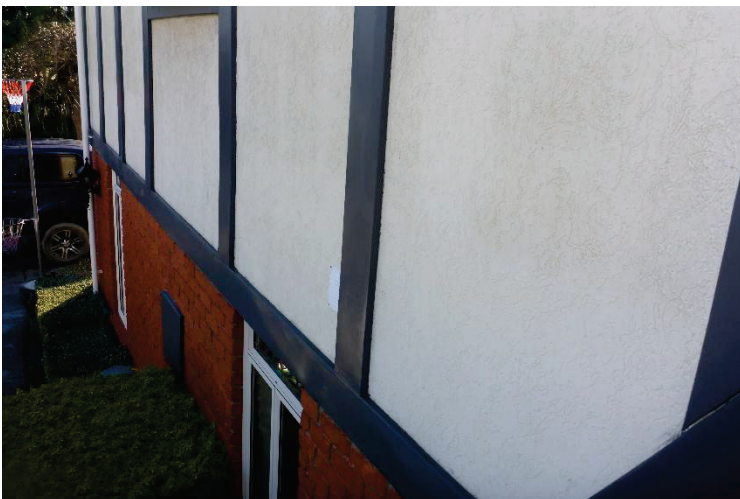
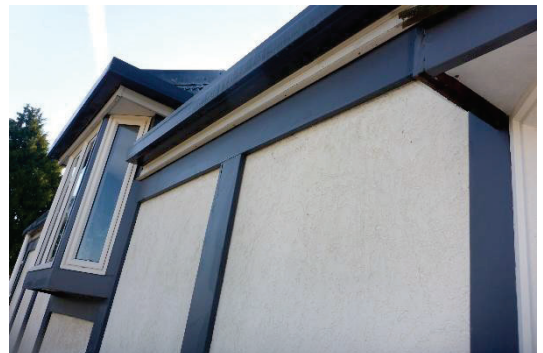
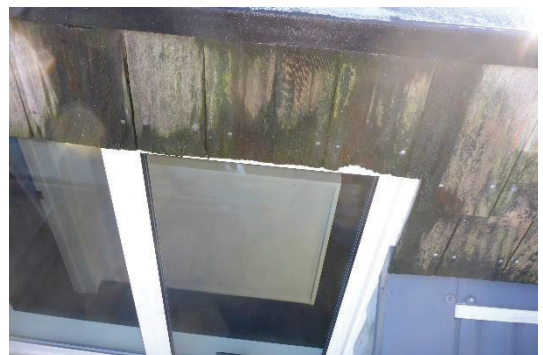
Timber facing boards to the upper level are weathered and require maintenance, including replacement of a few boards and repainting.

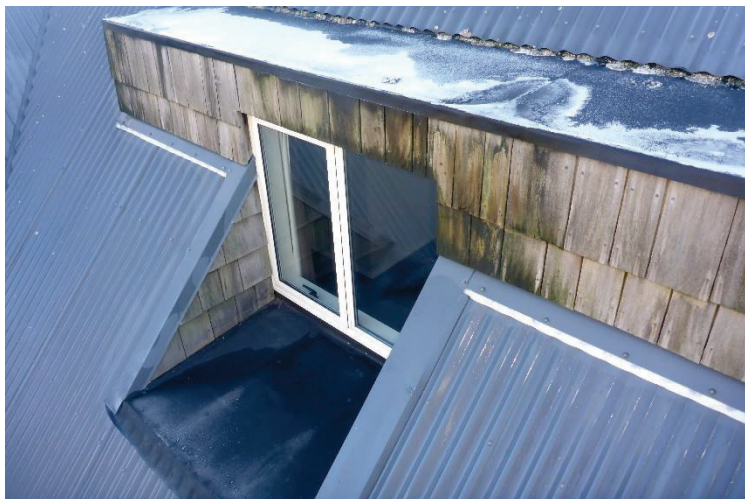
The timber shingles to the upper level dormers on the south elevation are deteriorating and require replacing to a few areas.

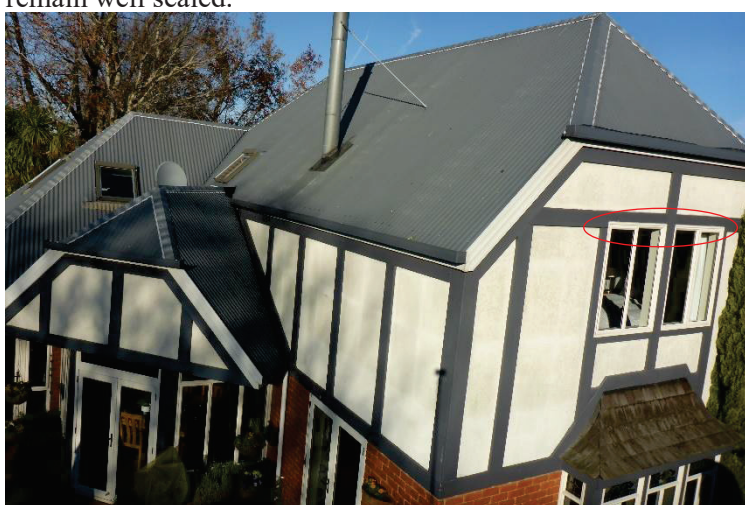
Upper level windows on the north gable end lack head flashings. It is important that the top edge sealant joints and back facings remain well sealed.

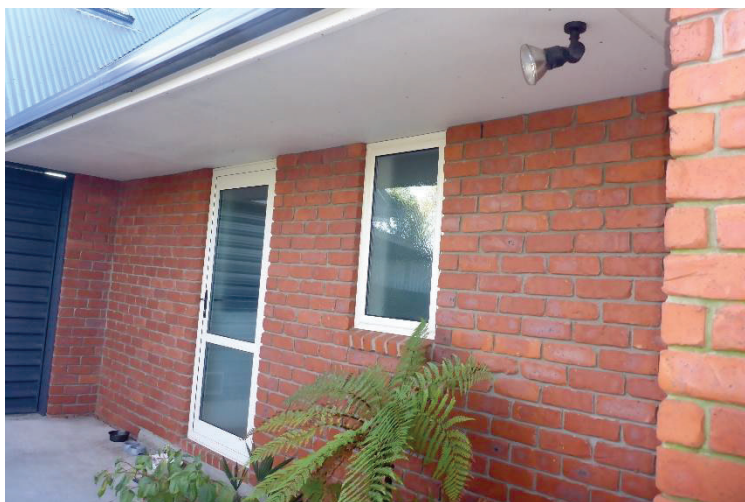
The plywood garage door shows wear and may require repainting.
