CASH SETTLED CLAIM(S)

Statement of Claim Checklist / Repair Strategy

CIM/2010/101940

13a BRYNLEY STREET

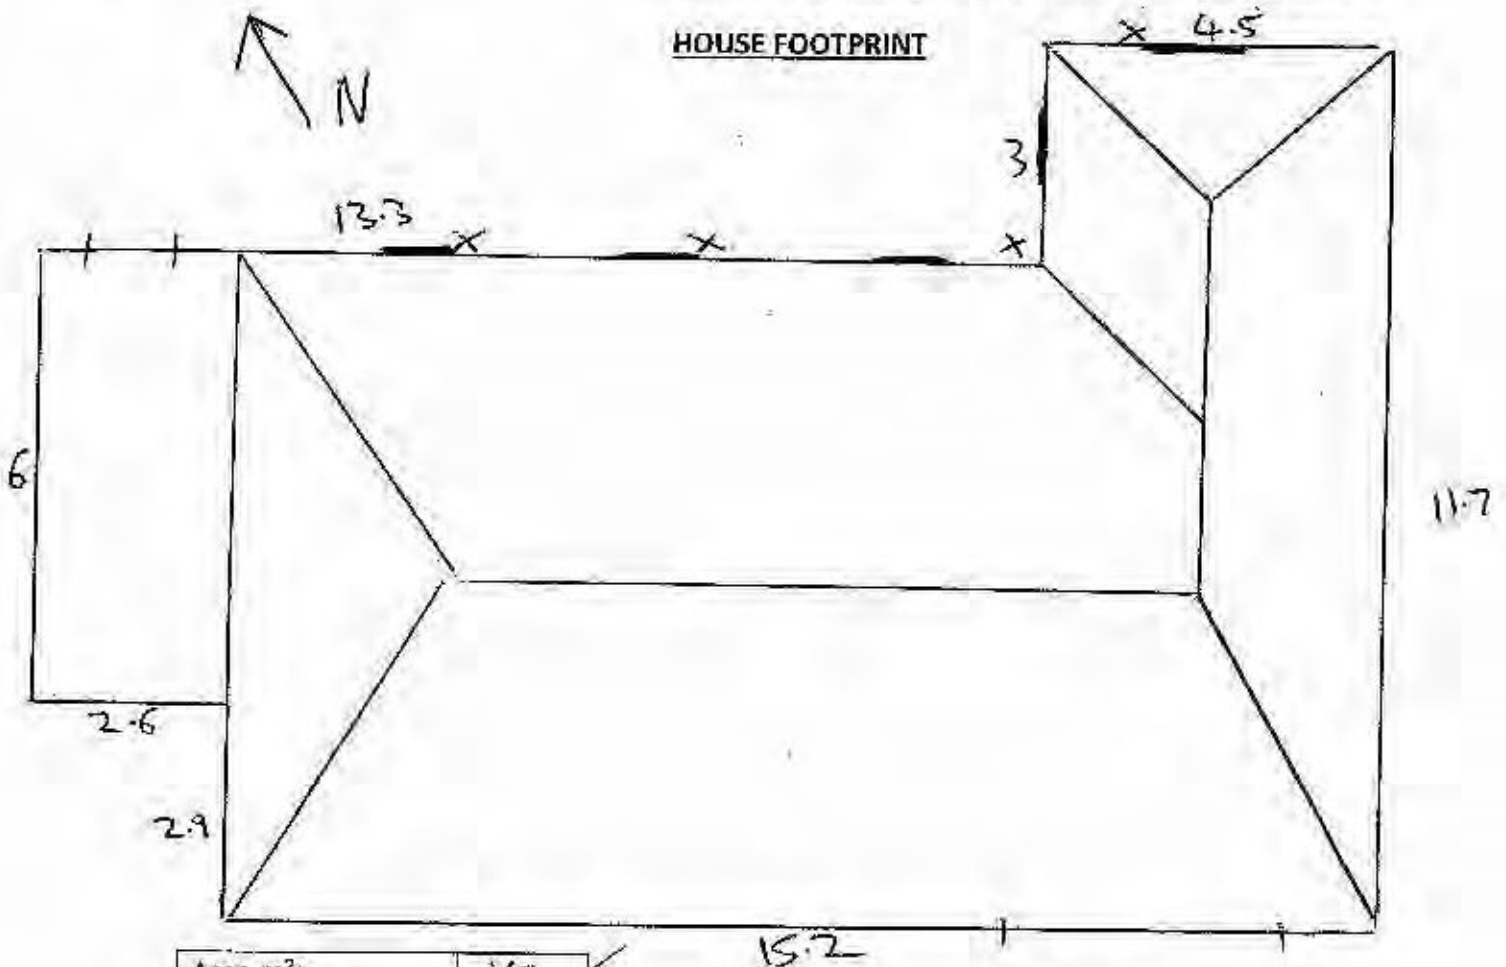
HOUSE FOOTPRINT

Ceiling framing displaced

* Aluminium soiney
disphed

Water damage

Area m ² :	160
Stud Heights:	2.4
Wall Finish:	Wallpaper <u>Plastered</u> <u>Paint finish</u>
Other	
Services:	Specify damage: leak in roof - unclear where leak is coming from - plumber req
Chimneys: N=1	Construction type: Height: Damage description: Above Roof Below Roof Total Repair
Foundations Damage: Nil	Timber Concrete Ring <u>Concrete Slab</u> Other (Specify): Minor Moderate Severe House moved off foundations?: No Concrete slab cracked? Crack width: Crack length:
Roof:	Framed <u>Trussed</u> Type: Clay Tiles Concrete tiles Metal tiles <u>Rolled Metal</u> Other Damage:
Cladding Type:	Weatherboard Brick Veneer Hardiplank <u>Other Stone Veneer</u>
