## **Geotechnical Investigation Report**

6 Shackleton Terrace, Lyttelton, Christchurch

| Project No. | C23080.01 | Revision | V0 |

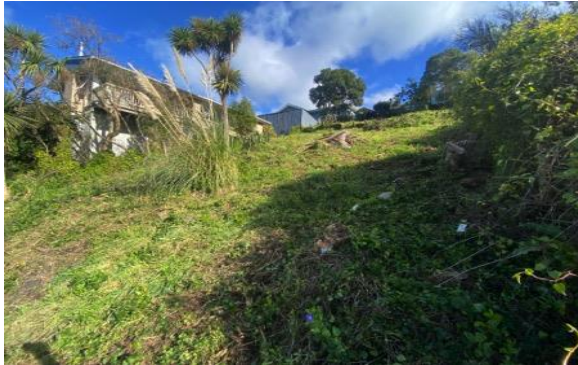
Photo 1: East side of the site, looking west (upslope).

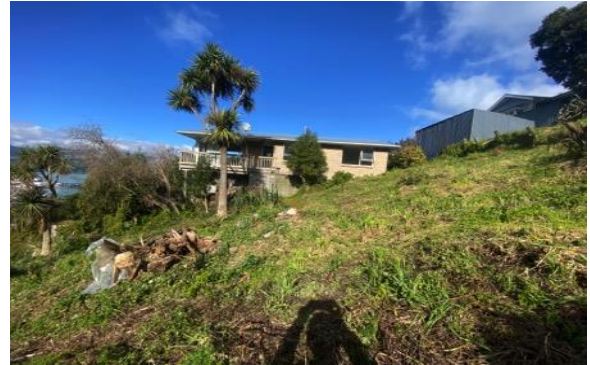
Photo 2: North side of the site, looking across mid-slope towards the south.

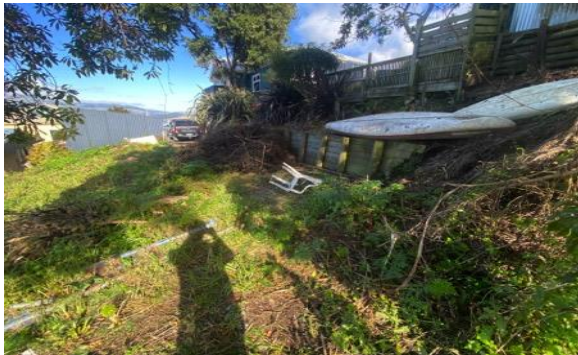
- On the upslope side of the driveway access there are two timber walls (approximately 1.2 m to 1.4 m high) that appear relatively intact and undamaged.

Photo 3: Relatively flat area at the top (west) of the site where there is driveway access. An intact timber post retaining wall is shown on the upslope side.

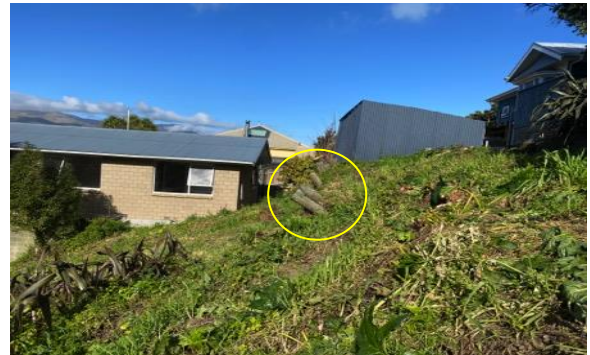
- On the downslope side of the driveway (at the edge of the relatively flat area, at the top of the site) there is a timber post wall that has failed and rotated. The wall is approximately 0.8 m to 1 m high. There is an area of ground behind the wall that has slumped with one tension crack up to 200 mm wide, the area of slumping is limited to the area behind the wall and appears to be associated with the failure of the wall.

- There are no obvious signs of significant land instability indicate deep seated failure, other than a small area of subsidence due to the deformation of timber post retaining wall near the top of the slope.

Photo 4: Looking across top (west) part of the slope towards number 4 Shackleton Tce, failed/rotated timber post retaining wall is circled.

New retaining walls may be required to replace some the existing retaining walls or provide a secure building platform and maintain long term stability of the slope.

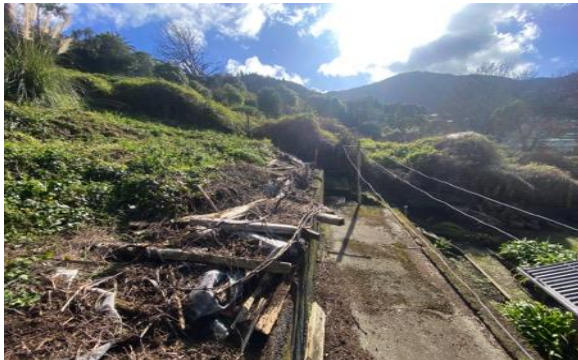
- On the downslope side of the site, near to the south eastern boundary, there are two mass in-situ concrete retaining walls. From what could be seen of these two walls they appear to be approximately up to 1.5 m high

Photo 5: Mass concrete retaining walls on downslope (east) side of the site, appear intact and upright and appear to be owned by the neighbour to the east.

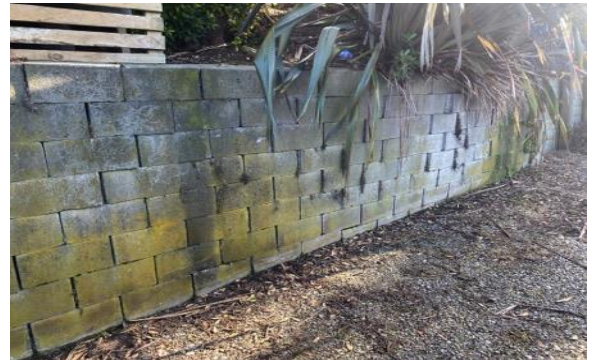
- A third wall on the upslope side of the driveway is of similar height, however it has been constructed from loosely stacked concrete blocks (without mortar). The wall is bulging and has rotated beyond vertical by several degrees. The wall may impede access to the site if it fails.

Photo 6: Loosely stacked concrete block retaining wall, west side of the site. The wall is retaining soil above the driveway
