SAFE AND SANITARY REPORT

**73 DEVON STREET
ROTORUA**

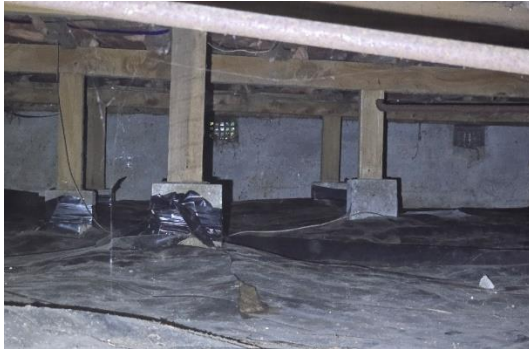
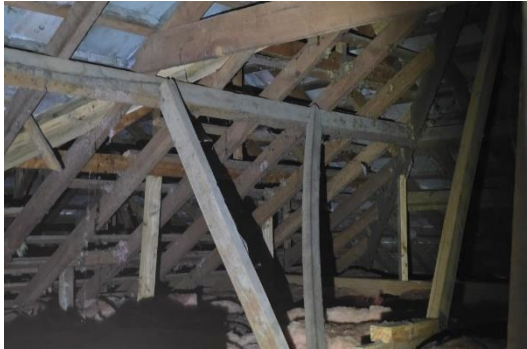
- Timber framing with pitched roof framing, appears visibly solid and in reasonable condition. Concrete and timber piles with 4 x 3 bearers, 6 x 2 joists, and T & G native flooring.
- Appears to be solid and correctly fixed.
- Ground barrier installed.

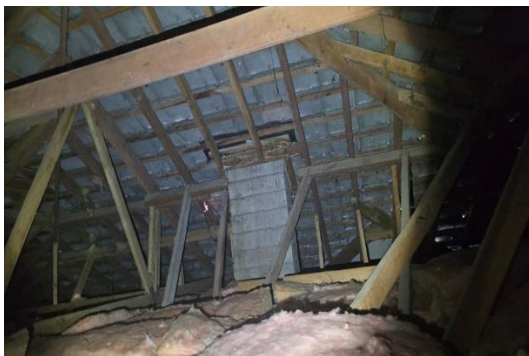
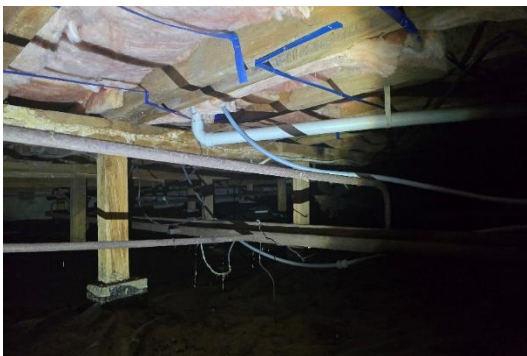
- Insulation to the roof space is Fiberglass/ Polyester R3.2.
- The foundation space has Fiberglass to areas visible.

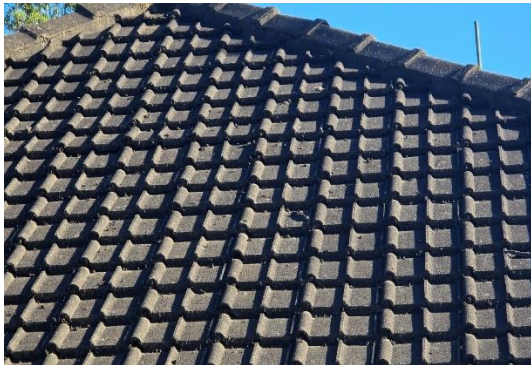
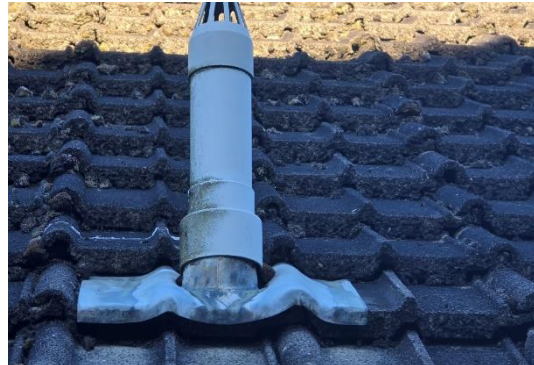
- Roof material Concrete Tile will need re mortar in near future.
- Flashings are lead, metal.
- Terminal vent pipe.

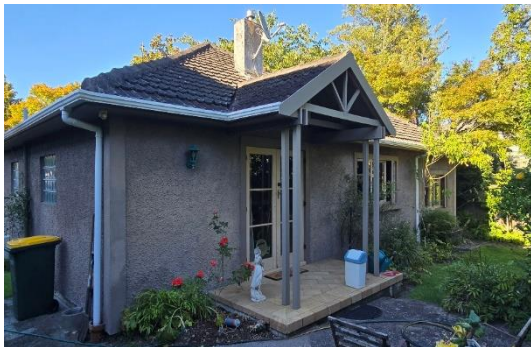
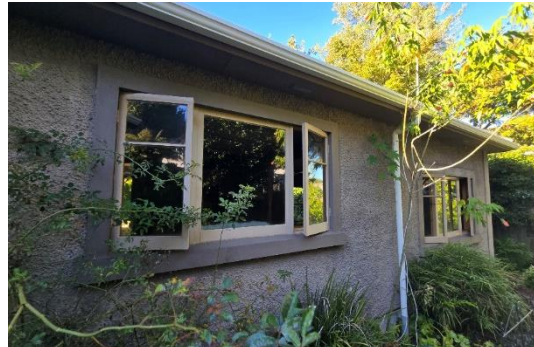
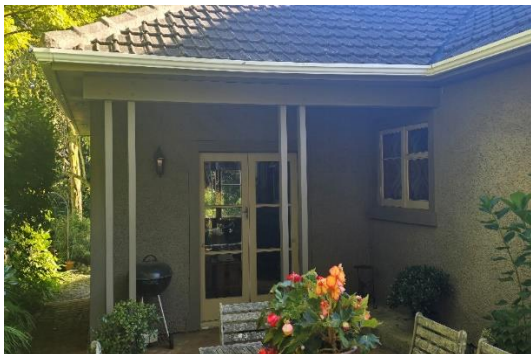
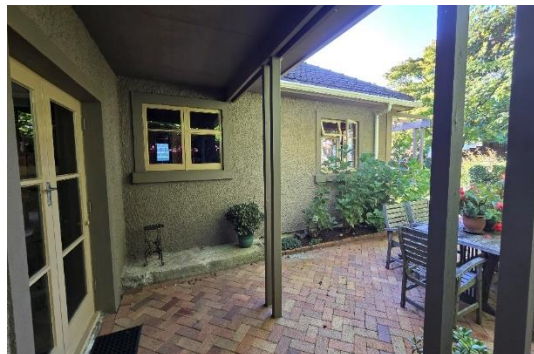
- Exterior cladding is wooden weather board, with Stucco plaster system over top. Pre 1991.
- Exterior joinery is wooden with single glazing.
- Standard hardware, all working with opening sashes and provides adequate light and ventilation.

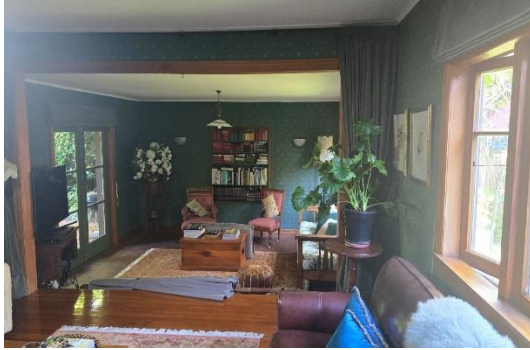
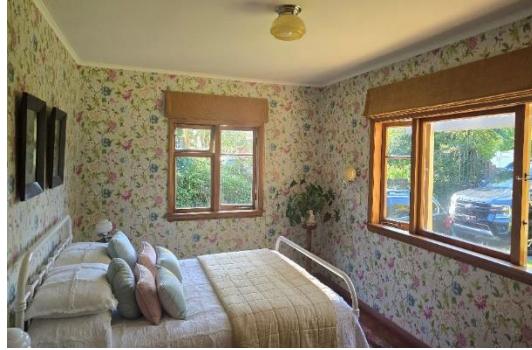
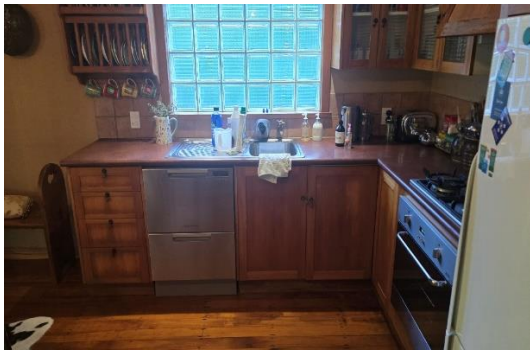
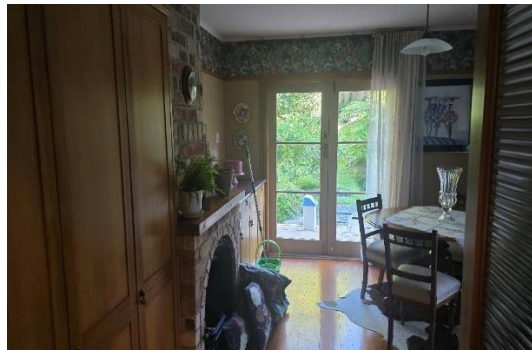
- Interior walls are plasterboard.
- Interior ceilings are plasterboard.

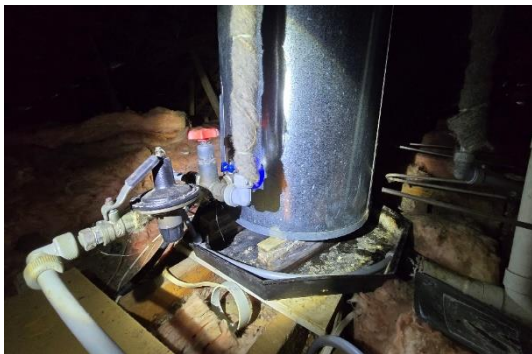
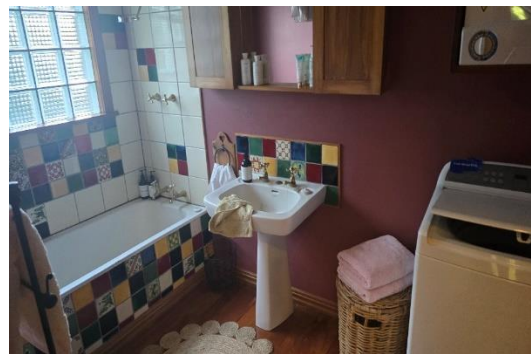
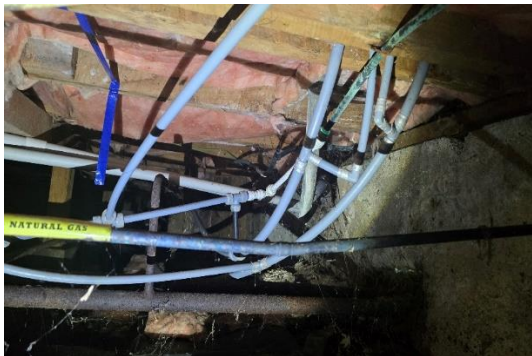
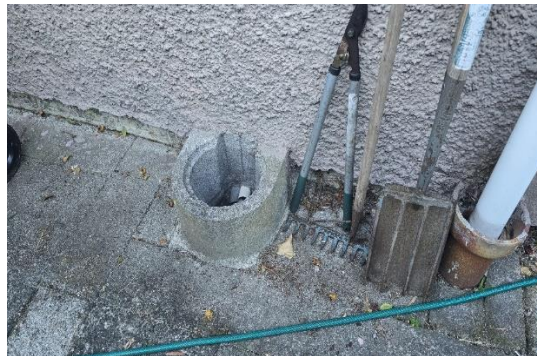
- The site has fall to the rear and front of the dwelling.
- The floor plan is a single-story dwelling.
- Moisture was not present at the time of the inspection.
- The plumbing is copper and grey buteline.
- Hot water low-pressure cylinder.
- S-Trap PVC waste pipes falling to gully traps.
- Timber and vinyl floor coverings.
- Vents are installed.

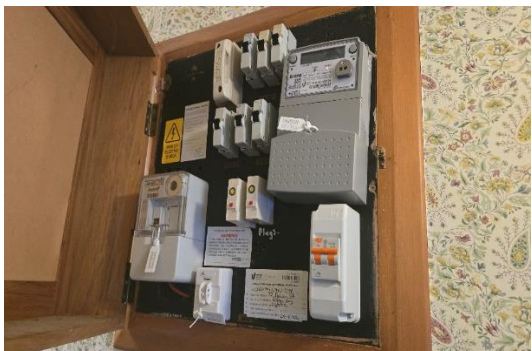
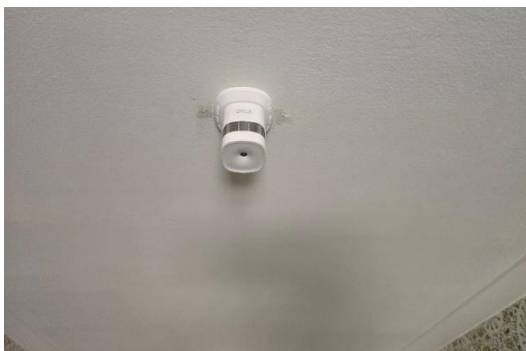
- Spouting and downpipes are PVC, falling to soak holes.
- Smoke alarms are installed, not tested to the hallway, lounge.
- Switchboard/meter box is located internally.
