THERMOGRAPHY REPORT

ADDRESS: 16B McCallum Street

THERMOGRAPHY DATE: 23 January 2025

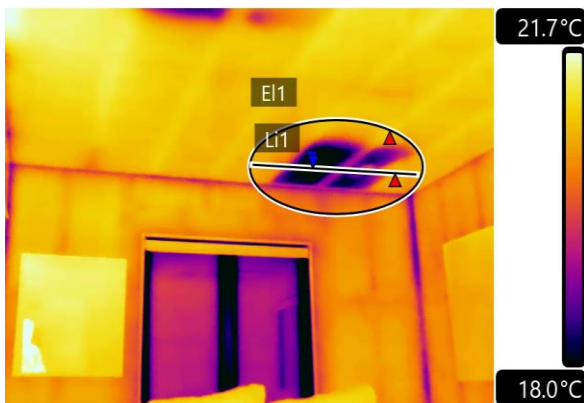
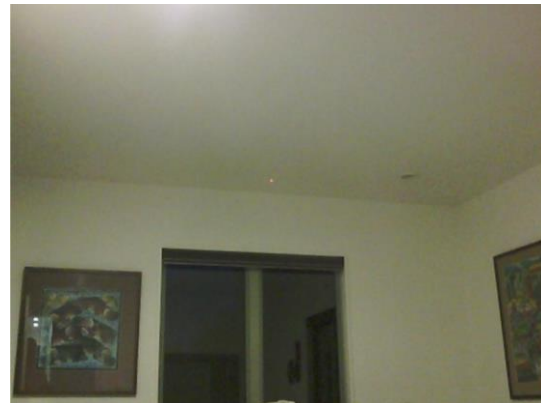
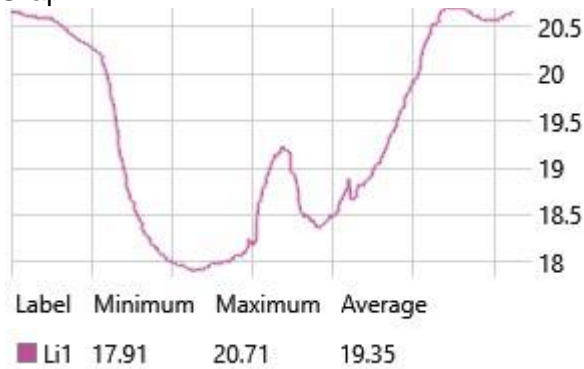
Bedroom 1 ceiling. First floor (North)

Image shows missing insulation or insulation not touching the plaster board in bedroom 1 ceiling on the first floor.

This is common around light fittings and light fitting that have been removed, cable routes and hard to reach roof cavities.

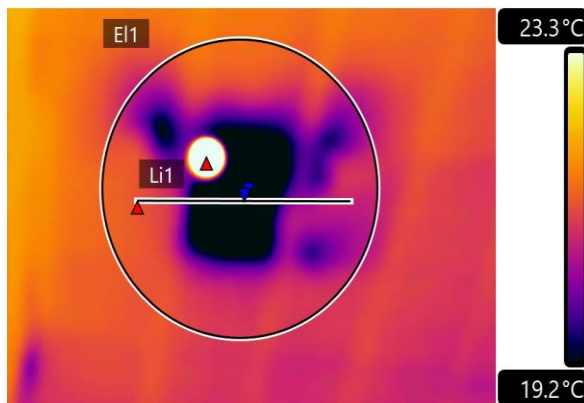
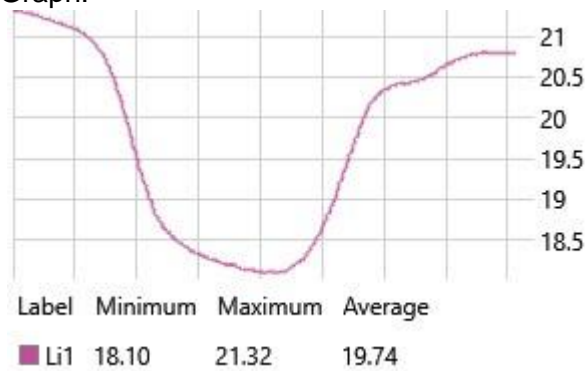
Bedroom 1 ceiling. First floor (North)

Image shows missing insulation or insulation not touching the plaster board in bedroom 1 ceiling on the first floor.

This is common around light fittings and light fitting that have been removed, cable routes and hard to reach roof cavities.

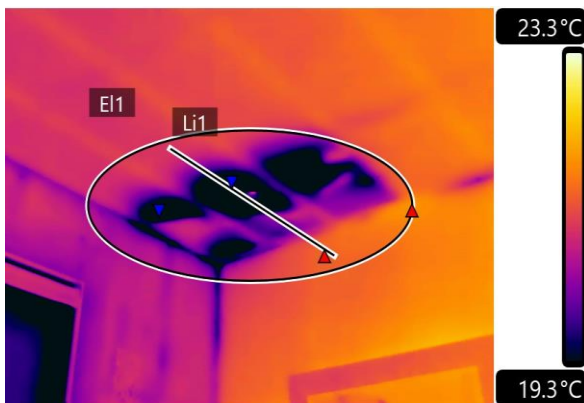
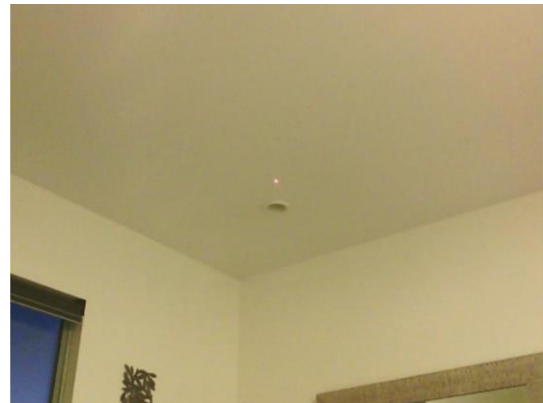
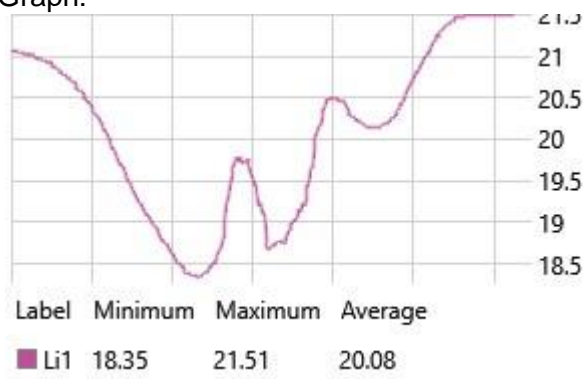
Bedroom 1 ceiling. First floor (North)

Image shows missing insulation or insulation not touching the plaster board in bedroom 1 ceiling on the first floor.

This is common around light fittings and light fitting that have been removed, cable routes and hard to reach roof cavities.

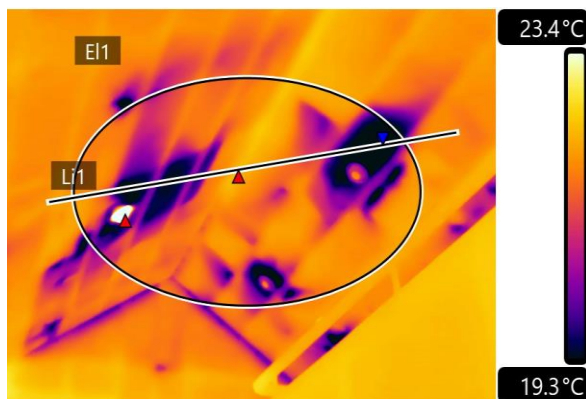
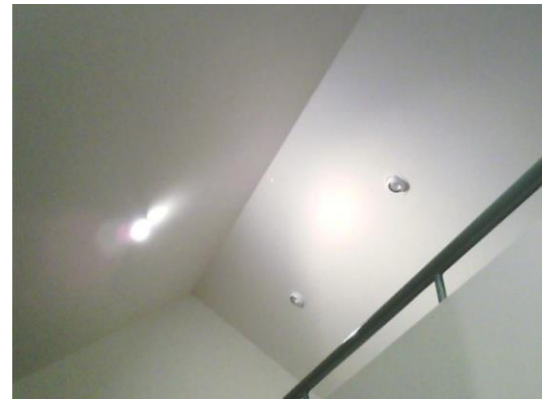
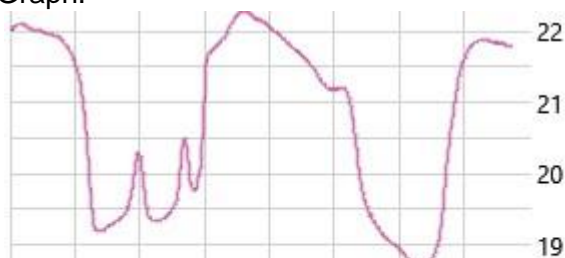
Hallway ceiling. First floor (North)

Image shows multiple missing insulation or insulation not touching the plaster board in the first-floor hallway ceiling.

This is common around light fittings and light fitting that have been removed, cable routes and hard to reach roof cavities.

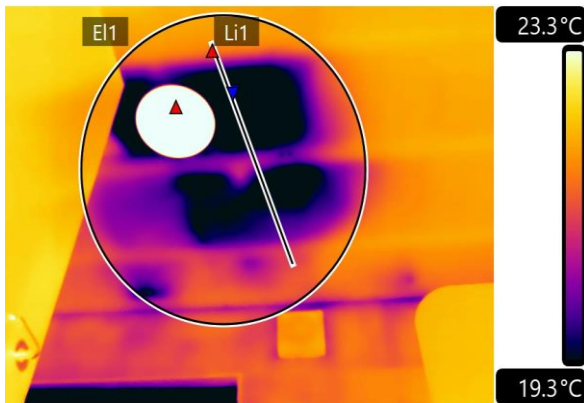
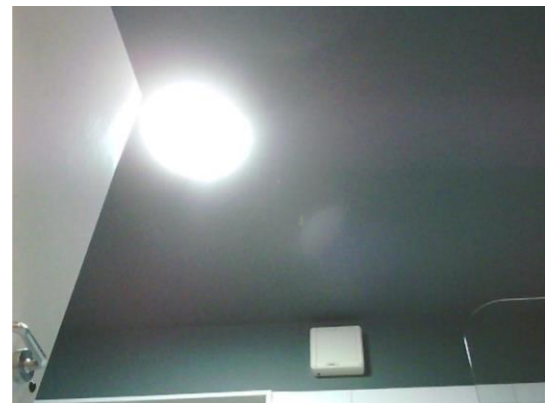
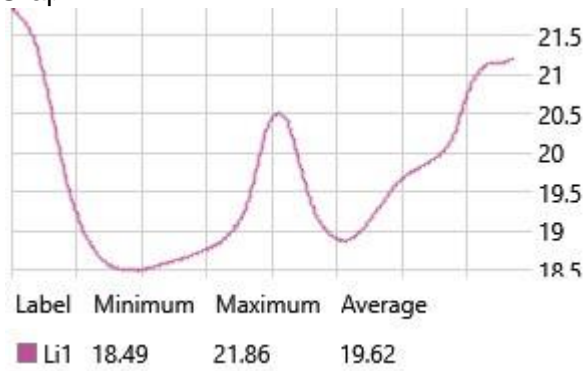
Bathroom ceiling. First floor

Image shows missing insulation or insulation not touching the plaster board in the first-floor bathroom ceiling.

This is common around light fittings and light fitting that have been removed, cable routes and hard to reach roof cavities.

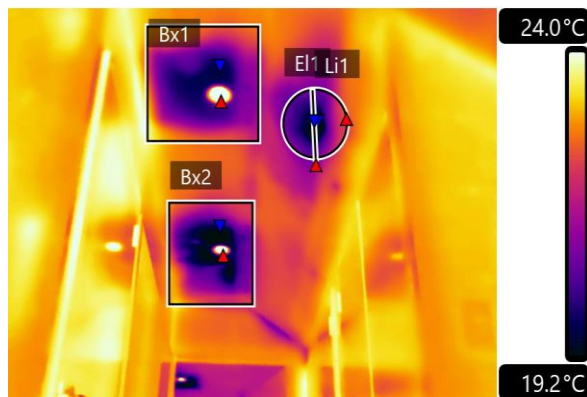
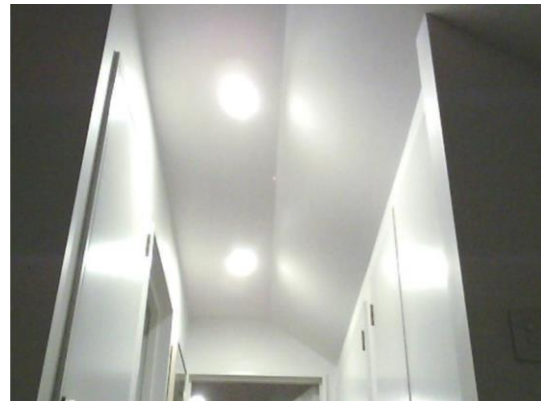
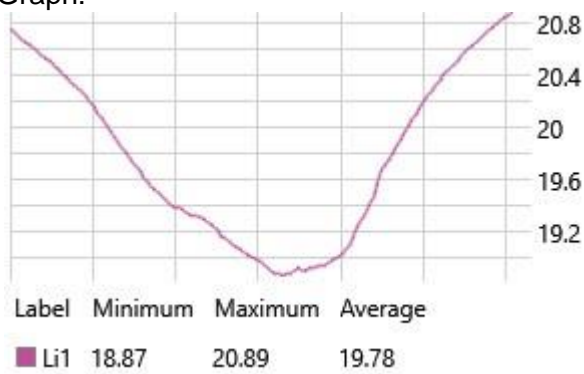
Hallway ceiling. First floor (South)

Image shows missing insulation or insulation not touching the plaster board in the first-floor hallway ceiling.

This is common around light fittings and light fitting that have been removed, cable routes and hard to reach roof cavities.

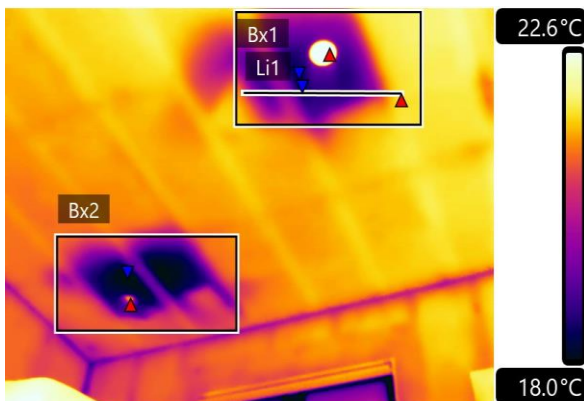
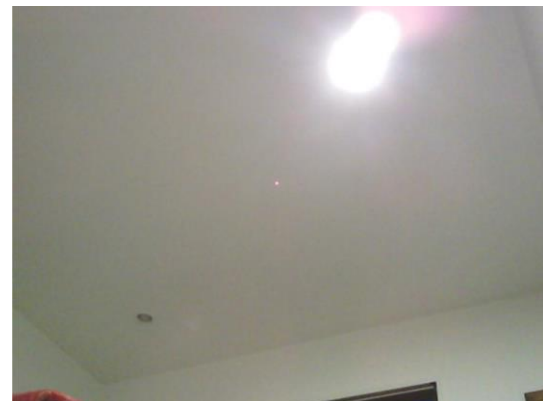
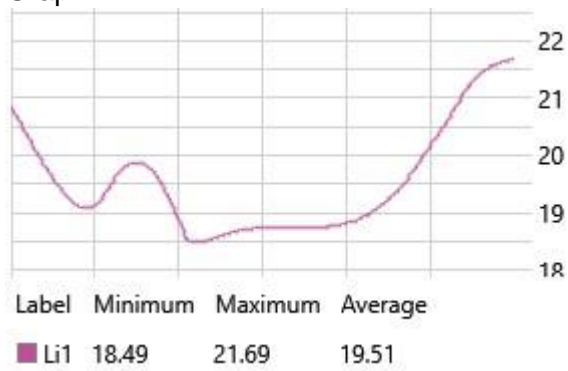
Bedroom 2 ceiling. First floor (South)

Image shows missing insulation or insulation not touching the plaster board in bedroom 2 ceiling on the first floor.

This is common around light fittings and light fitting that have been removed, cable routes and hard to reach roof cavities.

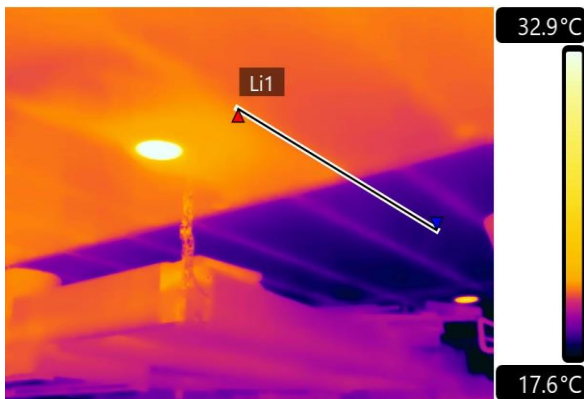
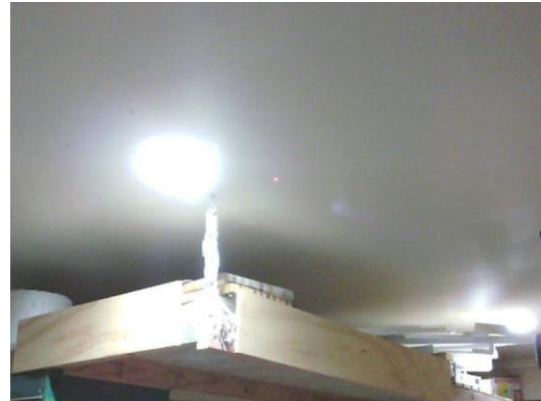
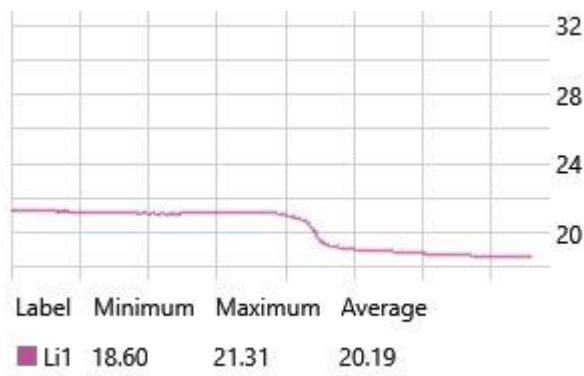
Garage ceiling

Image shows missing insulation in the garage ceiling space.

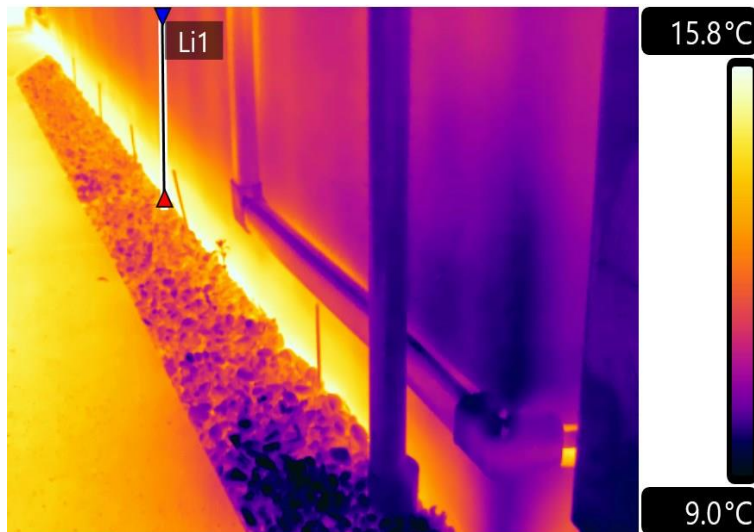
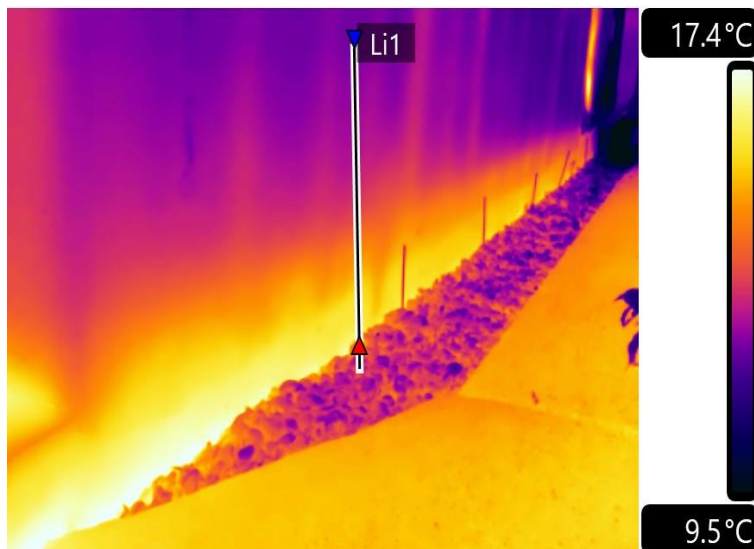
Building Envelope

Images shows clear gap between ground level and the building envelope, preventing moisture from entering the wall cladding due to capillary effect.

This is constant throughout the dwelling.
