NZ Residential Property Inspection Report

Inspection Date: Wed, 17 Apr 2024

Property Address: 7/58 Papanui Road, Merivale, Christchurch
8014, New Zealand

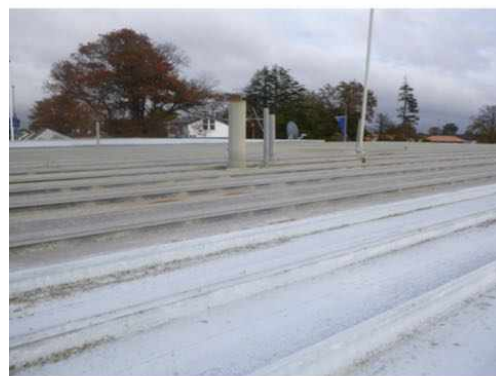
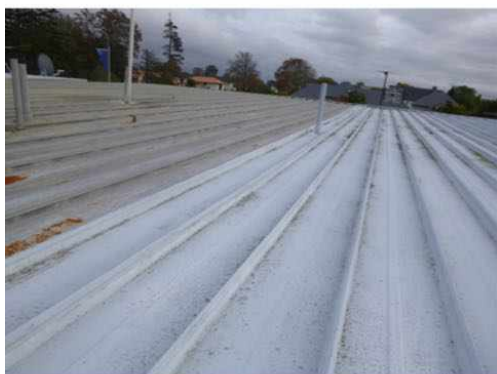
Defects 3.01

Location: Roof Exterior

Finding: Roof - Condition

Information: The visible profiled roof sheets appeared in good condition. As did the gutters and downpipes. All penetrations and flashings appeared installed and sealed adequately.

One area of surface rust was identified. If left unmanaged, this could allow water ingress to the internal roofing structures, potentially leading to secondary damage of building elements. Accelerated deterioration of the roofing sheets and any associated building elements is also likely to occur. It is advised that a professional painter be consulted to carry out works such as the application of rust-retardant surface protectors and roof paint, in the near future.

Note: the roof was visible from a ladder in one area only.

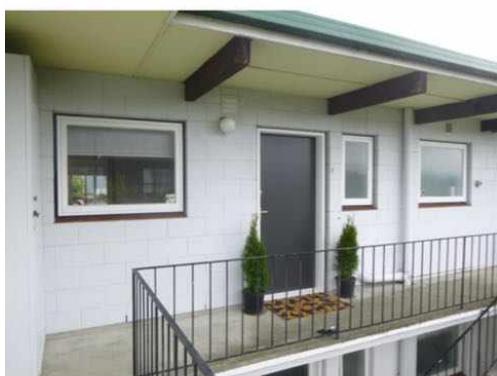
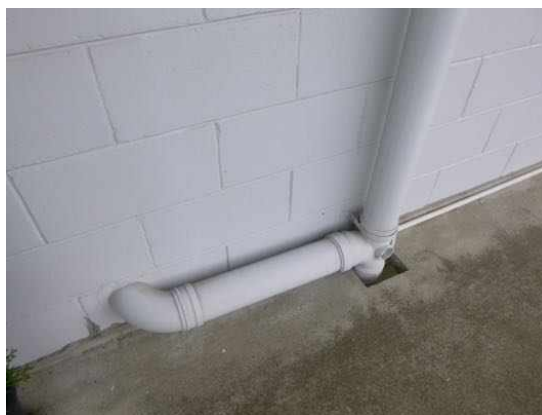
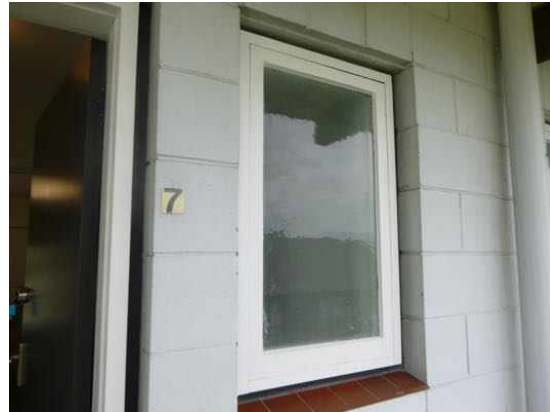
Defects 3.02

Building:	Main Building
Location:	All External Areas
Finding:	Exterior cladding
Information:	The concrete block cladding was in good condition overall, and has been constructed to a good trade standard. The exterior joinery is painted timber frame with single glazing, and timber reveals. All windows and doors were flashed and sealed adequately.

One small hole was identified. This should be sealed.

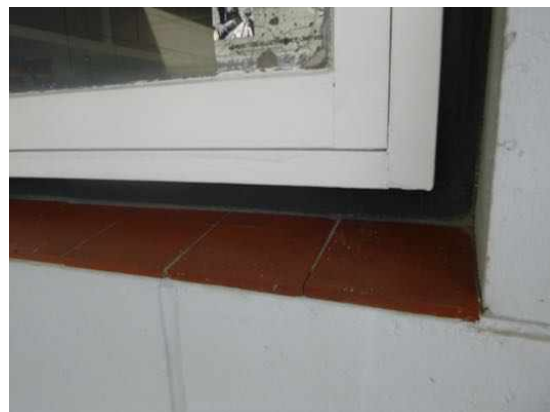
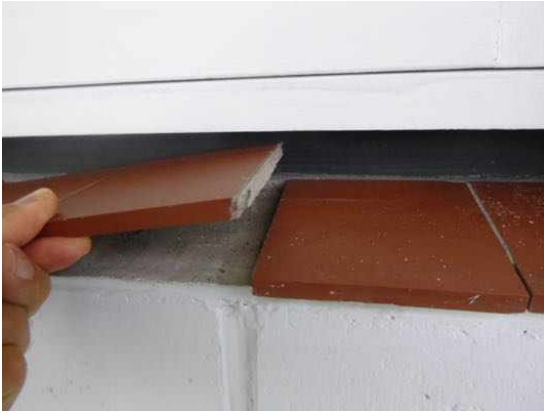
Defects 3.03

Building: Main Building
Location: Kitchen
Finding: Sill tiles - loose
Information: The exterior tiles on the kitchen window sill were loose.

They can be re-glued in place.

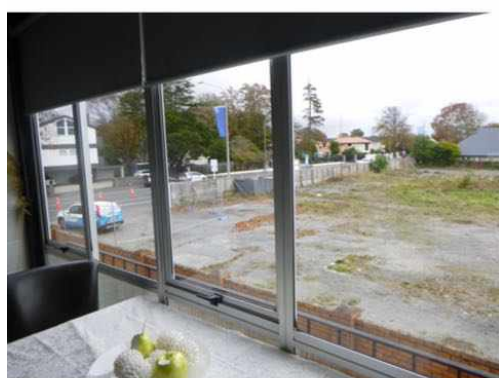
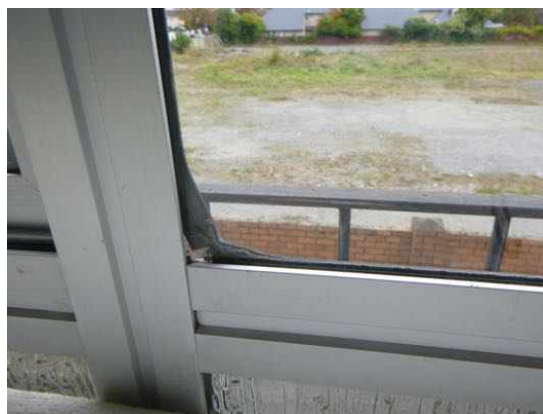
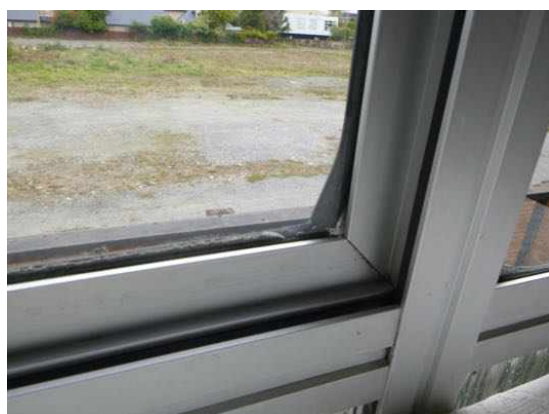
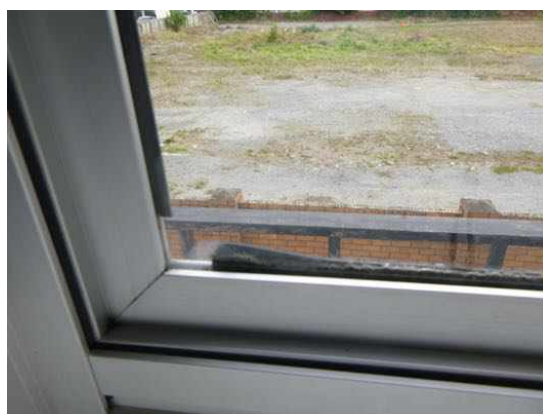
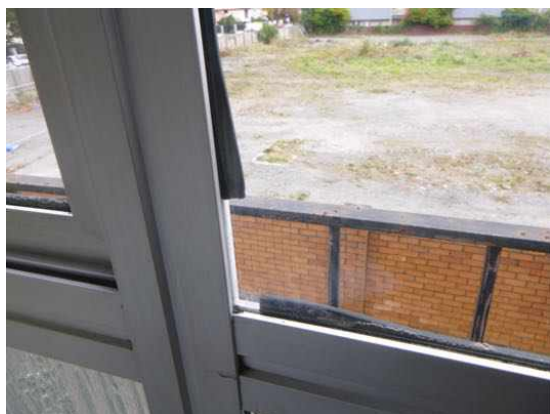
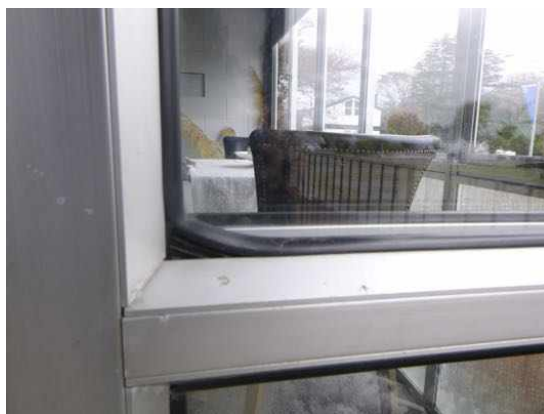
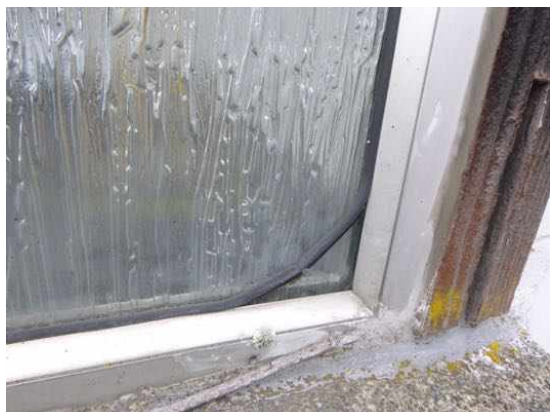
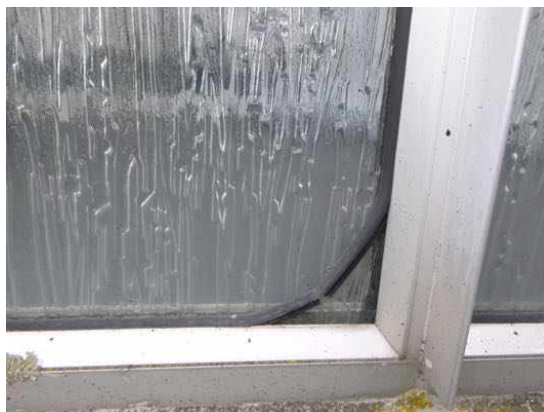
Defects 3.05

Building:	Main Building
Location:	Exterior walls - front
Finding:	Beading - Missing/Deteriorating
Information:	The rubber beading was found to be deteriorating in places around the windows in the conservatory.

Where beading (also known as 'quad' or rubber seals) are missing from glazing, the area is more susceptible to deterioration and decay, and is more likely to allow water ingress.

If the lack of beading or rubber seals is not addressed, the structure will generally age more quickly. This deterioration may subsequently lead to secondary building defects in adjoining building materials, as well as reducing the insulation properties of the window.

A general handyman or window specialist should be appointed to install adequate sealing to this area.

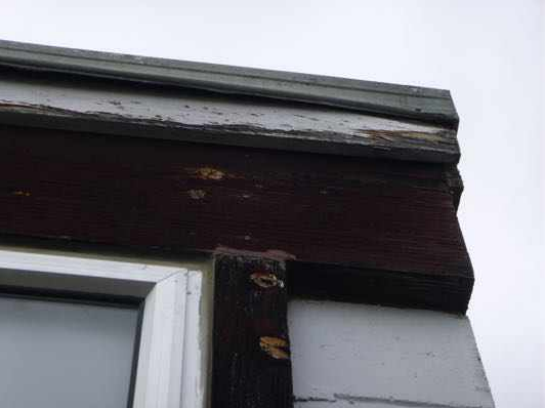
Defects 3.06

Building:	Main Building
Location:	All External Areas
Finding:	Paint finish - Deteriorating
Information:	The paint finish on the timber fascia was found to be deteriorating. Paint deterioration is generally classified as an appearance defect. However, the substandard appearance may also be indicative of poor surface preparation and substandard workmanship.

A painting contractor should be appointed to perform necessary works to aid the appearance of the affected area and to ensure that the area is protected against further deterioration. Alternatively, the homeowner following manufacturer instructions may be able to provide this service.

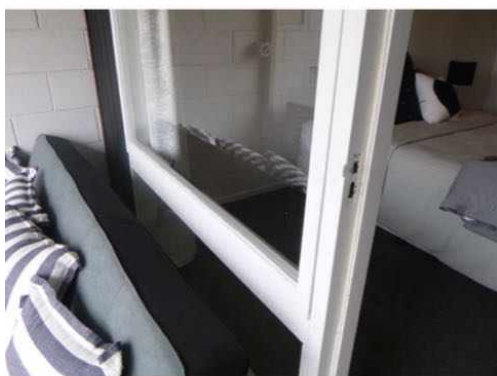
Defects 3.07

Building: Main Building
Location: Bedroom
Finding: Window and door - Jamming
Information: Binding and/or jamming of the bedroom window and door was evident during standard operation. This defect inhibits the functionality, as well as creating potential for secondary defects to associated building elements, and drafts as they don't fully close.

A qualified carpenter or general handyperson should be appointed to perform minor rectification works at client discretion.

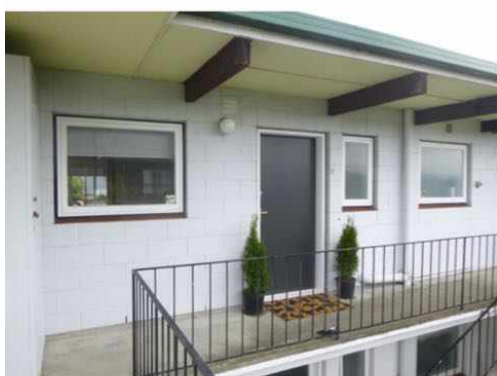
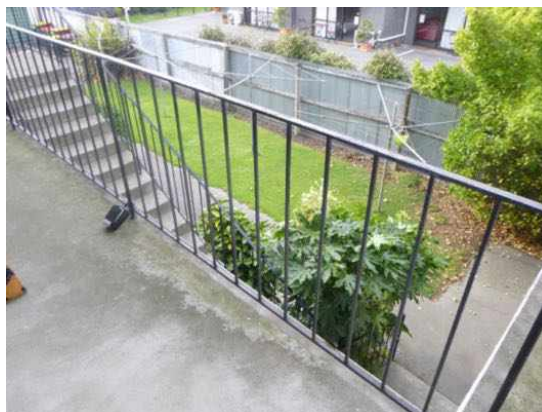
Defects 3.08

Building:	Main Building
Location:	All Areas
Finding:	Balustrade - Suspected Non-Compliance
Information:	The balustrade in this area was found to not be meeting the present building regulation requirements. The height of a barrier should be a minimum of 1000mm from the floor.

As with all constructions, compliance for a particular dwelling need only meet the regulations of the build date and not necessarily future changes to specific building regulations. Some changes to the building regulations are made to ensure the safety of all inhabitants and balustrades are definitely one of those crucial regulations.

The two end posts of the balustrade have rusted through and are movable.

This defect creates a potential safety hazard and should be rectified as to ensure the safety of the area and to meet present building standards and regulations.

A registered builder should be contacted to discuss possible rectification solutions.

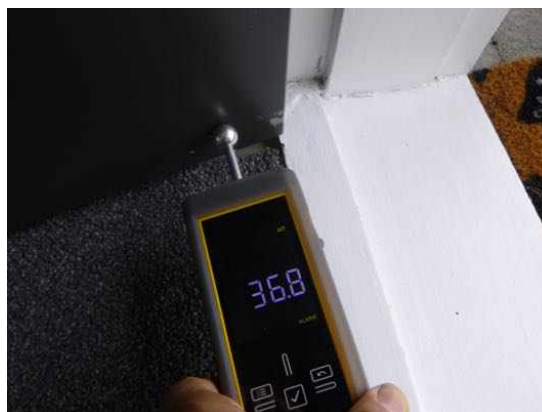
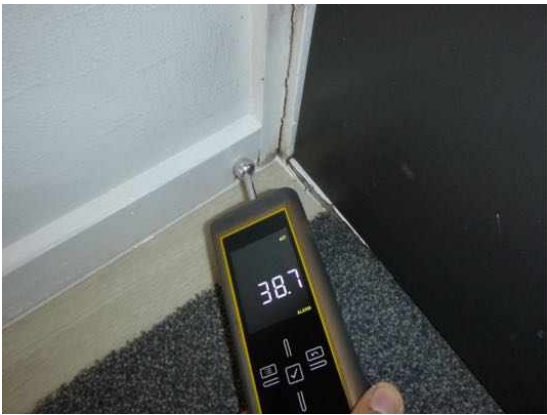
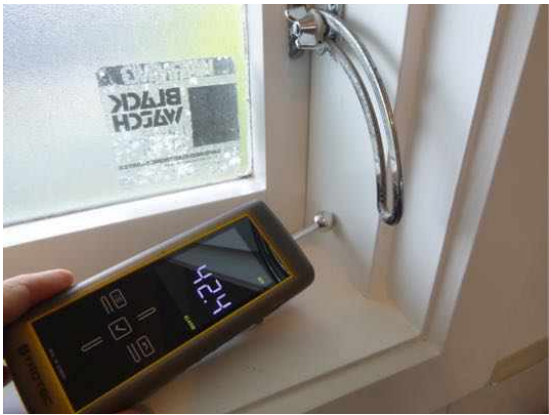
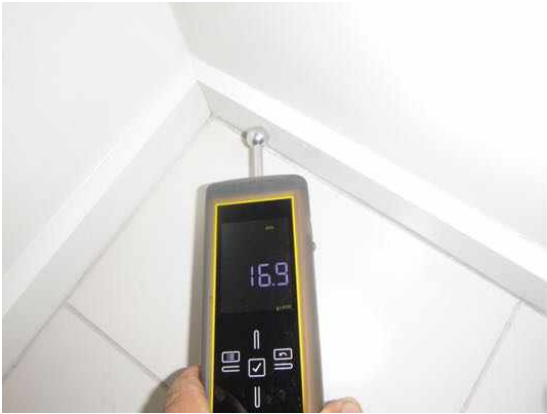
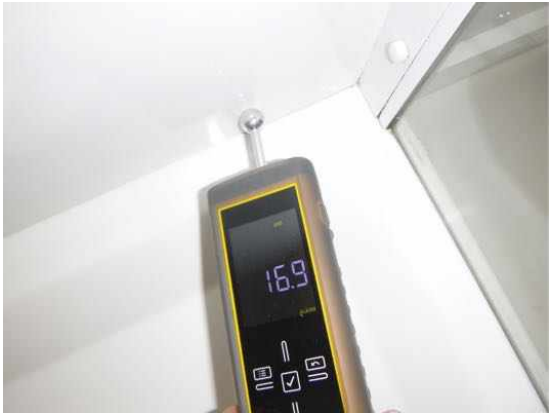
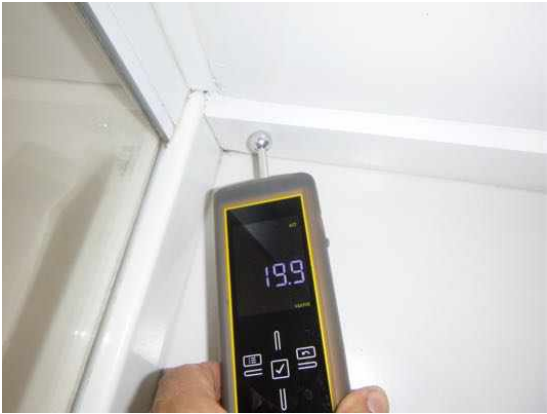
Building: Main Building
Location: All Areas
Finding: Moisture Readings
Information: Moisture readings were taken using a Trotec T660 capacitive non-invasive moisture meter. No indications of any elevated moisture levels were detected.

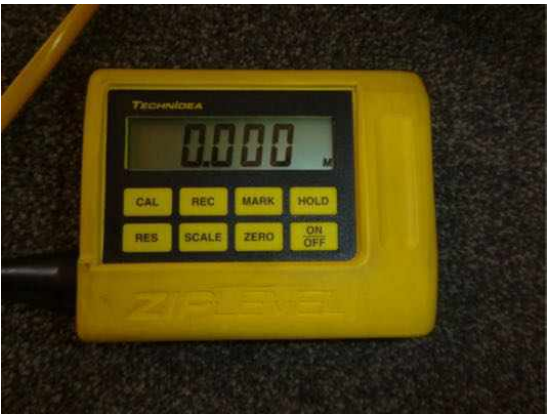
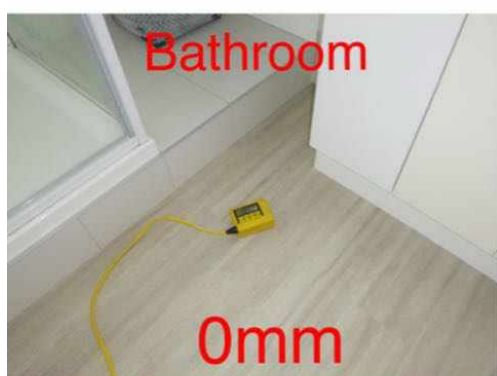
Building: Main Building
 Location: All Areas
 Finding: Floor - Levels
 Information: Basic floor level readings were taken throughout the main floor areas of the dwelling where accessible. (JBI take into account floor covering thicknesses as needed throughout the dwelling)

A high point of +8mm and a low point of -2mm was recorded throughout the house, this gives us an overall variance measurement of 10mm over the property.

This falls within the MBIE guidelines of 50mm over 10 metres.

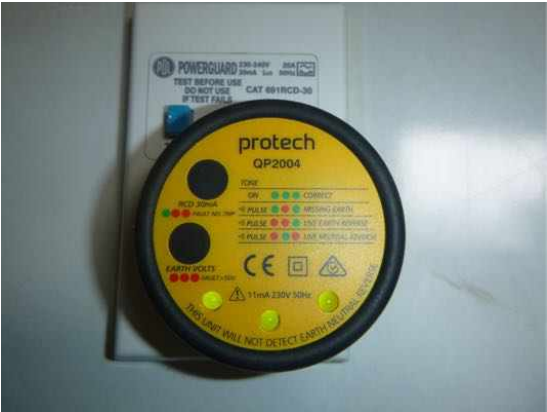
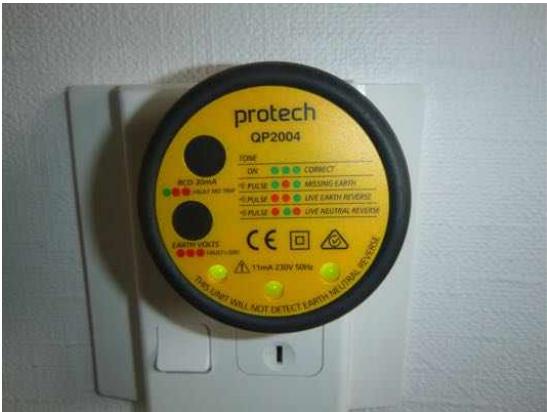
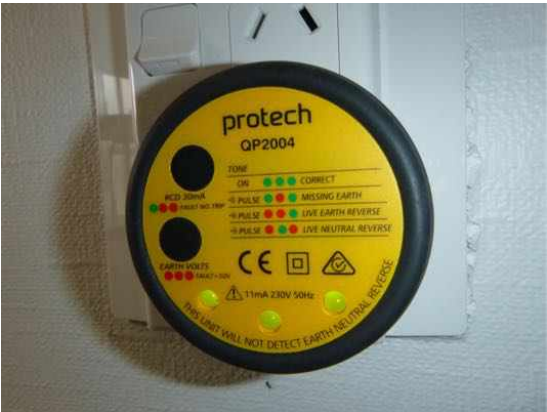
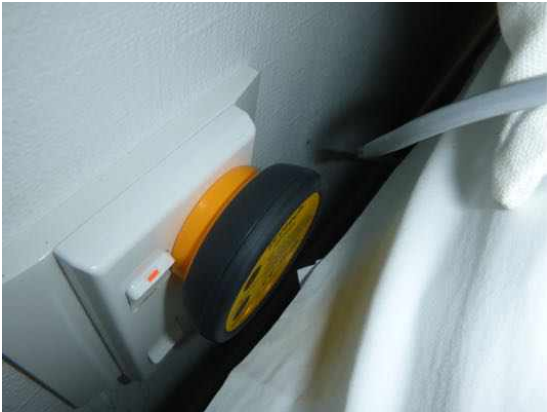
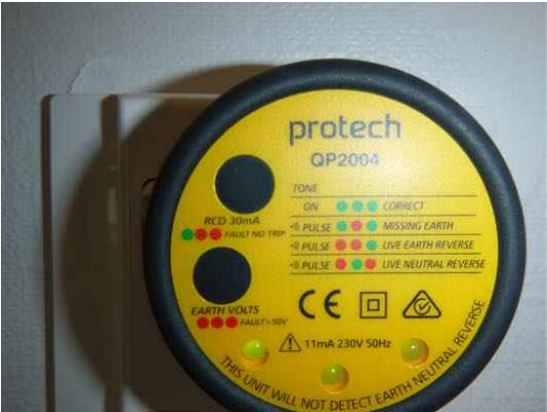
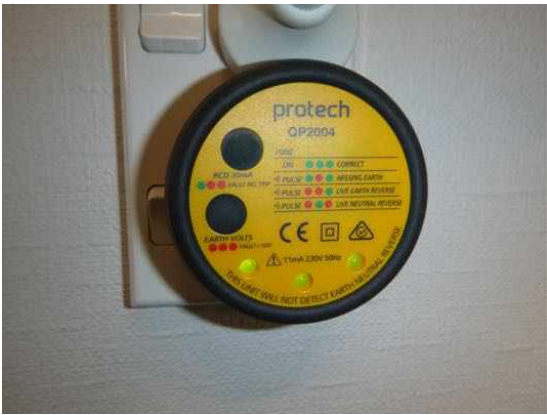
Information: JBI check the basic functions switches and plugs where accessible. We also inspect the general condition of Wires and connections where visible and accessible. Specialist checks should be undertaken by a qualified electrician if desired. JBI cannot comment on whether items meet acceptable electrical codes.

No issues were found during the inspection.
