RESIDENTIAL INSPECTION

145 Mount Pleasant Rd
Christchurch, Canterbury 8081

10/04/2025

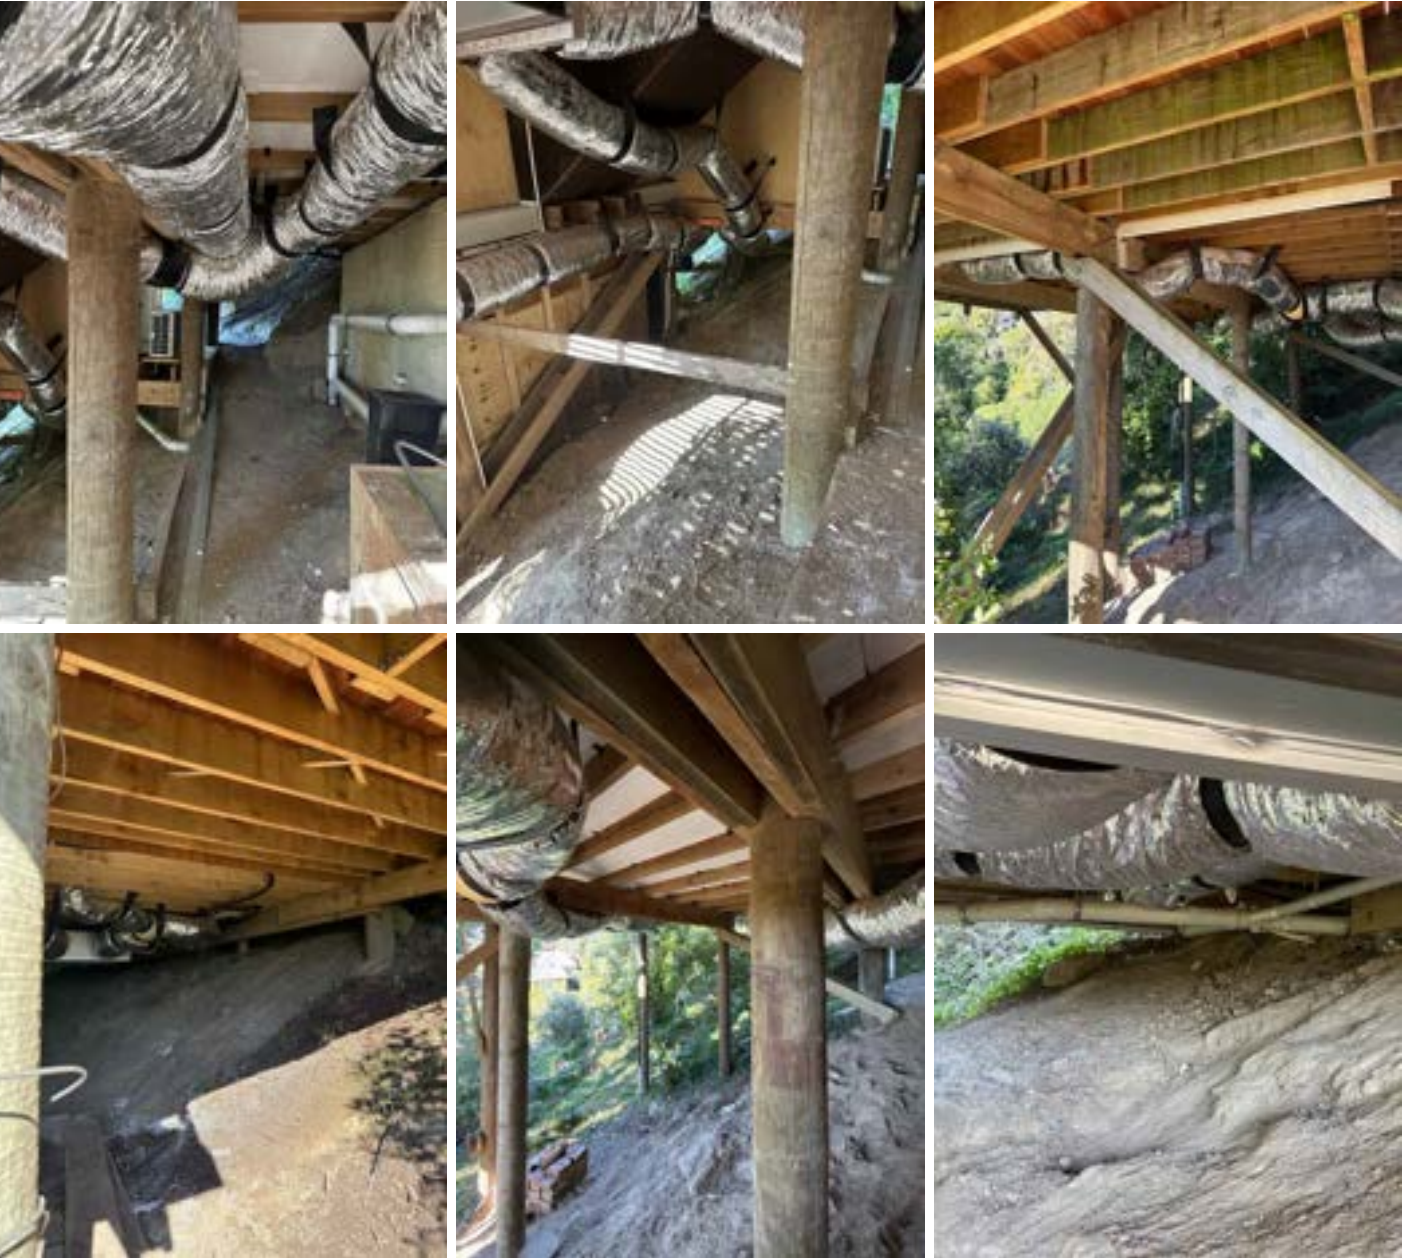
Spot floor levels were taken. An approximate variation of 30mm was recorded. This measurement is within MBIE guidelines which state a maximum allowable variation of 50mm across the floor plate.
