## INSPECTION REPORT

Consent No: **BC130618**

Address: **4 Walnut Drive, Motueka**

**29 FINAL INSPECTION: INTERIOR/EXTERIOR/CERTS CCC NEW RESIDENTIAL DWELLING WHEN CONSTRUCTION HAS BEEN COMPLETED & CCC APPLICATION RECEIVED WITH REQUIRED FINAL DOCUMENTATION**

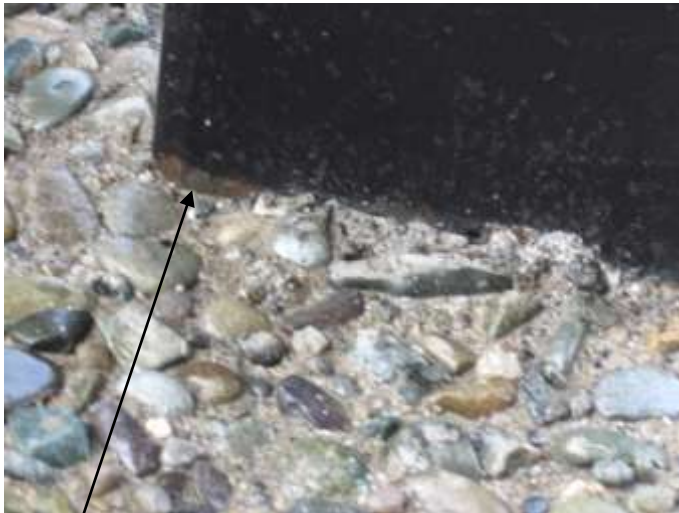
The provided PS1 dated 28/05/10 the address as Fearon Street and covers both clauses B1 and B2. The provided PS4 only relates to Clause B1. Also, the SHS sections appear to have rust developing at the base, there does not appear to be indication of the required 3 coats of flint-cote up to 200mm above the concrete. Please confirm. Also please have the engineer include the stack bond masonry and foundation reinforcing on the PS4

post, rust starting

No indication of Flint-cote at base of

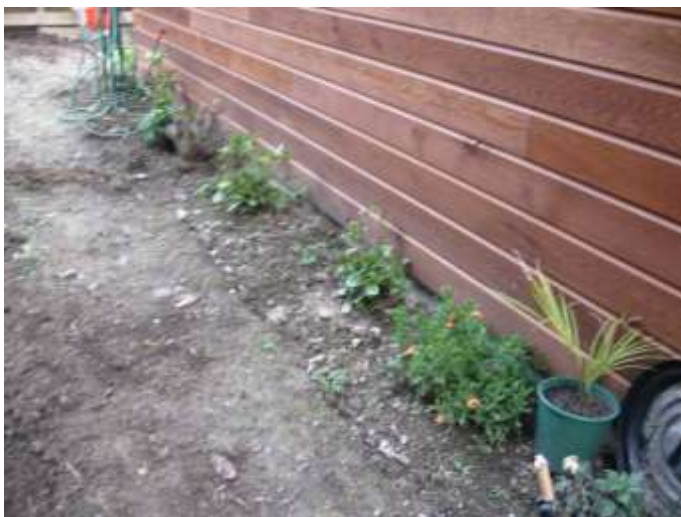
Please clear ground levels at rear of the house. 175mm from the bottom of the W/board to open ground is required for compliance.

Please correct ground levels
