RE UNAPPROVED BUILDING WORK

REPORT FOR TASMAN DISTRICT COUNCIL

ADDRESS 45 King Edward Street Motueka.

WORK Relocate Kitchen and create an opening between two rooms.

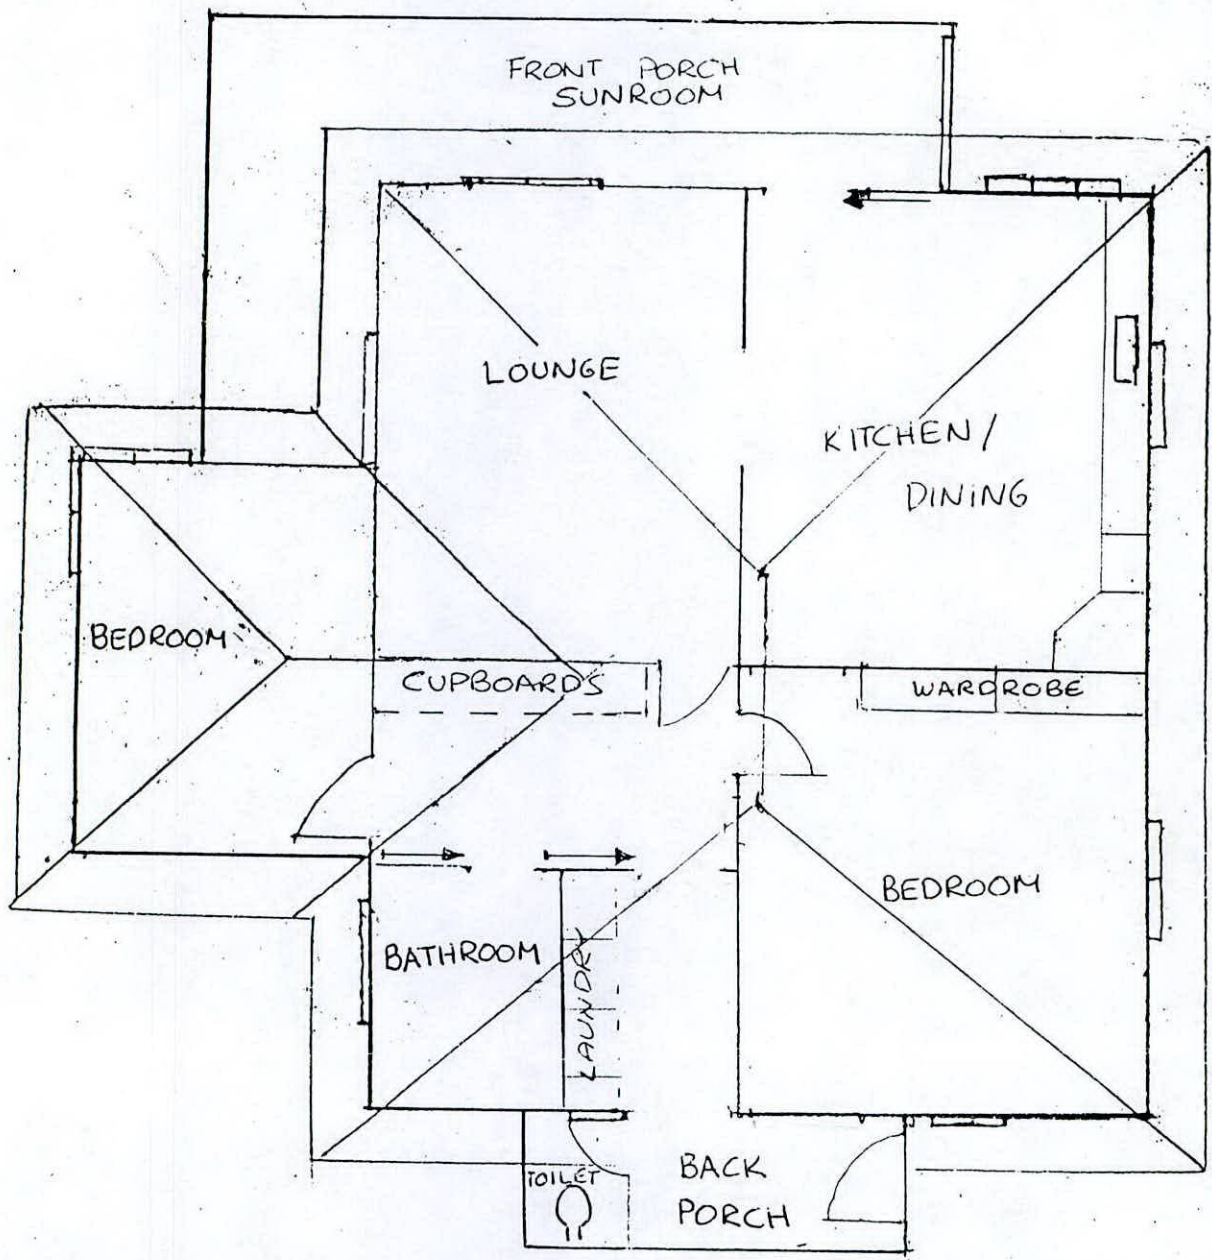
45 KING EDWARD ST

SPECIFICATION As shown on the attached plans provided by the owner the kitchen has been relocated to the front of the dwelling and an opening has been formed in the wall between the new kitchen and a new lounge.
The opening between the kitchen and lounge has a double 150 x 50 as a lintel over the opening that is 1250 wide.
Above the opening there is a 250mm depth of wall lining.
New kitchen facilities were put in place as shown on the photo.
The original pipe work to the kitchen has been extended to the new position and the waste under the dwelling has also been extended.
An air admittance valve is to be put in place at the head of the waste pipe due to the length.
The new lounge and kitchen rooms have been relined with gib and redecorated.

double 6x2 Douglas
above opening & window
Re giberd.

REMEDIAL WORK An air admittance valve is to be put on the waste.
