**171 TAYLOR
STREET,
CAMBRIDGE**

**PRELIMINARY
GEOTECHNICAL
ASSESSMENT**

PROJECT NO: HD1934
KOTARE CONSULTANTS
REFERENCE: PCR
09 APRIL 2021

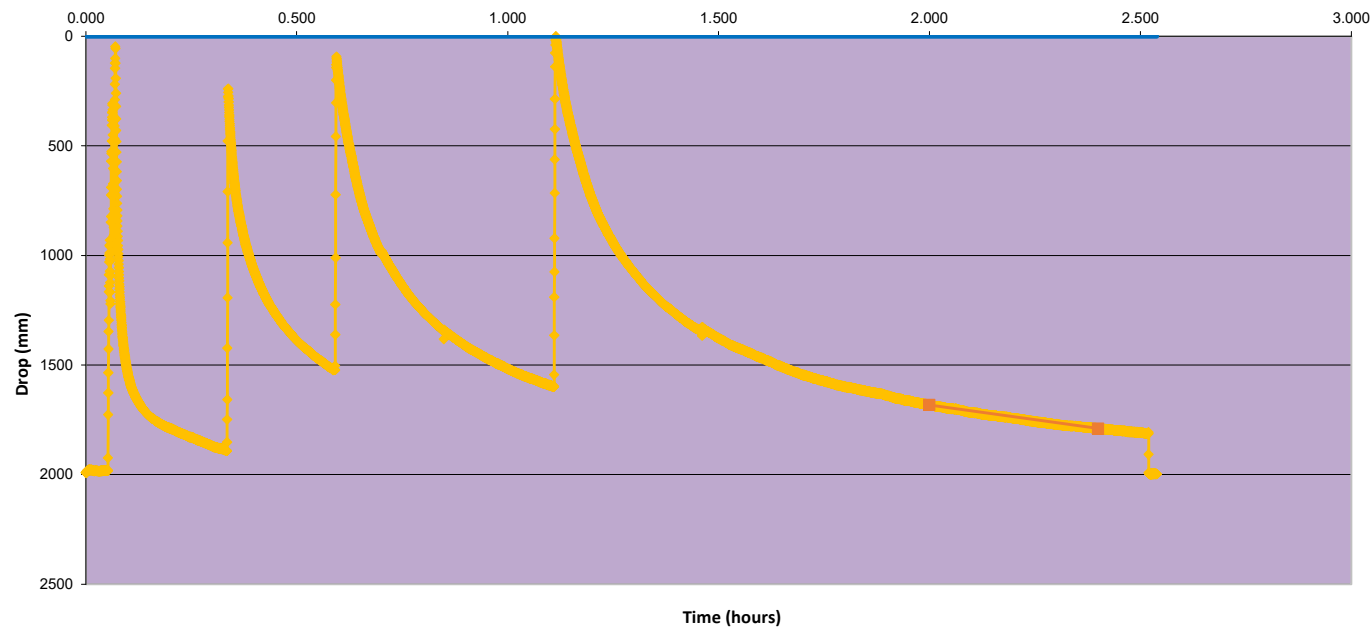
ST01

The design soakage rates shown are below the minimum soakage threshold of 150 mm/hr specified in the RITS. Based on the soakage rate and soils encountered we consider disposal of stormwater via soakage not viable for the proposed lot. We recommend a detention type system with a slow release to the kerb.

Percolation rate = 268 mm/hr
50% Percolation rate = 133 mm/hr

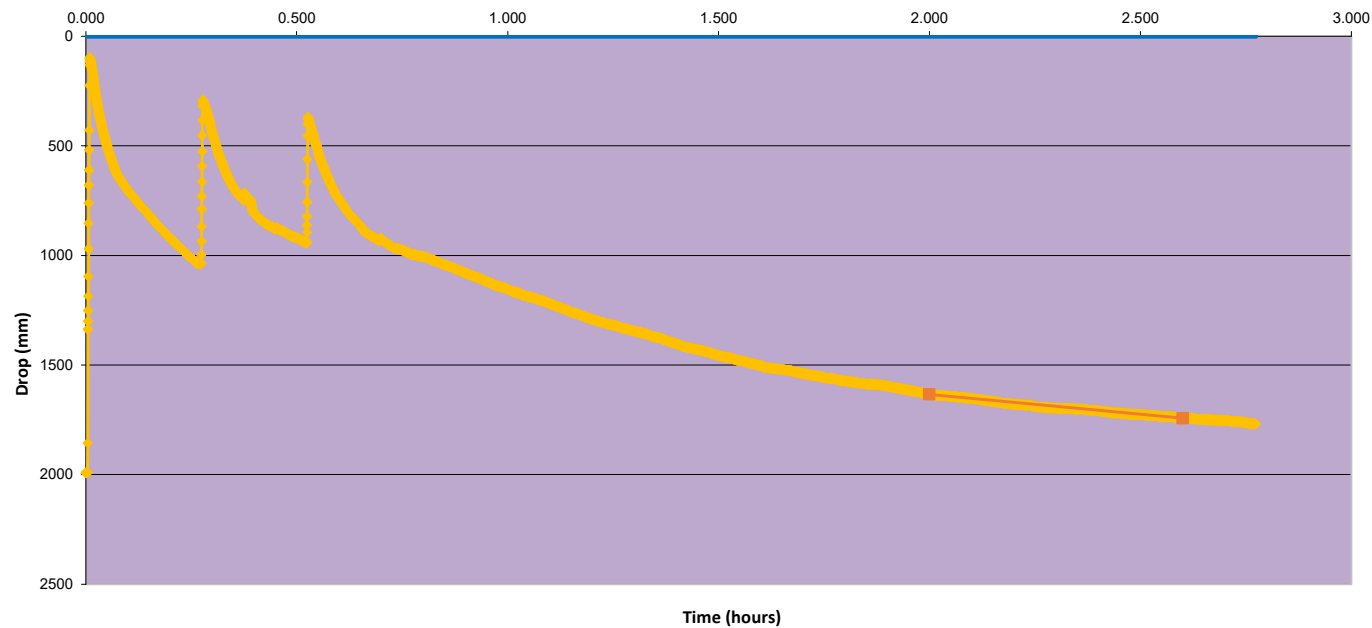
ST02

Percolation rate = 182 mm/hr
50% Percolation rate = 90 mm/hr

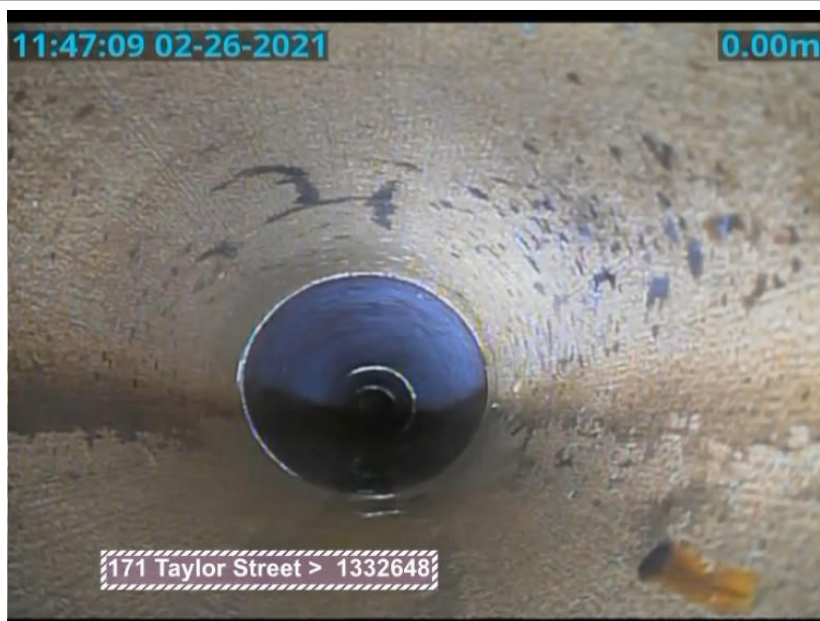
171 Taylor Street						
0.00m (25.49m)	IS	00:05	Inspection Start			
1.63m (23.86m)	2 JFL	00:17	Joint, Faulty, Large, 3-11 o'clock, Joint has root intrusion .

Joint, Faulty, Large, 3-11 o'clock, Joint has root intrusion .

Position 1.63m

Code abbreviations JFL

Damage category

25

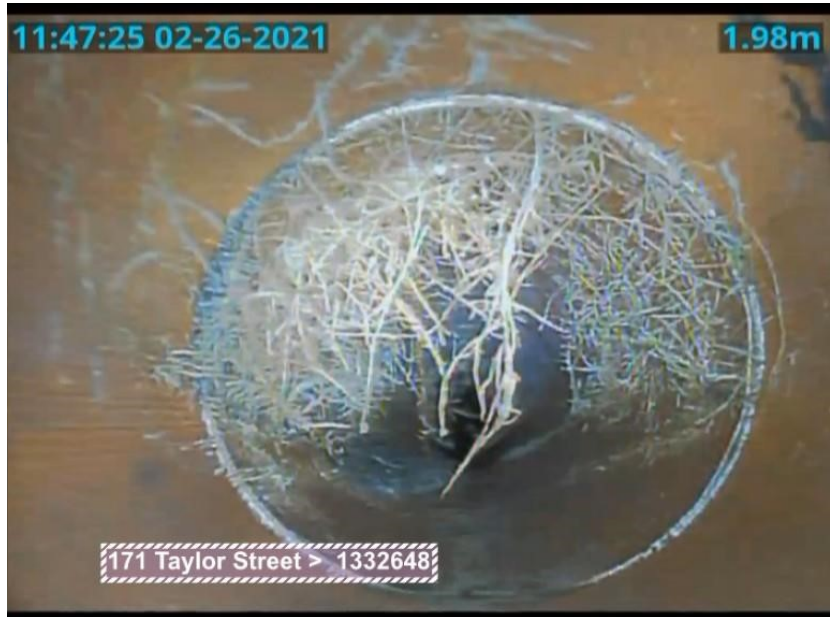
1.63m (23.86m)	5 RIS	00:17	Root Intrusion, Small, 8-3 o'clock			
2.31m (23.18m)	1 JFS	00:21	Joint, Faulty, Small, 8-3 o'clock, Joint has root intrusion .

Code abbreviations JFS

Damage category 1

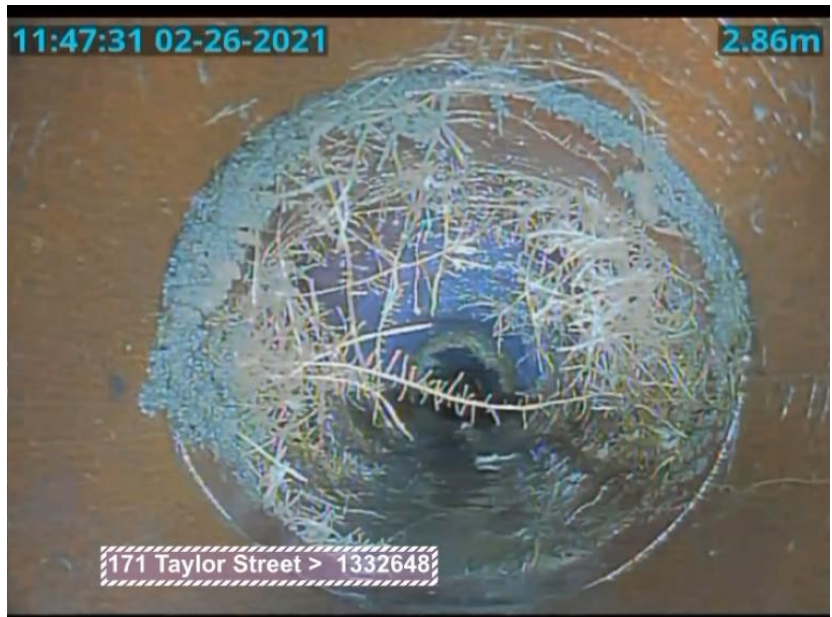
2.31m (23.18m)	5 RIS	00:21	Root Intrusion, Small, 8-3 o'clock			
2.86m (22.63m)	2 JFL	00:27	Joint, Faulty, Large, 12-12 o'clock, Circumferential crack in joint zone and root intrusions.

Joint, Faulty, Large, 12-12 o'clock, Circumferential crack in joint zone and root intrusions.

Position 2.86m

Code abbreviations JFL

Damage category 25

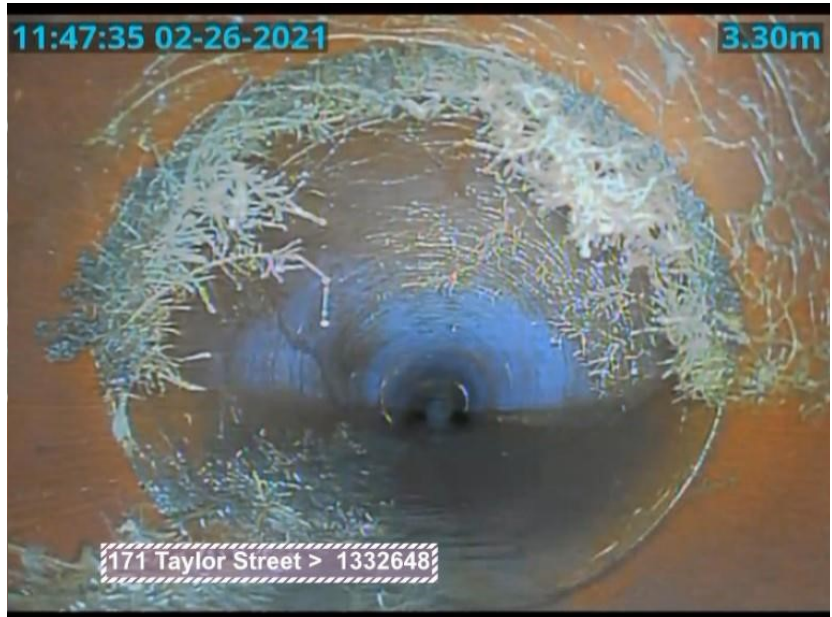
2.86m (22.63m)	5 RIS	00:27	Root Intrusion, Small, 12-12 o'clock			
3.50m (21.99m)	2 JFL	00:31	Joint, Faulty, Large, 9-3 o'clock, Joint has root intrusion .

Code abbreviations JFL

Damage category 25

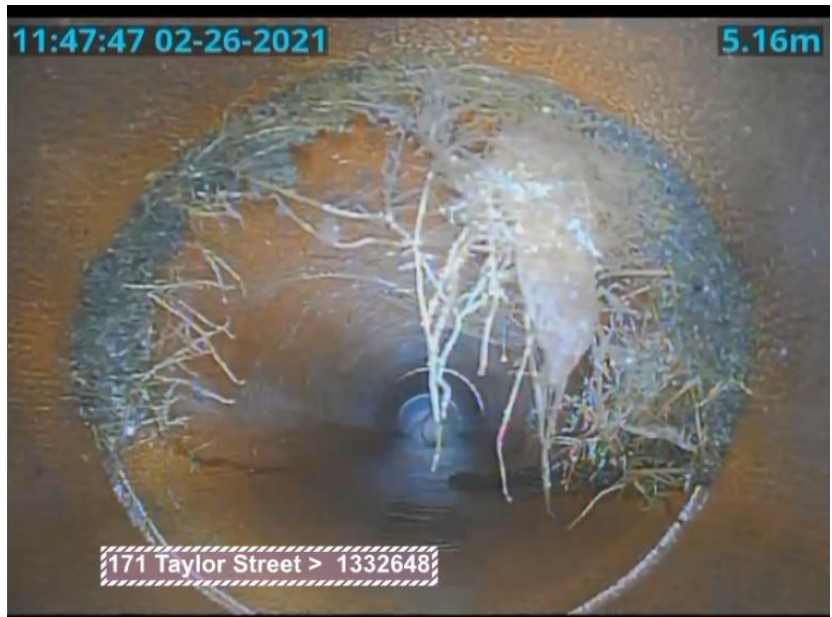
3.50m (21.99m)	5 RIS	00:32	Root Intrusion, Small, 9-3 o'clock			
5.49m (20.00m)	2 JFL	00:42	Joint, Faulty, Large, 9-3 o'clock, Joint has root intrusion .

Joint, Faulty, Large, 9-3 o'clock, Joint has root intrusion .

Position 5.49m

Code abbreviations JFL

Damage category 25

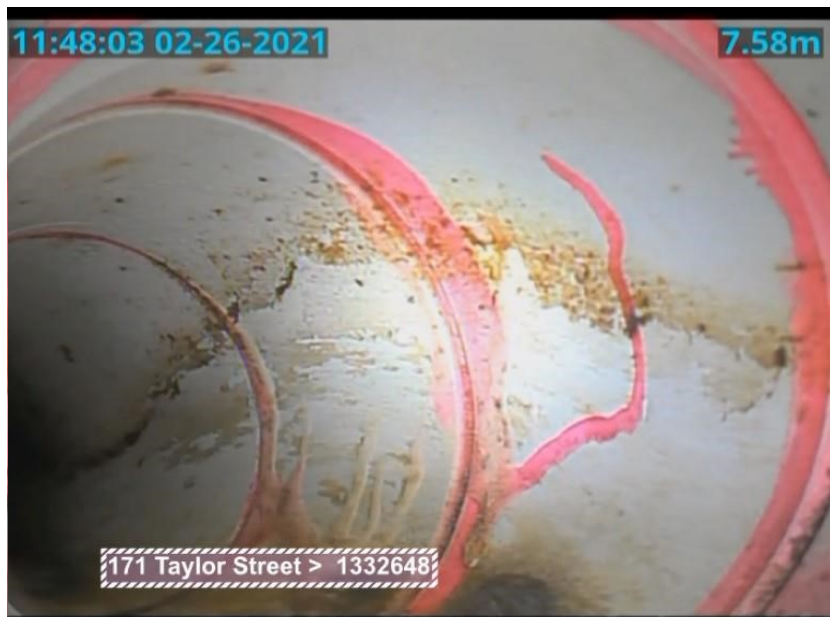
Line Deviates, Left

Position 7.98m

Code abbreviations LL

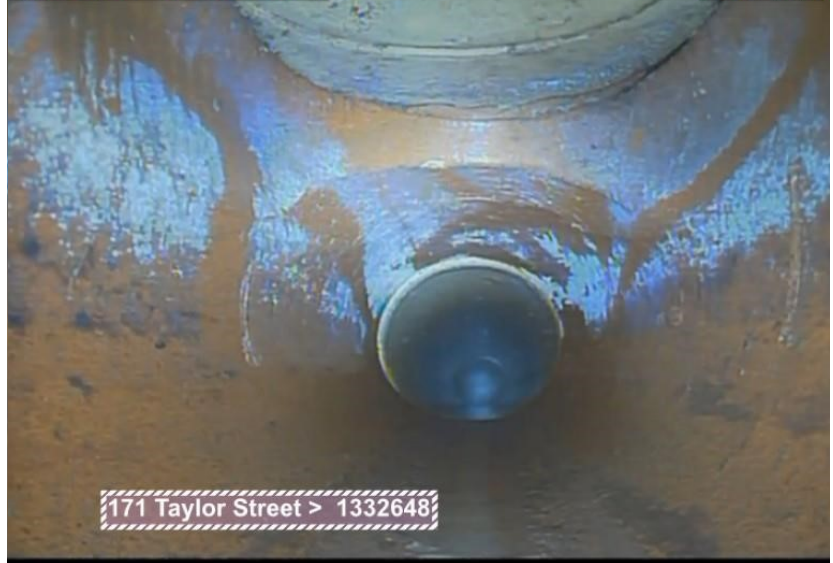
Construction Feature, 11-1 o'clock Inspection Lid.

Position 23.77m
