**GEOTECHNICAL SUITABILITY OF PROPOSED HOUSE SITE
25 DARWIN ROAD, OUTER KAITI, GISBORNE
GEOTECHNICAL INVESTIGATION REPORT**

Report Prepared for: Malcolm Galloway

Date: 31/05/22

AG Ref: 0150 - 1

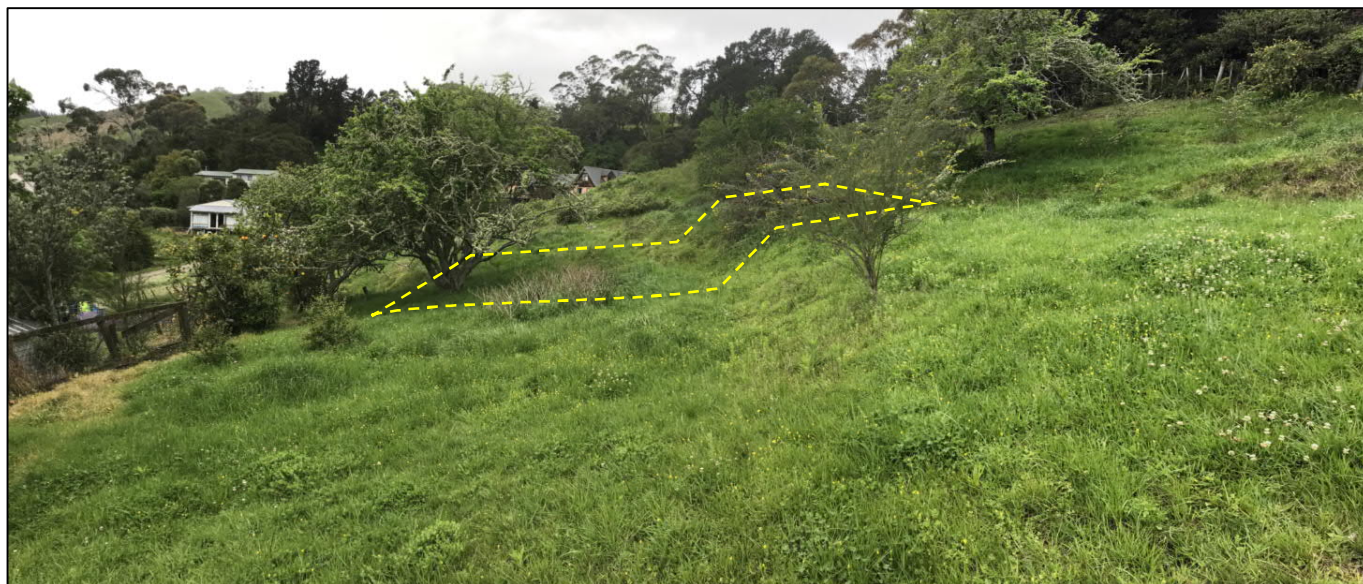
Figure 4: View southeast over property and indicative position of possible house site (dashed yellow outline).

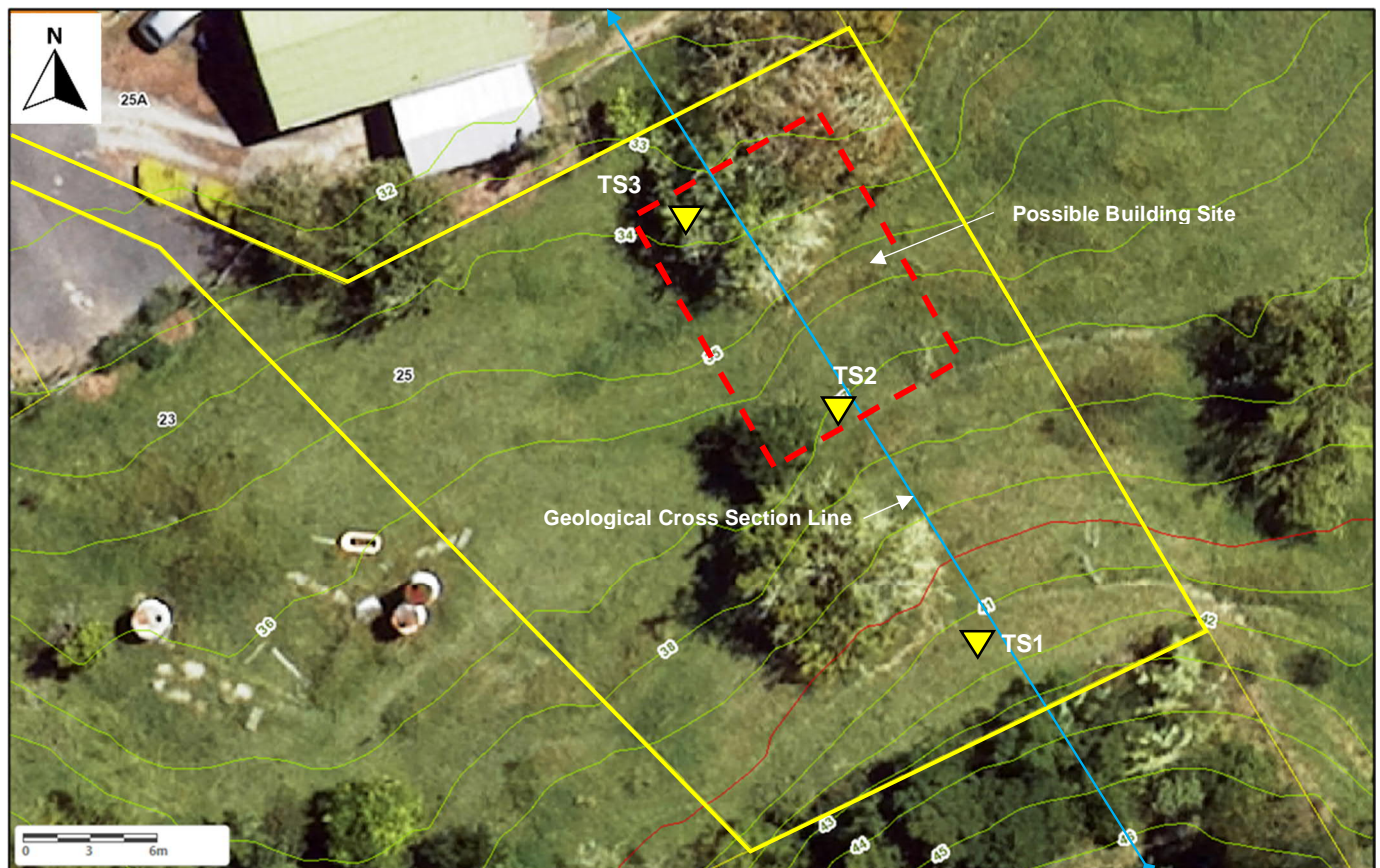
The locations of the site investigations are shown within Figure 5. The site investigation logs are appended.

Figure 5: Geotechnical Investigation Plan. Property boundary line indicated with bold yellow line. Proposed building site indicated with bold dashed red outline. Slope profile used in numeric stability analyses indicated with blue line. Each test site (yellow triangle) correlates to a hand auger and dynamic cone penetrometer test location. Fine green and red lines correlate to LiDAR contour lines at 1m intervals. Image source: Tairawhiti Maps¹.

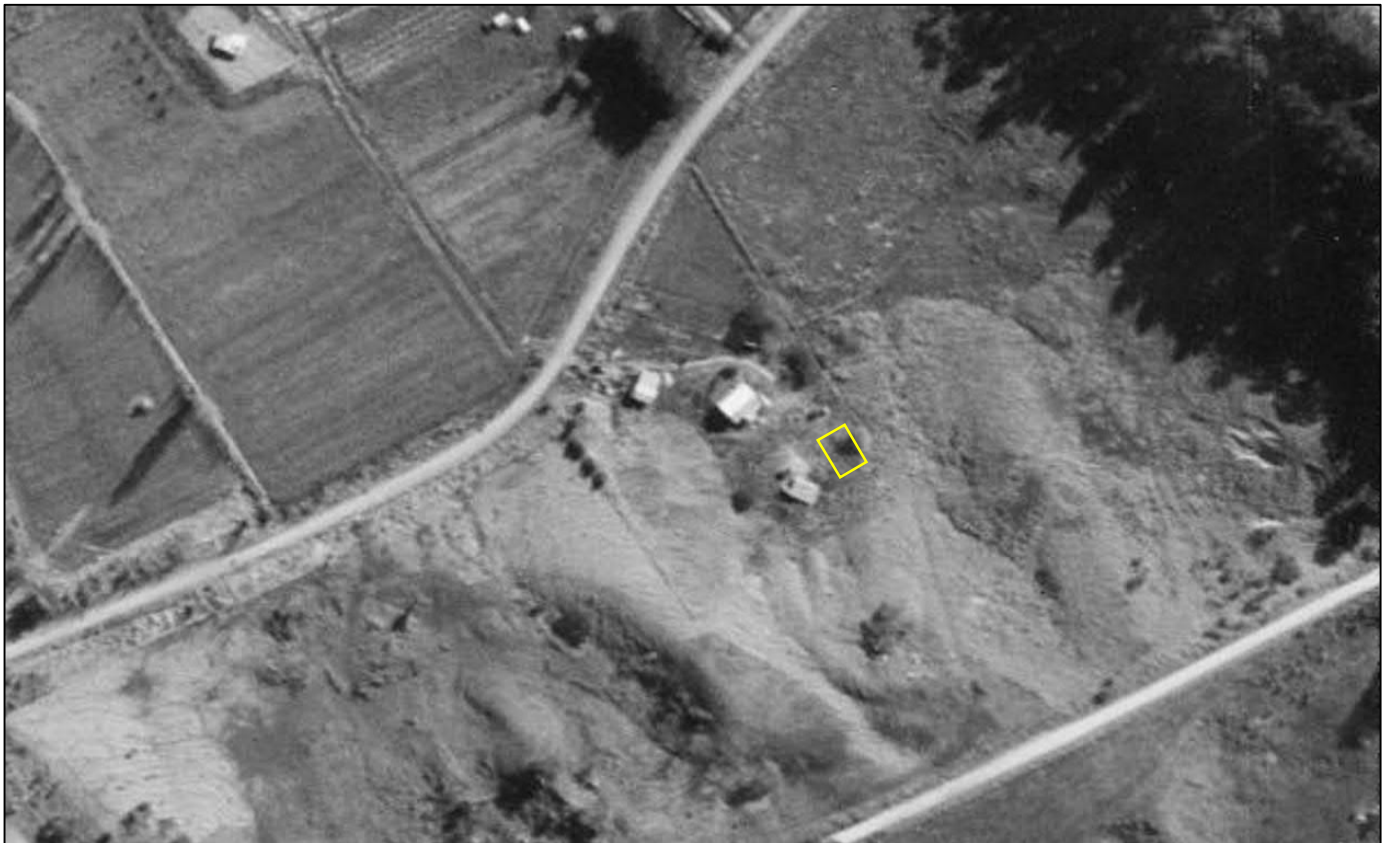
the property immediately up slope, evidence of historic shallow seated instability can be observed in the 1953 aerial photographs in the steeper parts of the hillside to the southwest and southeast in the form of localised undulating ground and arcuate landslip scars. However these areas and possible run-out zones below, are offset from the proposed house site. On this basis we consider that the proposed site is at a low risk of being affected by inundation or evacuation landslippage from the properties above and below, during a standard residential building's design life.

On a localised scale, undulating ground, terracettes, tension cracks or other evidence of indicative of instability were not identified above, within, or below the site, which is consistent with the general high strength nature of the ground encountered in the site investigation from a shallow depth. The only area within the house site zone considered to be at risk of possible ground movement comprises the localised wedge of fill and buried topsoil located on the outside edge of the historic farm track which traverses through the site. This wedge is standing at a relatively steep grade of some 40° and may be at risk of movement as a result of an extreme weather or seismic event. This is expected to be able to be address through site preparation/remediation works. There was no other evidence of instability identified above, within or below the house site within the image review or walkover assessment.

Figure 6: 1953 aerial image of property and surrounding area. Approximate proposed house site position indicated with yellow rectangle.

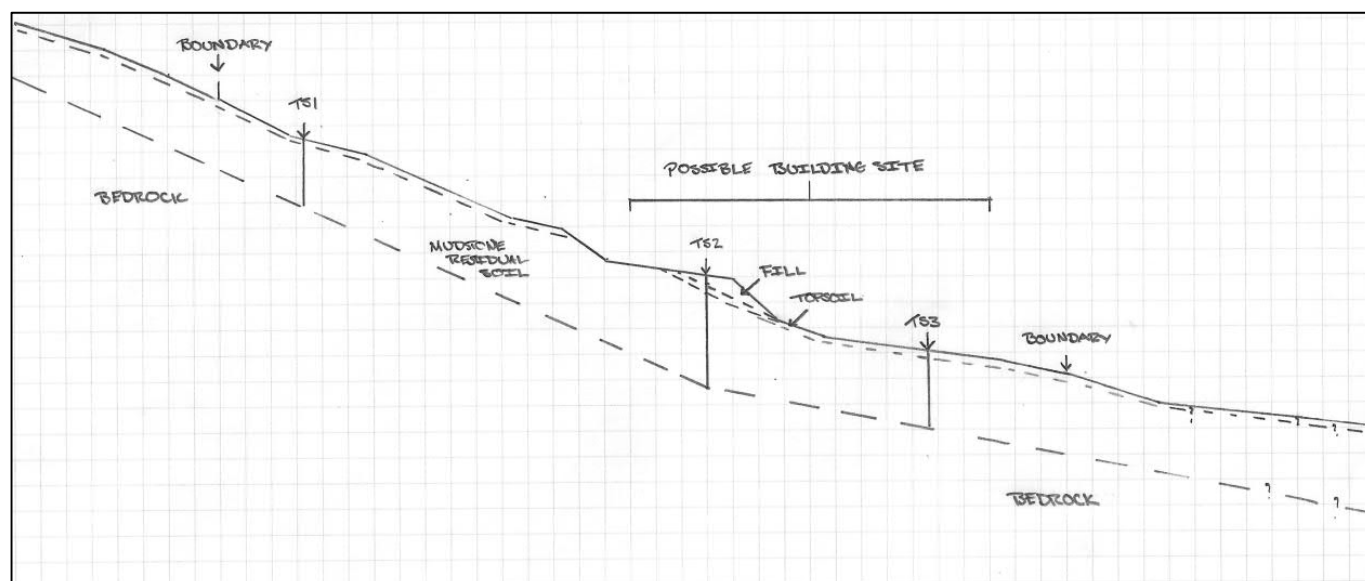
Figure 7: Geological cross section through possible building site.

To confirm the localised stability of the land above, within, and below the proposed house site, we have undertaken numeric slope stability analyses on the site using specialist geotechnical software (Slide). The assessment was carried on a model developed of the underlying geology, using the site testing data and site profile survey information. The location and orientation of the slope profile analysed is shown in Figure 5. The geological model utilised in the analysis is shown in Figure 7.

- Under prevailing ground water conditions all slip surfaces FoS values are shown to exceed 1.5.
- Under extreme groundwater conditions (fully saturated) slip surface FoS values as low as 0.97 are shown indicating failure. These slip surfaces and slip surfaces less than 1.2 are shown to be isolated to the wedge of fill within the site (on outside edge of historic farm track).
- Under SLS seismic loads, all slip surface FoS values are shown to exceed 1.0.
- Under a significant Ultimate Limit State event all slip surface FoS values are shown to exceed 1.0.

Based on the stability assessments measures are considered to be required to address the wedge of fill (and topsoil beneath) which exists within the building site. Recommendations regarding this are outlined in Section 7. Summary printouts of the critical stability assessment results are appended to this report.

Based on the work carried out, and provided that the wedge of fill and underlying topsoil within the proposed house site is removed (where required), foundation extension down to a minimum depth of 0.6m below ground level into the underlying residual mudstone soils is considered appropriate. At the recommended foundation depth, the topsoil

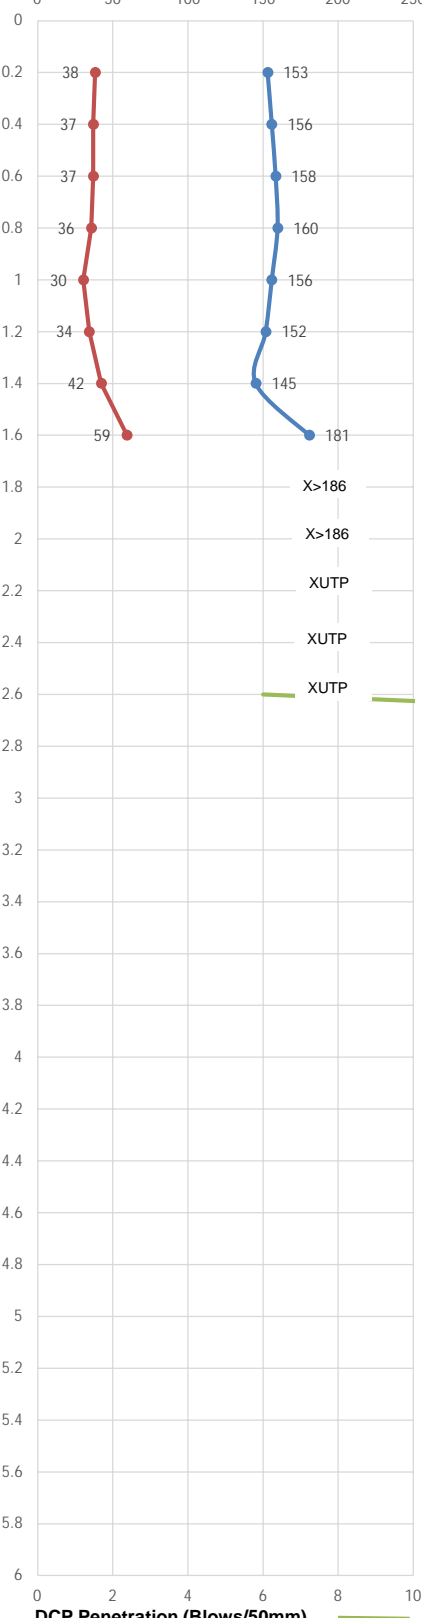
</div>
0.0		D-M	VSt	SILT, some clay, dark grey, very stiff, dry to moist	Topsoil

0.1						
0.2		D-M	VSt	SILT, clayey, light brown, very stiff, dry to moist	Mudstone Residual Soil	
0.3						
0.4						
0.5						
0.6						
0.7						
0.8

0.9						
1.0				minor highly to completely weathered fine angular mudstone gravel		
1.1						
1.2						
1.3						
1.4						
1.5						
1.6						
1.7						
1.8			VSt-H	very stiff to hard		X>186

1.9						
2.0						X>186
2.1						
2.2						XUTP
2.3						
2.4		D-M	H	SILT, clayey, light brown to grey, difficult to auger, some highly to completely weathered mudstone gravel, hard, dry	Mudstone Regolith	XUTP

2.5						XUTP
2.6				End of borehole @ 2.6m		
2.7				Cannot advance through high strength ground		
2.8				DCP put down in base (instant refusal - 14 blows/50mm recorded)

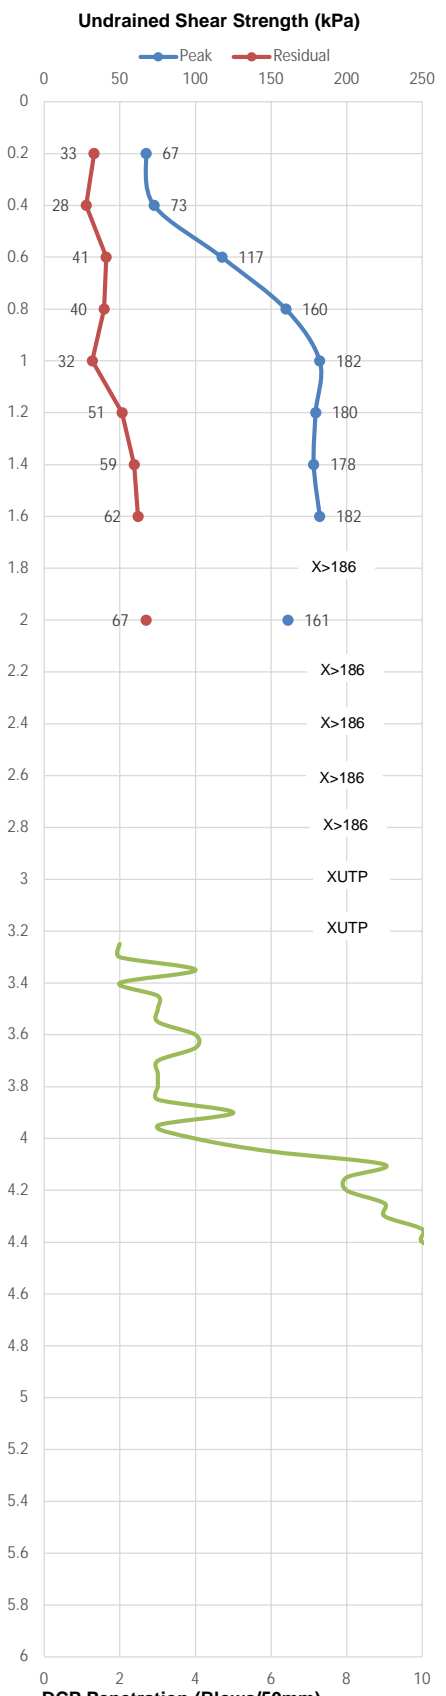
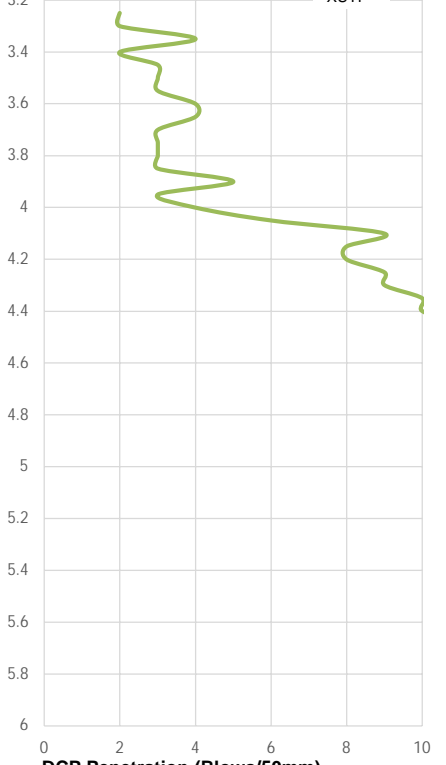
Depth (m)	Colour	Moisture	Strength	Description	Geology	Undrained Shear Strength (kPa)
0.0		M	VSt	SILT, some clay, minor fine to medium pumice sand, dark grey with minor orange brown, stiff, moist	Topsoil Fill

0.1						
0.2						
0.3		M	VSt	SILT, some clay, dark grey, stiff, dry to moist	Buried Topsoil	
0.4						
0.5		D-M	VSt	SILT, clayey, light brown, very stiff, dry to moist	Mudstone Residual Soil

0.6						
0.7						
0.8				mottled orange brown and light brown, minor highly to completely weathered fine angular mudstone gravel		
0.9						
1.0						
1.1

1.2						
1.3						
1.4						
1.5						
1.6						
1.7						
1.8			VSt-H	very stiff to hard		
1.9						
2.0						
2.1						
2.2						
2.3						
2.4						
2.5				some highly to completely weathered fine angular mudstone gravel

2.6						
2.7						
2.8						
2.9						
3.0				difficult to auger		
3.1				cannot advance through very high strength ground		
3.2				End of borehole @ 3.25m

3.3				Cannot advance through high strength ground		
3.4				DCP put down in base and advanced to refusal (4.4m)		
3.5				Hole dry on completion		
3.6

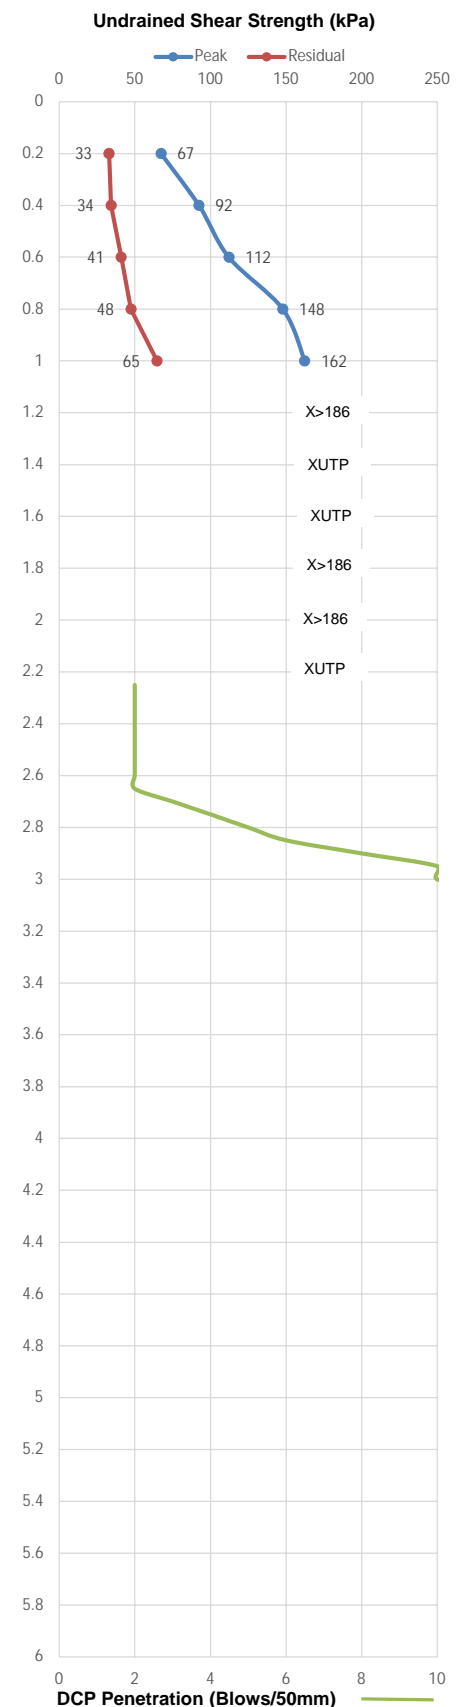
0.0		M	VSt	SILT, some clay, dark grey, moist	Topsoil	
0.1						
0.2						
0.3						
0.4		M	St	SILT, clayey, some fine to medium pumiceous sand to 0.6m, mottled orange brown and light brown, stiff, moist	Mudstone Residual Soil

0.5						
0.6			VSt	very stiff		
0.7				minor highly to completely weathered fine angular mudstone gravel		
0.8						
0.9						
1.0						
1.1						
1.2			VSt-H	very stiff to hard

1.3						
1.4						
1.5						
1.6						
1.7						
1.8						
1.9				some highly to completely weathered fine angular mudstone gravel		
2.0				difficult to auger

2.1				cannot advance through very high strength ground		
2.2				End of borehole @ 2.2m		
2.3				Cannot advance through high strength ground		
2.4				DCP put down in base and advanced to refusal (3m)
