ALLIED GEOTECH LTD

**GEOTECHNICAL SUITABILITY OF POTENTIAL HOUSE SITE  
23 DARWIN ROAD, OUTER KAITI, GISBORNE  
GEOTECHNICAL INVESTIGATION REPORT**

Report Prepared for: Malcolm Galloway

AG Ref: 0150 - 2

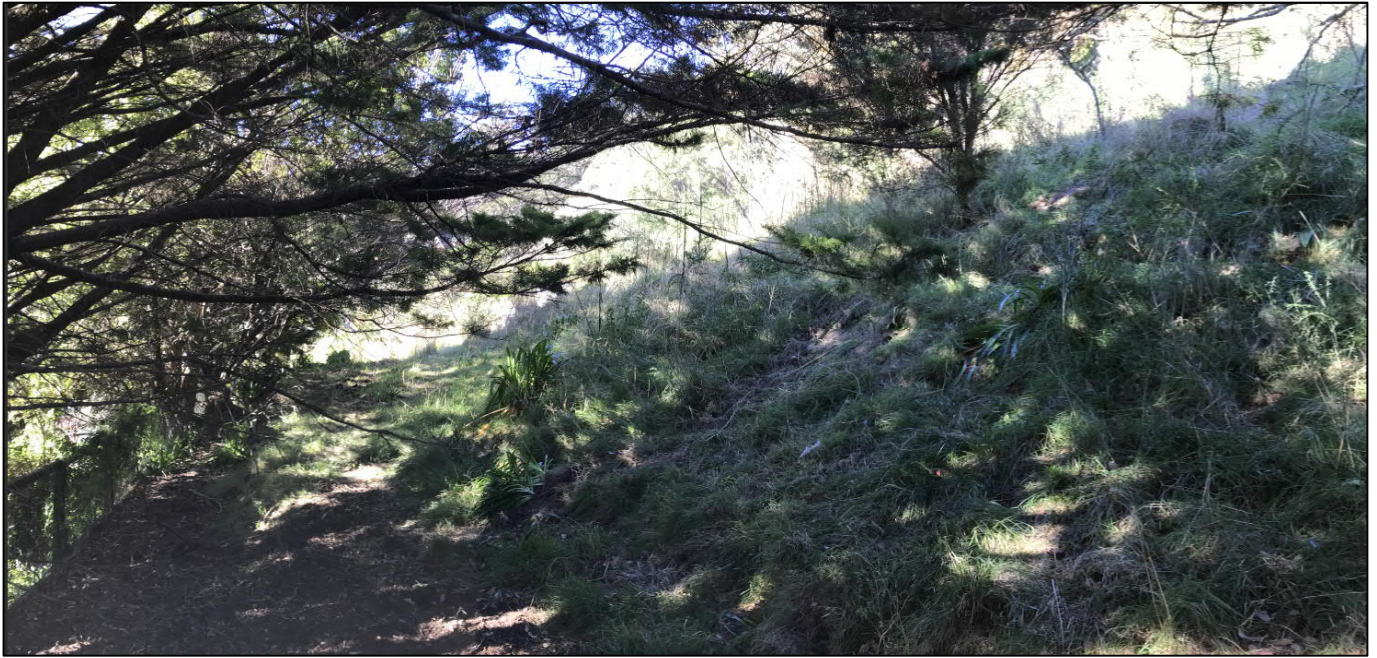
Figure 4: View northeast across historic farm access and lower part of proposed house site. Retaining wall running along approximate north boundary (above 21 Darwin Road) located at extreme left of image with fence attached to top.

Along the north boundary of the property a set of non-engineered retaining walls comprising a small 0.4m high feature behind an approximately 1 to 1.5m high wall are present, which are likely supporting a wedge of fill placed when the historic farm track was developed immediately above. These walls show evidence of localised yielding (rotation), which is expected given their non-engineered status. The shallow seated instability is expected to be able to be address through isolation of a dwelling and/or site preparation/remediation works. There was no other evidence of instability identified above, within or below the house site within the image review or walkover assessment.

In addition, to address the possible evacuation risk of the non-engineered fill supported by a non-engineered retaining wall (which runs along the boundary with 21 Darwin Road), a new retaining wall, or possible palisade wall installed in the ground back from the boundary may be required subject to the final proposed location of the dwelling. It is possible that the in-ground wall could be incorporated into the northern foundation line of the new building, or it could be built independently. Depending on the location of the wall, a retained height of between 1 and 1.7m is expected, although this is subject to confirmation of the wall location and final building footprint and building type proposed. There is a possibility that this could be avoided, although this is expected to minimise the available building area, and or push the building site further back to the south or east.

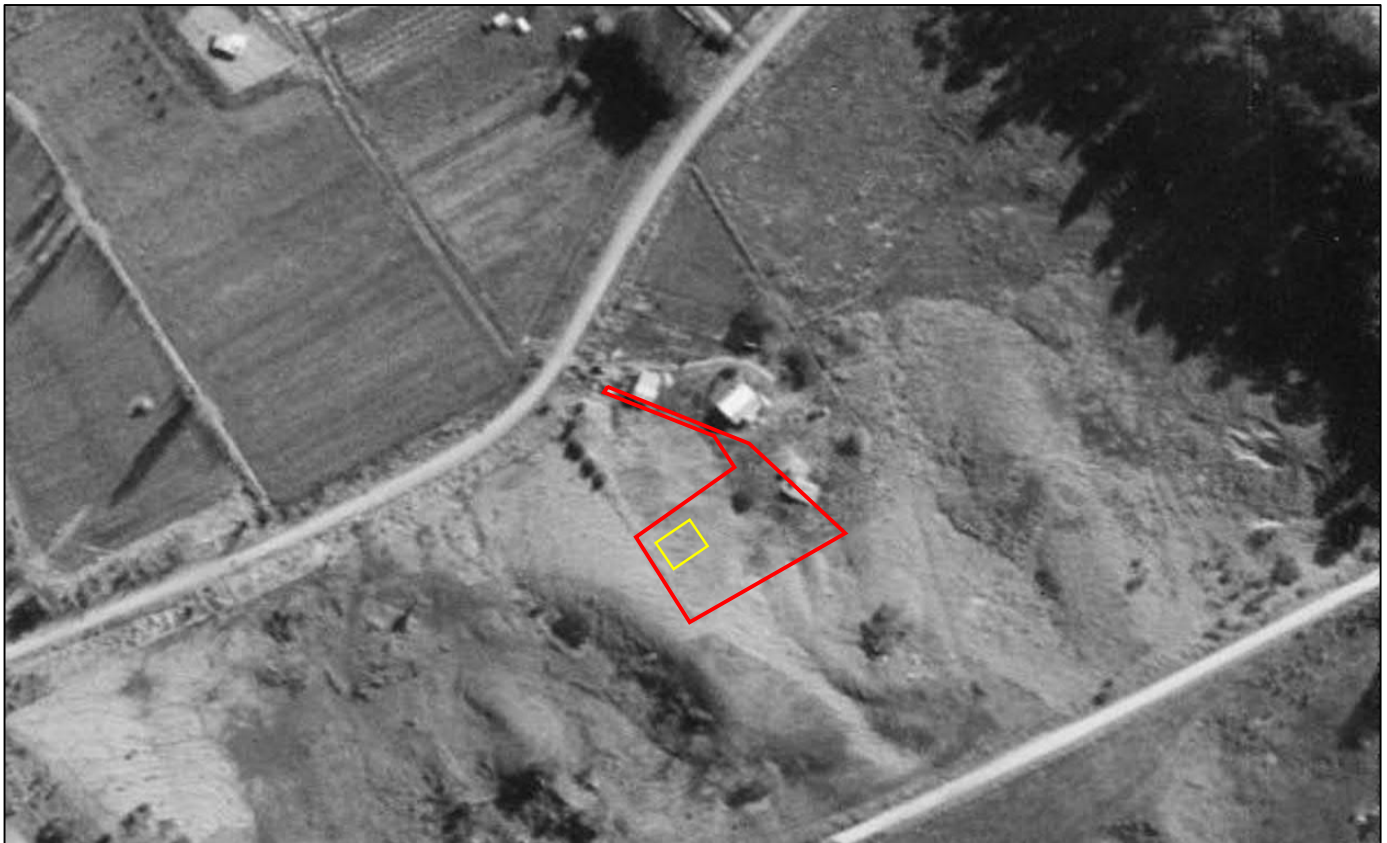
Prior to establishment of the thick vegetation which now occupies the property up slope of the property, evidence of historic shallow seated instability can be observed in the 1953 aerial photographs in the steeper parts of the hillside to the southeast with some material appearing to come to rest within the subject property in the shallow gully zone below and to the east of the proposed house site. These areas, are however, offset and isolated from the proposed house site. On this basis we consider that the proposed site is at a low risk of being affected by inundation landslippage from the property above, during the building's design life.

On a localised scale, evidence of shallow seated instability in the form of terracettes can be observed above, within and below the site in the earlier 1953 photography. These are consistent with observations made on site with evidence

Figure 6: 1953 aerial image of property and surrounding area. Approximate property boundary line position indicated with red line and proposed house site indicated with yellow rectangle.

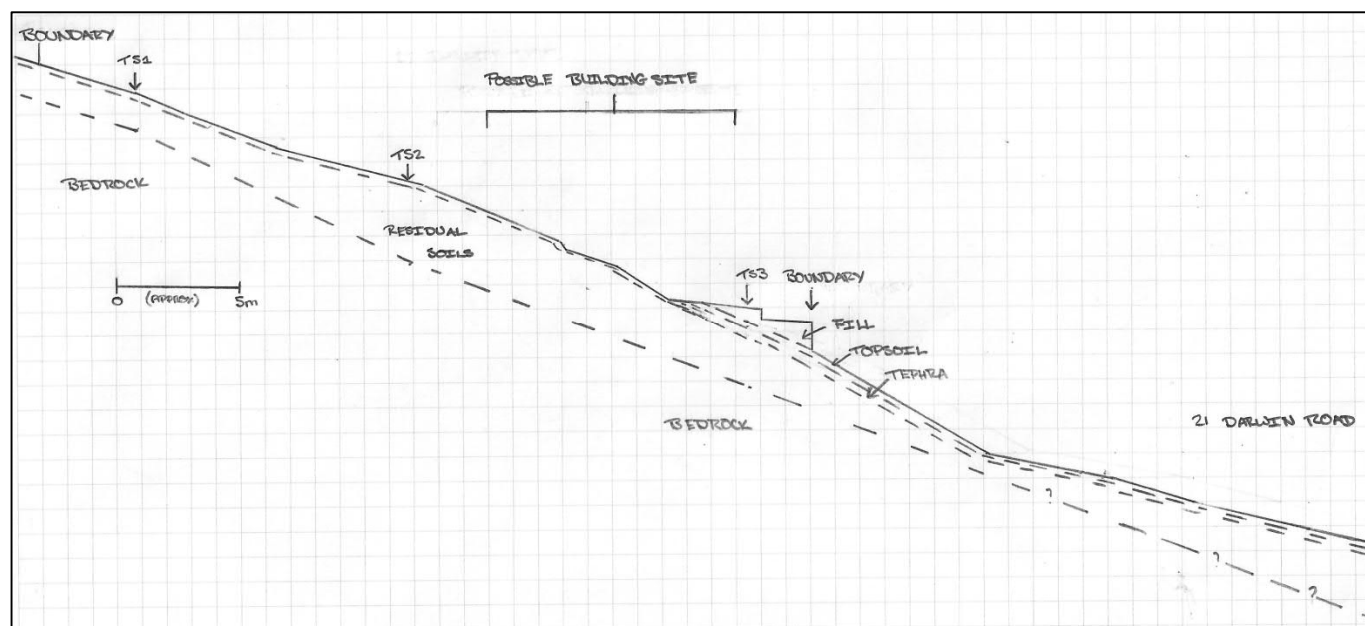
Figure 7: Geological cross section through possible building site.

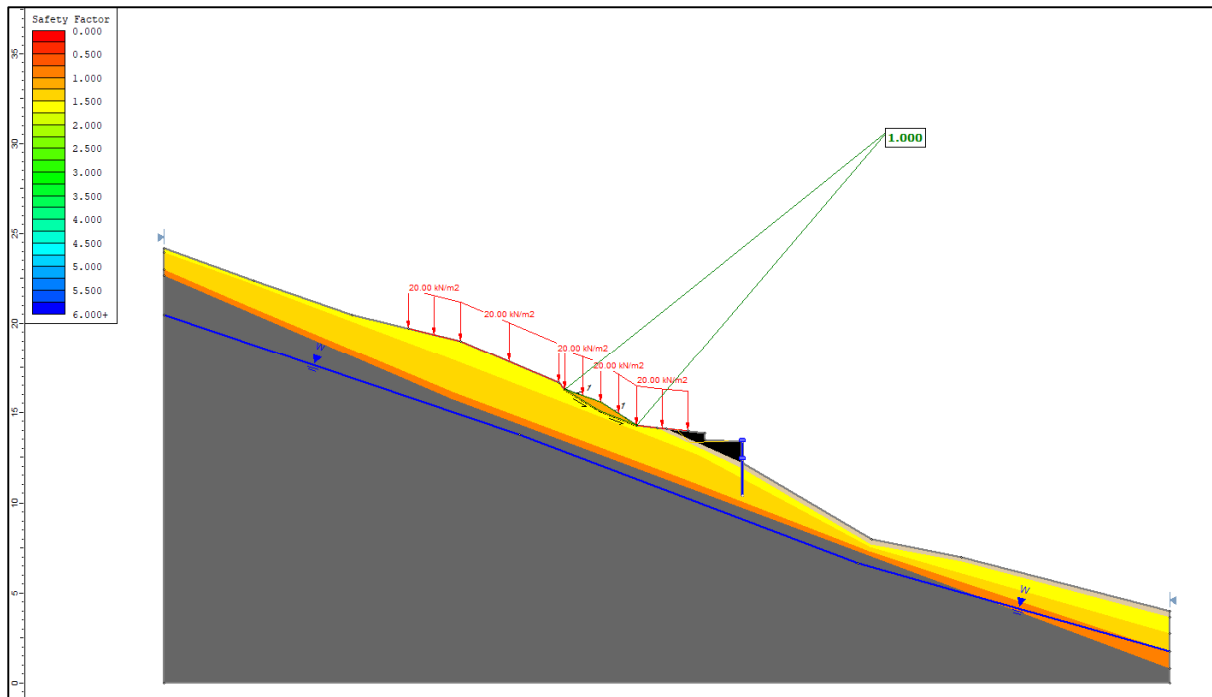
- Under prevailing ground water conditions whilst failure is not indicated, slip surfaces with marginal FoS values (as low as 1.0) are shown to exist within the batter slope formed above the historic farm track and the non-engineered fill supported by the non-engineered wall at the base of the site (boundary with 21 Darwin Road).

Prevailing groundwater condition model showing slip surface factor of safety values less than 1.5. 20kN/m<sup>2</sup> distributed load represents possible position of building.

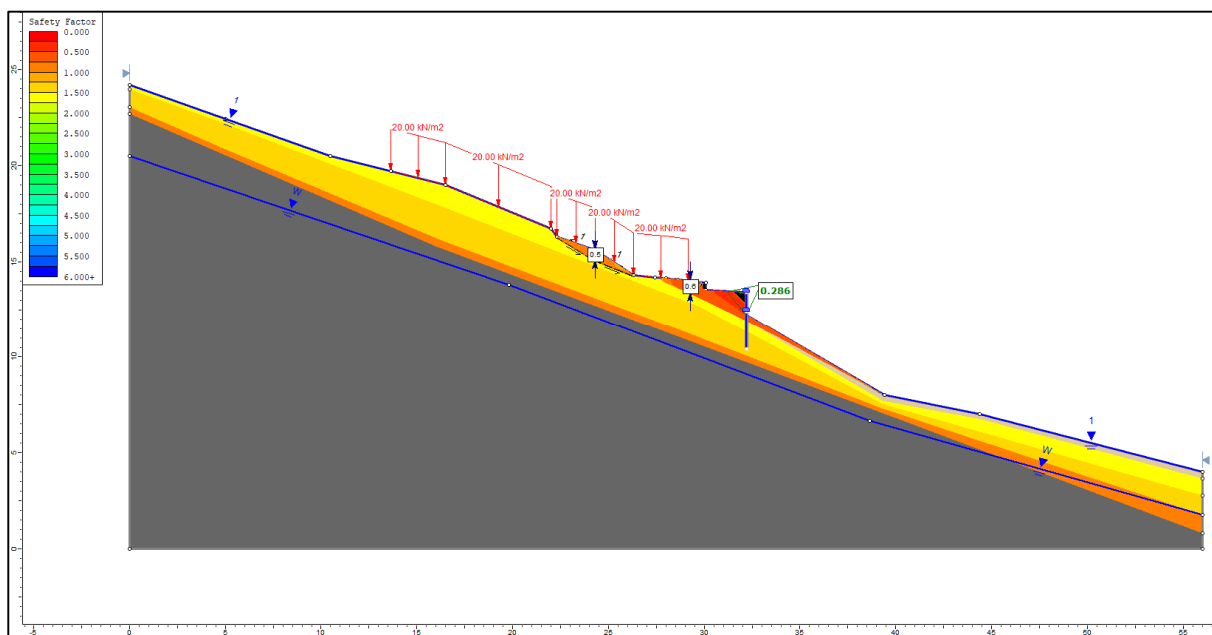
- Under extreme groundwater conditions slip surface FoS values as low as 0.3 are shown, indicating failure. These slip surfaces with FoS values less than 1.2 are shown to be isolated to the batter slope formed above the historic farm track and the non-engineered fill supported by the non-engineered retaining wall at the base of the site (boundary with 21 Darwin Road), which is consistent with site observations.

Extreme groundwater condition model showing slip surface factor of safety values less than 1.2. 20kN/m<sup>2</sup> distributed load represents possible position of building.

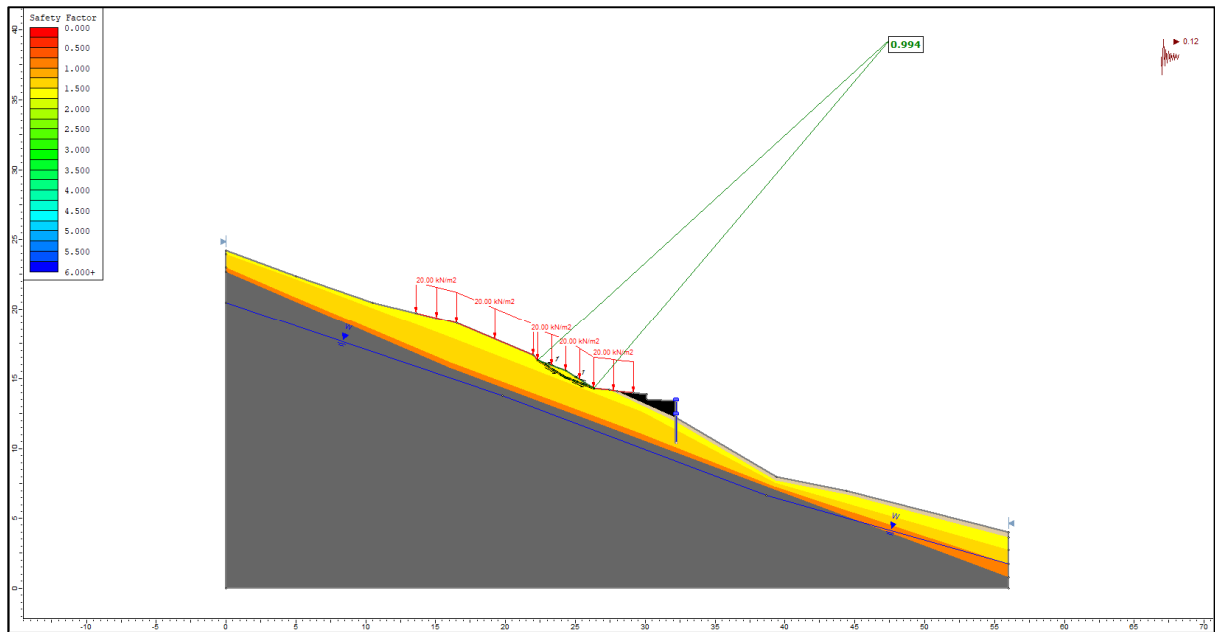
- Under SLS seismic loads, marginal yielding (FoS =0.99) is indicated in the batter slope formed above the historic farm track.
- Under a significant Ultimate Limit State event, slip surfaces with FoS values less than 1.0 (indicating failure) are shown to exist. These are isolated to the batter slope formed above the historic farm track and the non-engineered fill supported by the non-engineered retaining wall at the base of the site (boundary with 21 Darwin Road).

SLS seismic model showing all slip surface factor of Safety values less than 1.0. 20kN/m<sup>2</sup> distributed load represents possible position of dwelling.

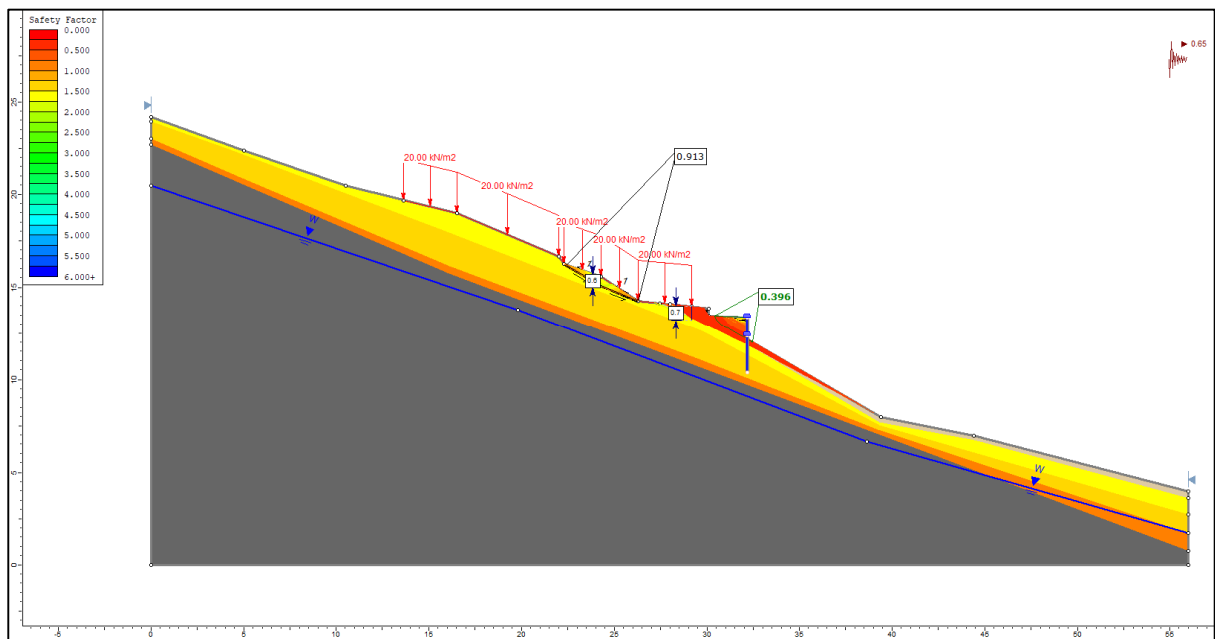
ULS seismic model showing all slip surface factor of safety values less than 1.0. 20kN/m<sup>2</sup> distributed load represents possible position of dwelling.
