Title: Maungatapu Landslide Advice					
Date	Version	Description	Prepared by:	Reviewed by:	Authorised by:
18/05/2023	0.1	Draft for consultation	J Beetham	D Milner	D Milner
27/06/2023	1.0	Report issued to client	J Beetham	D Milner	D Milner
28/08/2023	2.0	Addition of executive summary and minor edits to report	J Beetham	D Milner	D Milner
29/08/2023	3.0	Minor edits	J Beetham	D Milner	D Milner
20/09/2023	4.0	Addition of relevant data	J Beetham	D Milner	D Milner

Executive summary

Tonkin & Taylor Ltd (T+T) was engaged by Tauranga City Council (TCC) to help develop a greater understanding of the landslides occurring on the Maungatapu Peninsula (also described as the “Study Area”, or “the peninsula” through the document). Over the past year, a number of large landslides have occurred in several locations across the peninsula which have caused property damage and social disruption. TCC is interested in understanding the factors that drive the landslides on the peninsula and are considering what mitigation methods/processes could be applied to the peninsula to reduce the impact of the landslides.

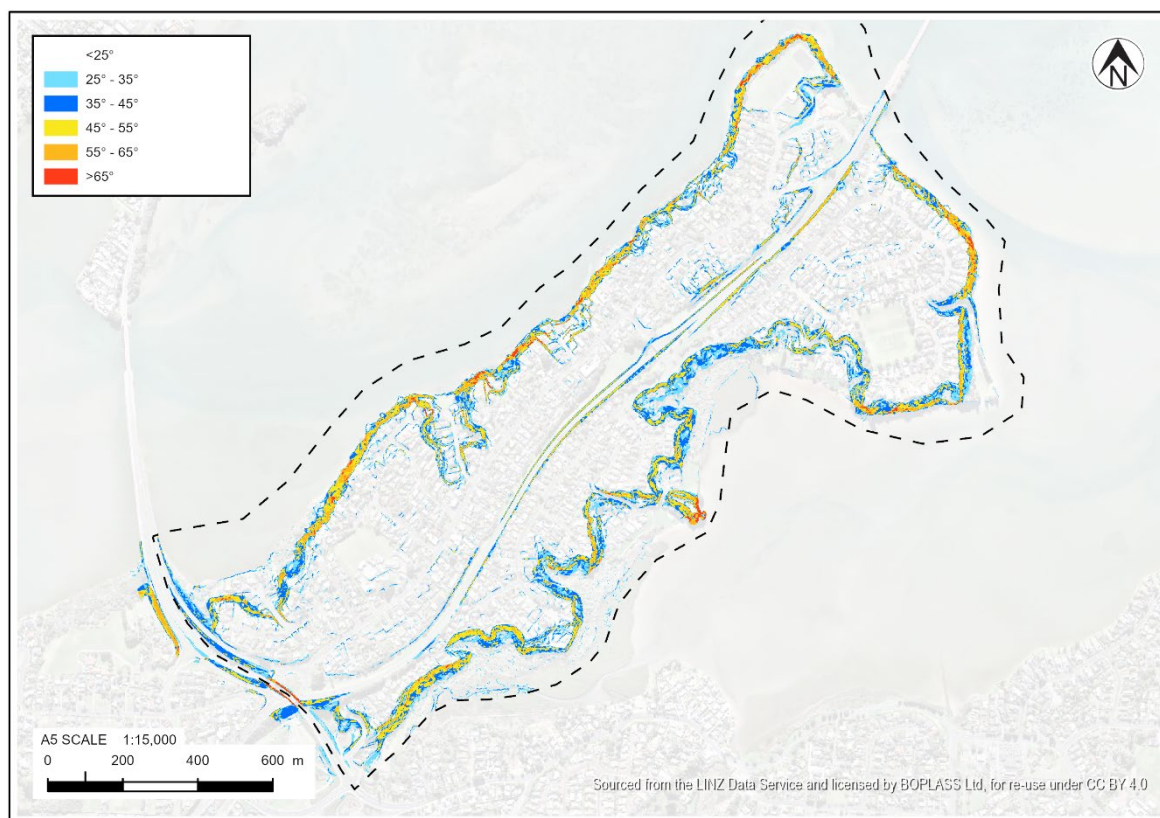
Figure 1.4: Sloping land and slope angles across the Study Area.

A number of these factors are difficult to assess, however, T+T (2006) found that slopes steeper than 25° and higher than 5 m were generally more vulnerable to instability than other areas in Ōtūmoetai. Figure 1.4 is a colour coded map of slope gradients around Maungatapu Peninsula. It shows that the north-western and north-eastern slopes of the peninsula tend to be steeper than at other locations and this likely makes them more prone to instability. The highest concentrations of EQC 'landslip' claims are also coincident with these steeper north-western and north-eastern slopes.

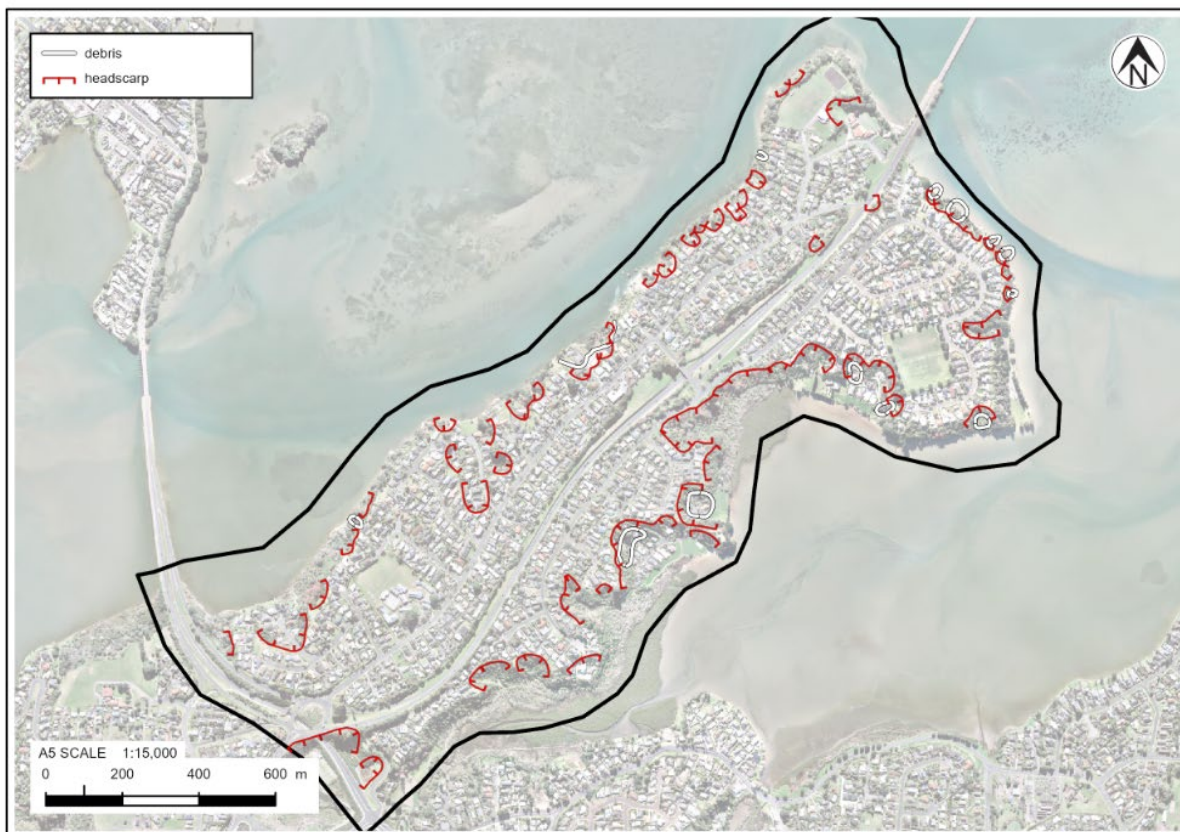
Figure 4.1: Relic landslides mapped within the Study Area (sourced from TCC MAPI platform).

The Tauranga City Council GIS MAPI platform provides a publicly available relic landslide feature dataset that extends across the Tauranga City Council area. These relic landslides were mapped by Houghton and Hegan in 1979, and Bell, Richards and Thomson in 2001. Figure 4.1 shows the mapped relic landslides within the Study Area.

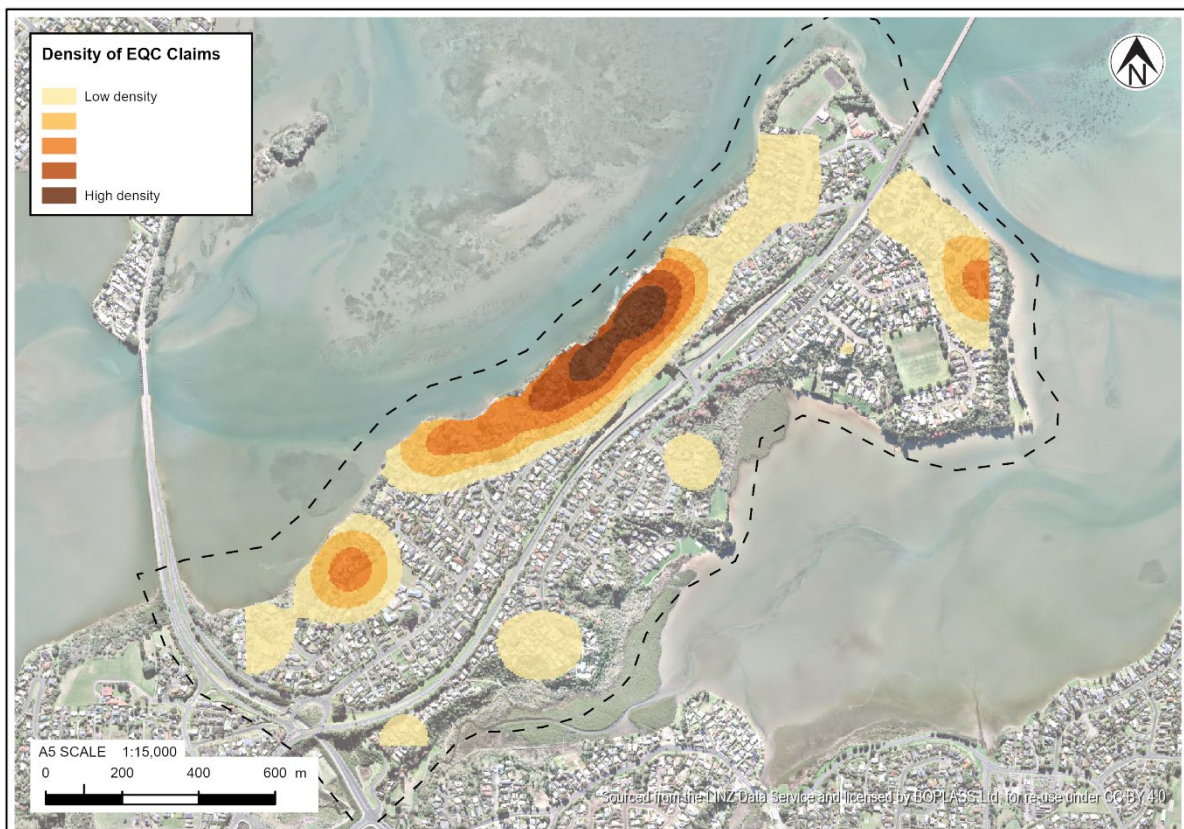
Figure 5.1: Spatial density of EQC claims within Study Area (note that areas that are not coloured represent no claims).

It is likely that there were more landslides within the Study Area over the past 23 years, but they would not have been recorded if either a claim wasn't made, or if they affected areas that were not covered by EQC.

Table 5.1 shows that the number of claims across the peninsula in 2005 is a significant outlier to the dataset. In 2005, there were 65 EQC claims within the Study Area. However, 51 of these claims are associated with the extreme weather event that caused significant flooding and landslides across the western Bay of Plenty Region (including the Matata Debris flows) on 18 May 2005.

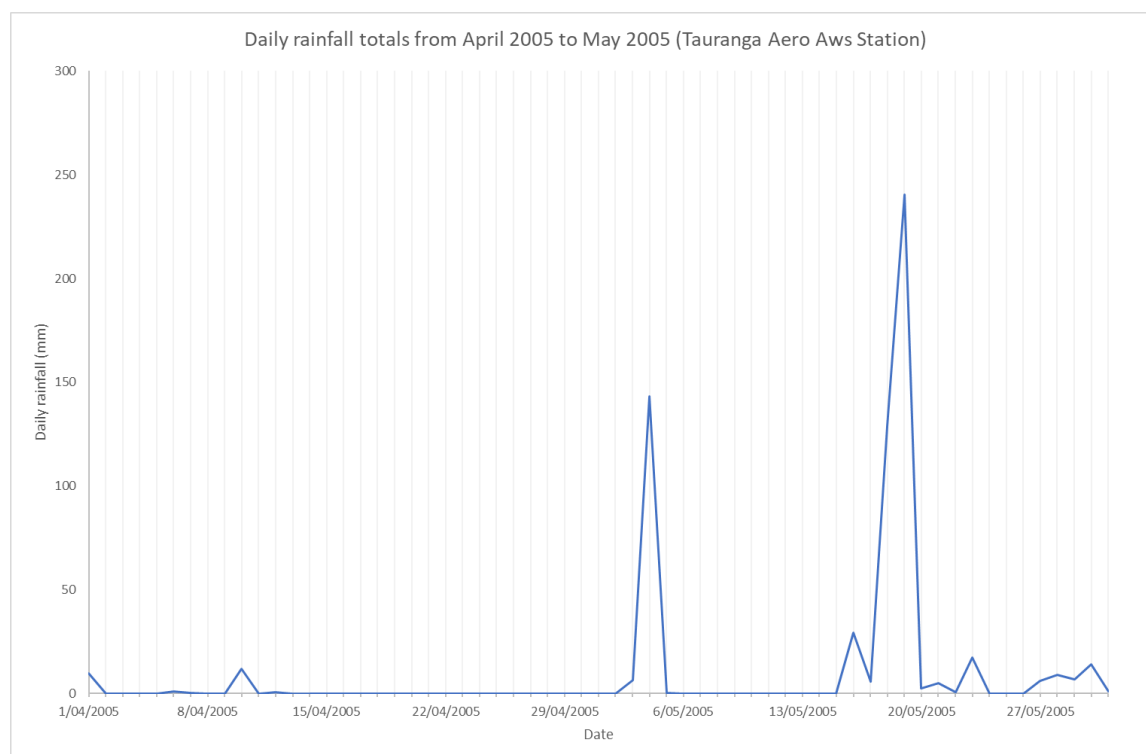
Figure 8.1: Graph showing daily rainfall amounts from April to May 2005 (sourced from Tauranga Aero AWS weather station).

An outlier to this trend occurred in 2005, when 65 EQC claims were recorded but, the majority of these claims were not preceded by several successive months of above average rainfall. The reason for the 2005 spike in claims was the extreme rainfall event that occurred on 18 May 2005 (267 mm of rainfall was recorded over 24 hours at the Airport weather station, i.e. more than twice the average total May rainfall). This followed a period of heavy rain earlier in the month. The 18 May 2005 event resulted in significant landsliding across the Tauranga area. As outlined in Section 3 of this report, Hegan and Wesley (2005) suggested that it was not the single extreme rainfall event that caused the landslides across the Tauranga area rather a combination of previously elevated rainfall conditions followed by the extreme rainfall event (554.8 mm of rainfall was recorded between 1 May and 18 May 2005 at the Tauranga Airport weather station, approximately five times the average rainfall for the month). Figure 8.1 presents a graph showing the daily rainfall totals for April and May 2005 from the Tauranga Aero Aws weather station (for reference to the May 2005 extreme weather event).

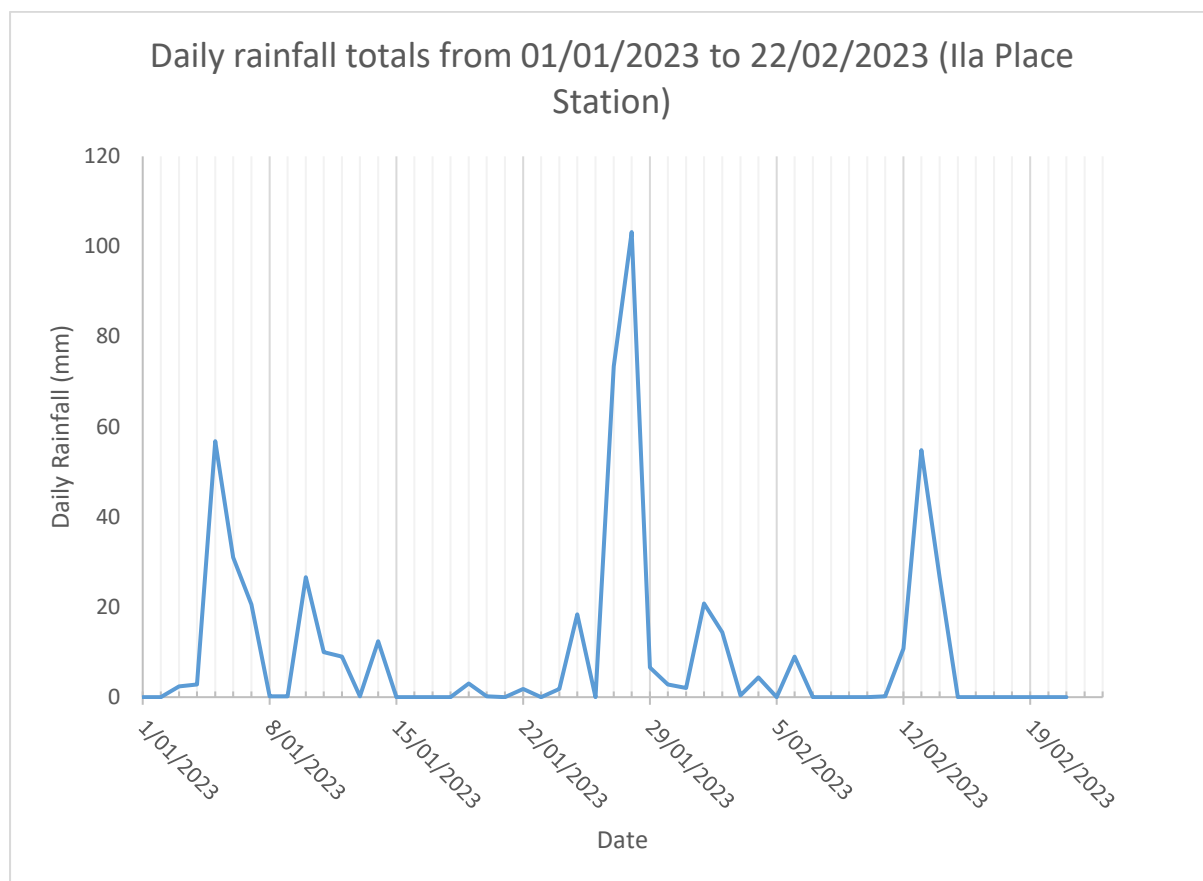
Figure 8.2: Graph showing daily rainfall amounts from January 01 to February 19 2023 (sourced from Ila Place weather station).

The 2023 landslide events followed four months of above average rainfall. As shown on Figure 8.2, January 2023 experienced approximately four times the average rainfall which included three days throughout the month which exceeded daily rainfall totals of 50 mm (56.8 mm on 5/01/2023, 73.4 mm on 27/01/2023 and 103.2 mm on 28/01/2023). The combination of both the above average rainfall conditions and high daily rainfall events meet the conditions described by T+T (1980), Bird (1981), Oliver (1997), and Hegan and Wesley (2005) that generate landslides within the Study Area.

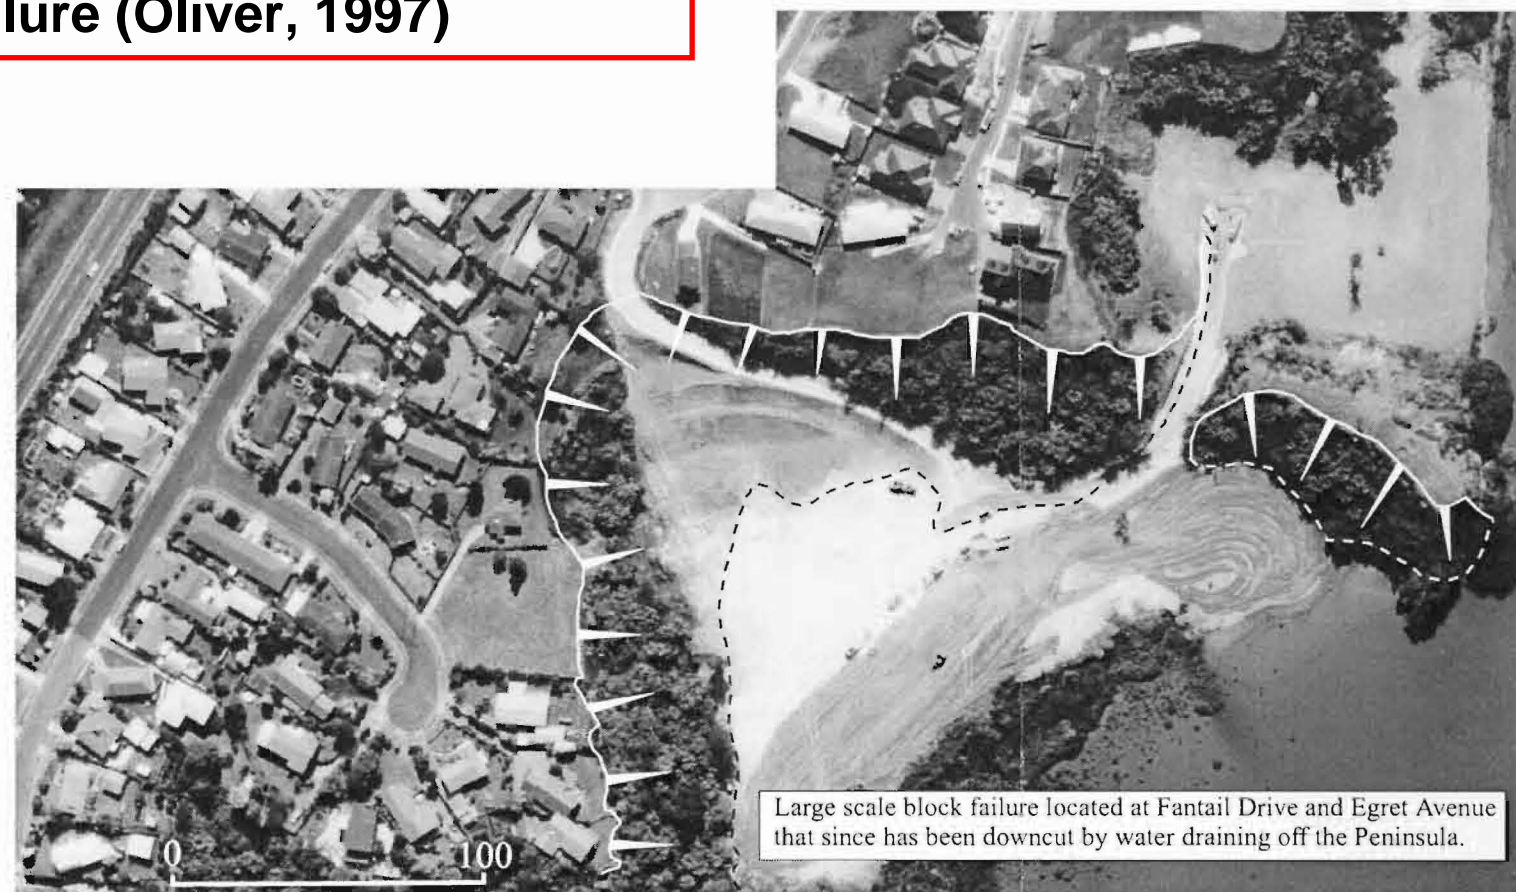
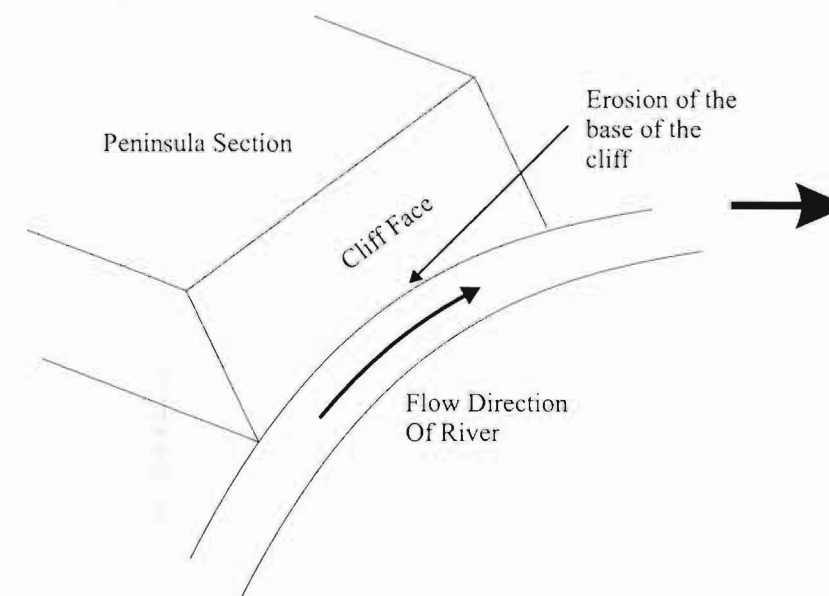
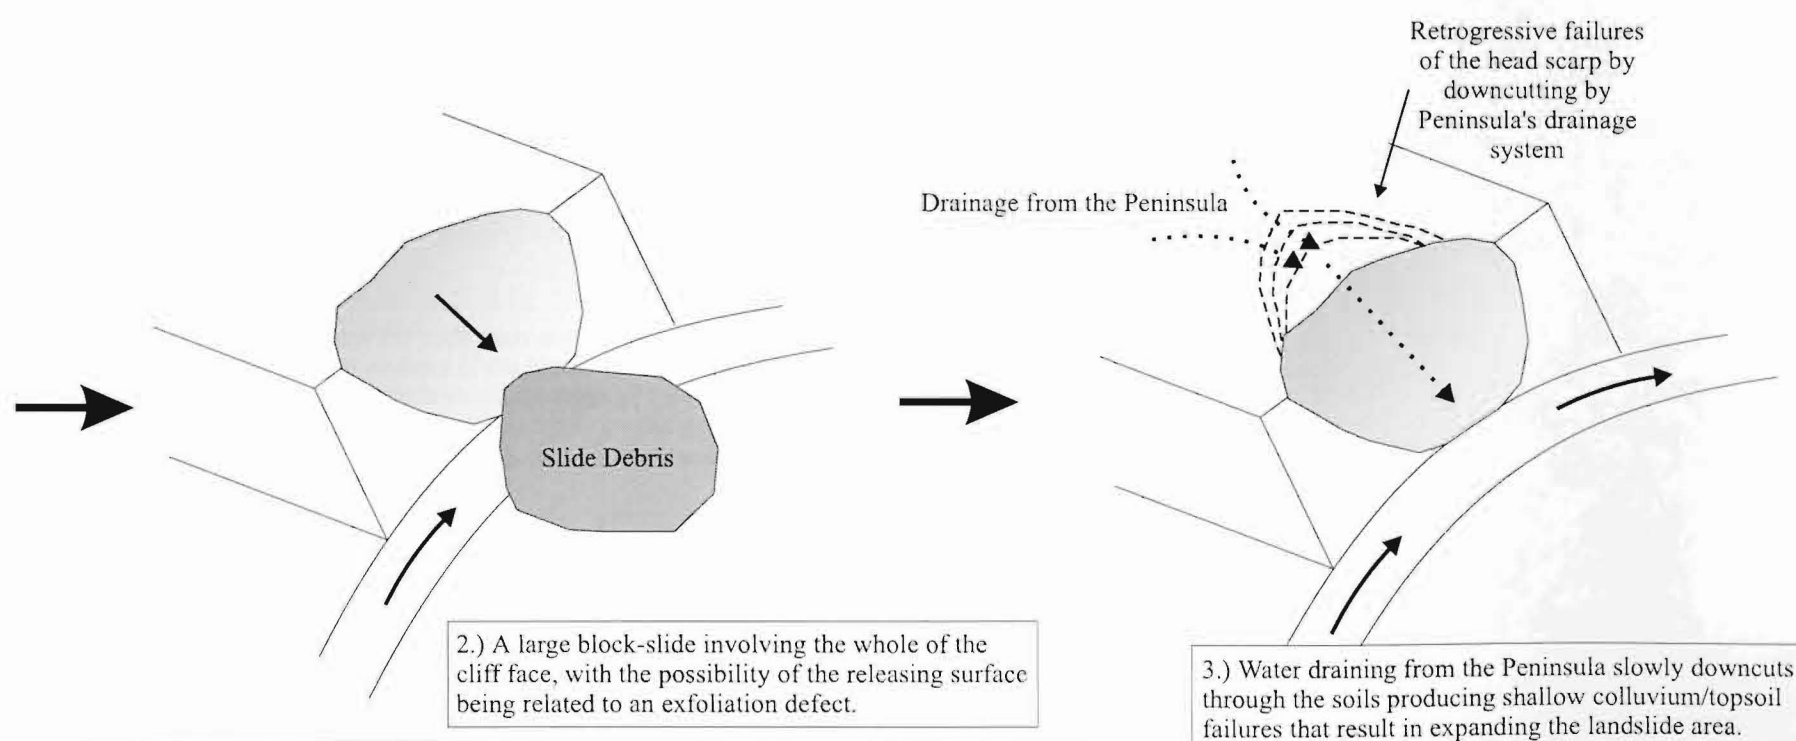
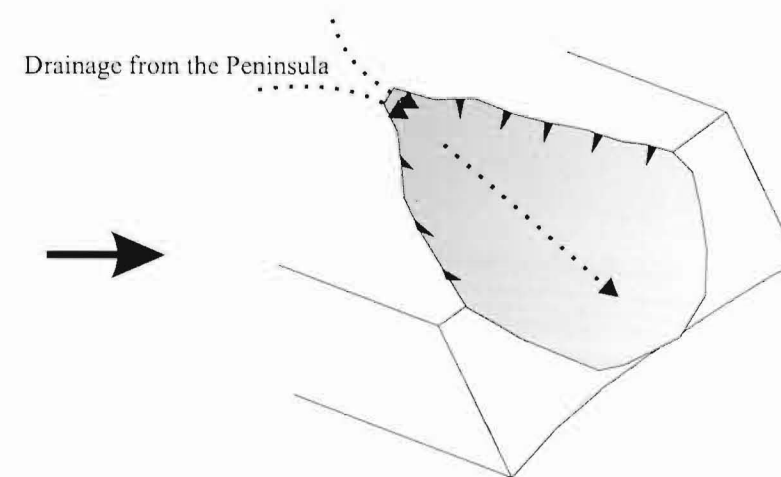
Figure A1: Large scale block failure (Oliver, 1997)

1.) Erosion of the toe of the cliff by the river results in a decrease in the stability of the cliff face.

Figure 2.7 Developmental stages of the "probable larger scale landslides" seen around the Maungatapu Peninsula with an example located at Fantail Drive and Egret Avenue (grid reference 704350 274850).

4.) Downcutting by the Peninsula's drainage system produces the geomorphological features seen at Fantail Drive and Egret Avenue.

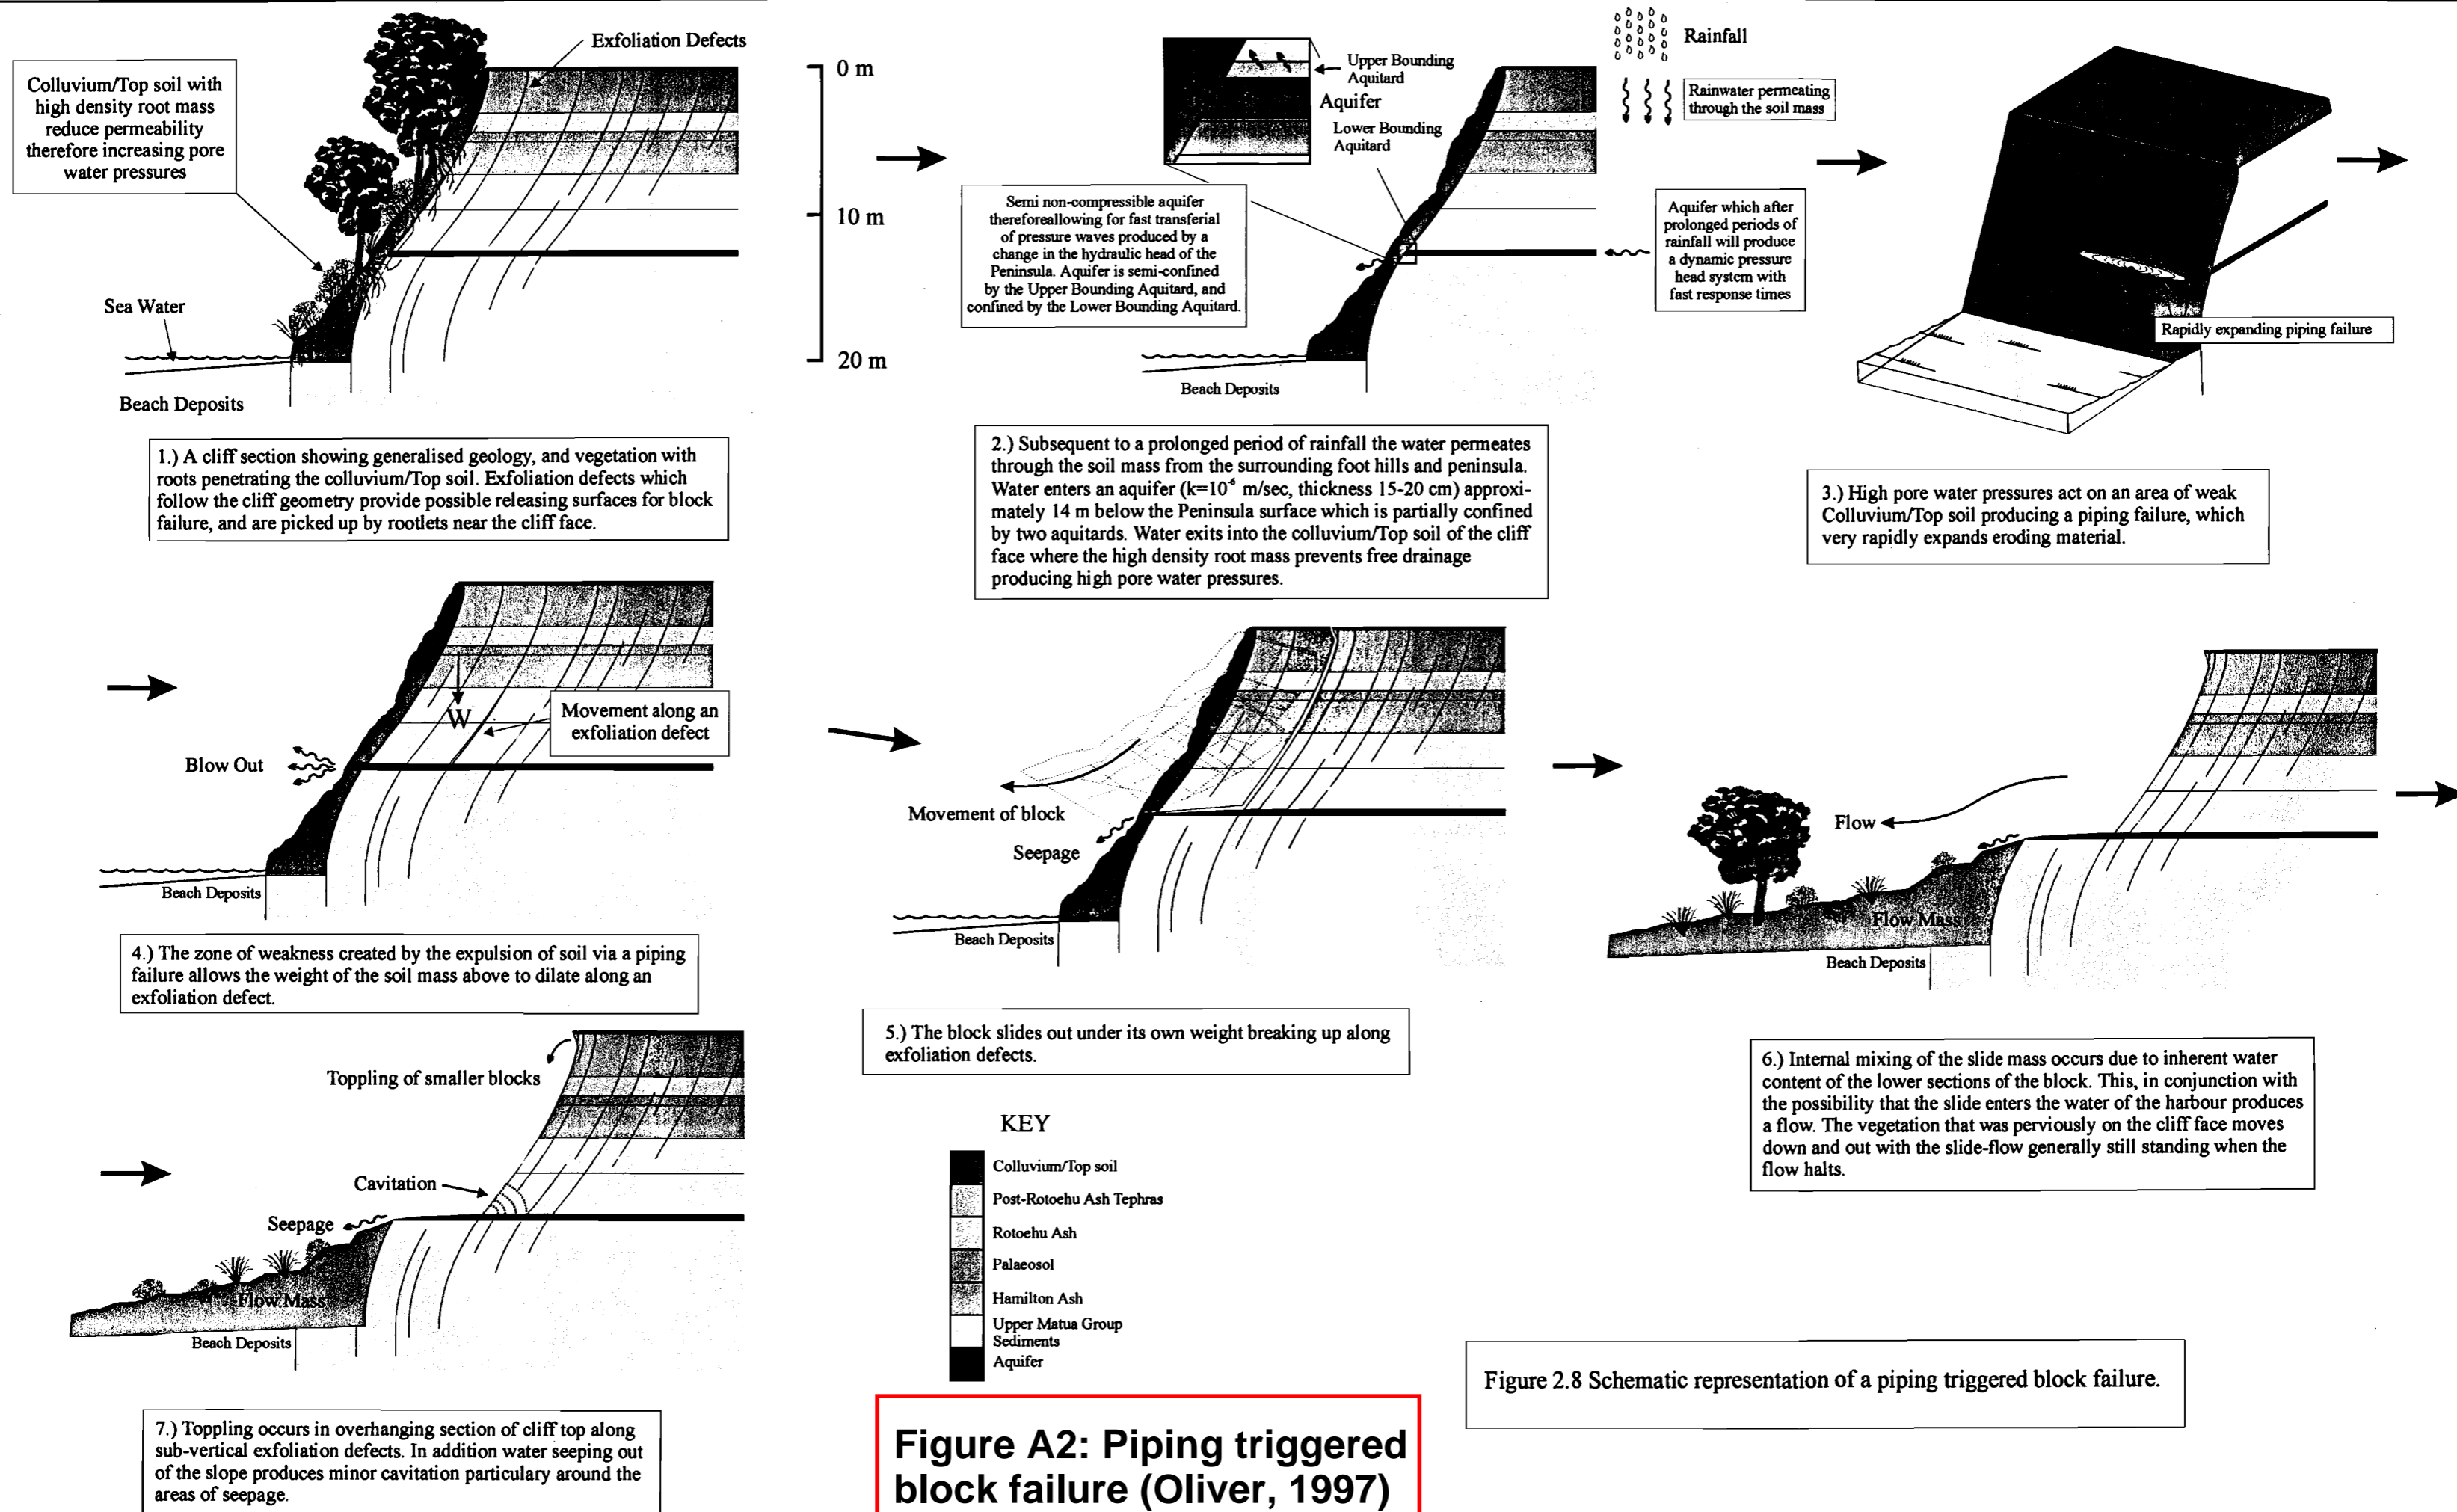
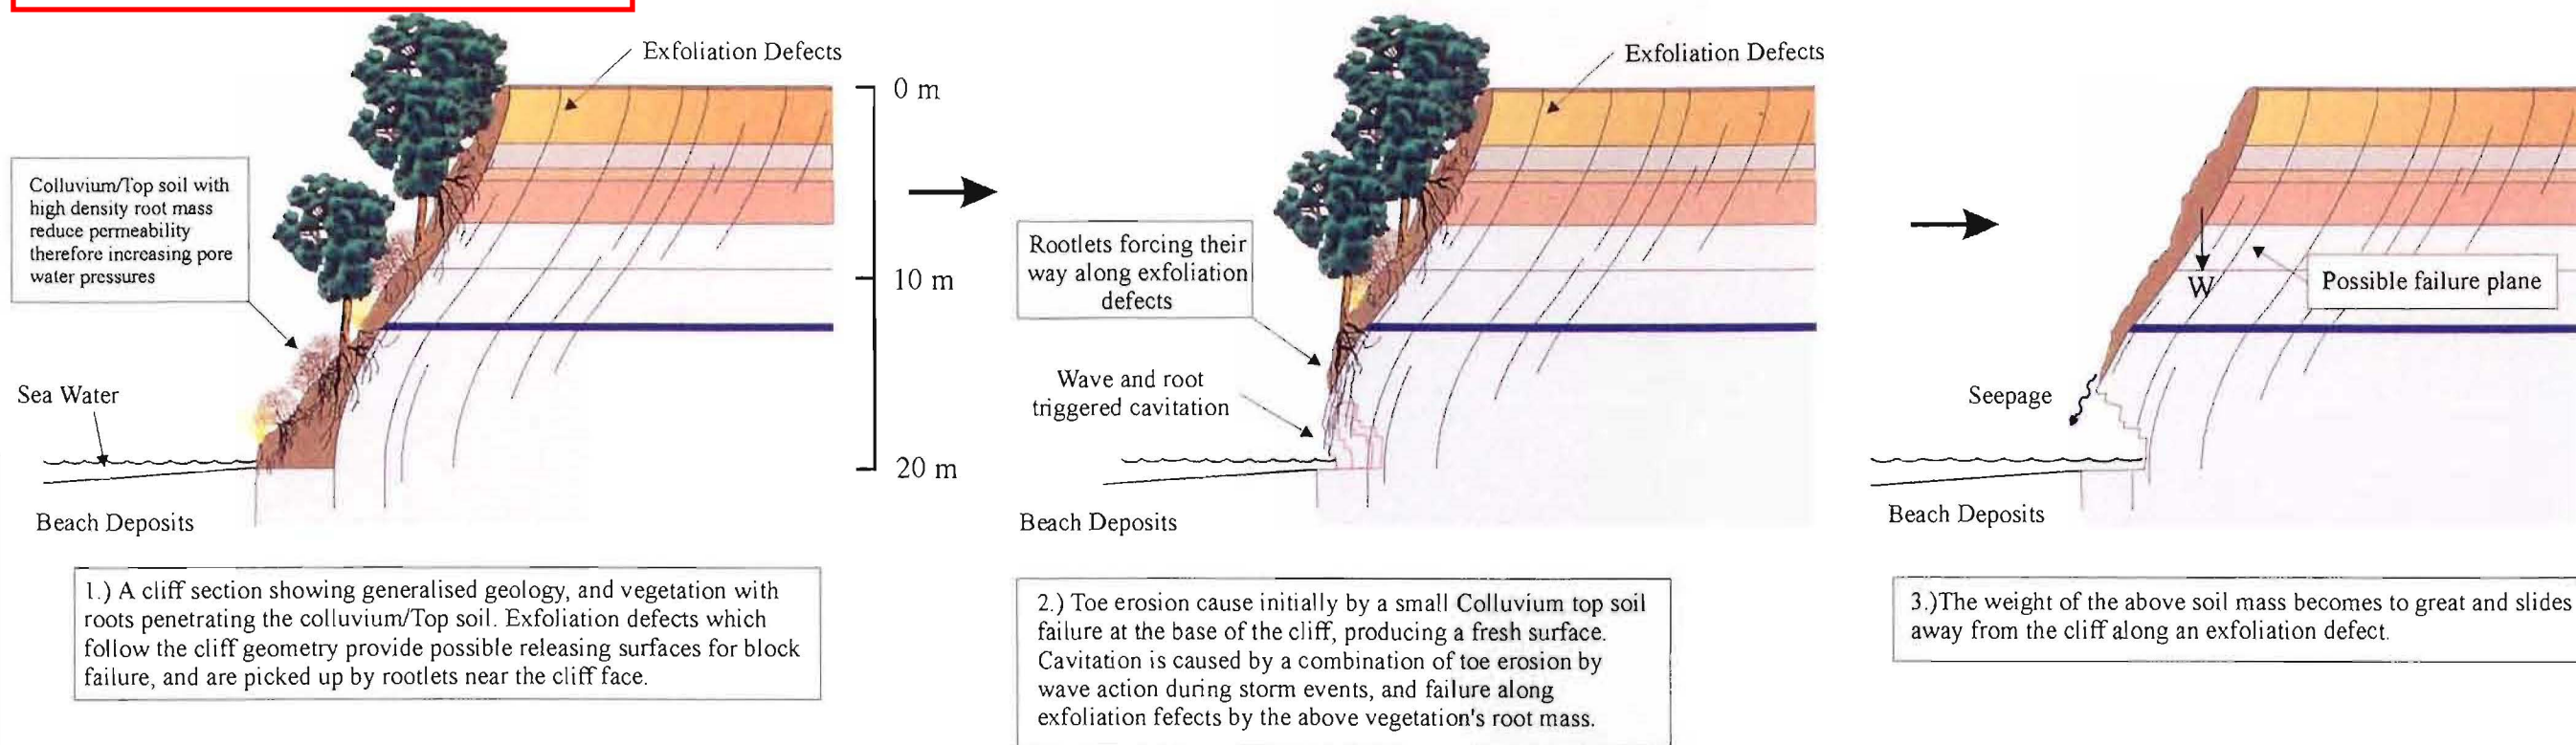
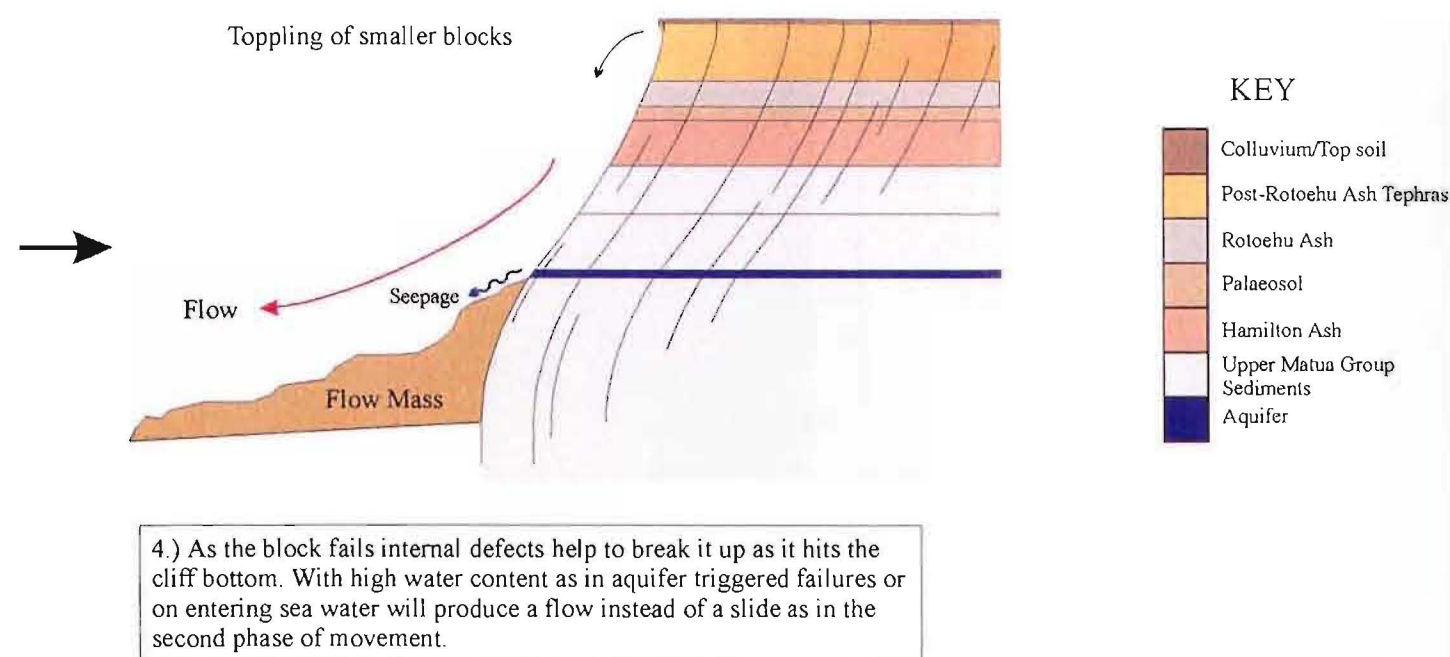
Figure A3: Wave erosion triggered block failure (Oliver, 1997)

Figure 2.9 Schematic representation for a wave erosion triggered block failure. Failure occurs where the toe of the cliff has been removed by erosion producing either a colluvium/top soil failure or a larger block failure. The later stages of failure can be dramatically influenced by water content of the soil mass. From Cruden and Varnes (1996) terminology the failure can be defined as a "Retrospective, complex; very slow-extremely slow, dry-moist, debris, fall; very rapid-extremely rapid, moist-very wet, debris, slide-flow".

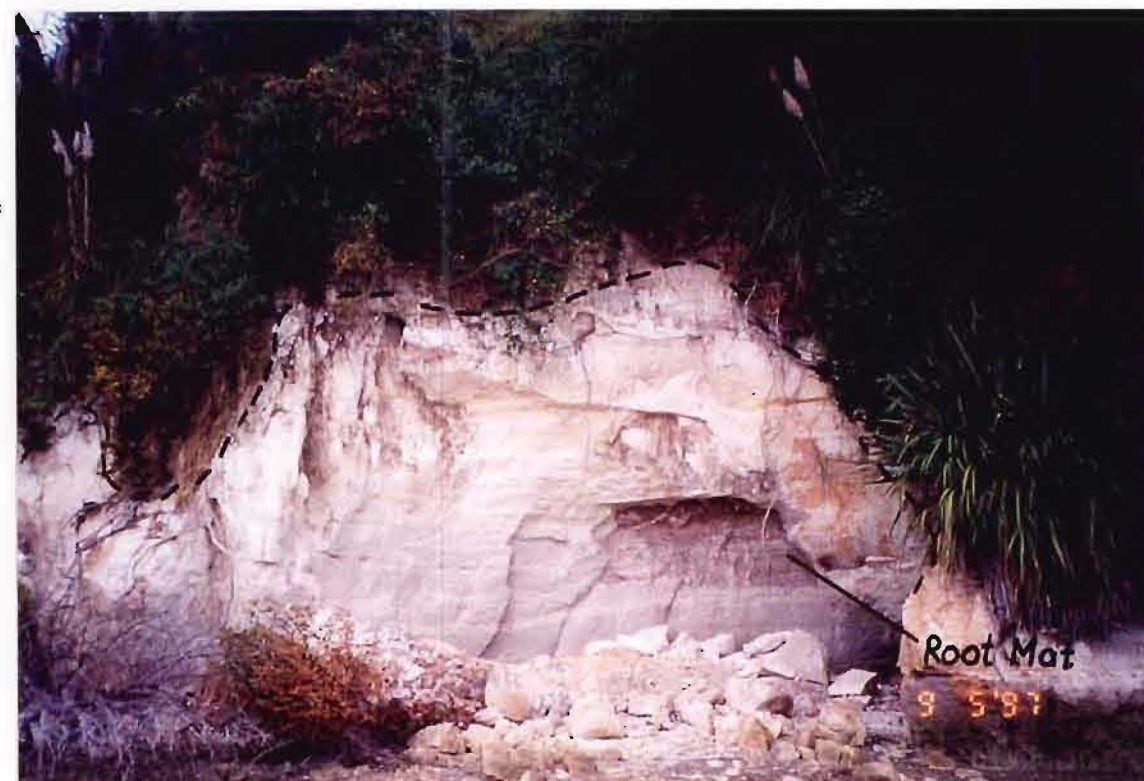
The Photograph depicts how the root mass from vegetation above pushes its way through the soil mass along exfoliation defects creating a root mat. This provides a surface on which the soil can fail after it has been undercut by wave action. Failure in this case tends to occur more as falls with debris easily seen accumulated at the bottom of the cliff.

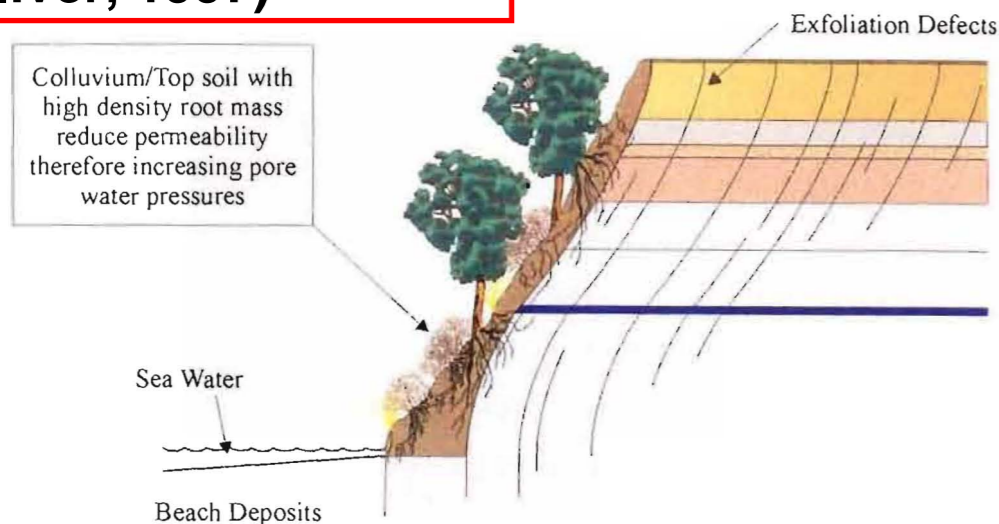
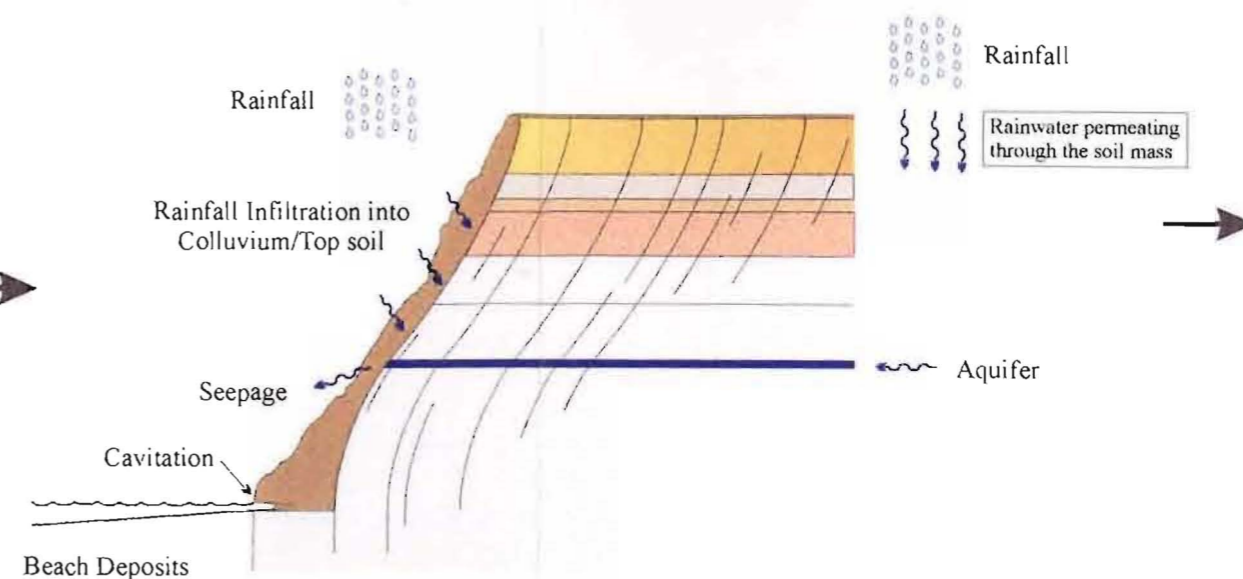
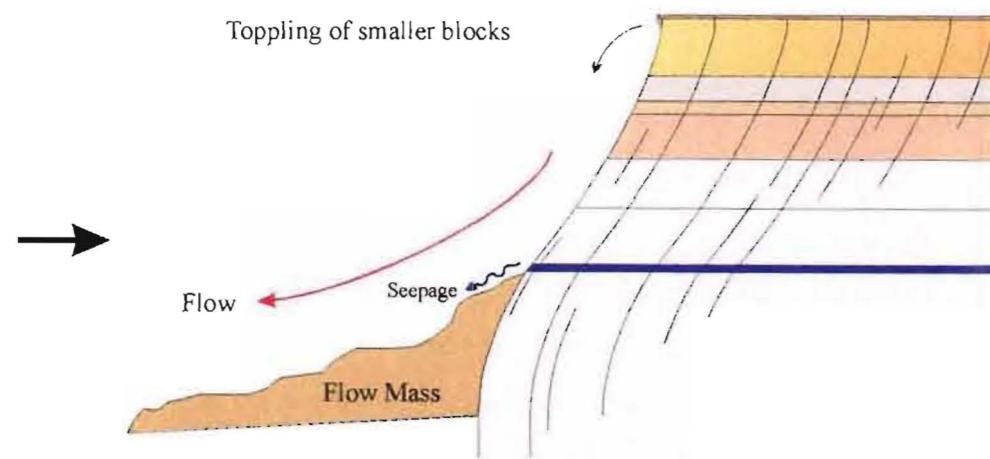
Figure A4: Colluvium/topsoil failure (Oliver, 1997)

1.) A cliff section showing generalised geology, and vegetation with roots penetrating the Colluvium/Top soil. Exfoliation defects which follows the cliff geometry provide possible releasing surfaces for block failure, and are picked up by rootlets near the cliff face.

2.) Rainfall entering the soil mass from the surrounding hinterland and Peninsula is transferred to the aquifer which exits at the cliff face. In Addition, rainfall can help to saturate the Colluvium/Top soil mass adding extra weight and increasing pore water pressures. Also erosion by wave action at the base of the cliff can increase the possibility that failure will occur.

3.) The boundary between the Colluvium/Top soil and underlying geologic units can provide a surface on which a top soil failure may occur. As the top soil slides internal mixing of the soil mass due to the high water content produces a flow. If the flow enters sea water this will increase the effects of the internal mixing and how far the flow will travel. Most of the vegetation tends to survive the failure remaining in a semi-vertical position as on the cliff face.

Figure 2.10 Schematic representation of a Colluvium/Top soil failure. From Cruden and Varnes (1996) terminology the failure can be identified as a "Retrogressive, complex, very slow-very rapid, dry-wet, debris, slide-flow".

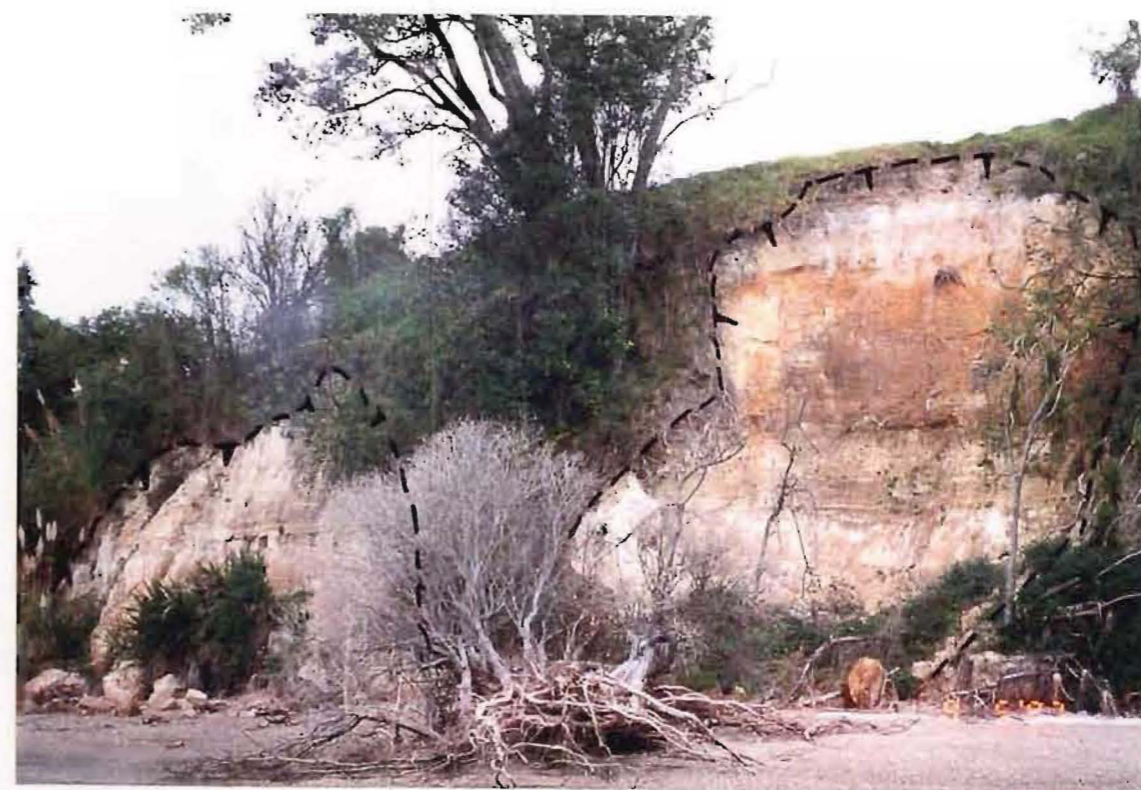
The Photograph show vegetation root mass in conjunction with Colluvium/Top soil produces a surface on which failure may occur. Vegetation weight especially larger trees results in a torque placed on the soil mass aiding in production of instability. Sliding has occurred along the interface between the vegetation root mass-Colluvium/Top soil and a shallow exfoliation defect. The debris has subsequently been eroded away by wave action.
