# EARTHQUAKE RECOVERY (EQR) DOCUMENTATION

## EQR Property Overview Report

EQC Property ID	Property Address	Vulnerable?	Property F Status	Property Finalisation Indicator		
2010036521	97 SULLIVAN AVENUE, WOOLSTON		F3 - Complete & Finalised	Some Finalisation has taken place		
Main Contractor:	CLOSED OUT-Canterbury Home Services Limited - In Liquidation ***** (S784)		Property F2'd By:	EQR\NickJor	F2 Completed Date:	04-02-2015
Cont Managing Hub:	Ensors	Not Vulnerable	Property F3'd By:	System Generated Finalisation	F3 Completed Date:	07-05-2015

<b>Address</b>	97 SULLIVAN AVENUE, WOOLSTON, CHRISTCHURCH, 8023	<b>EQC Claim Number</b>	CLM/2010/036521
<b>Hazards</b>	DOGS ON PROPERTY	<b>EQC Assessor (L,F)</b>	Milne, John
<b>Inspection Date</b>	13-Sep-2011	<b>Placard</b>	No Sticker
		<b>EQC Estimator (L,F)</b>	Thomas, Les

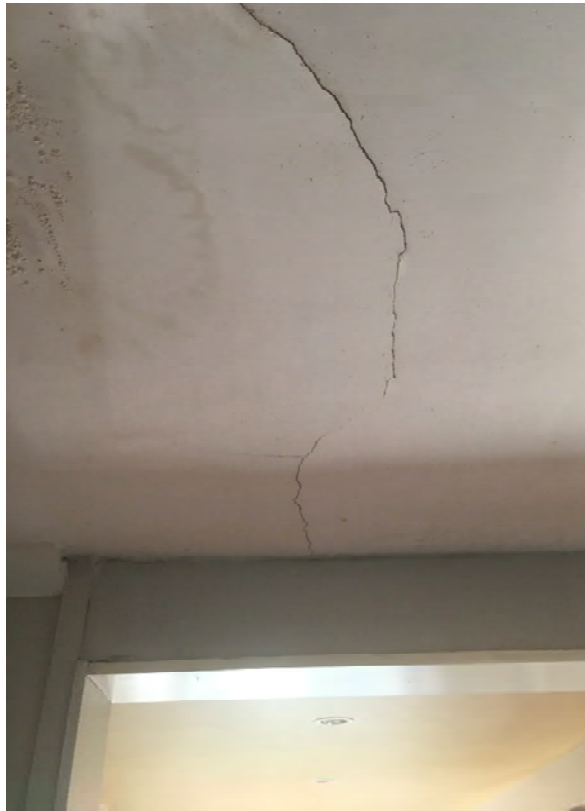
*Cracked ceiling lining-previous water damage*

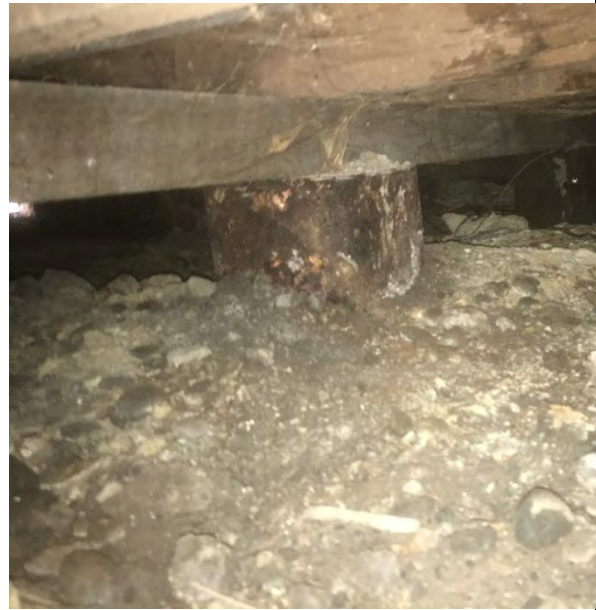
*Subfloor view*

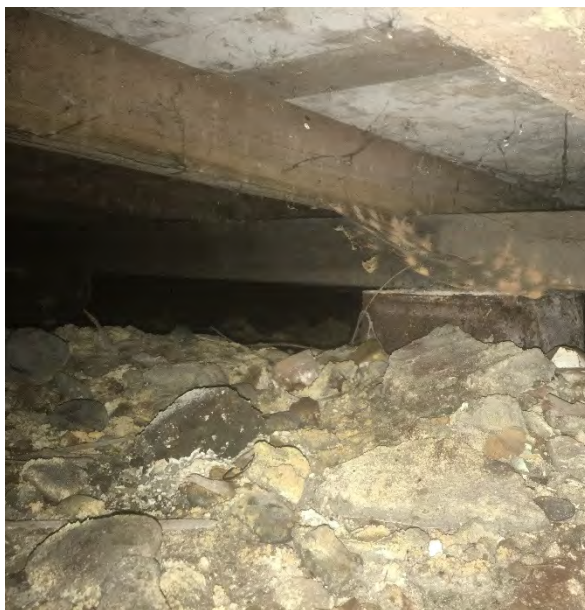
*Subfloor view*

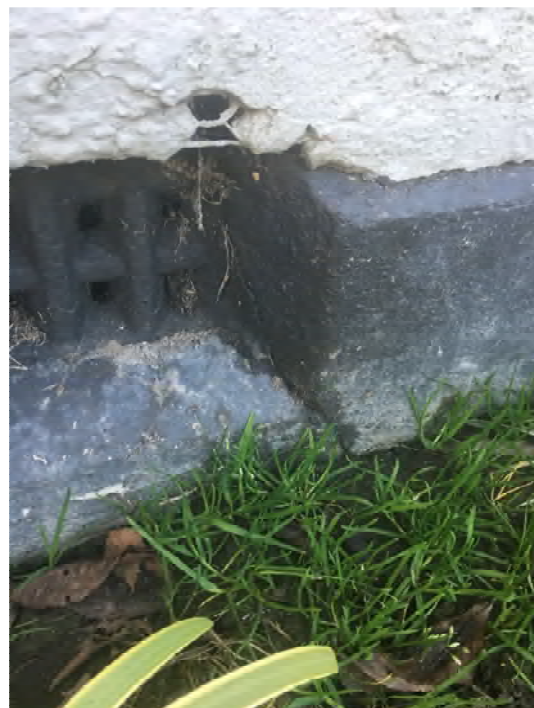
*Cracked foundation*

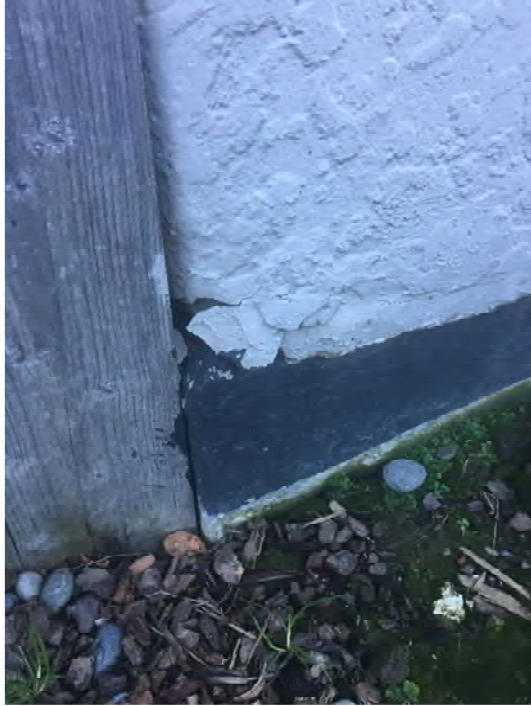
*Damaged stucco corner*

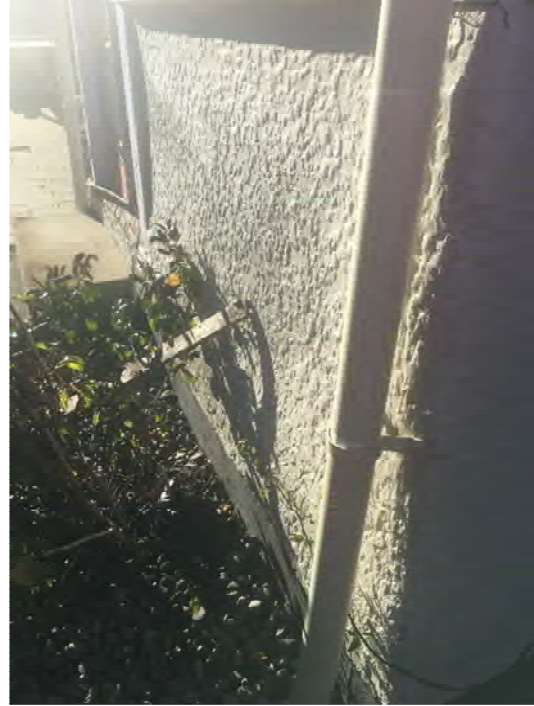
*Bowed stucco cladding historic*

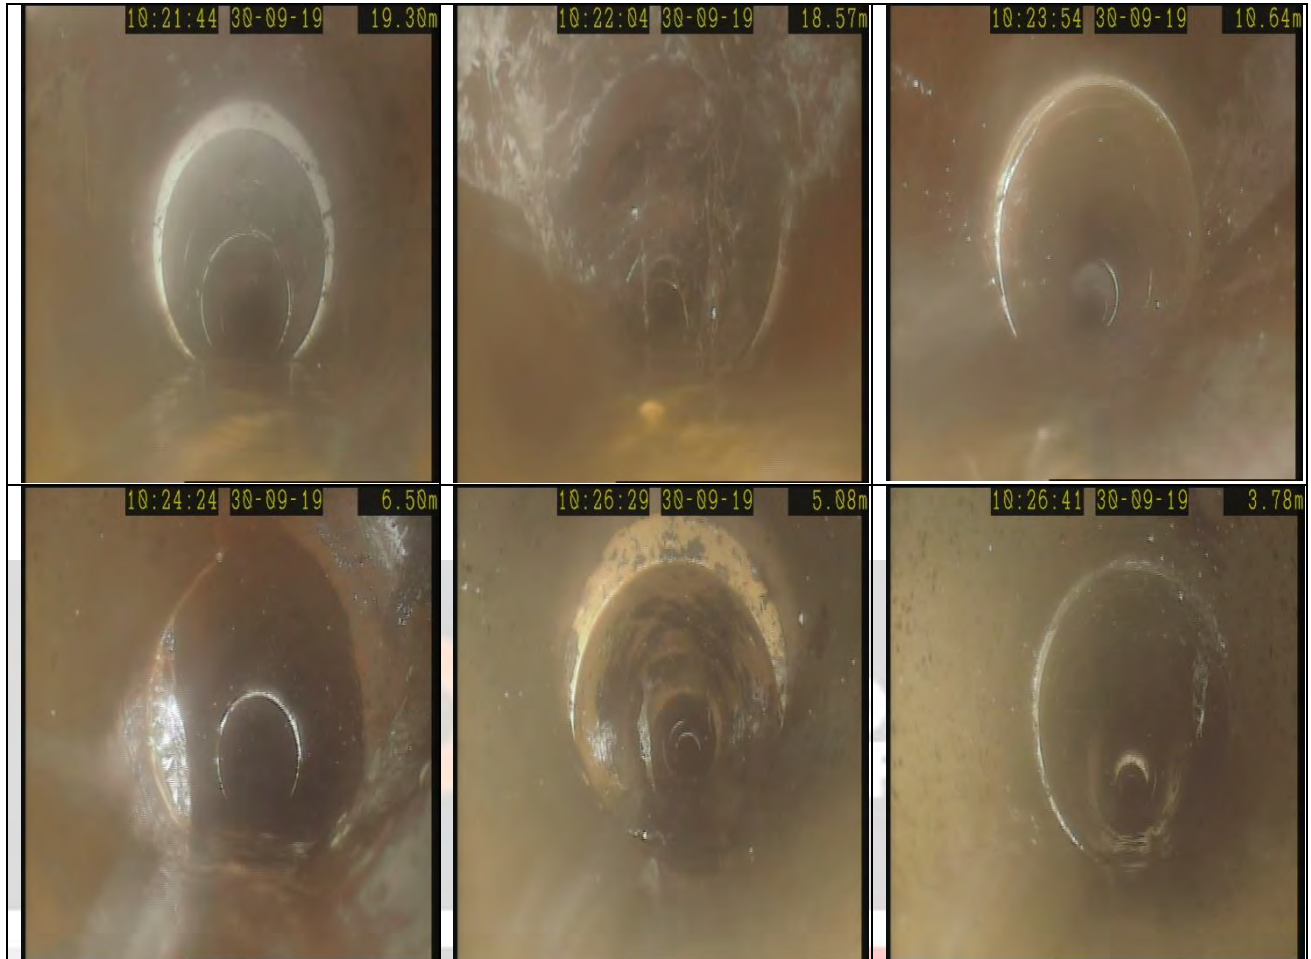
The stormwater drains consist of Earthenware Ceramics (EWC) and some sections of 100mm uPVC, which were located near downpipe 1 and outside the property boundary. These were cleaned out as part of this survey. A junction was also sighted near downpipe (DP1), although not confirmed, this is likely to be servicing the rear dwelling.

The footage from downpipe 2 (DP2) ends at 22.05m, in the stormwater lateral. This section of line had a build-up of silt and debris throughout.

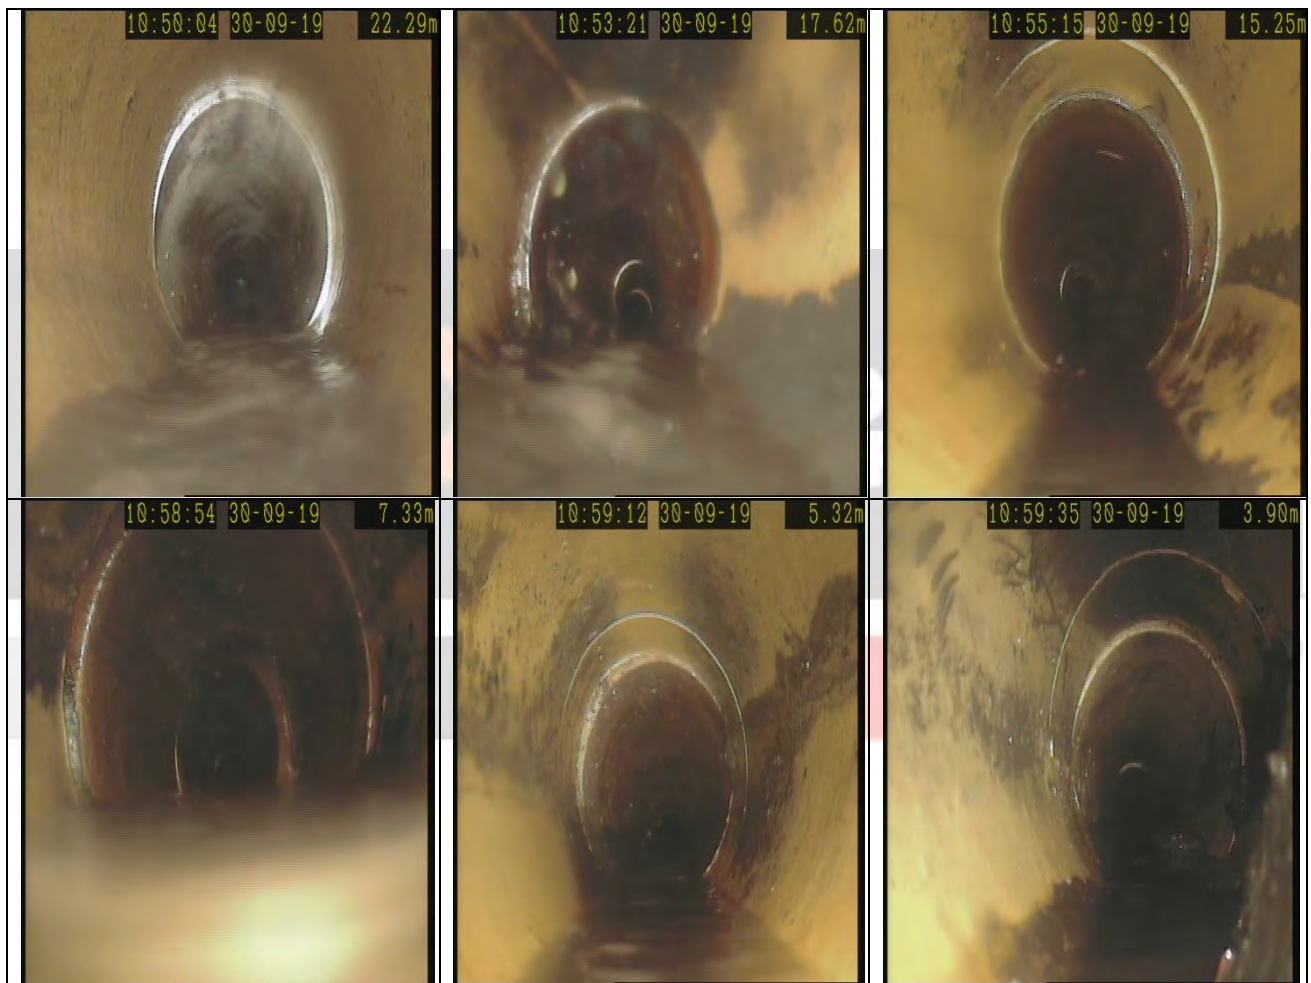
The CCTV footage identified that the EWC sections of the stormwater line have cracking and misaligned joints. This damage is typical of earthquake related movement. The location of this property further supports this.
