NZ Residential Property Inspection Report

Inspection Date: Mon, 27 Oct 2025

Property Address: 20 Pentire Parade, Lincoln 7608, New

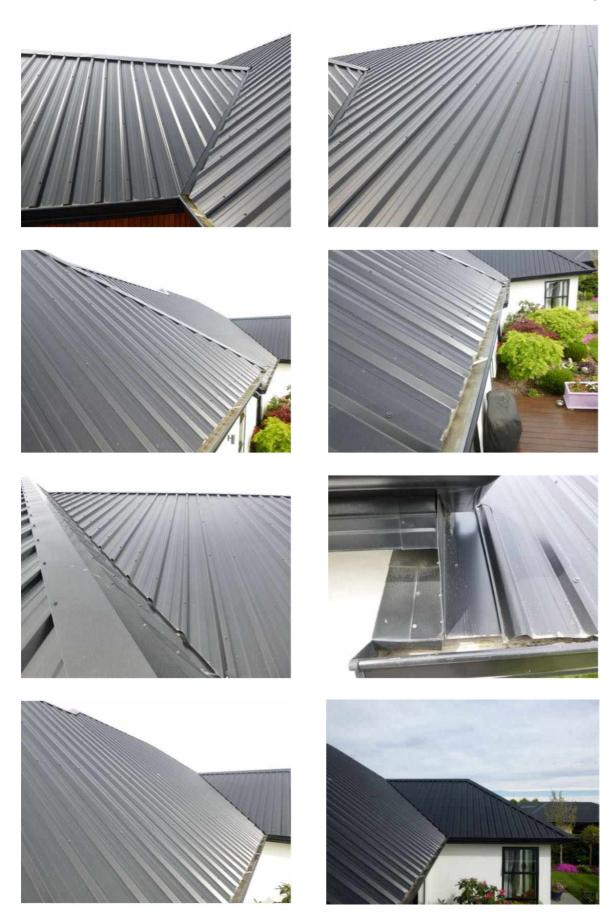
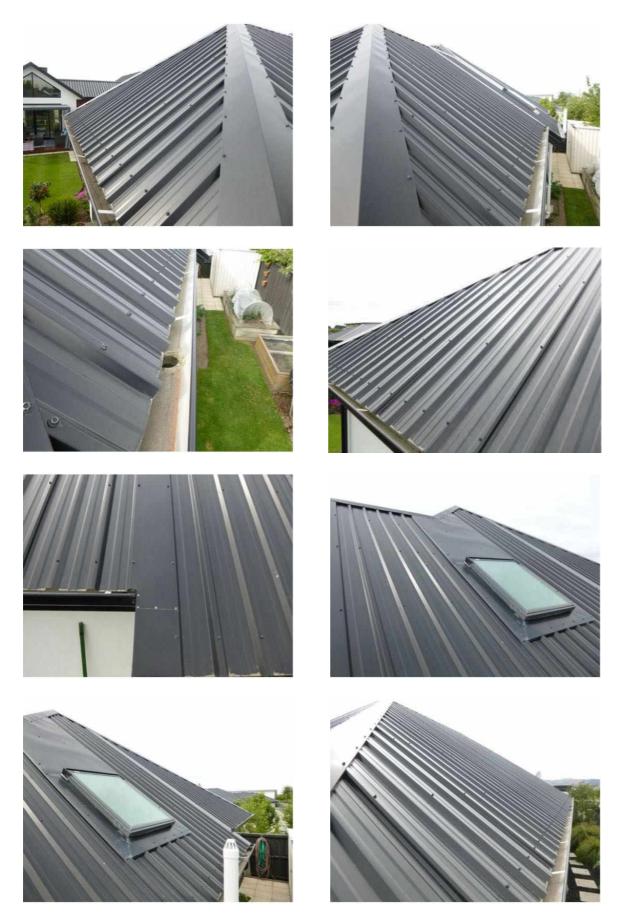
Finding: Additional photos / Good condition

Information: Additional photos are provided for your general reference. These areas are noted as in
