**5-202 Hinemoa St, Birkenhead,  
Auckland**

**REPORT TYPE:** Pre-Sale Building and Weather Tightness  
Inspection

**DATE OF INSPECTION:** 10/03/2025

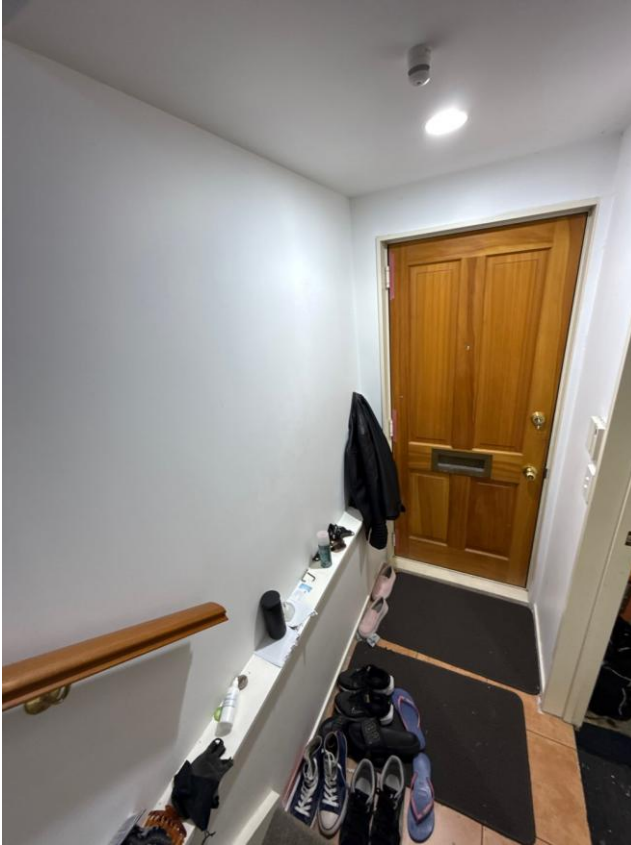
Photo 2

Moisture readings of 10 - 18 % were obtained throughout the Entry North-West Wall. There were no thermal anomalies or any other signs of moisture ingress.

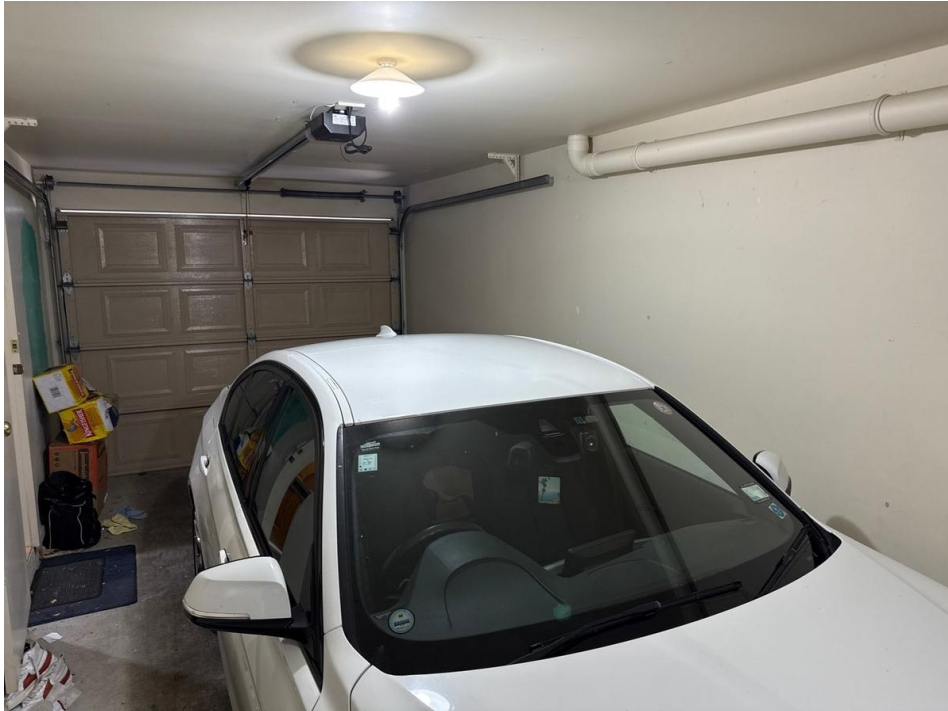
Photo 3

Moisture readings of 11 - 19 % were obtained throughout the Garage North-East Wall. There were no thermal anomalies or any other signs of moisture ingress.

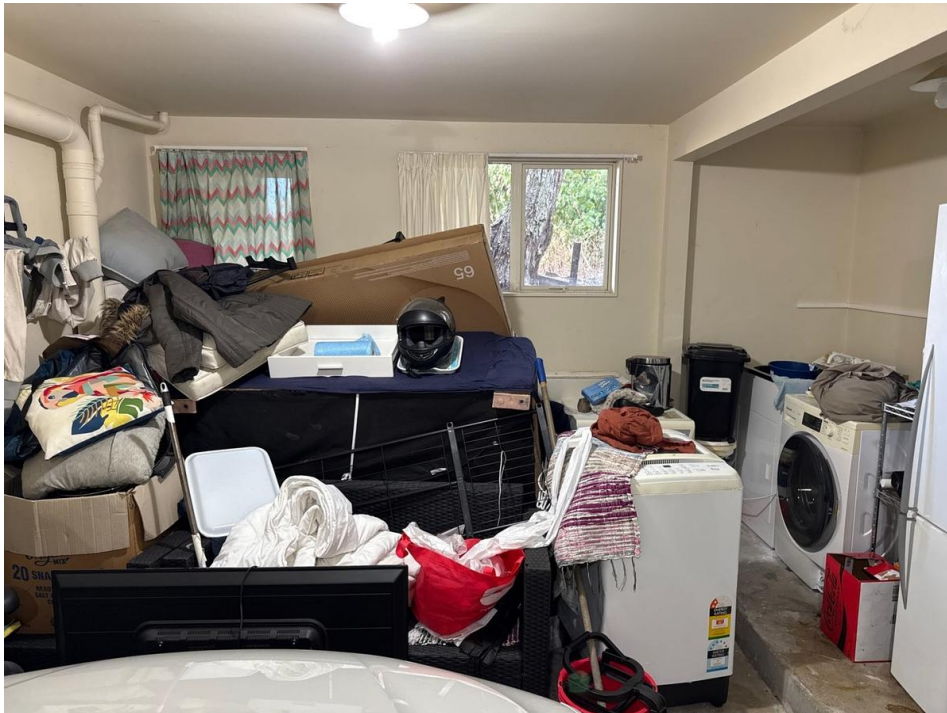
Photo 4

Moisture readings of 11 - 19 % were obtained throughout the Garage/Laundry South-West Wall. There were no thermal anomalies or any other signs of moisture ingress. There was limited access to these walls due to storage in this area.

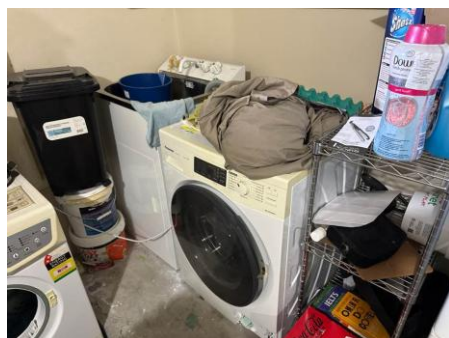
Photo 5

Laundry Tub and Plumbing appears to be in good working order (photo 5).

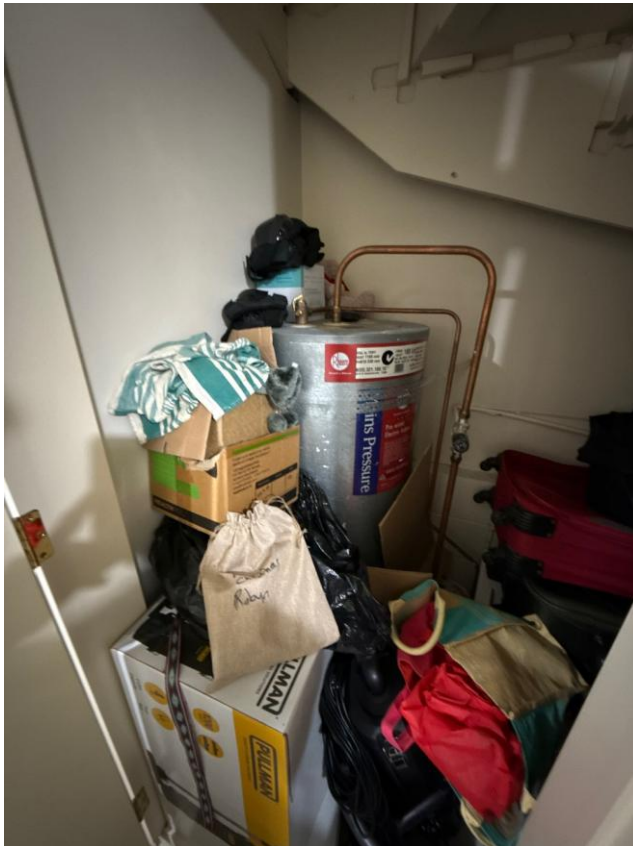
Photo 6

Moisture readings of 08 - 12 % were obtained throughout the Hot Water Cupboard Central Internal Wall. There were no thermal anomalies or any other signs of moisture ingress.

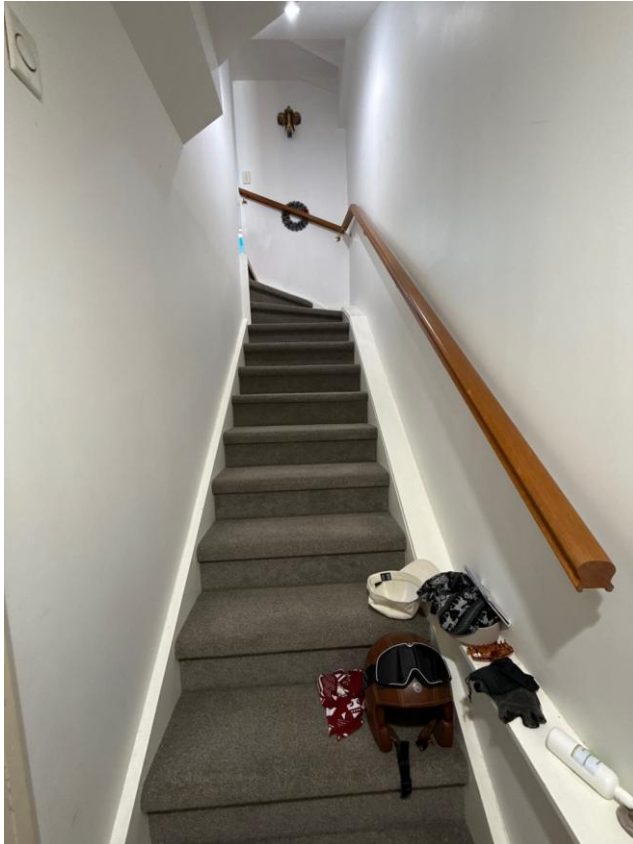
Photo 7

Moisture readings of 09 - 14 % were obtained throughout the Stairwell West Wall. There were no thermal anomalies or any other signs of moisture ingress.

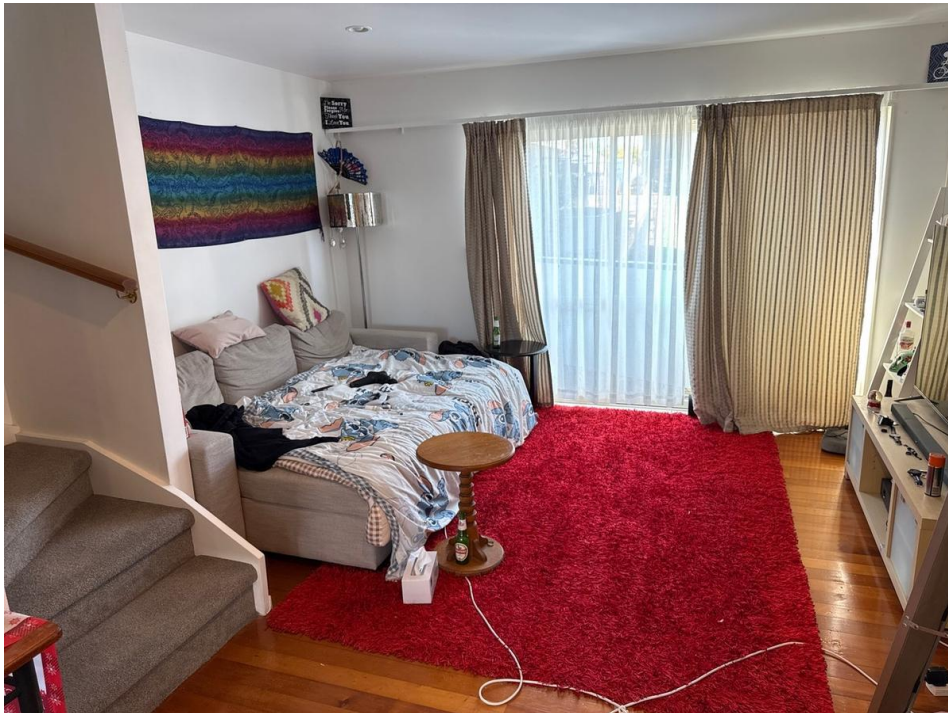
Photo 8

Moisture readings of 10 - 14 % were obtained throughout the Lounge North-West Wall. There were no thermal anomalies or any other signs of moisture ingress.

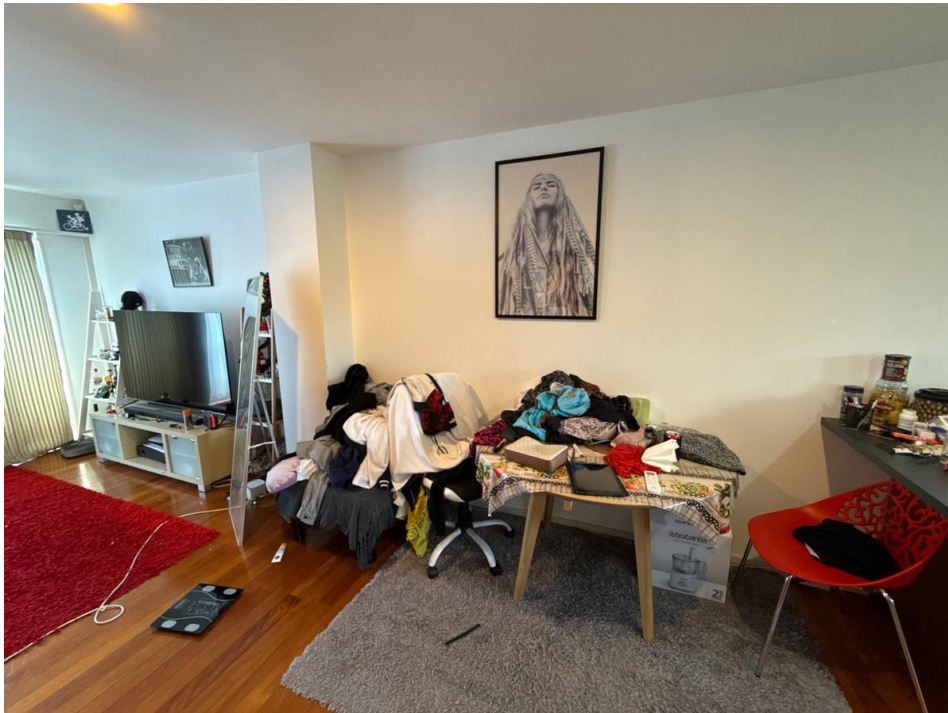
Photo 9

Moisture readings of 09 - 14 % were obtained throughout the Lounge/Dining East Wall. There were no thermal anomalies or any other signs of moisture ingress.

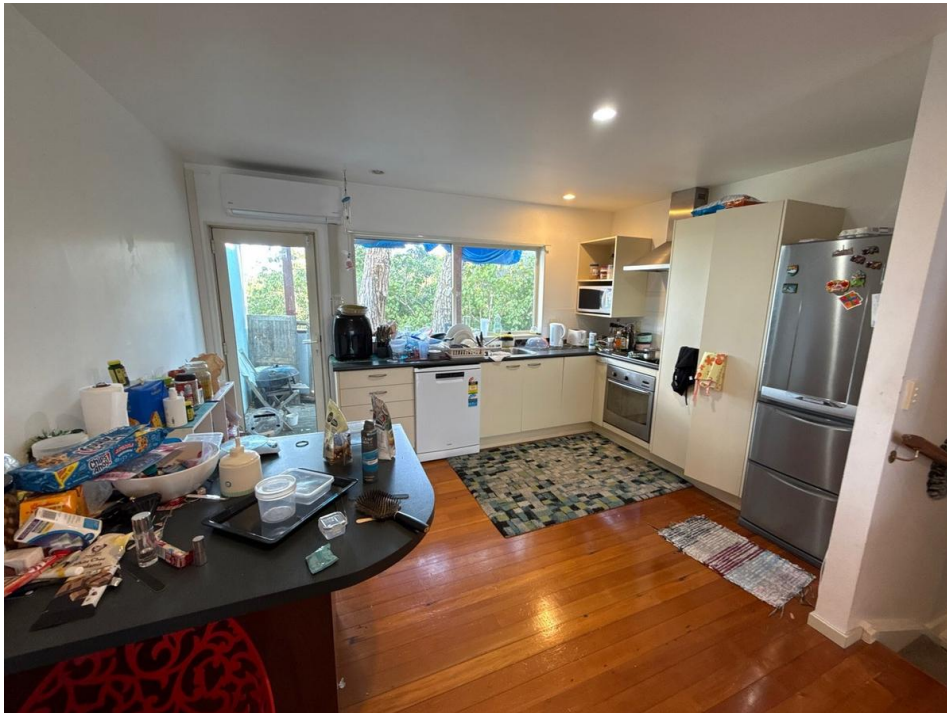
Photo 10

Moisture readings of 09 - 15 % were obtained throughout the Kitchen South-West Wall. There were no thermal anomalies or any other signs of moisture ingress.

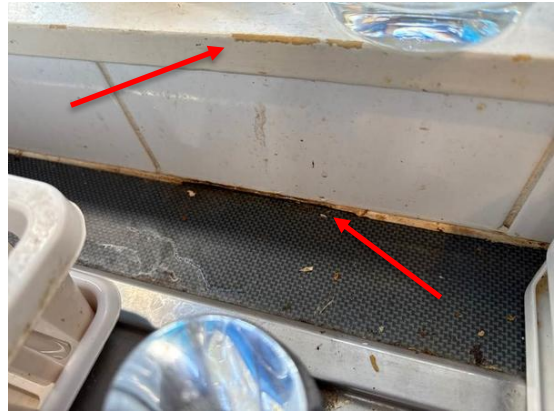
Photo 12

The kitchen sink plumbing appears to be in good working order; the kitchen tap is leaking at the join and there is a large amount of water damage behind the sink that will require remedial attention (photos 11 to 13). The rangehood is ducted correctly (photo 14).

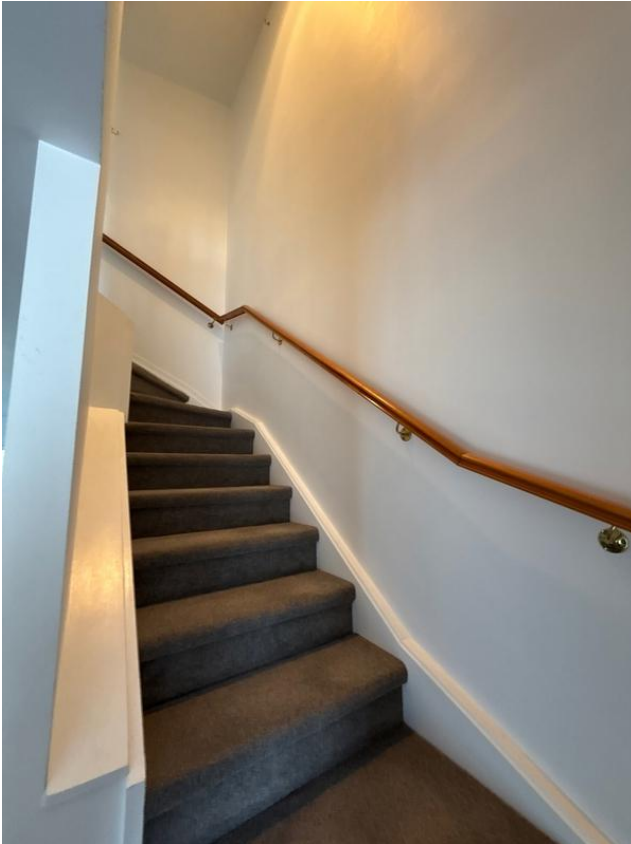
Photo 15

Moisture readings of 08 - 14 % were obtained throughout the Stairwell West Wall. There were no thermal anomalies or any other signs of moisture ingress.

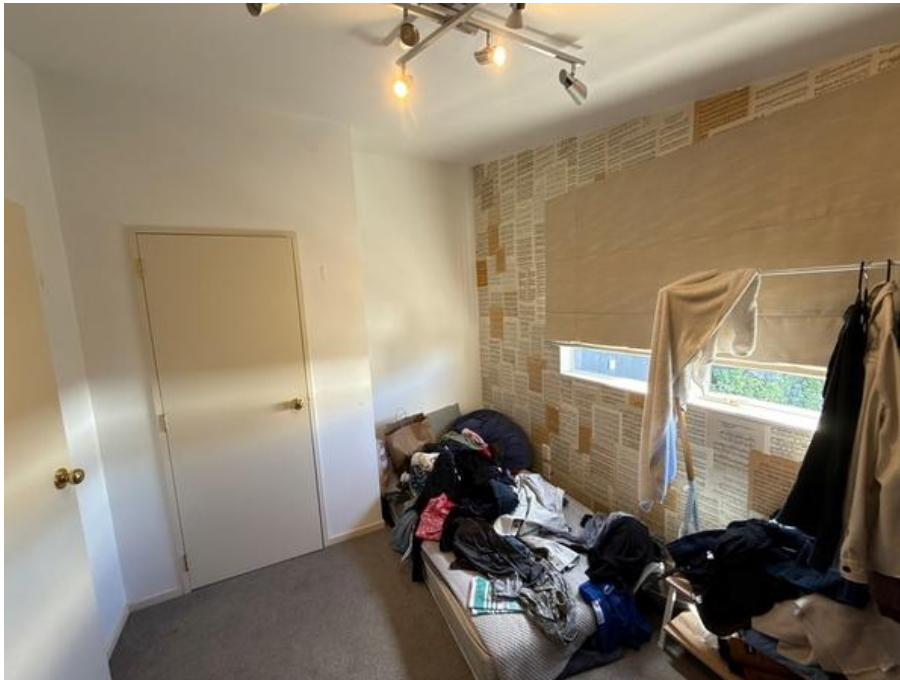
Photo 16

Moisture readings of 08 - 14 % were obtained throughout the Bedroom 1 North-West Wall. There were no thermal anomalies or any other signs of moisture ingress.

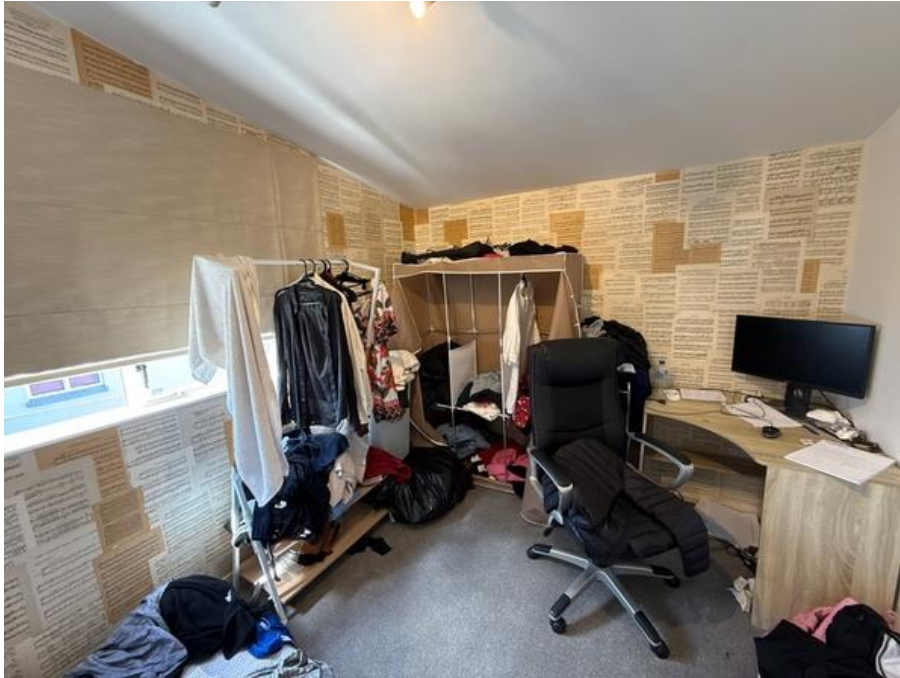
Photo 17

Moisture readings of 08 - 15 % were obtained throughout the Bedroom 1 North-East Wall. There were no thermal anomalies or any other signs of moisture ingress.

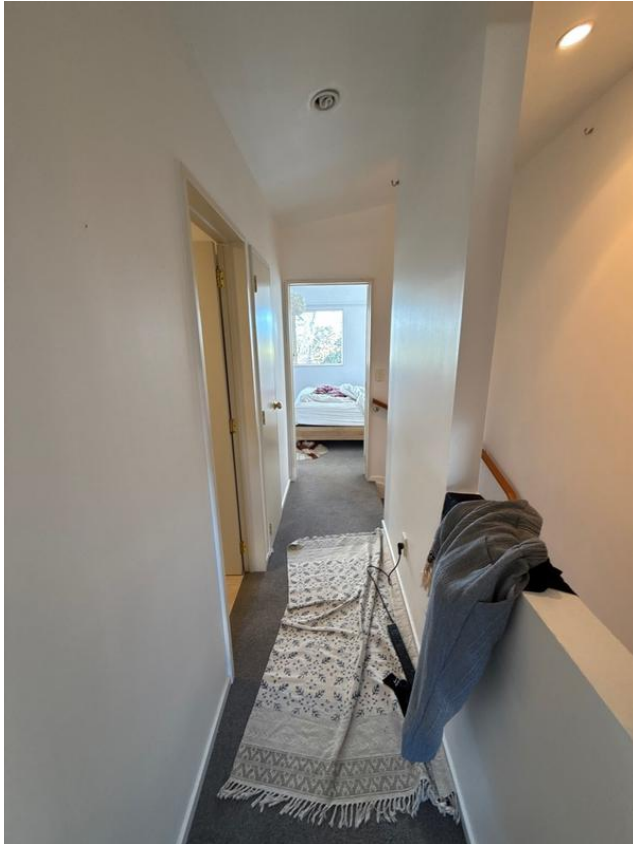
Photo 18

Moisture readings of 08 - 14 % were obtained throughout the Hallway Central Internal Wall. There were no thermal anomalies or any other signs of moisture ingress.

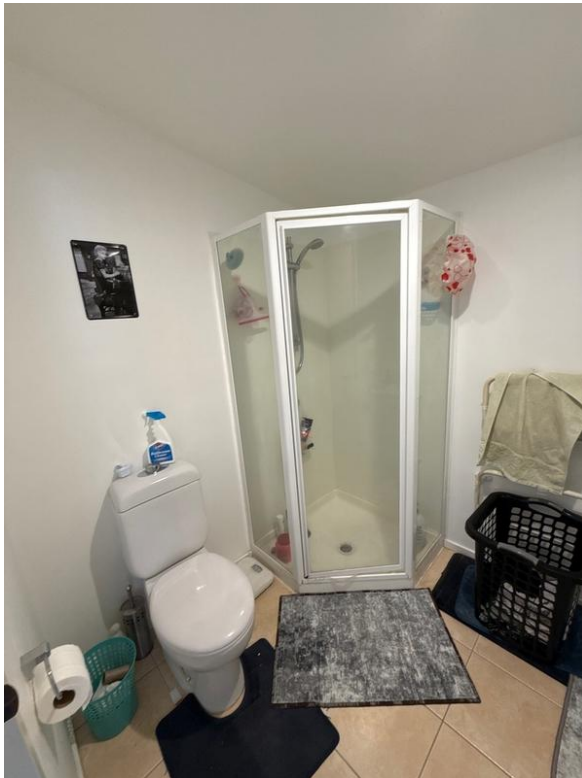
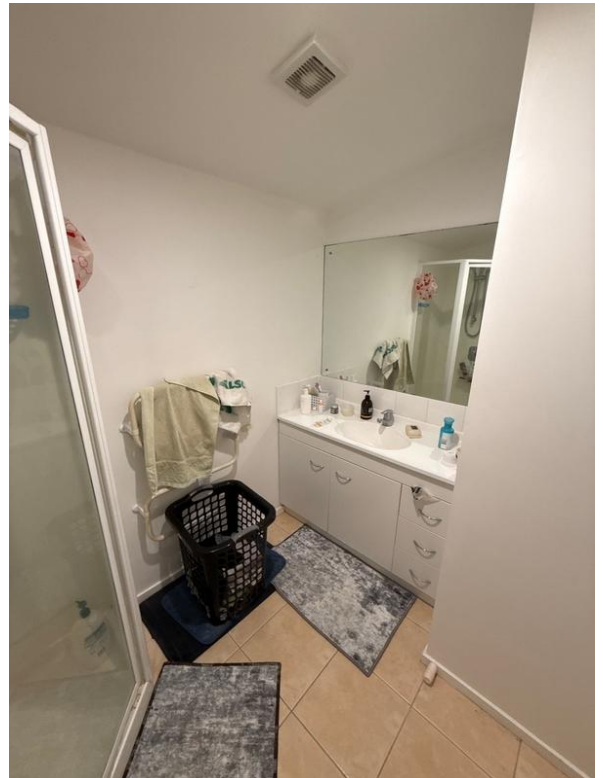
Moisture readings of 13 - 19 % were obtained throughout the Bathroom 1 East Wall. There were no thermal anomalies or any other signs of moisture ingress.

A hot water shower test was carried out to determine if the junctions of the shower were failing. The shower is in satisfactory condition.

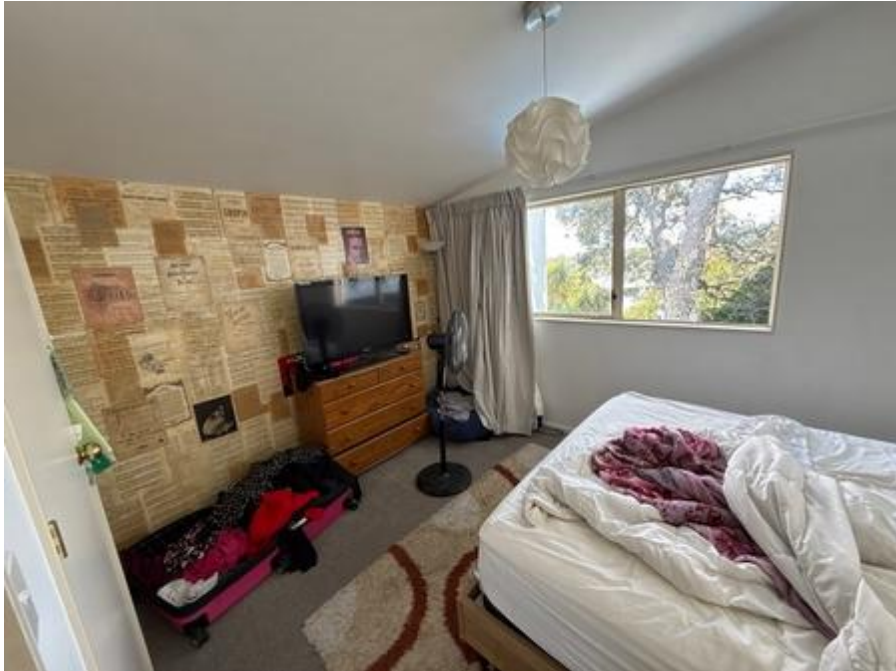
Photo 21

Moisture readings of 08 - 14 % were obtained throughout the Bedroom 2 South-East Wall. There were no thermal anomalies or any other signs of moisture ingress.

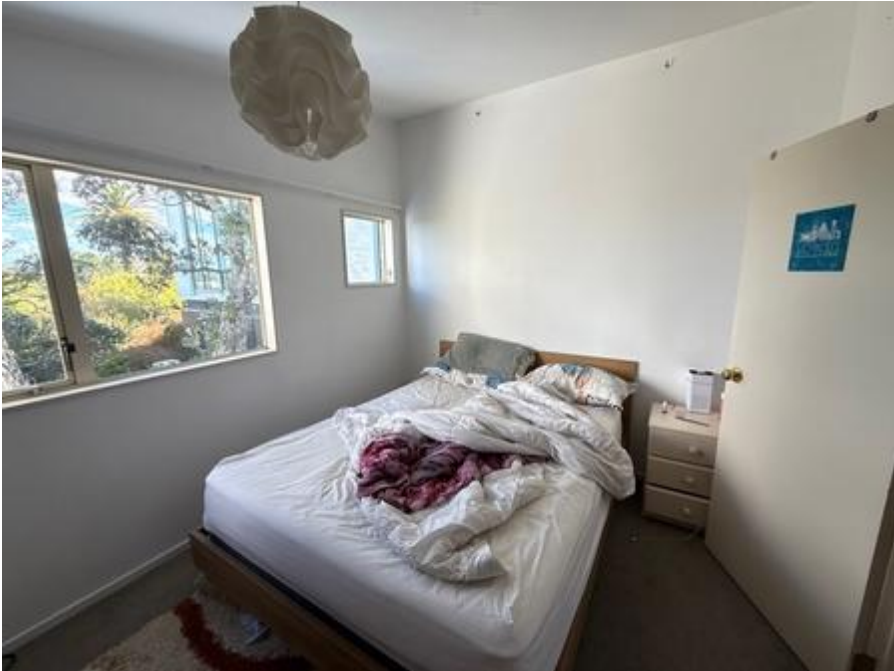
Photo 22

Moisture readings of 09 - 15 % were obtained throughout the Bedroom 2 South-West Wall. There were no thermal anomalies or any other signs of moisture ingress.

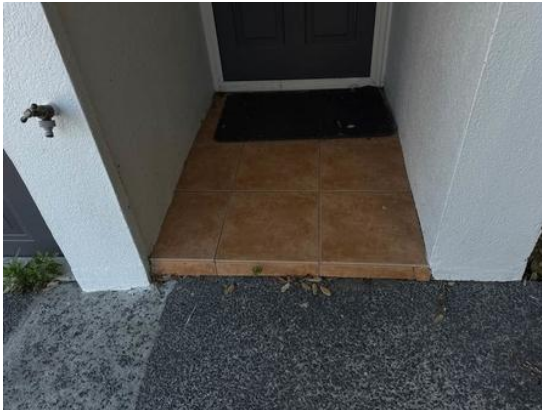
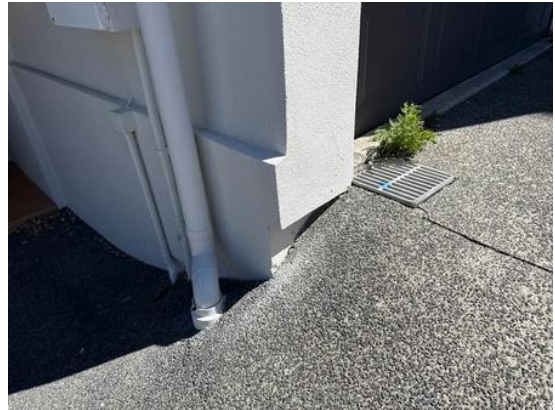
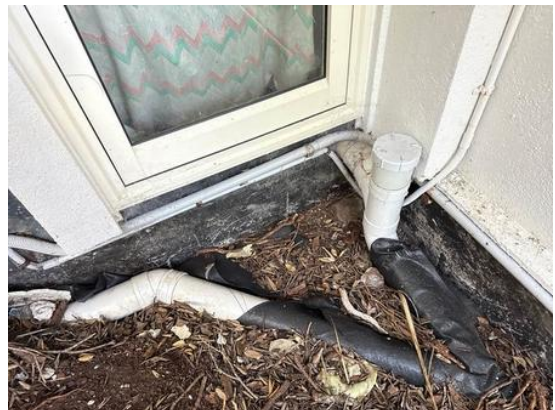
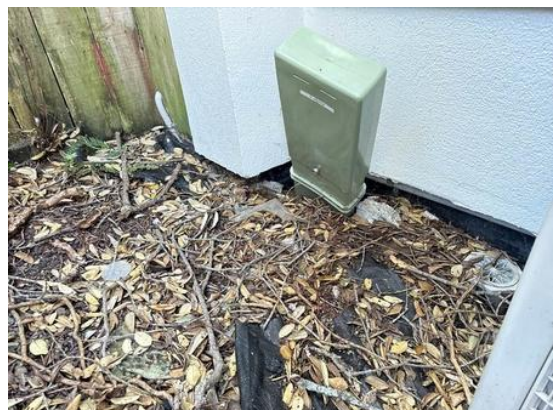
The dwelling has concrete slab floor and foundation with sufficient clearance between the bottom edge of the cladding and the finished ground level throughout the dwelling (photos 23 to 28).

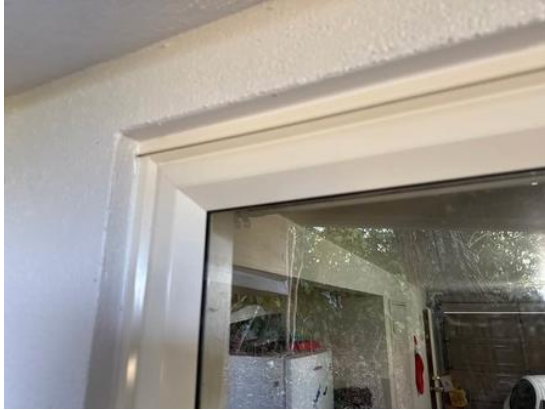
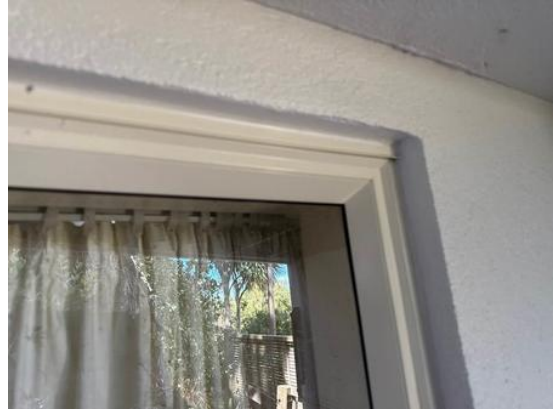
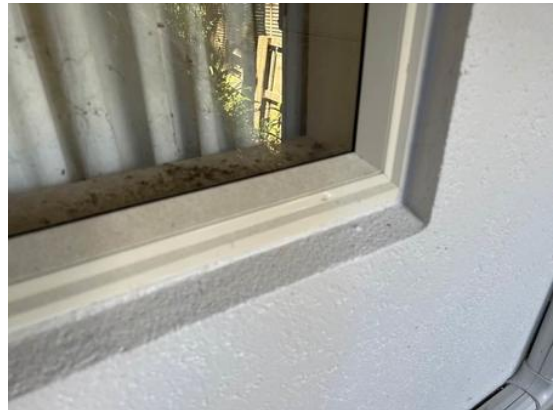
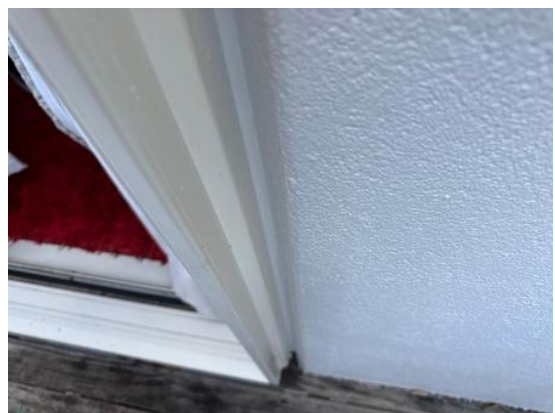
There are head flashings apparent above the windows (photos 29 and 30). The joinery and joinery to cladding junctions are in good condition throughout the dwelling (photos 31 to 34).

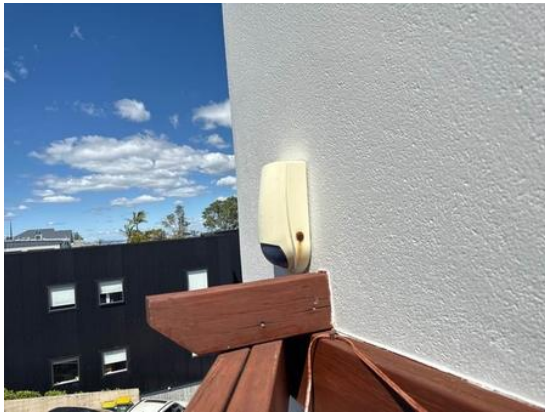
Photo 35

The external alarm to wall cladding junction is in good condition (photo 35).

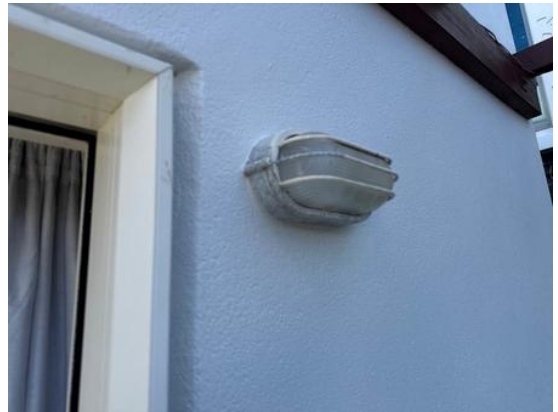
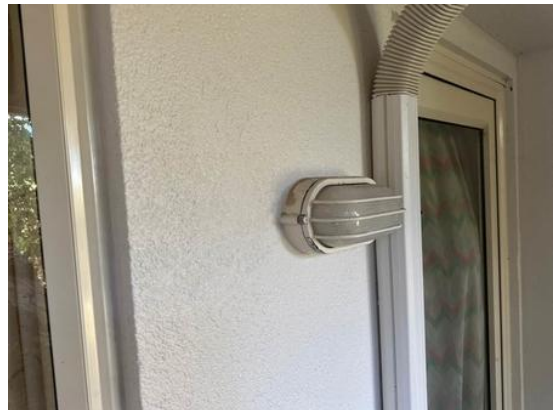
The external light fittings to wall cladding junctions are in good condition (photos 36 to 38).

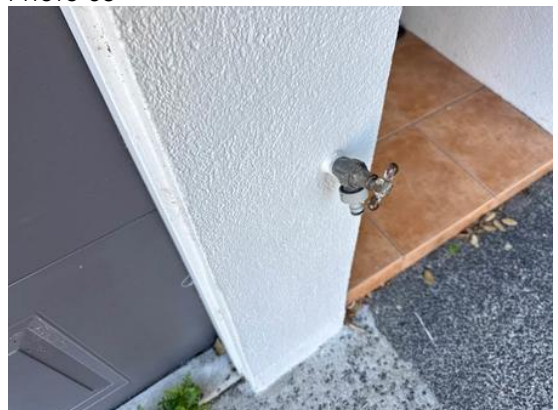
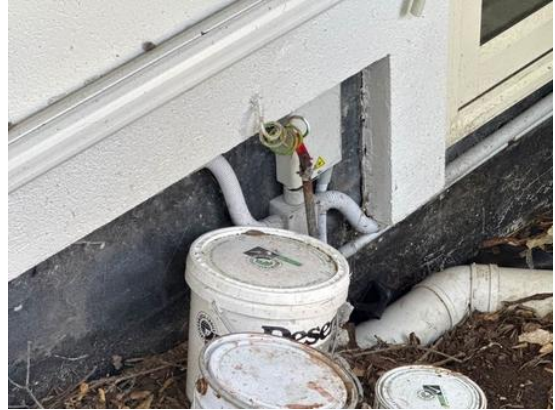
The external taps and pipework to wall cladding junctions are in satisfactory condition (photos 39 to 43).

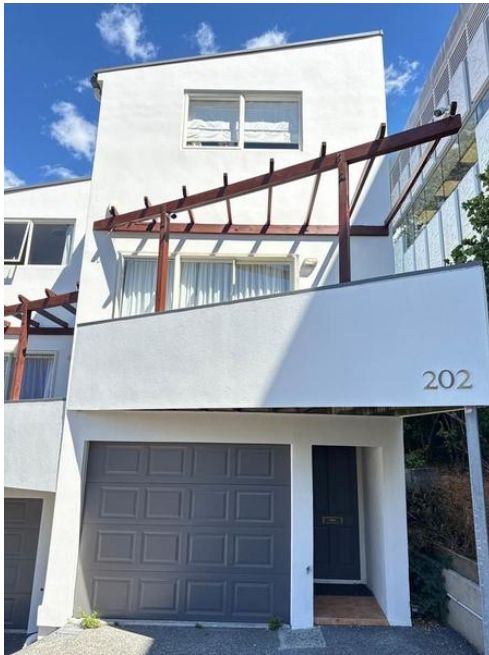
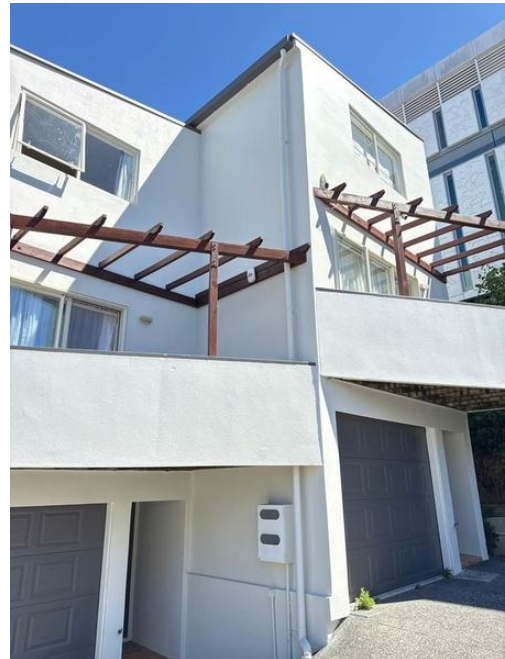
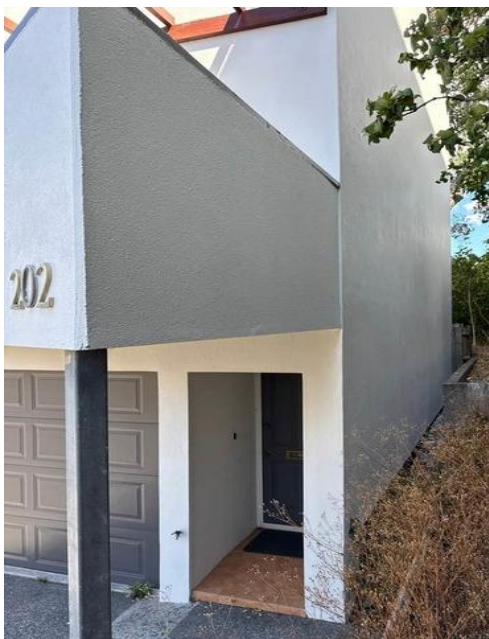
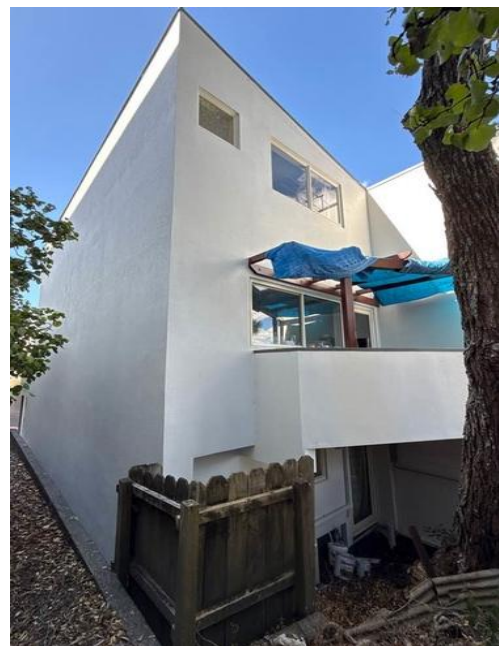
The dwelling has non-cavity EIFS/Insulclad style cladding system that is in good condition (photos 44 to 47).

The paint application waterproofs the plaster system and should be repainted every 5 to 7 years to help maintain the plaster cladding. This cladding was recently re-painted.

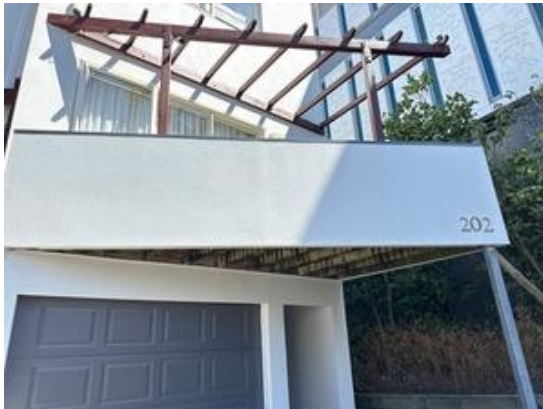
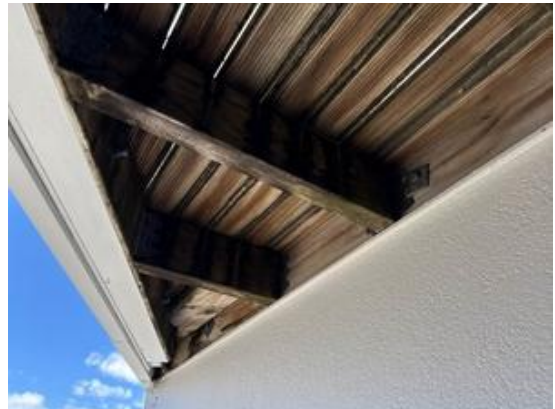
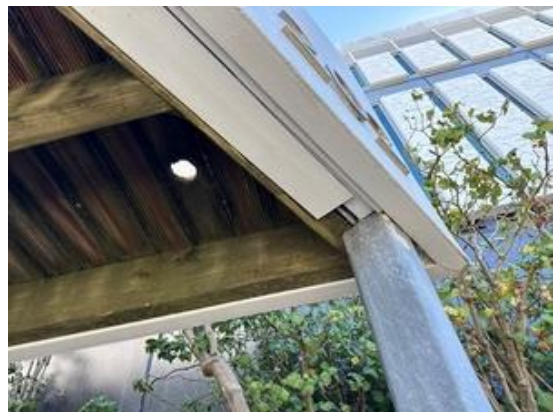
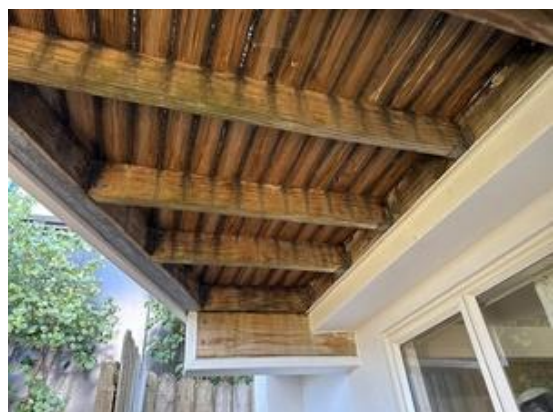
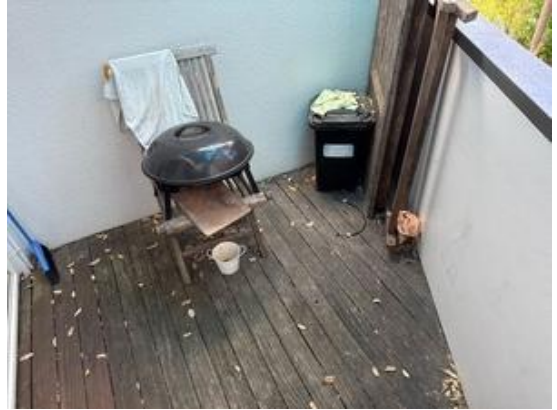
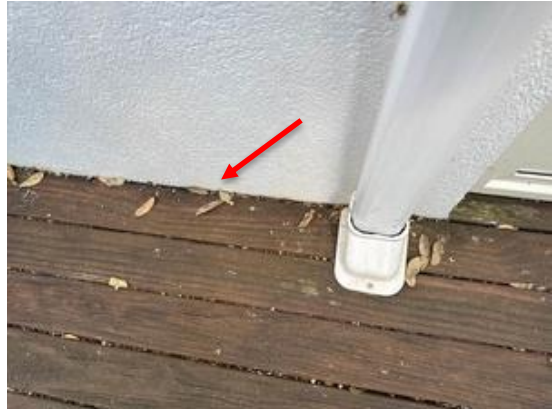
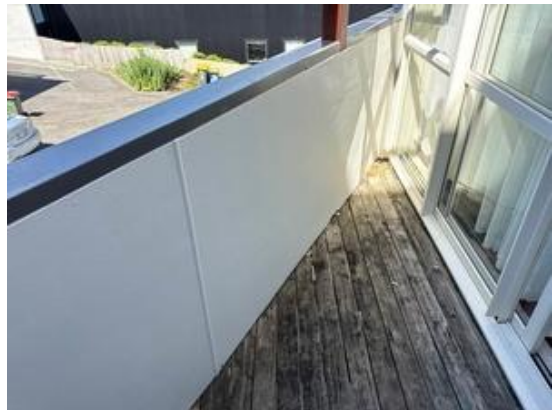
There is a timber deck that is in good condition, with a flashing detail in place; however, there is no cladding clearance at the deck junction (photos 48 to 59).

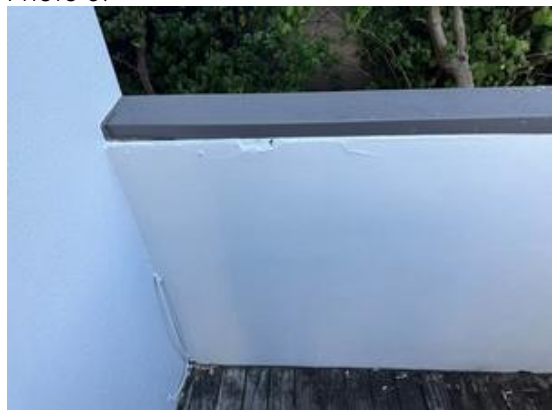
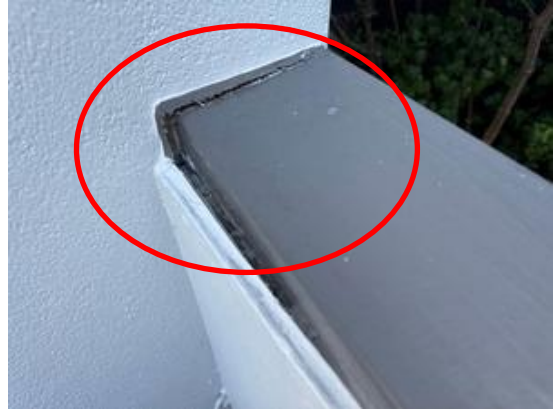
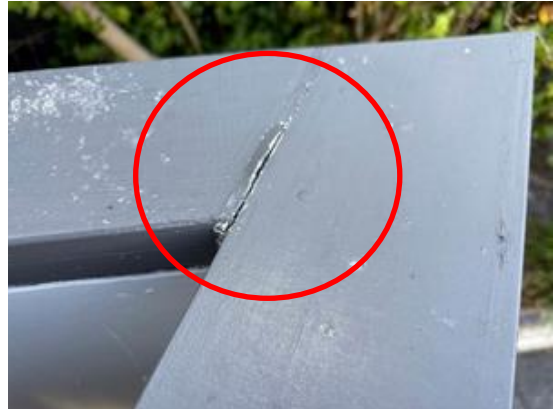
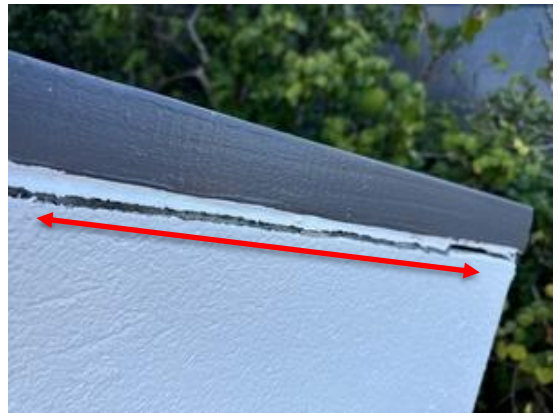
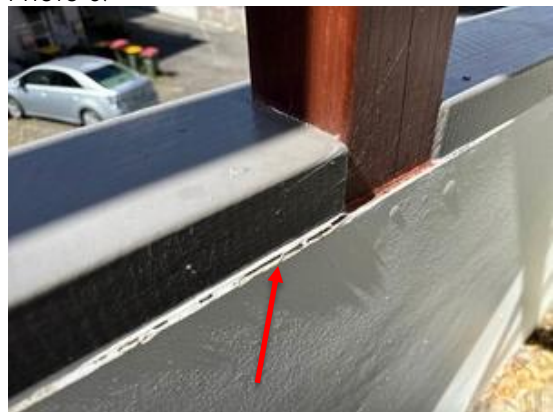
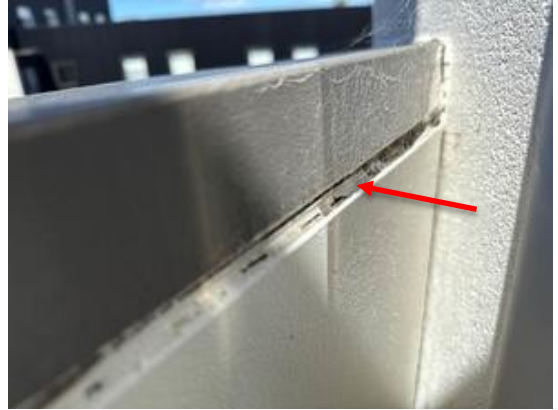
There is a mix of solid plaster and timber balustrades in place; There is cracking at the timber capping detail junctions, as well as cracking at the cladding junctions of the front balustrades that need remedial attention (photos 60 to 71).

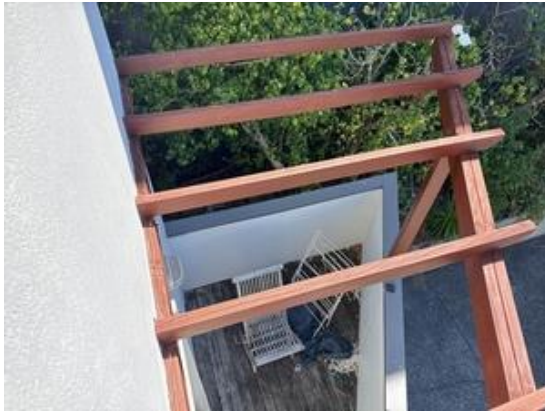
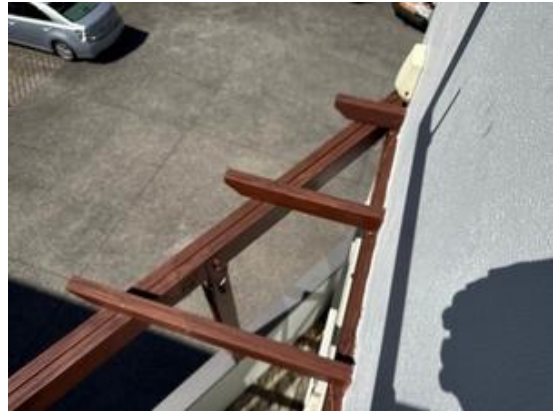
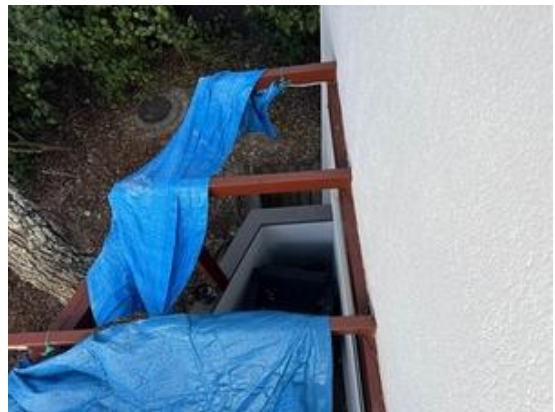
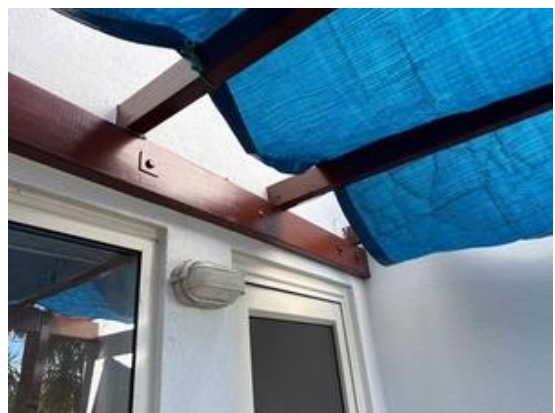
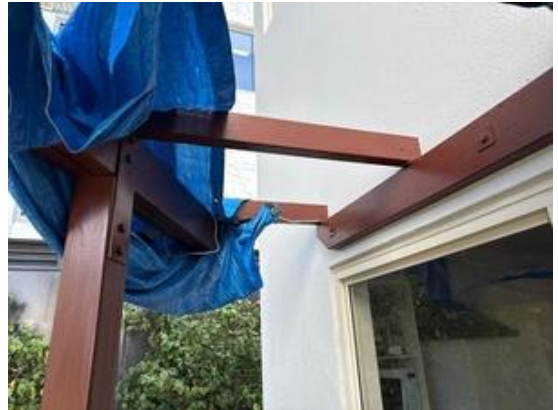
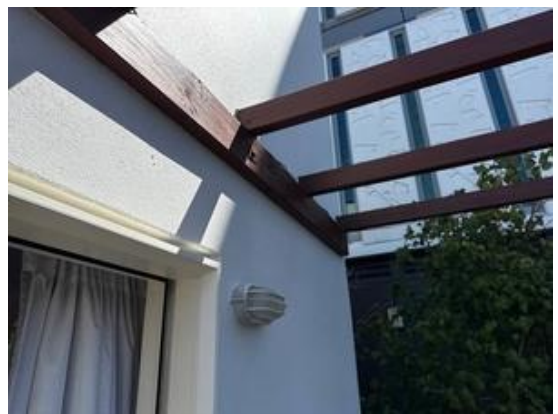
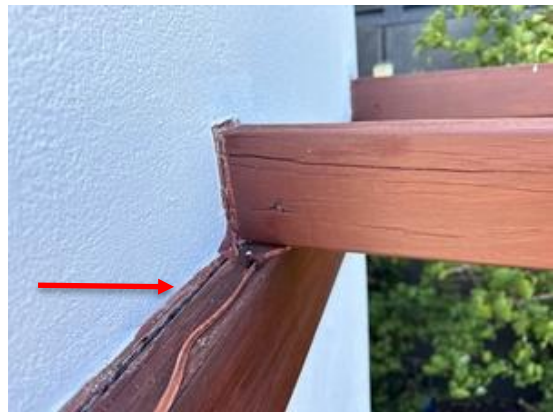
There is a direct-fixed timber framed pergola over the front and back decks that are generally in good condition; The wall junctions need to be sealed and kept well sealed at all times (photos 72 to 83).

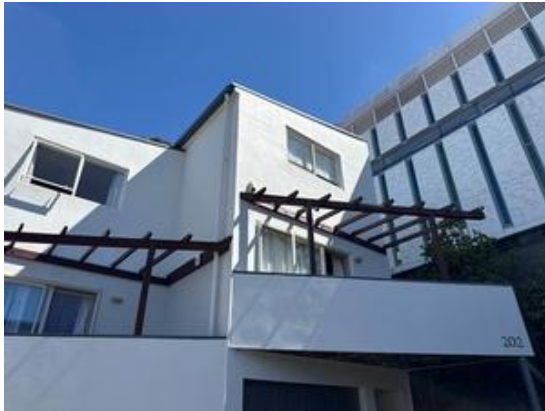
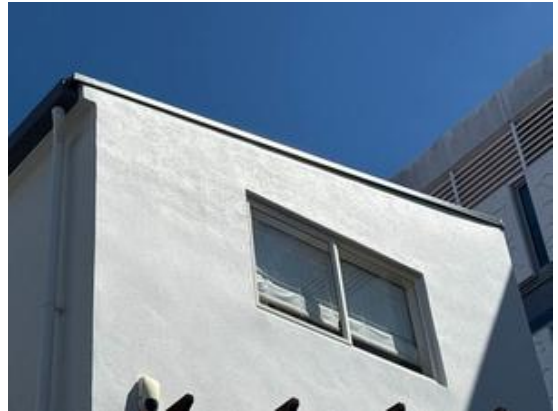
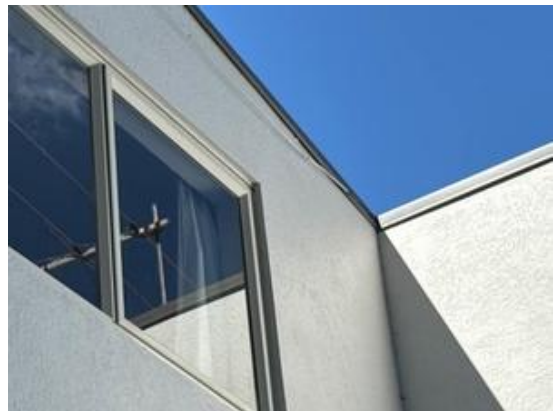
There was no access to the roof and roof flashings with no sign of leaking inside at this time (photos 86 to 89).

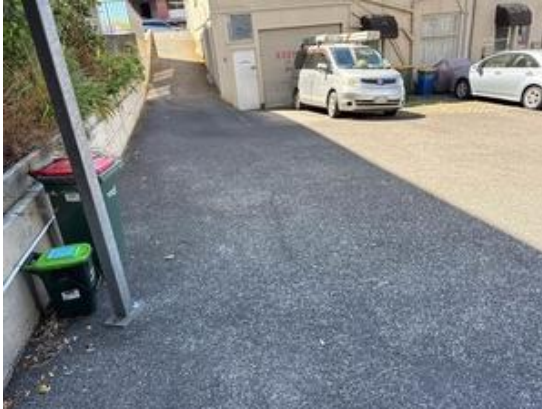
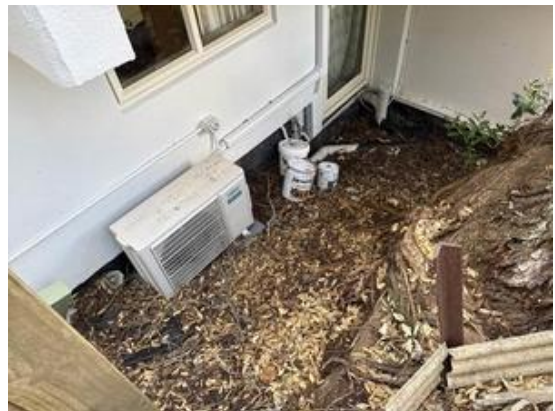
The shared driveway and pathways are in good condition (photos 90 to 93).

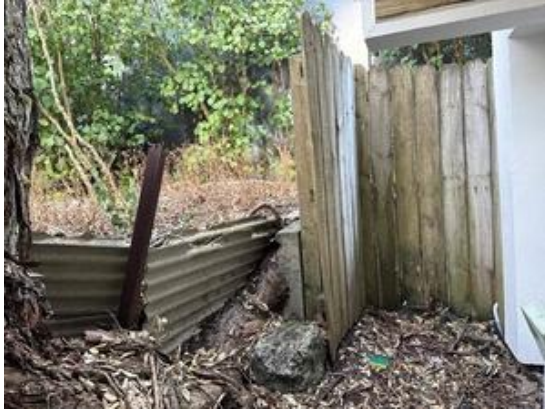
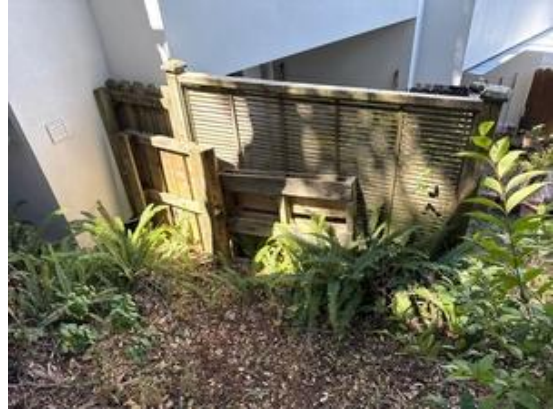
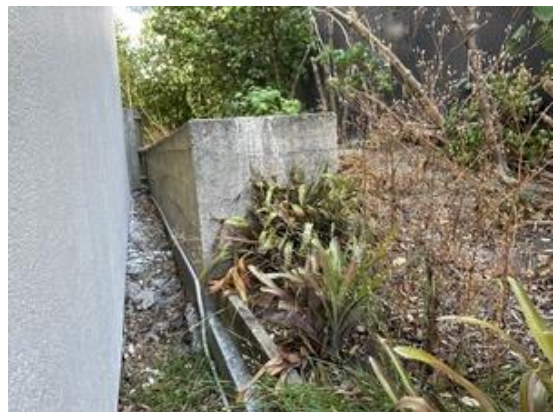
The timber post and rail fences, as well as the concrete block fences are in satisfactory condition (photos 94 to 97).
