Long-Term Maintenance Plan Review

On Point

9-11 Walmer Road

Unit Plan 553081

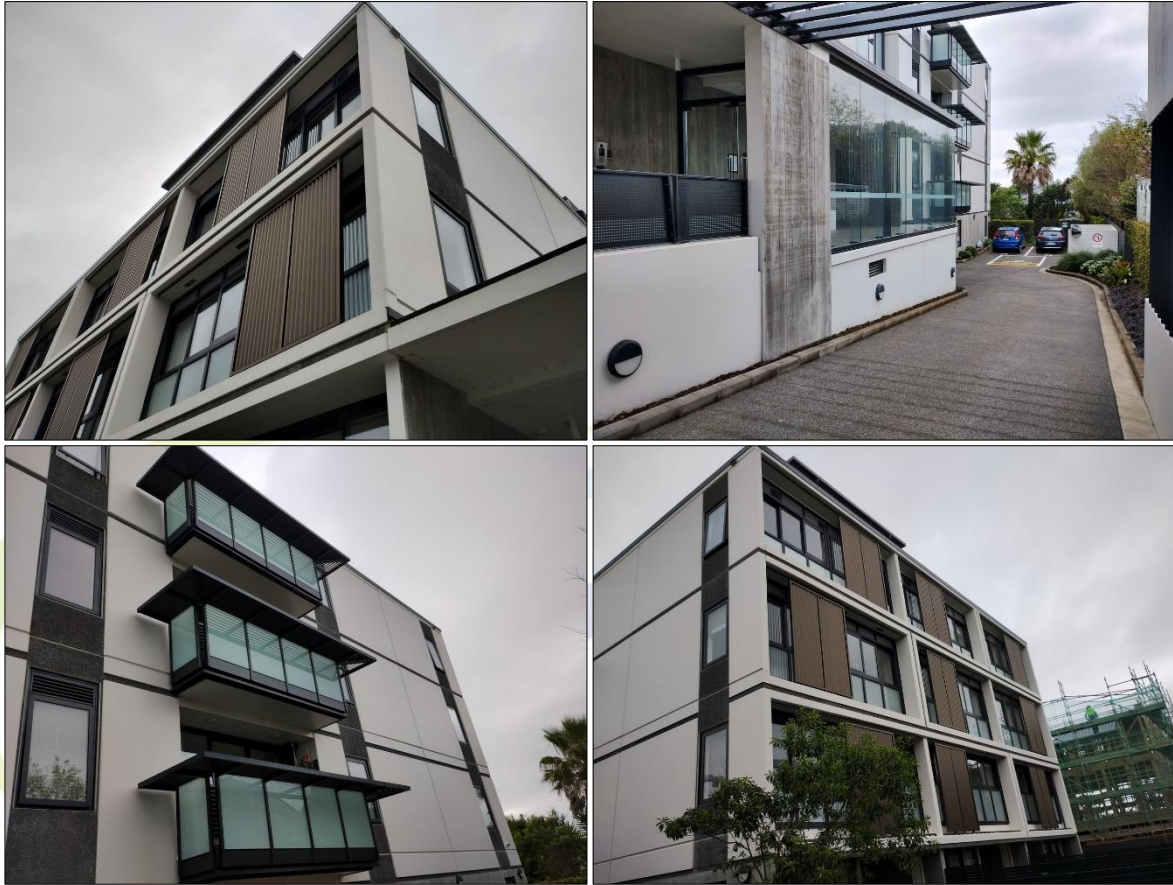
BUILDING EXTERIOR

The exterior was in good condition at the time of inspection. As the property ages repairs will be required and an allowance has been included in the report.

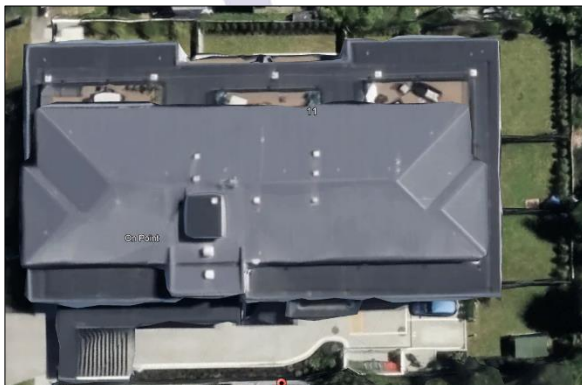
ROOFTOP

The roof was not accessible at the time of inspection. .

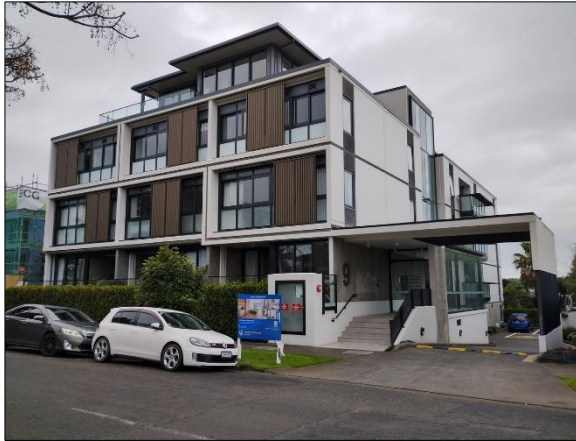
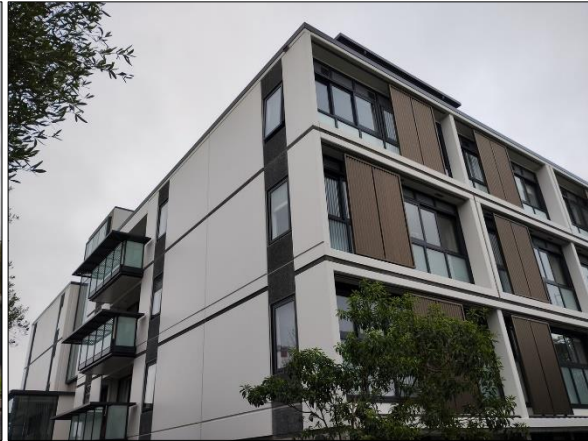
Item Group**ACCESS FOR WORK AT HEIGHTS**

The building was in good condition at the time of inspection. As the property ages repairs will be required and an allowance has been included in the report.

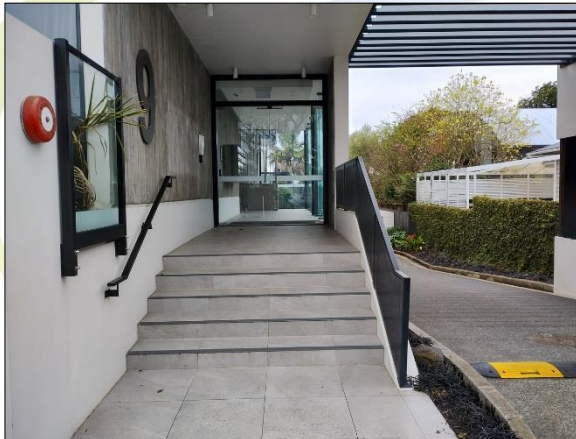
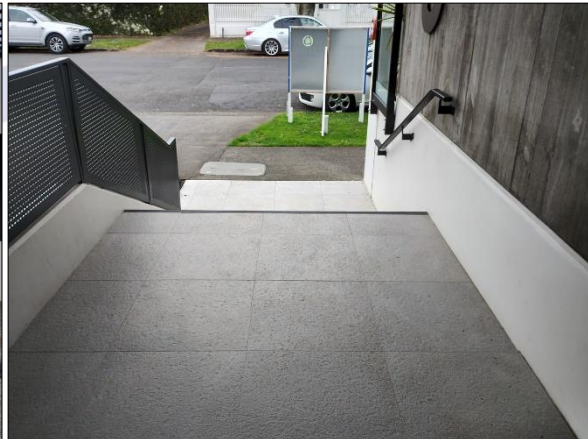
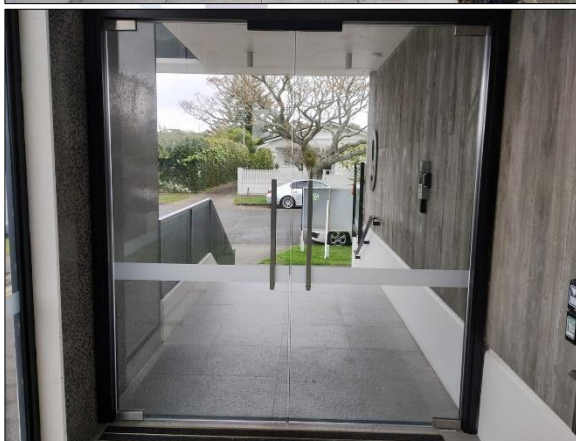
ENTRY LOBBY

The lobby was in good condition at the time of inspection. As the property ages repairs will be required and an allowance has been included in the report.

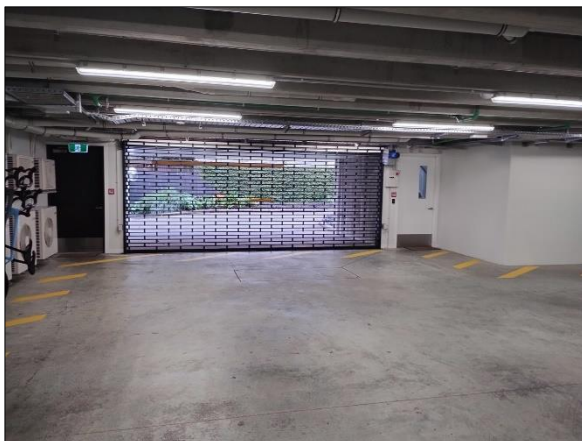
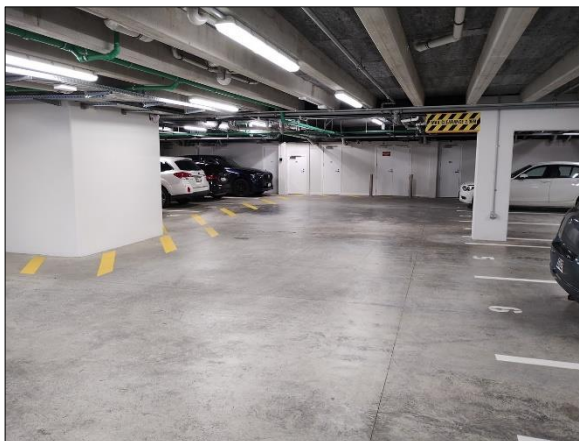
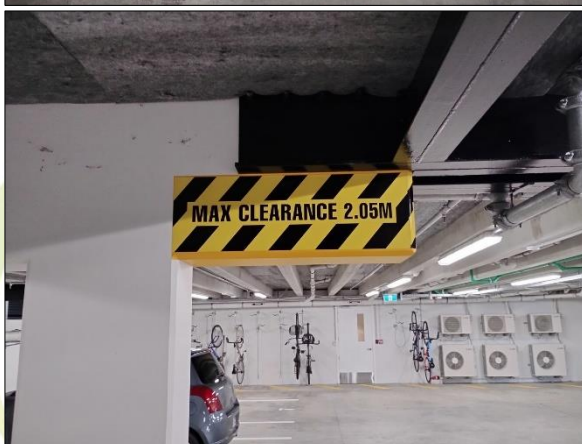
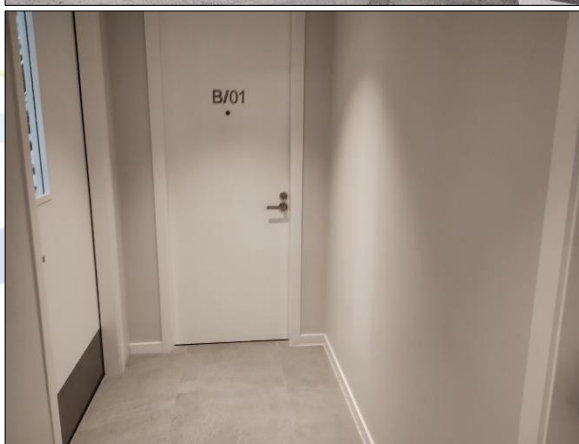
Item Group**BASEMENT CARPARK & APARTMENT LOBBY**

The basement was in good condition at the time of inspection. As the property ages repairs will be required and an allowance has been included in the report.

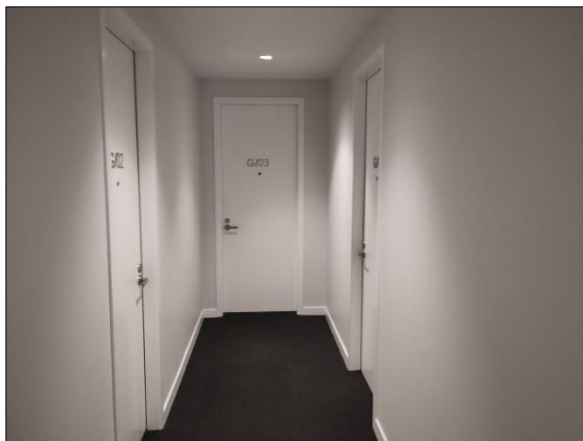
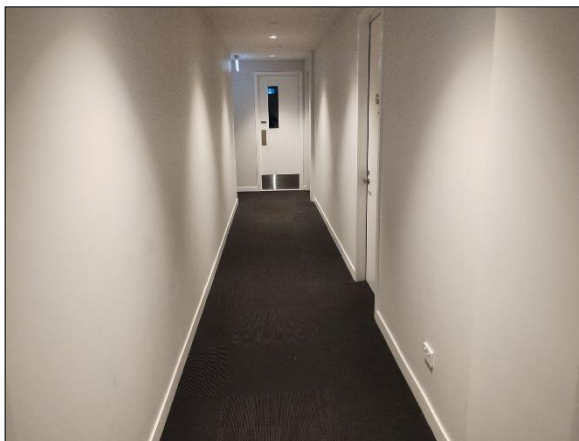
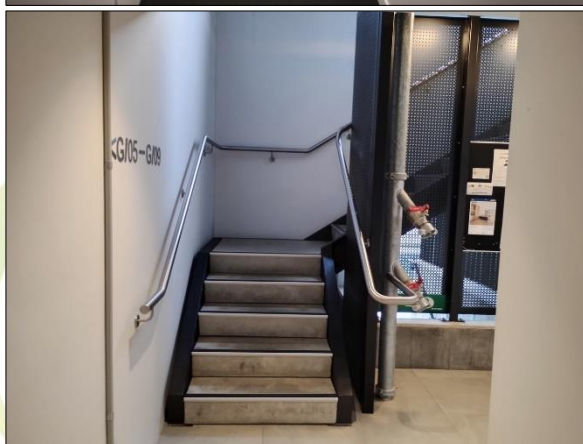
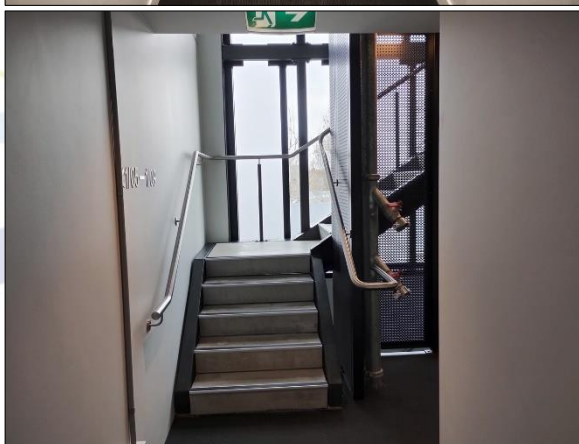
Item Group**BUILDING INTERIOR**

The interior was in good condition at the time of inspection. As the property ages repairs will be required and an allowance has been included in the report.

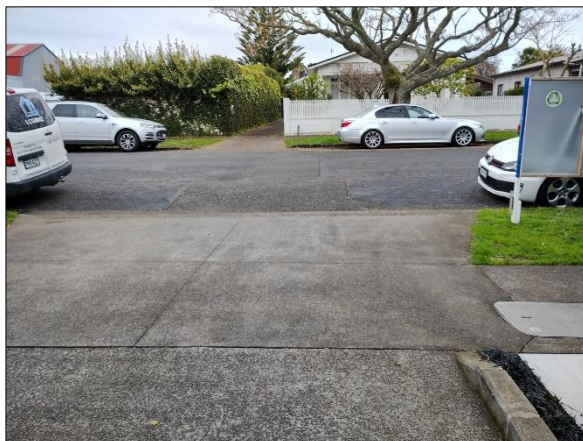
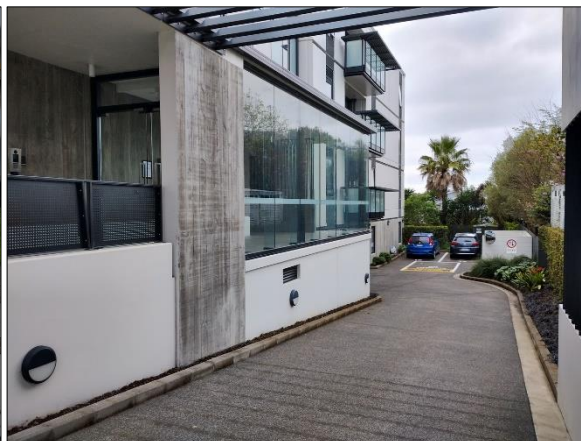
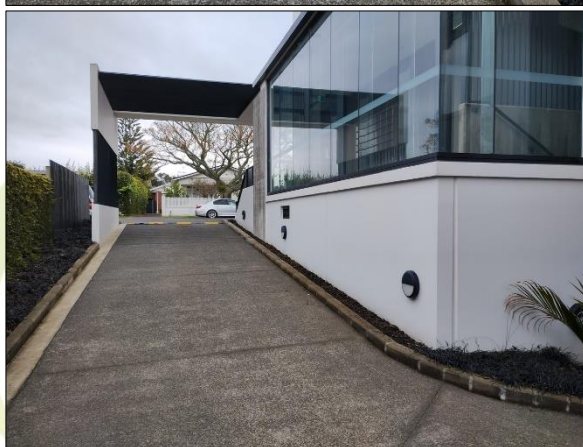
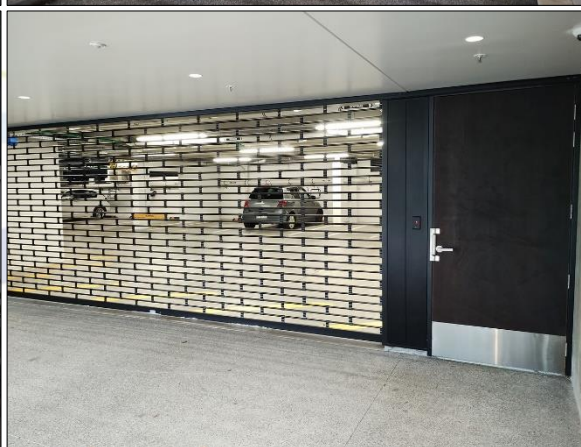
Item Group**DRIVEWAY**

The vehicle accessway was in good condition at the time of inspection. As the property ages repairs will be required and an allowance has been included in the report.

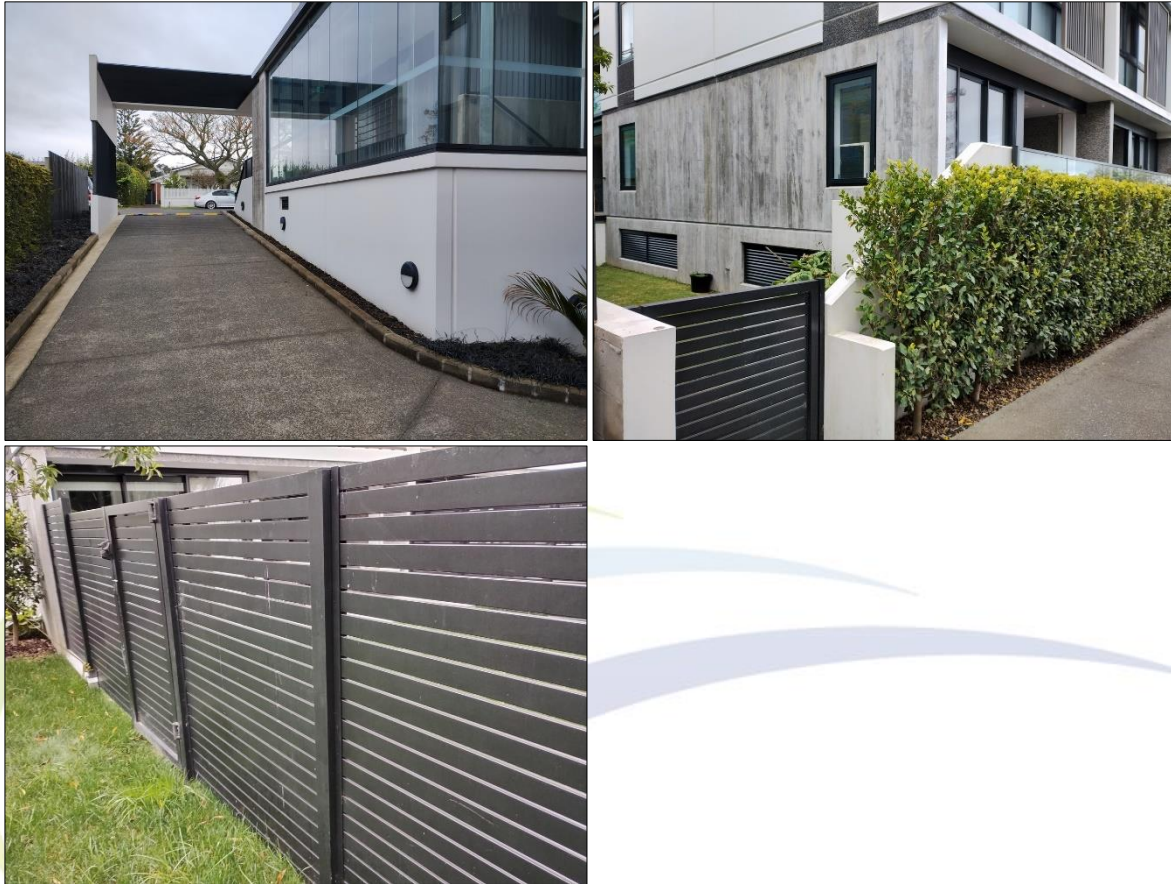
Item Group**FENCING AND WALLS**

The fences were in good condition at the time of inspection. As the property ages repairs will be required and an allowance has been included in the report.

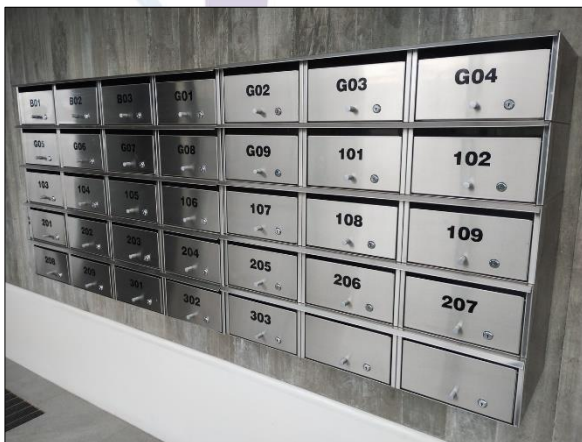
FIXTURES & FITTINGS

The mailboxes were in good condition at the time of inspection. As the property ages repairs will be required and an allowance has been included in the report.

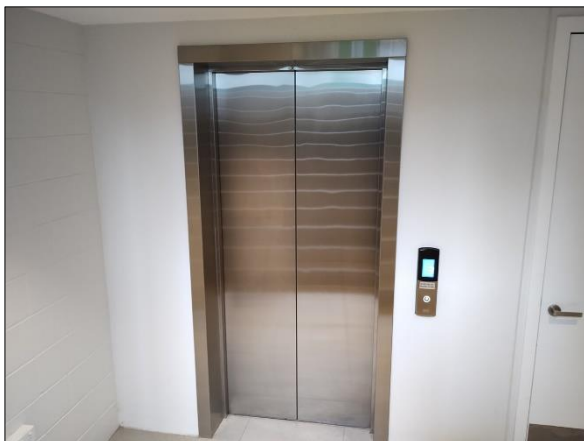
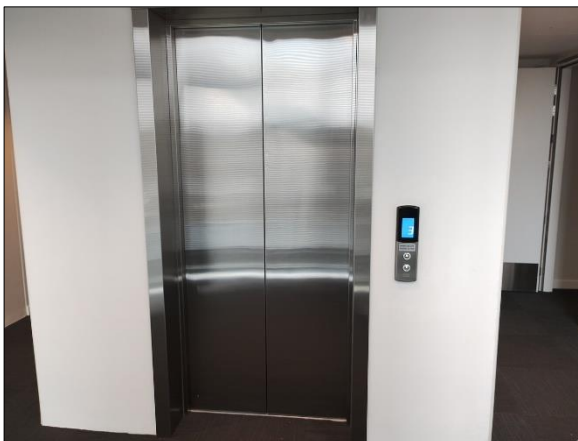
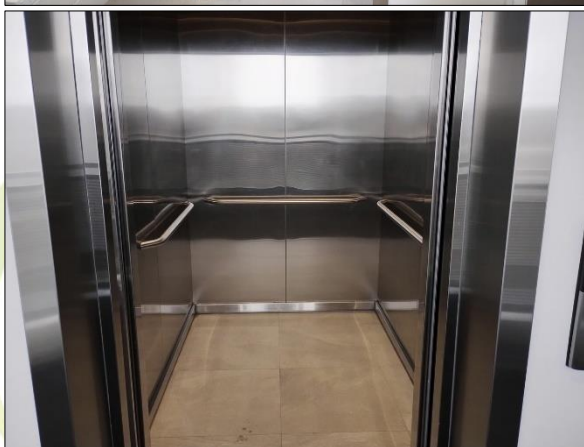
Item Group**LIFTS**

The lift was in good condition at the time of inspection. As the property ages repairs will be required and an allowance has been included in the report.

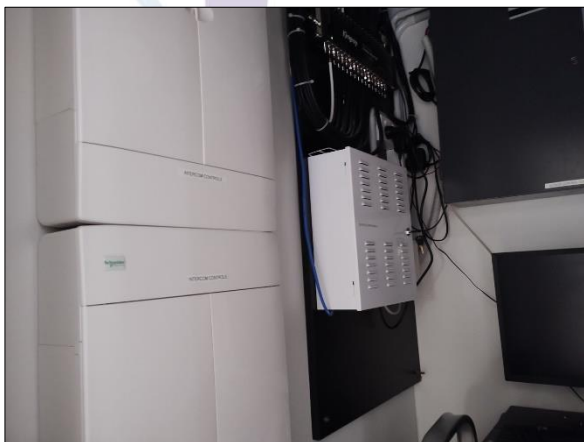
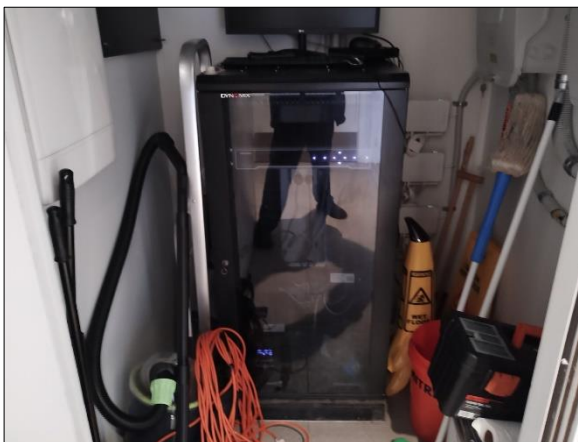
ELECTRICAL

The electrical system cupboard was in good condition at the time of inspection. As the property ages repairs will be required and an allowance has been included in the report.

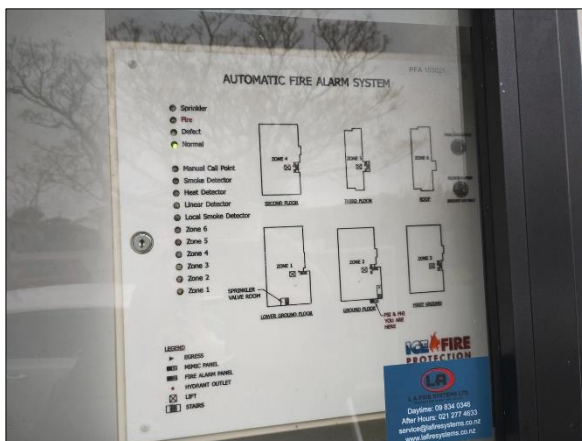
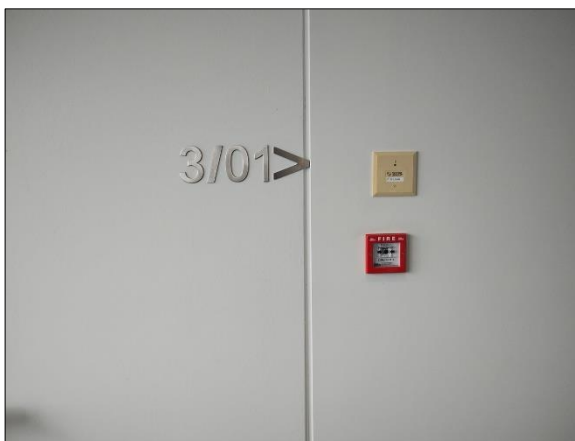
FIRE

The fire systems were in good condition at the time of inspection. As the property ages repairs will be required and an allowance has been included in the report.

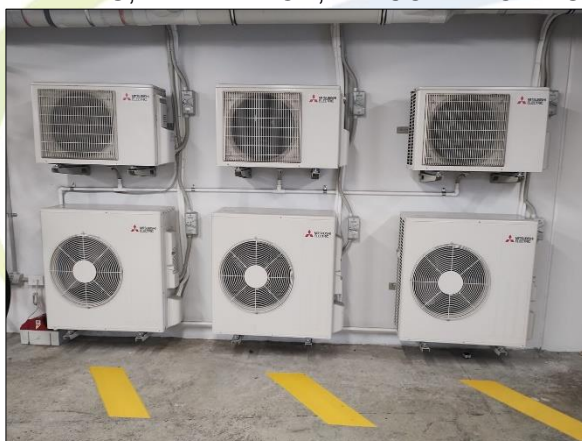
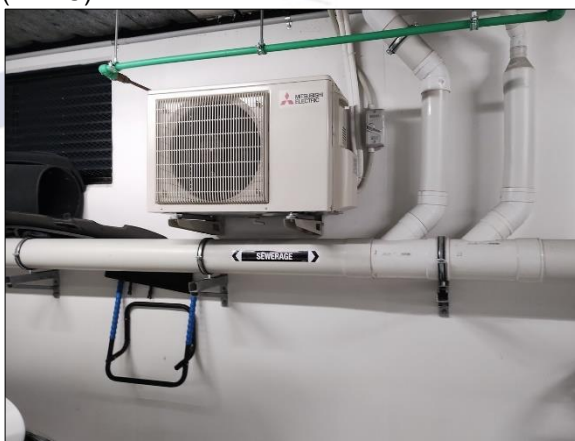
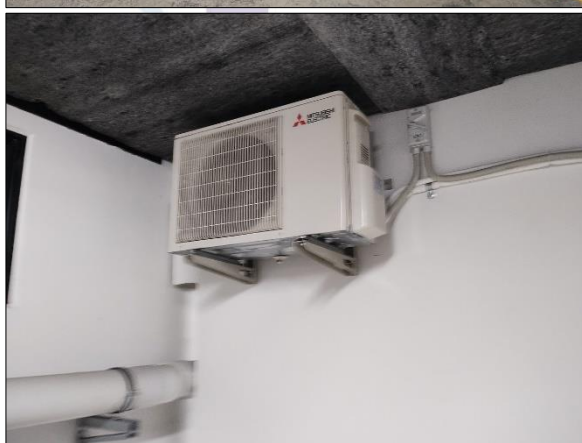
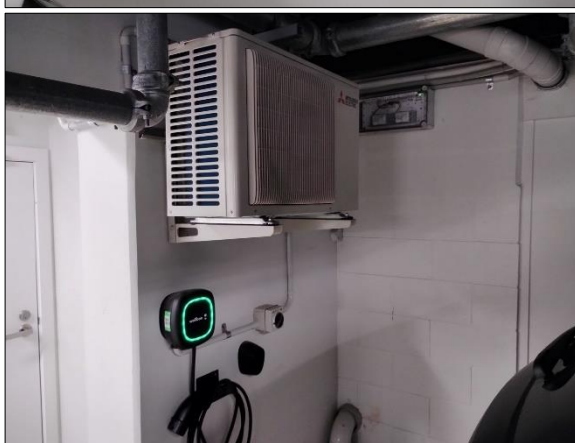
HEATING, VENTILATION, AIR-CONDITIONING (HVAC)

The heat pumps were in good condition at the time of inspection. As the property ages repairs will be required and an allowance has been included in the report.
