# CASH SETTLED CLAIM(S)

Claim No. CLM/2011/200970

**Damage Location:** 67 Tuckers Road, Casebrook, Christchurch 8051

# Drainage Assessment Report

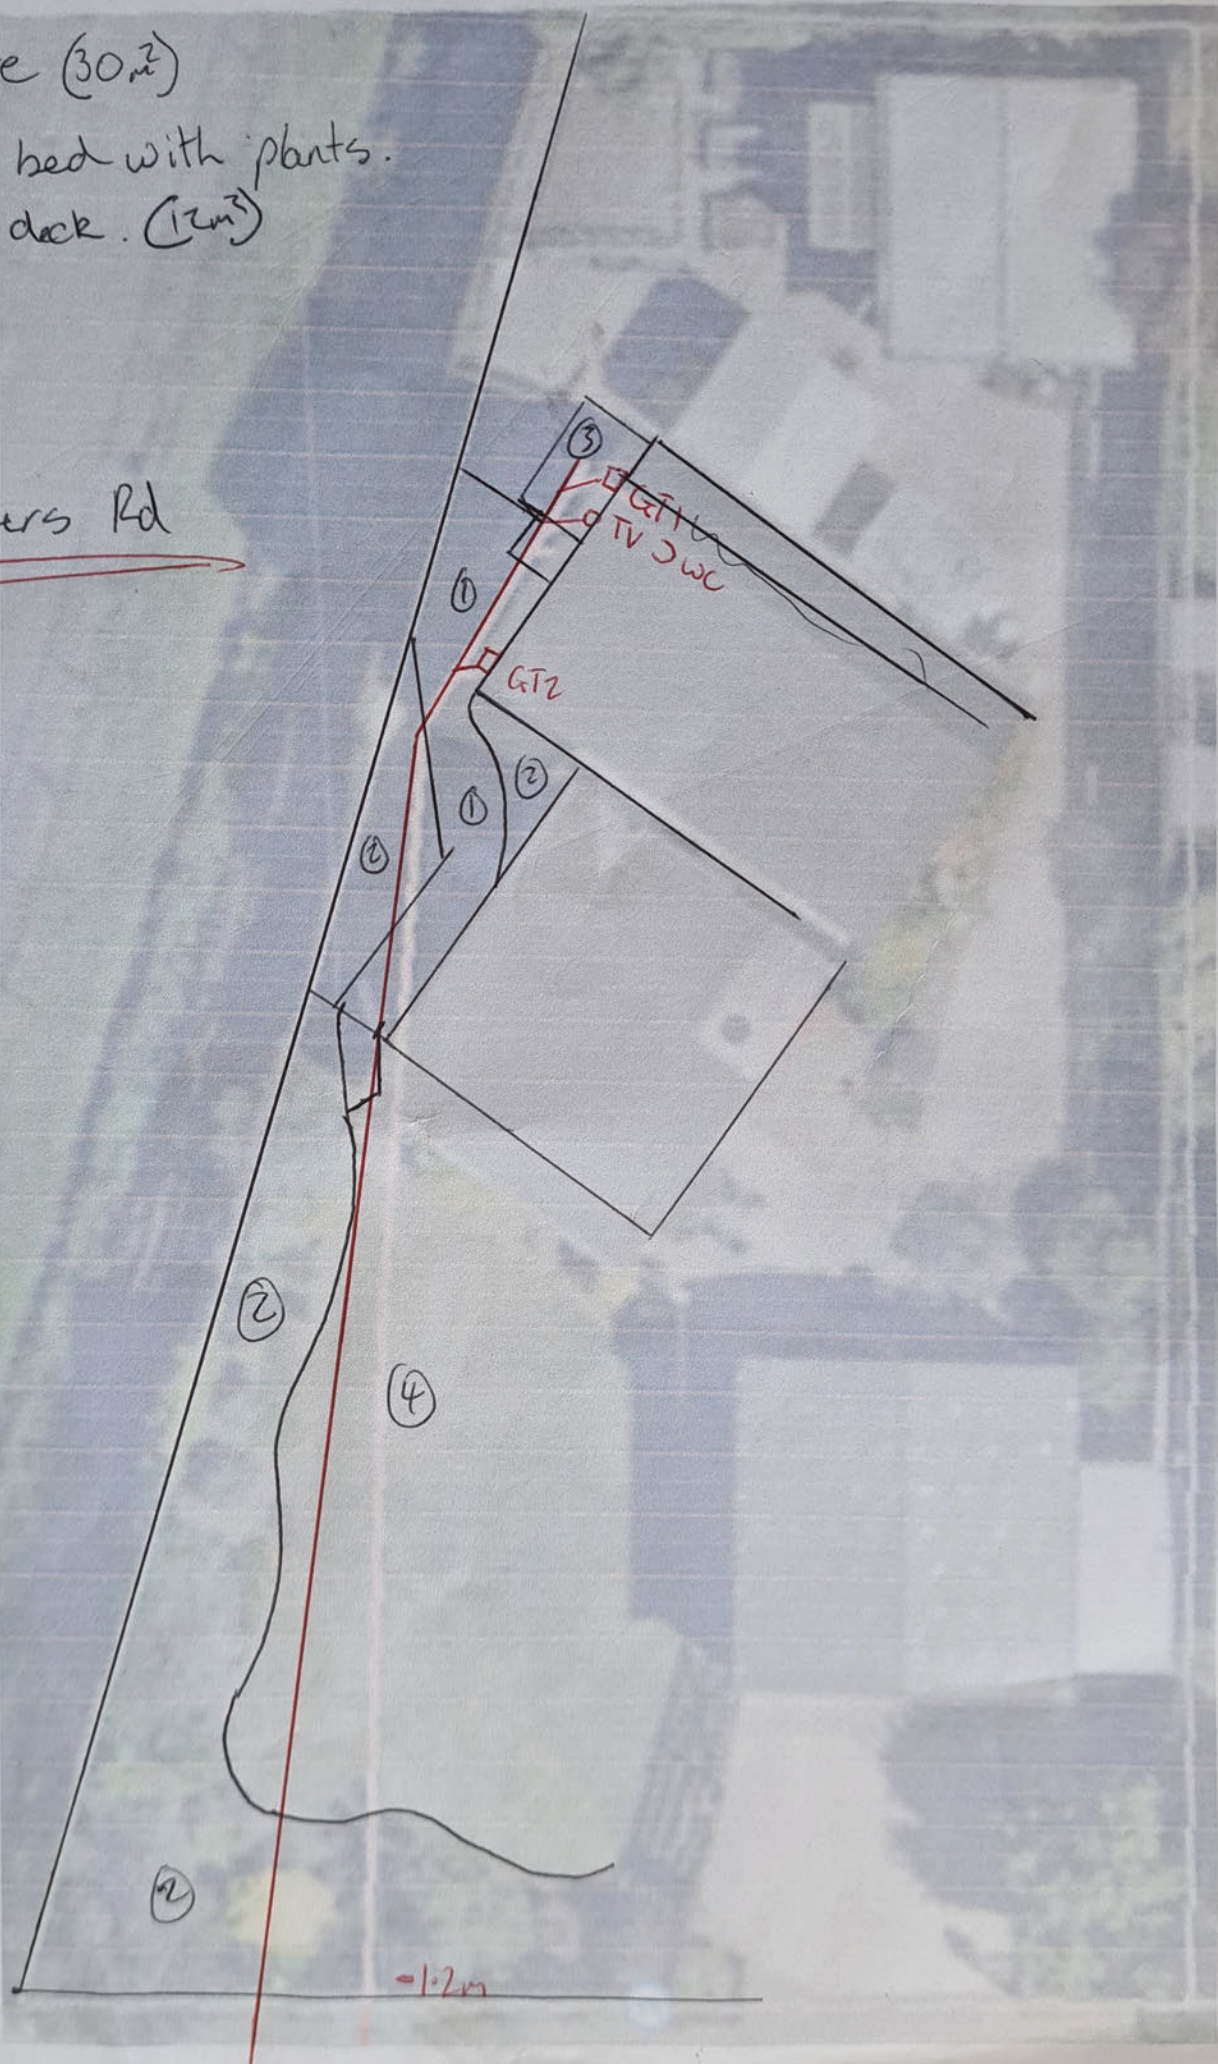
67 Tuckers Rd

- ① Concrete ( $30m^2$ )
- ② Garden bed with plants.
- ③ Wooden deck ( $12m^2$ )
- ④ Grass

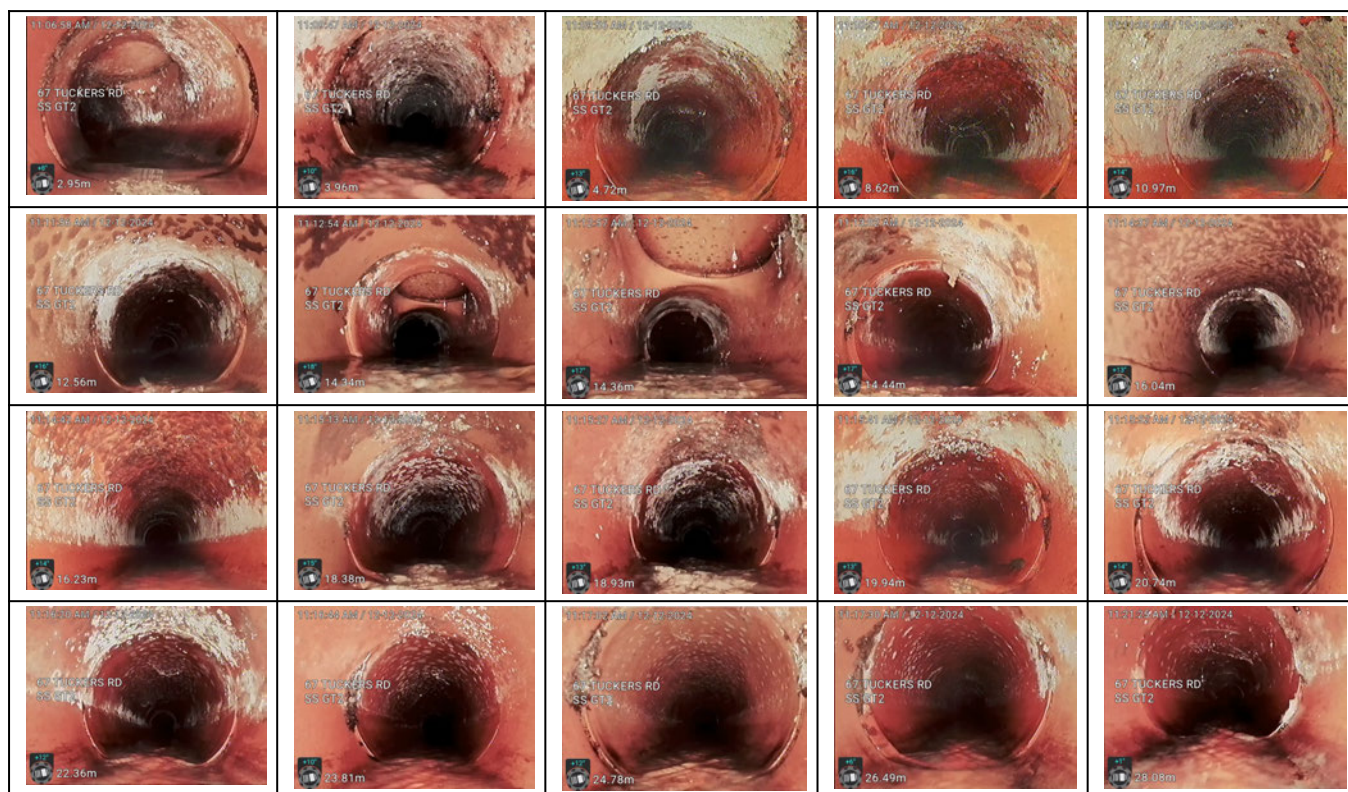
JD at 3.0m (pulled joint), 4.0m, 4.7m, 7.3m, 8.6m, 11.0m (pulled joint), 12.6m, 14.3m, 14.4m, 18.4m (pulled joint), 18.9m (pulled joint), 20.0m, 20.7, 22.4m, 23.8m, 24.8m, 25.5m, 26.5m (pulled joint), and 28.1m. Cracking at 14.3m (CL), 16.0m (CL), and 16.2m (CL; partially obscured by build-up on roof).

Although open and functional, there are widespread displaced and pulled joints in the sewer line, with some instances of cracking. This damage is consistent with damage caused by earthquake ground movement. We recommend this line be re-laid to restore integrity. We were unable to inspect the head of the line between the first and second gully trap as the first gully trap is underneath a deck. During repairs, we will inspect that portion of the line and if earthquake damage is found, a variation will be raised with NHC for additional works.

26m PVC to replace damaged earthenware.

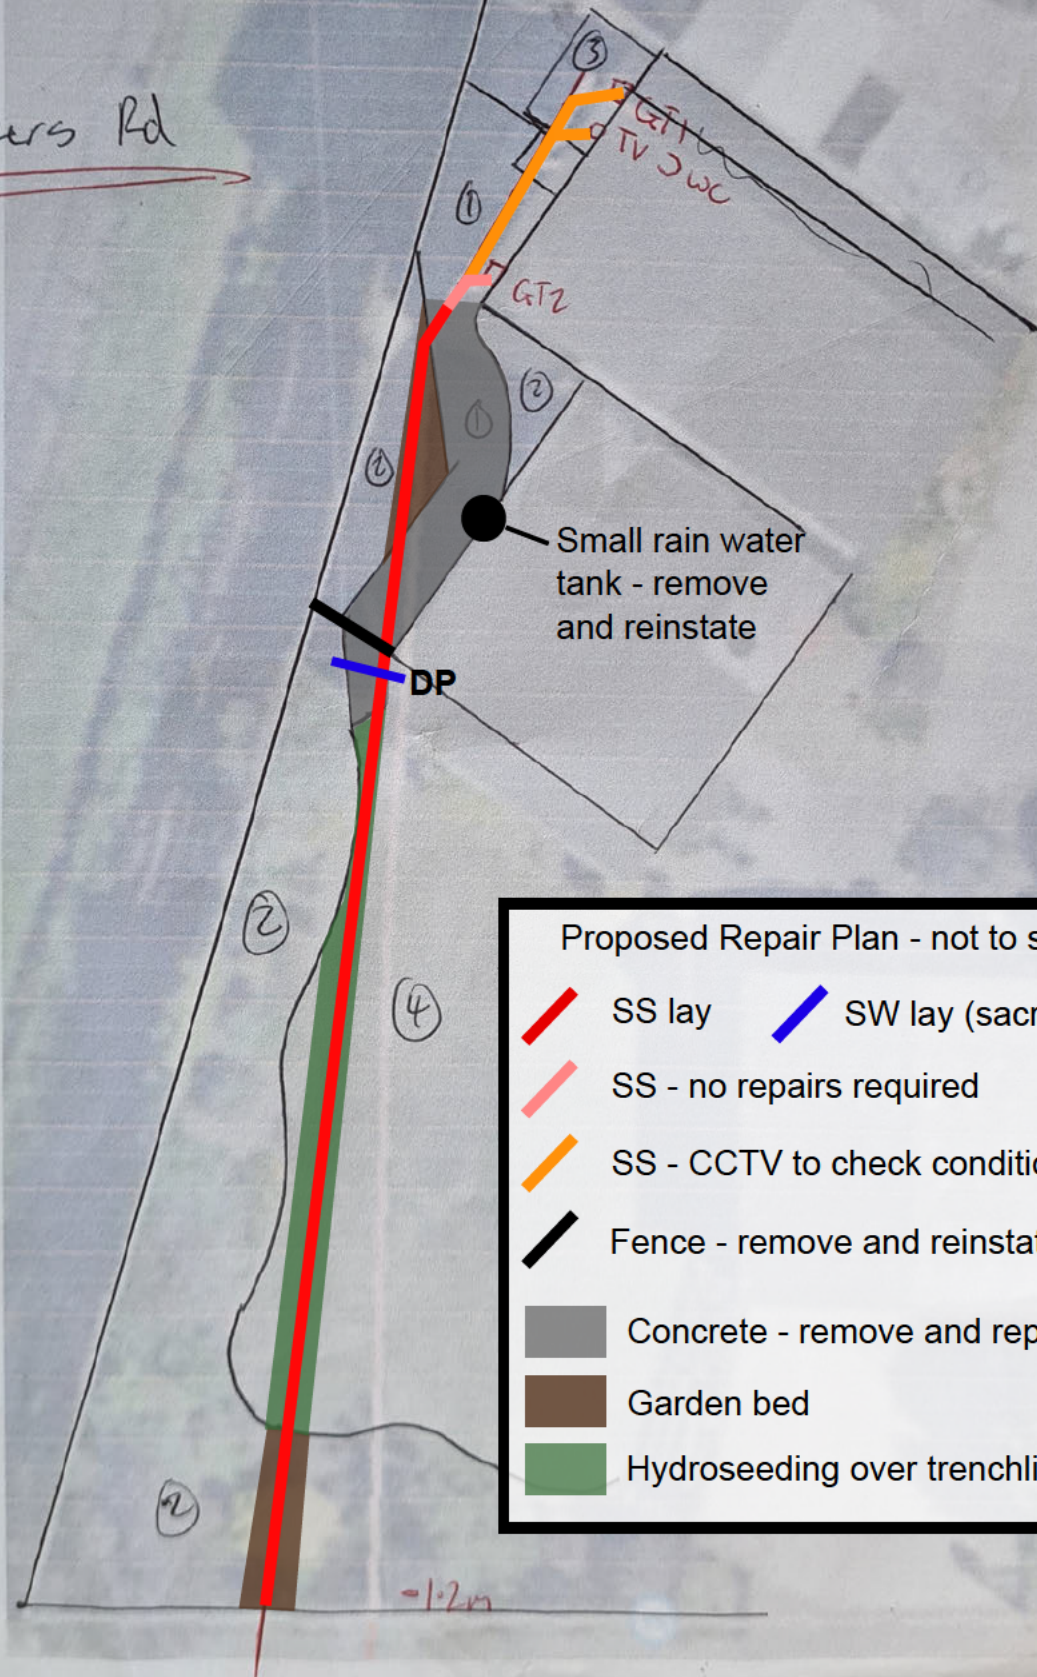
67 Tuckers Rd

④ Grass
