# RESIDENTIAL PROPERTY INSPECTION

**Inspection Address:** 67 Tuckers Road, Christchurch

**Inspection Date:** Thursday, 17 July 2025

**BuildQual NZ Ltd**

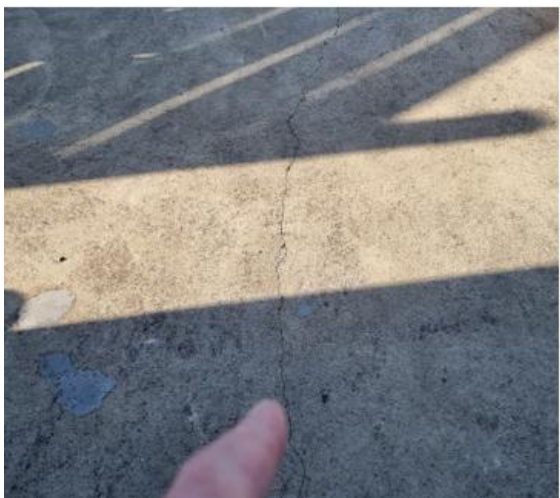
ITEM ASSESSED	DEFECT	COMMENTS/NOTES
Retaining Walls	N/A	-
Stairs	N/A	-
Steps, Handrails, Paths, Driveway	Minor	Minor crack to concreted area near front door.
Swimming Pool/Tennis Court	N/A	-
Fencing <ul style="list-style-type: none"><li>Material Type</li><li>Height</li><li>Condition</li></ul>	None	Various heights and rail and timber paling. Good condition.
Ground Movement/cracking	None	No defects noted
Surface water control <ul style="list-style-type: none"><li>Signs of Pooling</li><li>Direction of Water Flow</li></ul>	None	No defects noted

Cosmetic cracking by entry

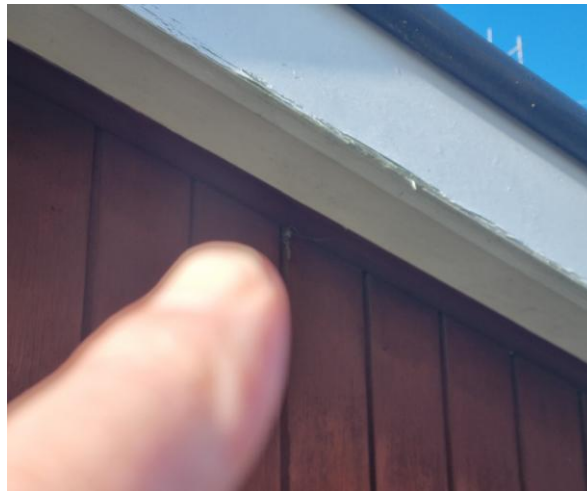
- The house's fascia has some paint blistering.

ITEM ASSESSED	DEFECT	COMMENTS/NOTES
Roof System - material	-	Corrugated iron
Roof condition	None	The second-storey roof was not closely inspected due to the height off the ground, access & H&S requirements.
Gutters/Spouting/downpipes	None	No defects noted.
Eaves/Fascia/Soffits	Minor	Fascia has some paint blistering.

Paint blistering to fascia

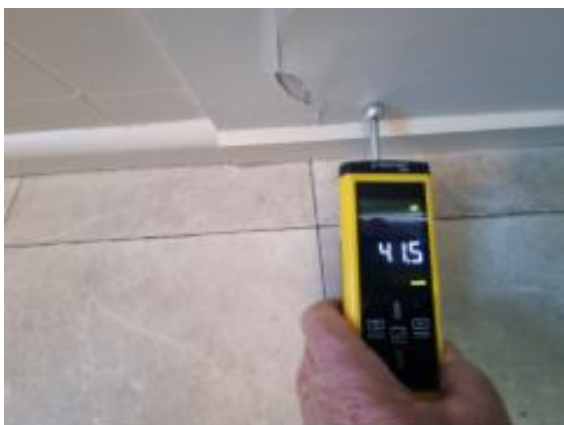
The moisture readings were between 16.4 and 41.5 – these are in the dry range.

Moisture testing – dry range

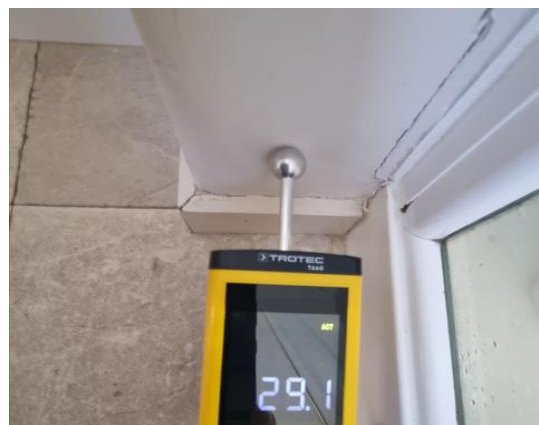
Adjacent shower – dry range

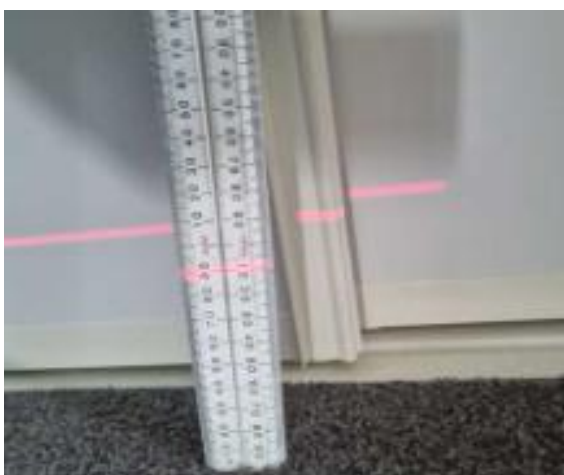
Laser floor level assessment.

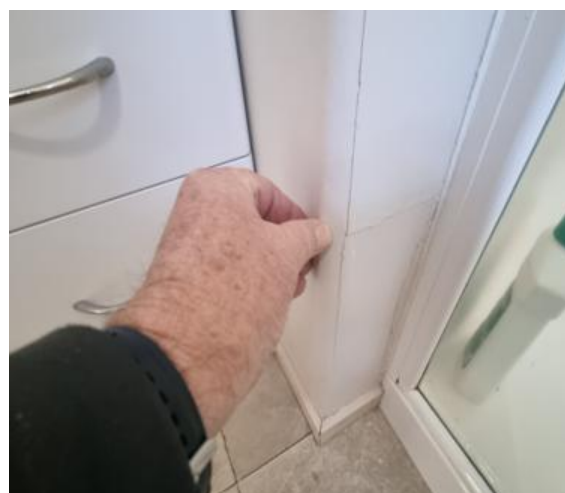
- Ceiling cracks to bathroom noted.

Gib crack bathroom

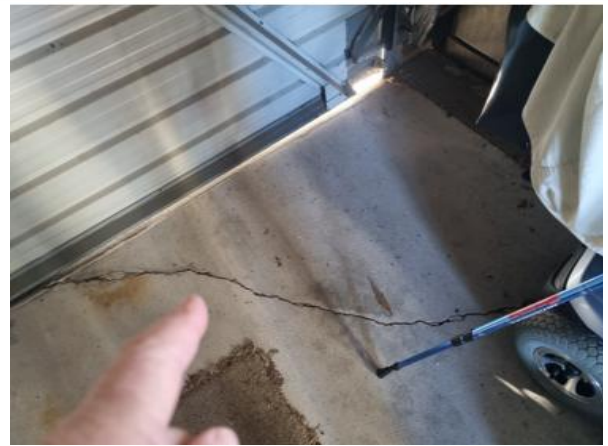
- Cracks noted to garage floor.

Cracks to garage floor
