Earthquake/Insurance Documentation & Disclosure

Statement of Claim

Assessment of Property at: 171B Wales Street, Halswell, Christchurch 8021

NON-EQC ASSESSMENT REPORT

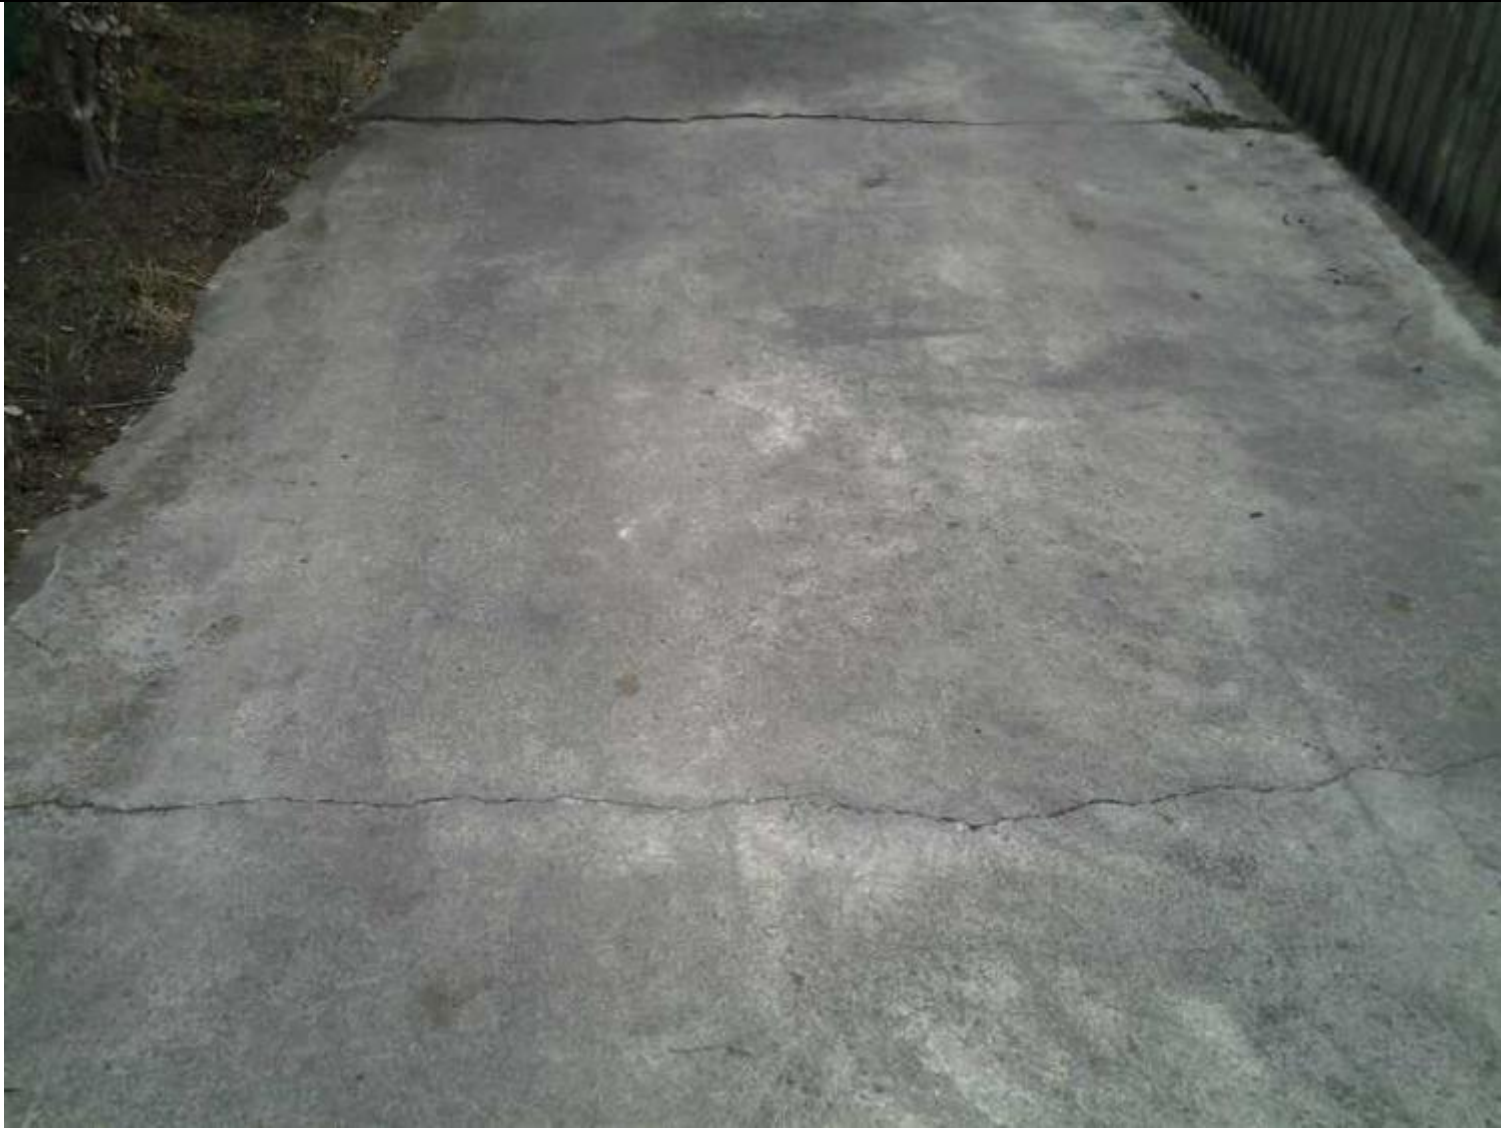
Cracking, slumping

Cracks to shared drive

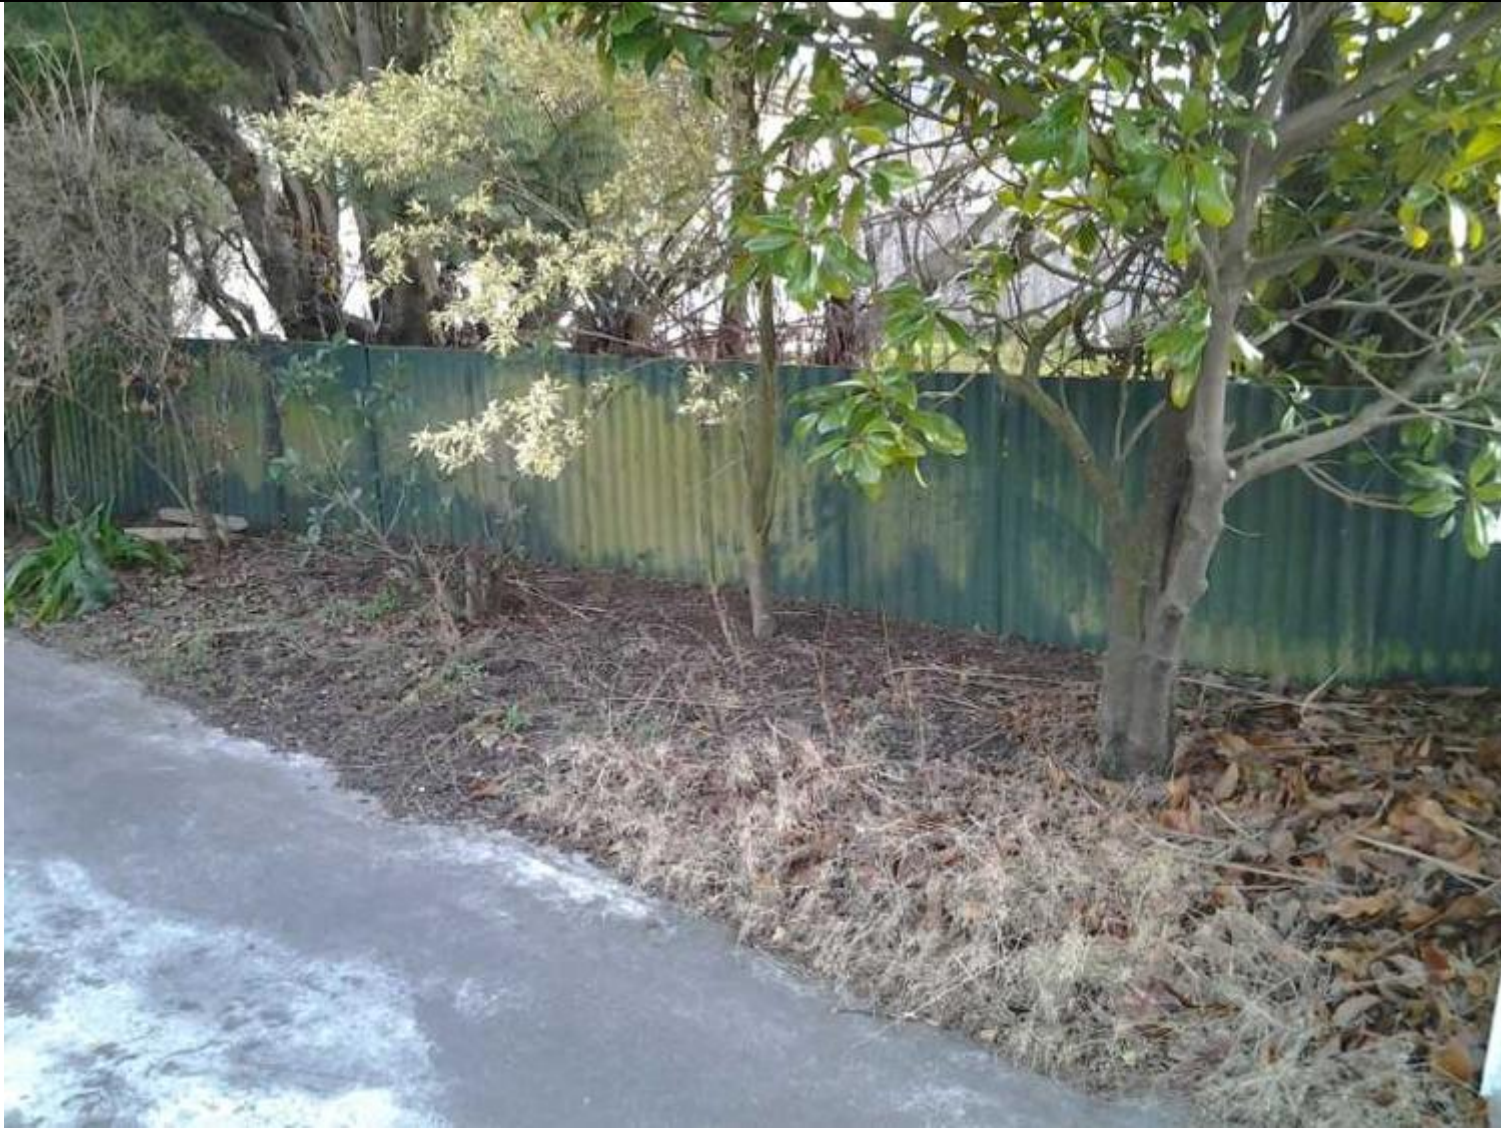
Shared with 173 no damage

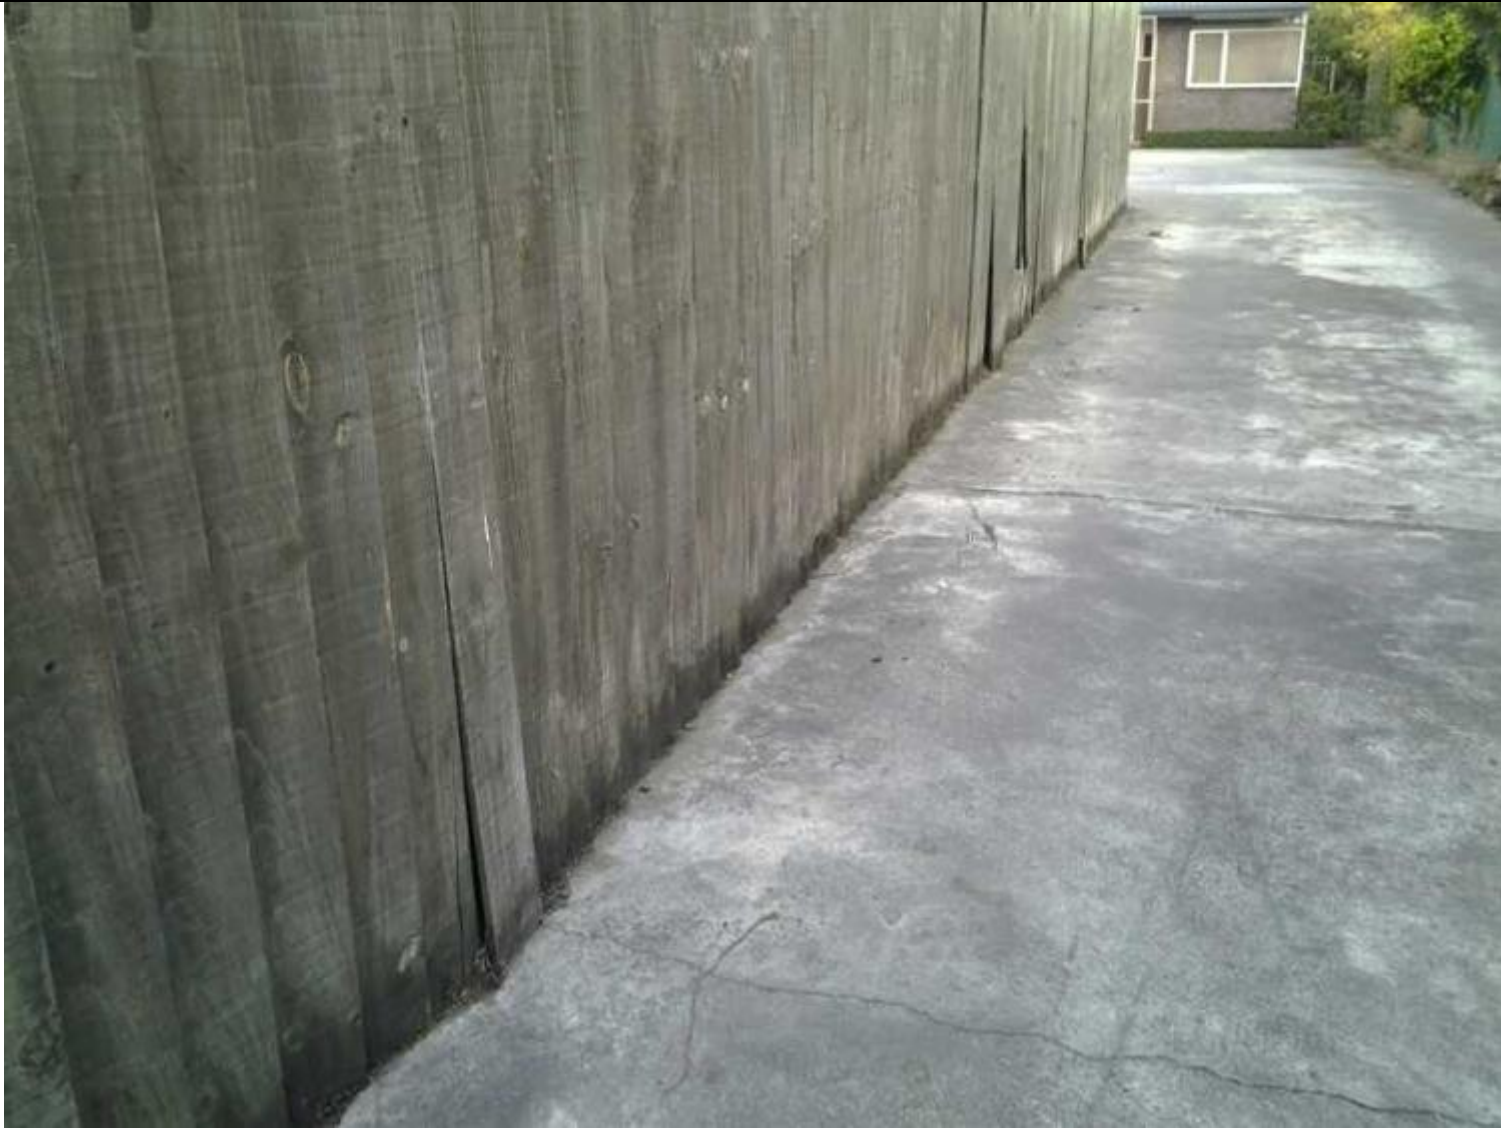
Misalignment

Damage to fence shared with 171a

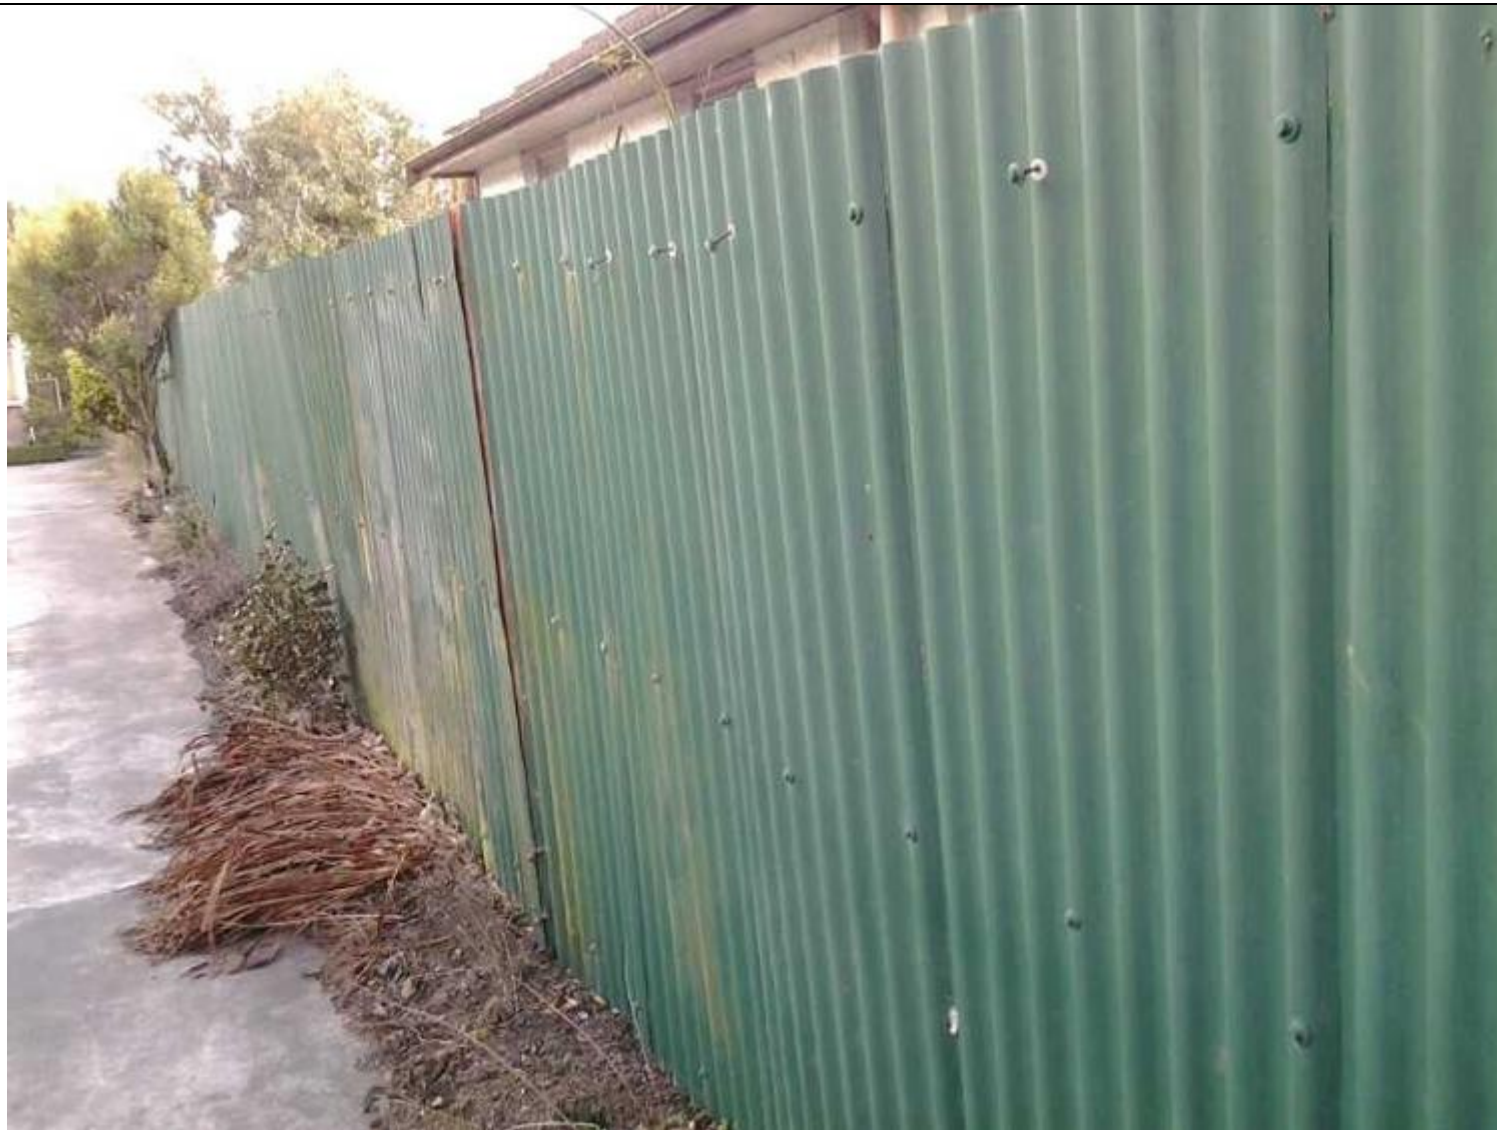
This fence is shared with 171a & 173

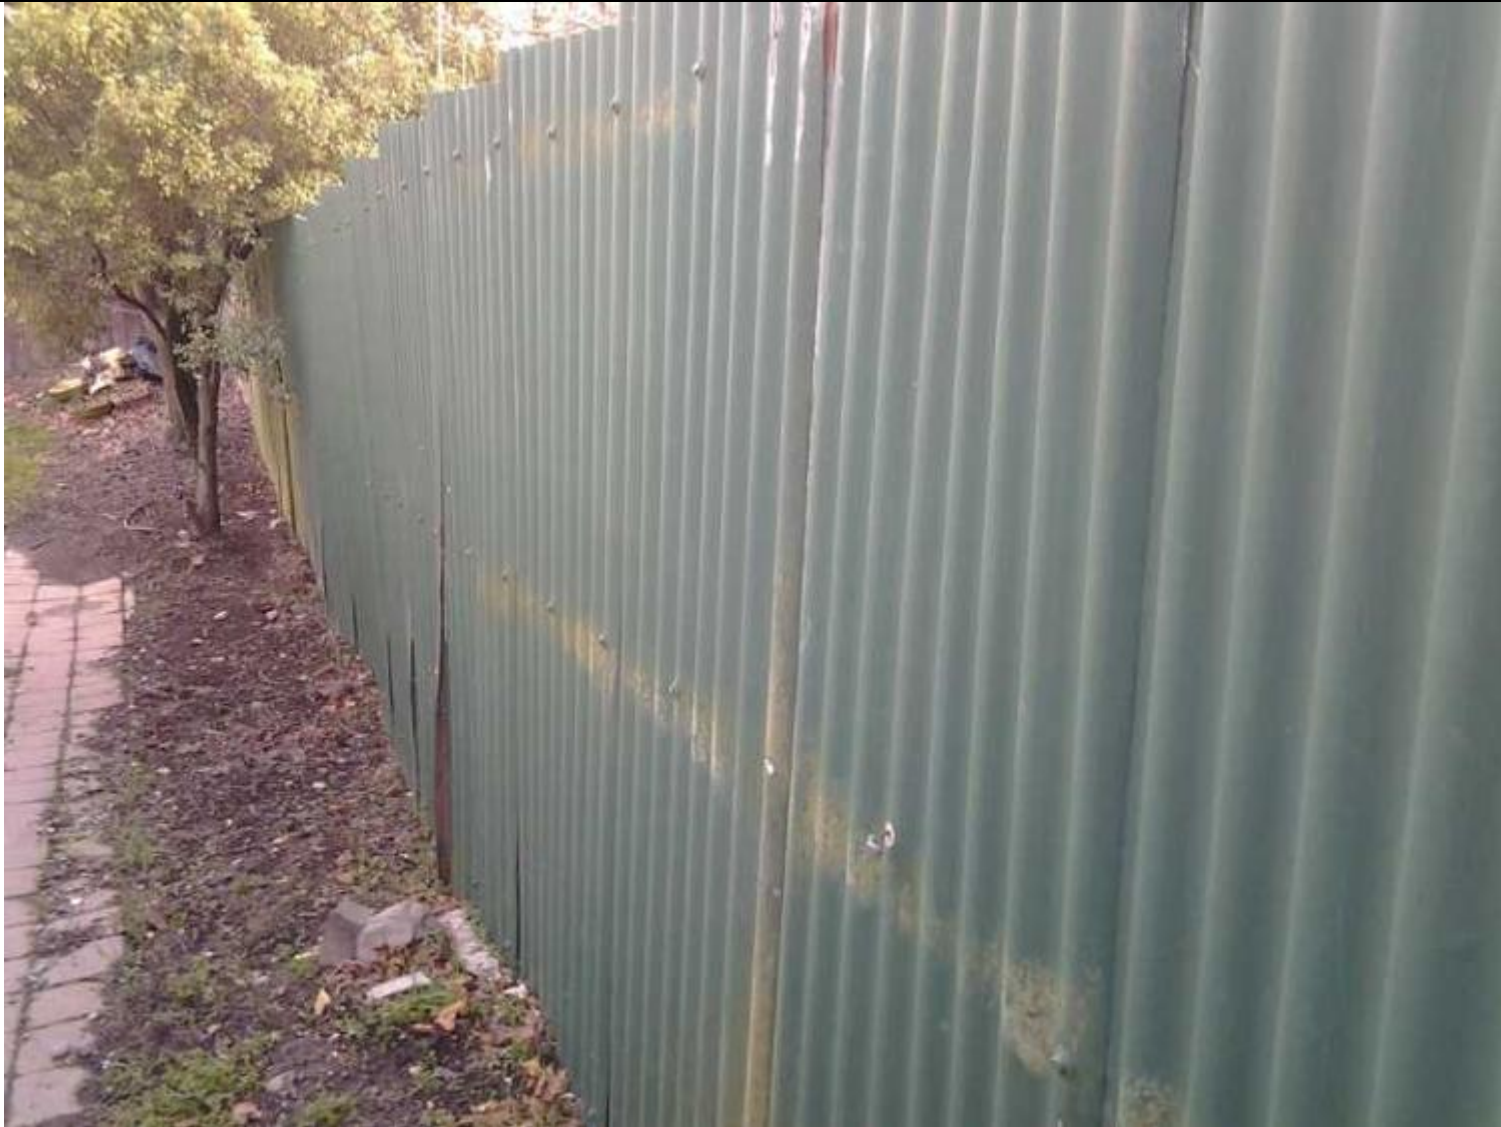
This section is shared with 173

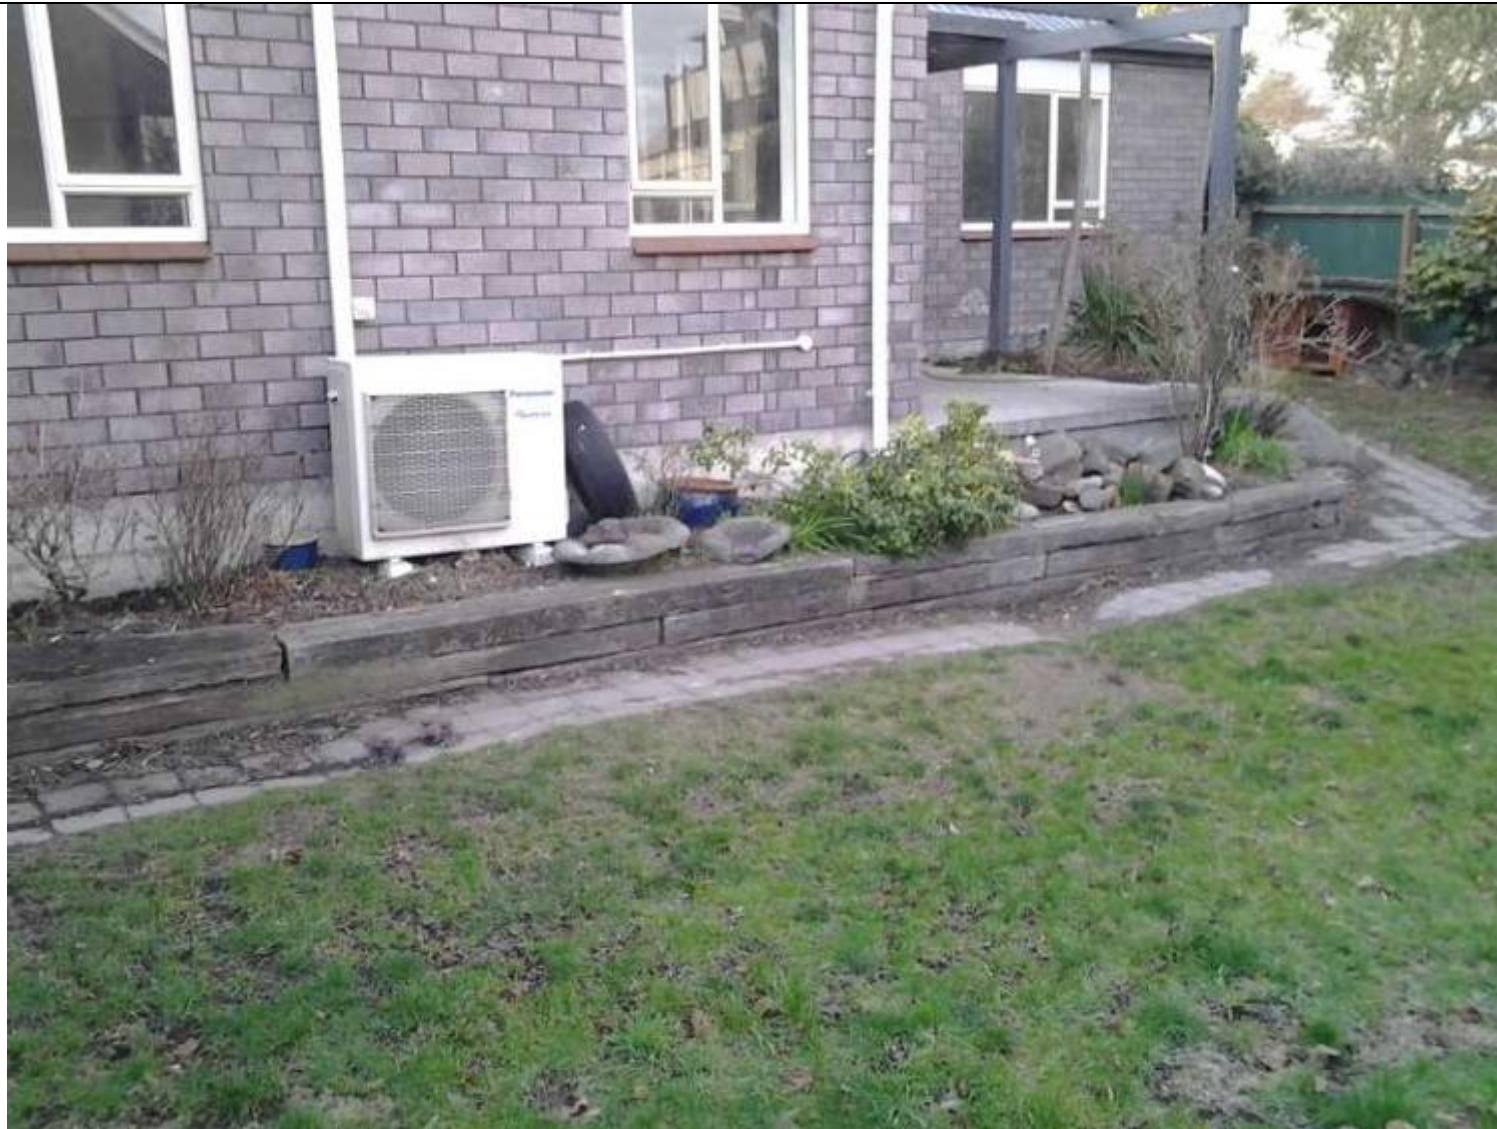
Path overview

Slumping, heaving

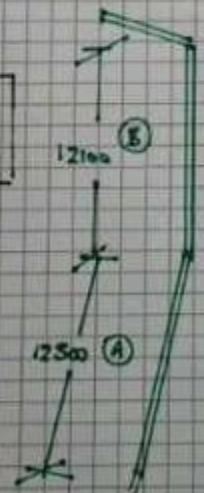
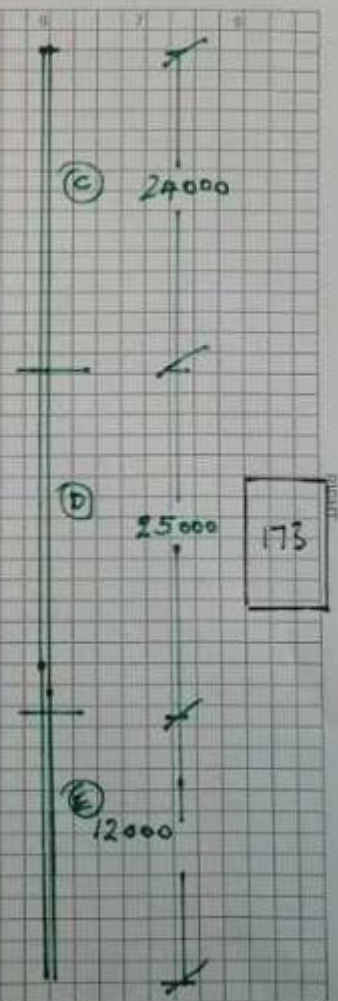
Fence sketch

- Ⓐ + Ⓑ SHARED SO/SD WITH 171A
- Ⓒ SHARED SO/SD WITH 173
- Ⓓ SHARED 25/25/50 WITH 171A + 173

Ⓐ PALING FENCE 900 HIGH
X 12.5 LM = 11.25m²

Ⓑ PALING FENCE 1800 HIGH
X 12.1 LM = 21.78m²

Ⓒ IRON FENCE
1800 HIGH X
24 LM = 43.2m²

Ⓓ IRON FENCE
1800 HIGH X
25 LM = 45m²

Ⓔ UNDAWAGED
