# BUYSMART HOME INSPECTIONS

Property Address: 20 Willow Avenue, Rotorua  
Legal Description: LOT 29 DP 33114

Date of Inspection: 29<sup>th</sup> July 2015  
Inspector: Steve Fertich

## Inspection Report

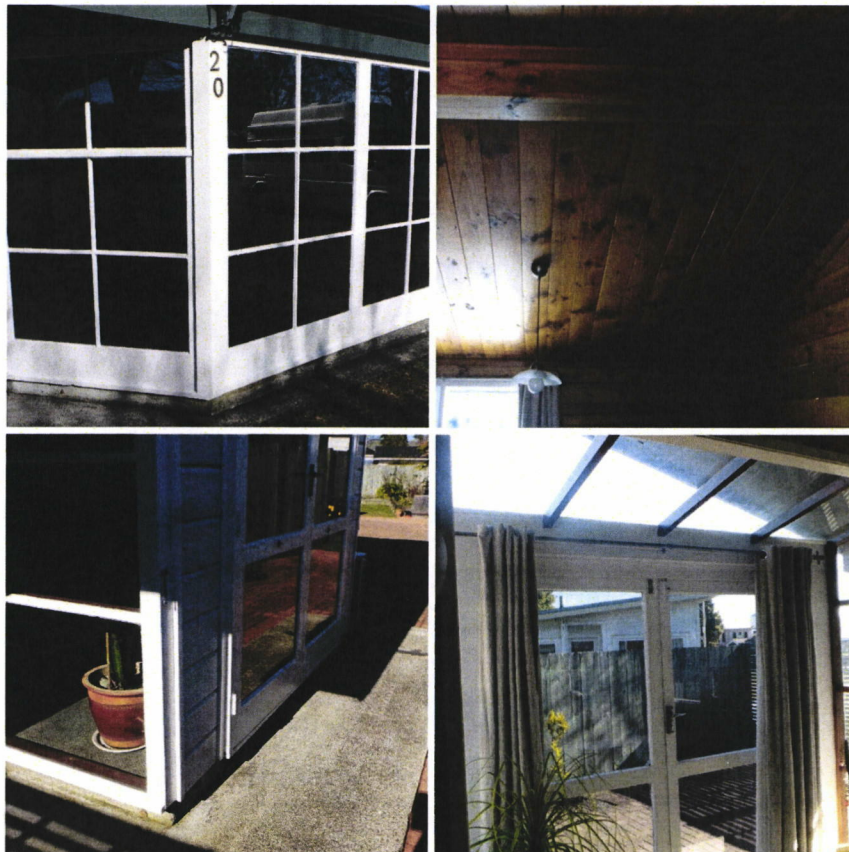
- The building footprint appears to match what is shown on the council file apart from the following items:
  - A timber bay window has been installed to the front of the lounge, extending the floor. There is approximately 150mm of visual floor above the existing surface with remnants of polythene damp proofing extruding from the side of the slab, giving indication that damp proofing is present. The opening appears to be within the original opening of the doors that were indicated on the original plan. This does not protrude past the original roof line. Given the style of timber joinery present and the age/wearing of the timber of this area it gives indication of considerable age dating to approximately early to mid 1980's.

- A small conservatory extension has been added to the end of the dining room, which is approximately 800 x 2m. This is consisting of timber joinery, aluminium Lockwood cladding, with a glass ceiling. This also is within the eaves of the original house and I believe to be within the existing structure of the original doors that would have been present. The style of timber joinery present and the age/wearing of the timber of this area gives indication that this was carried out at the same time as the lounge timber bay window.

- Low pressure electric hot water cylinder located in the kitchen cupboard and fitted with seismic strapping.
- Cylinder is fitted with a pressure reducing valve to copper pipe and vented through the roof.

- Welded copper plumbing present.
- PVC spouting is entering PVC downpipes and appears to be disposing correctly via stormwater drainage.
- Two gulley traps present; the kitchen is entering one and the bathroom/laundry are entering the other.

- Drainage is entering gulley traps, stormwater appears to be disposing correctly and carried out in a manner acceptable at the time of construction.

**\*\*Showing example photos of items discussed above:**

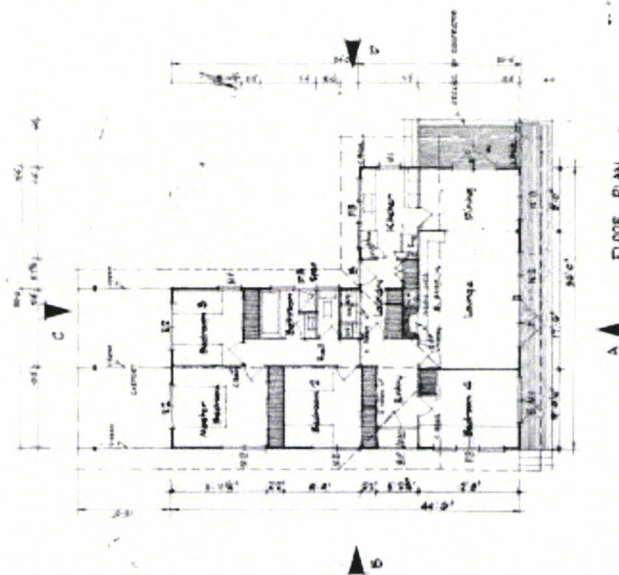
**\*\*Showing original plan recorded on the council file:**

- The original plans show the end master bedroom as two rooms, yet only one exists. The wall to separate these two rooms as the Lockwood beam designed would not have been a structural wall, in my opinion I believe that this wall was likely never present as there is no visual markers on the beam, or where the wall would have been junction, no colour variations to the stain and no holes or fillers where the wall would have been fixed to these areas.

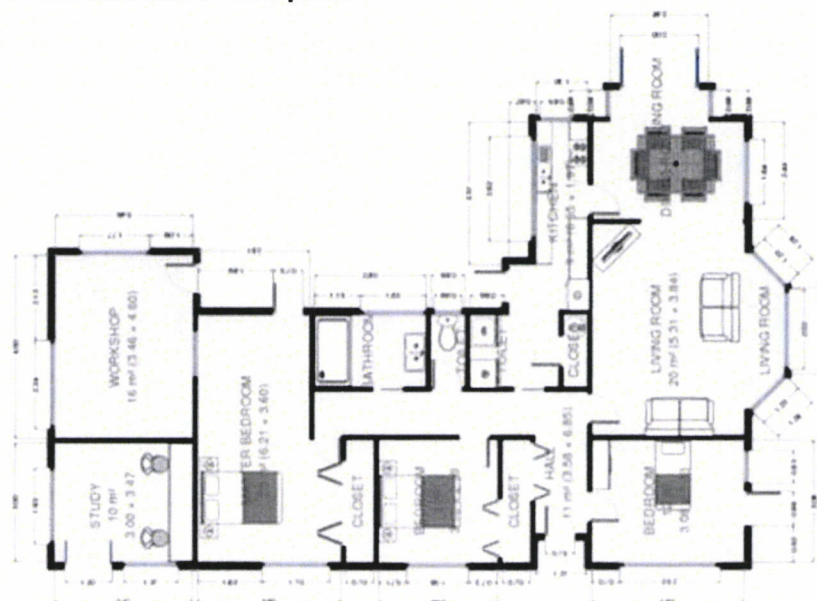
**\*\*Showing current indicative floor plan:**

completed. Since this time, a non-structural wall has been installed to use the workshop as an office. This is not a habitable space and cannot and is not being used as such.
