RED LBP PRE-PURCHASE REPORT

PRE-PURCHASE BUILDING REPORT

Property Address	16 Kitchener Place, Opawa, Christchurch 8023
Client	White Sparrow Homes Ltd.
Date of Inspection	21st April 2026
Time	9:30 am
Inspector	Andy Vann National Certificate in Carpentry, Licensed Building Practitioner.
LBP Number	BP135432
People Present	Inspector
House Occupied	Staged

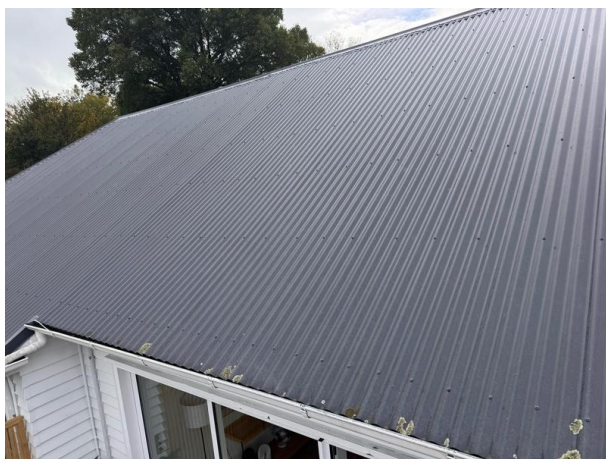
Photo 3

Moss, mould or lichen - Areas noted, refer to the photos below.

Profiled metal corrugated hip roof west elevation. Lichen spores visible.

The roof displayed visible signs of lichen growth in certain areas, and it is advised to address this issue as part of regular maintenance. Failure to do so could cause deterioration of the coating system.

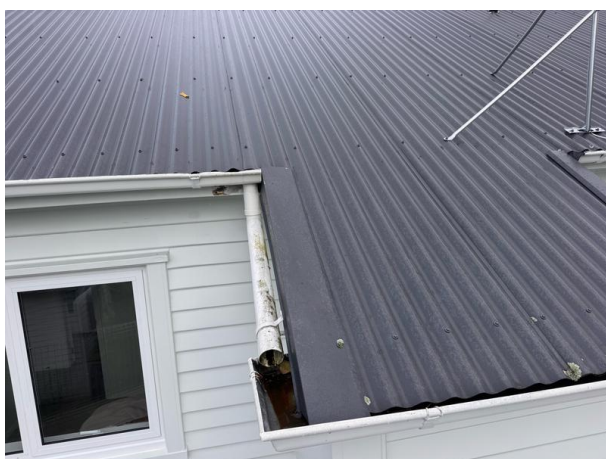
Photo 6

Profiled metal barge roof edge flashing on the east elevation, flashing should continue on the way up to the ridge.

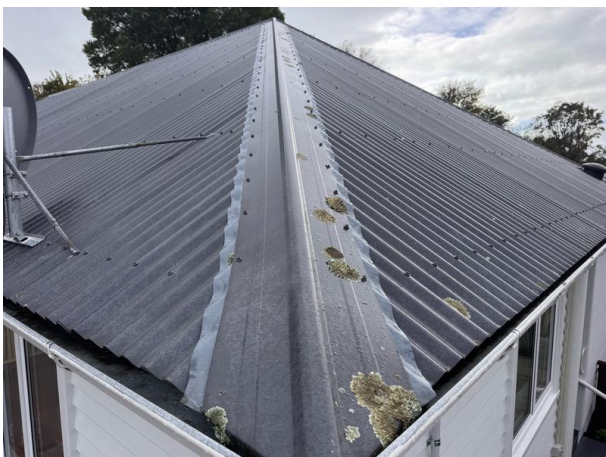
Photo 7
Profiled metal hip flashings, lichen growth visible recommend treatment.

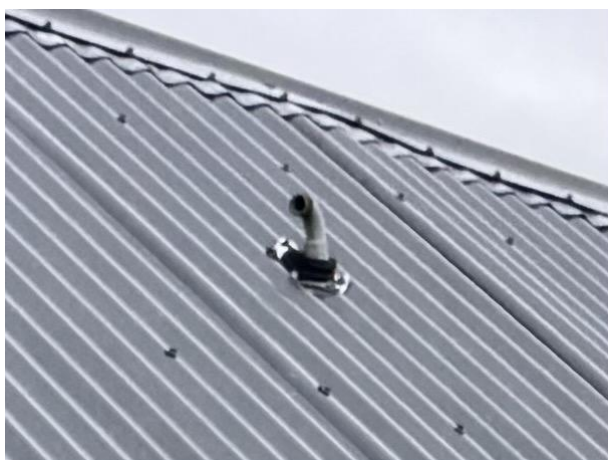
Photo 11

Hot water pressure pipe roof penetration with a EPDM boot base flashing.

It is recommended the installation of a water-shed back flashing beneath any EPDM boot flashing where the pipe diameter exceeds 85 mm or covers one or more troughs. In accordance with E2/AS1.

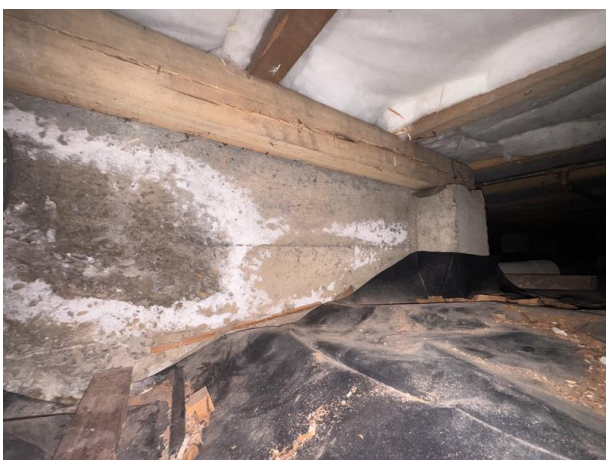
Photo 41

Efflorescence visible on the perimeter ring foundation on the south elevation.

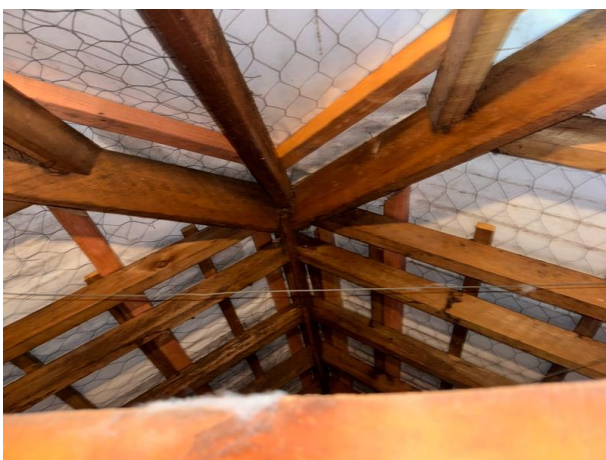
Photo 47

Structural alterations were observed within the roof space, including the installation of additional underpurlin supports, new purlins, and an LVL structural beam over the open-plan living area. These works are indicative of modifications to the original roof framing structure.

Pitched timber roof frame, new timber purlin installed. New roofing underlay with wire mesh support.

Structural alterations were observed within the roof space, including additional supports and structural members. These works are indicative of modifications to the original roof framing and require verification of compliance. Refer to the Roof Space section for further detail. It is recommended that documentation, including any LBP Record of Work, is obtained to confirm compliance with the Building Code.

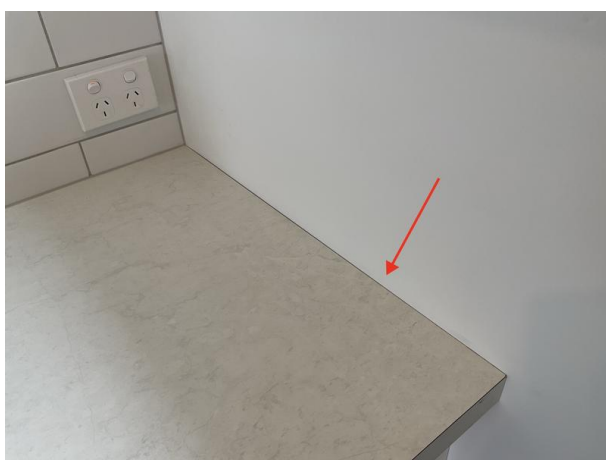
The junction between the kitchen benchtop and the adjoining wall is not sealed. Without proper sealing, water from regular use may track into concealed areas, leading to deterioration of wall linings, cabinetry, and adjacent floor finishes. To mitigate this risk, it is recommended that a durable, flexible sealant be applied and maintained at this junction to provide a watertight seal and protect the surrounding materials from moisture damage.

Photo 72
Benchtop edge not sealed.

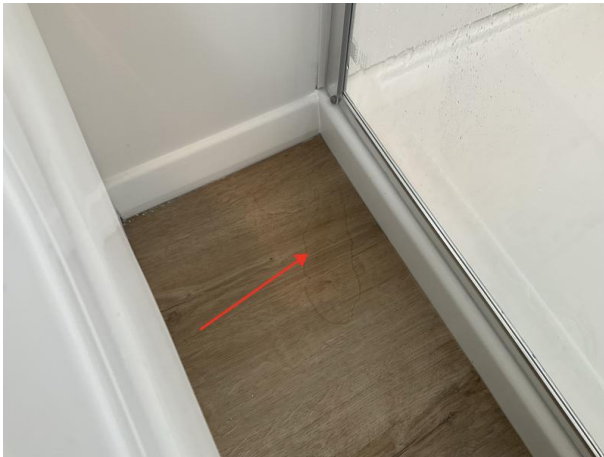
Photo 79
Shower leaking from the corner.

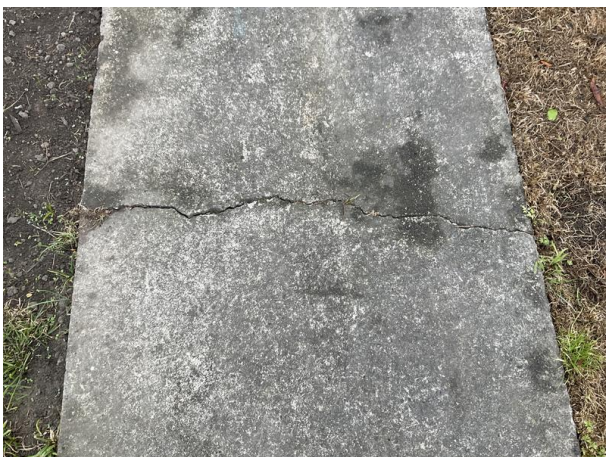
Photo 81
Cracking visible.

General upkeep and maintenance of the driveway is recommended, including cleaning it and keeping it free of debris.

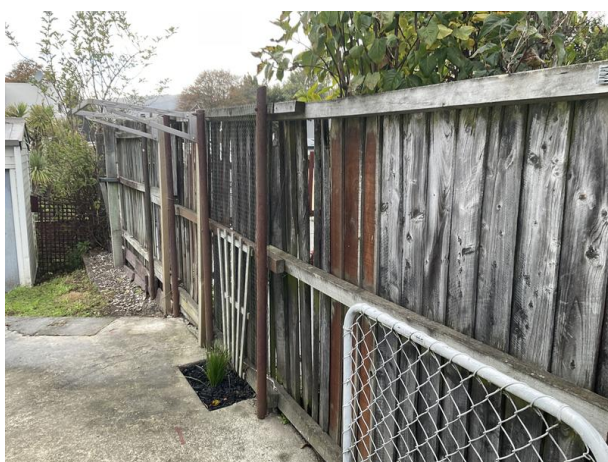
Photo 85
Original timber paling south boundary fence with areas of deterioration visible.

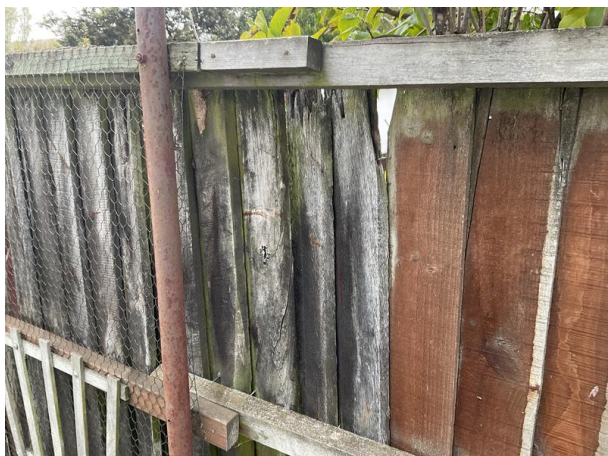
Photo 86
Loose and damaged timber palings visible.

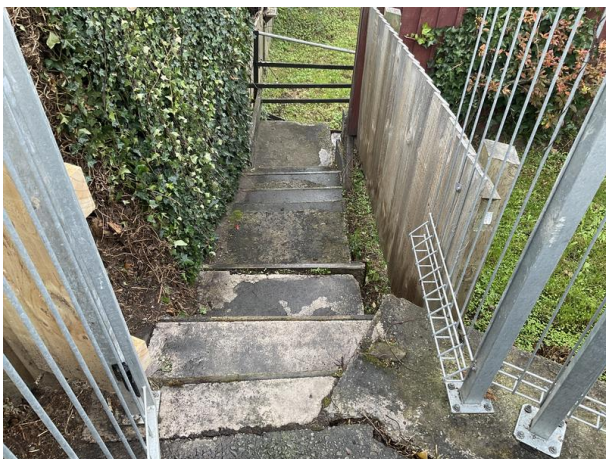
Photo 92
Concrete stairs on the east elevation down to the creek side lawn. Uneven sort height and loose timbers visible.

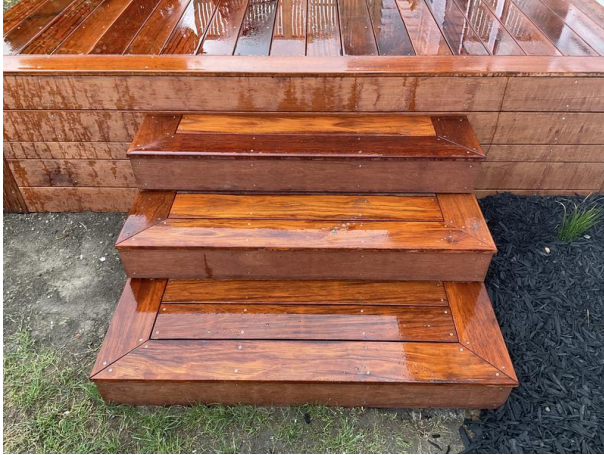
Photo 97
Hardwood timber deck steps with no tread. This could be a slip hazard.

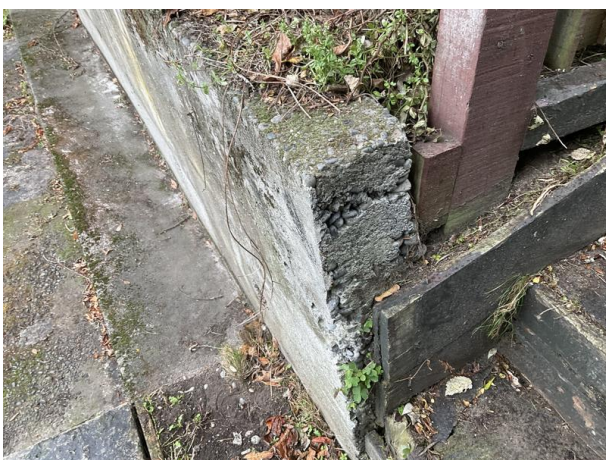
Photo 98

Concrete retaining wall on the east side of the dwelling. Some rotation visible.

It is recommended to clear vegetation from the retaining wall to prevent damage and to inspect for any signs of deterioration.
