RED LBP PRE-PURCHASE REPORT

PRE-PURCHASE BUILDING REPORT

Property Address	18 Kitchener Place, Opawa, Christchurch 8023
Client	White Sparrow Homes Ltd.
Date of Inspection	21st April 2026
Time	12:00 pm
Inspector	Andy Vann National Certificate in Carpentry, Licensed Building Practitioner.
LBP Number	BP135432
People Present	Inspector
House Occupied	Staged

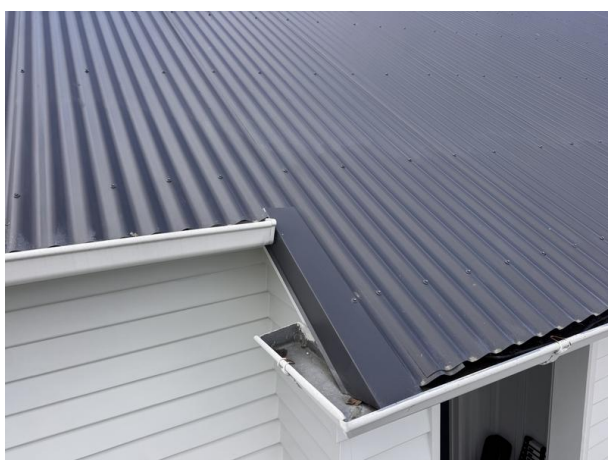
Photo 8
Profiled metal barge roof edge flashings, no water shed back flashing installed up to the ridge.

It is recommended the installation of a water-shed back flashing beneath any EPDM boot flashing where the pipe diameter exceeds 85 mm or covers one or more troughs. In accordance with E2/AS1.

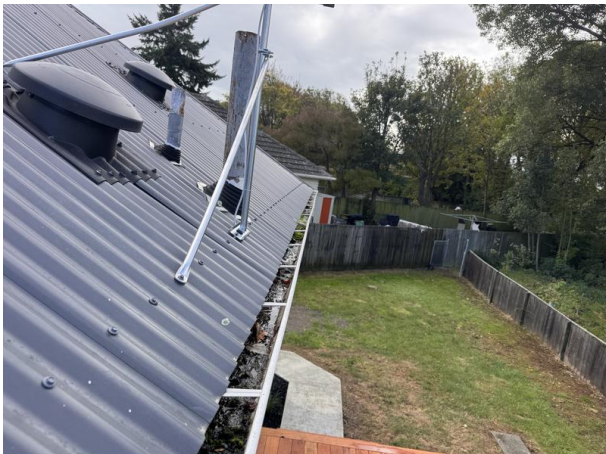
Photo 16
PVC roof edge gutter on the east elevation, recommend clearing of debris.

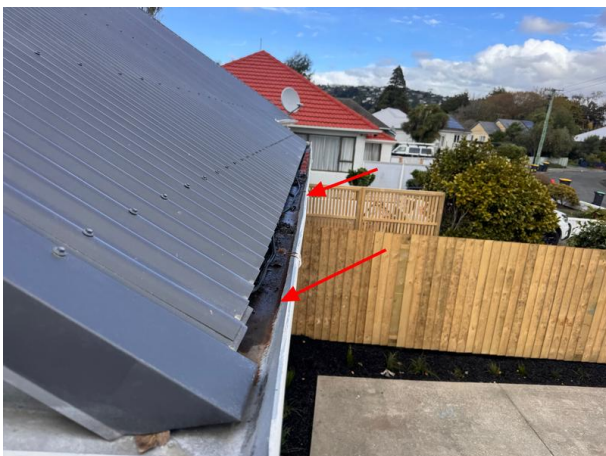
The profiled metal guttering is displaying visible corrosion consistent with age-related deterioration. Corrosion of this type can reduce the gutter's ability to manage stormwater effectively and may lead to leakage, overflow, and further damage to adjacent building elements. It is recommended that a Licensed Building Practitioner (LBP) specialising in roofing or plumbing assess the full extent of deterioration and provide guidance on repair or replacement to restore the system's performance and ensure effective stormwater management.

Photo 18
Profiled metal roof edge gutter on the west elevation, corrosion visible clear at the time of inspection.

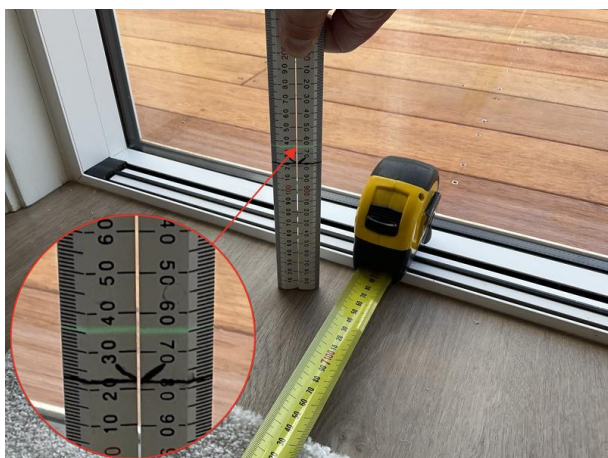
Photo 32
14 mm deviation over 7.3 m from the front entrance into the living room.

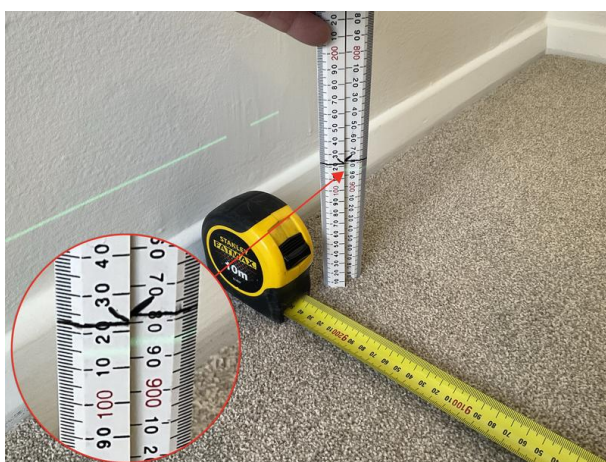
Photo 34

7 mm deviation over 9.2 m from bedroom one to bedroom two.

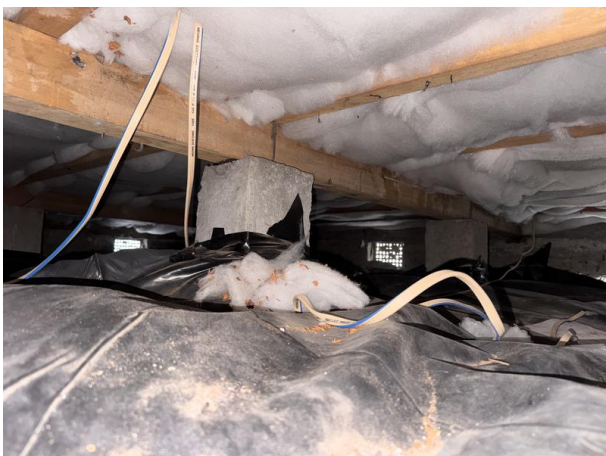
Photo 38
Modern TPS wiring visible unsupported.

It is recommended to support any wiring that is unsupported.

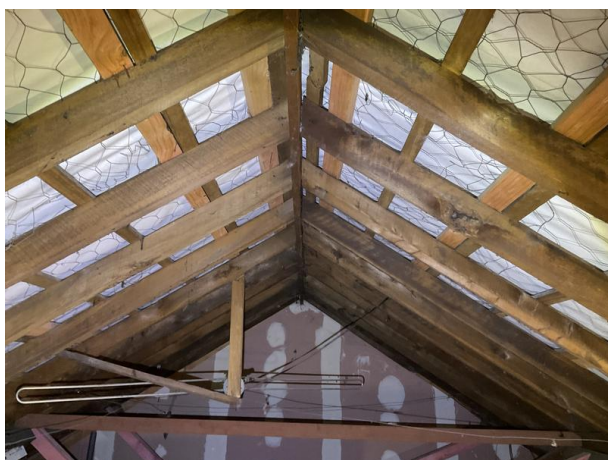
Structural alterations were observed within the roof space, including additional supports and structural members. These works are indicative of modifications to the original roof framing and require verification of compliance. Refer to the Roof Space section for further detail. It is recommended that documentation, including any LBP Record of Work, is obtained to confirm compliance with the Building Code.

Photo 41
Pitched timber framed roof with underlay with wire mesh support. Additional timber purlins installed. Plasterboard intertenancy wall.

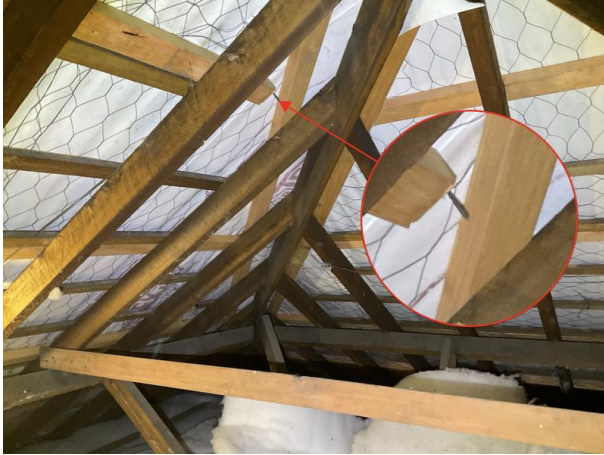
Photo 46

Roofing screw missing the timber purlin where the timber purlin isn't connected to the hip purlin.

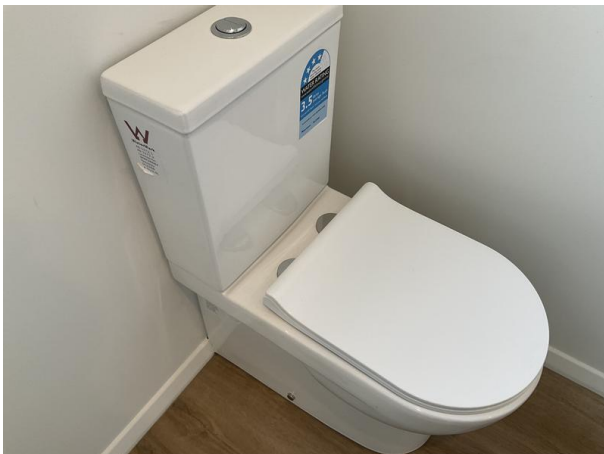
Photo 68
Loose toilet seat.

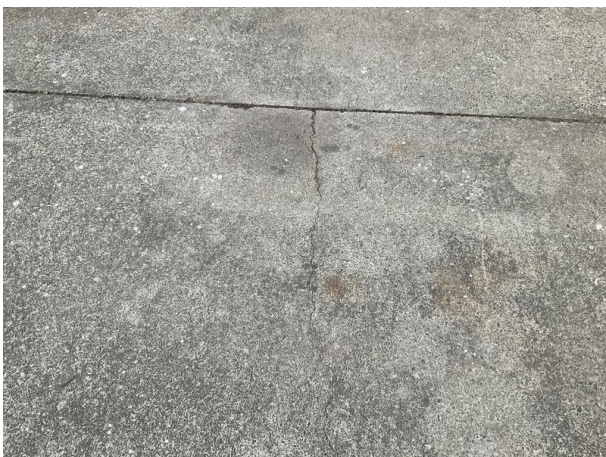
Photo 75
Cracking visible.

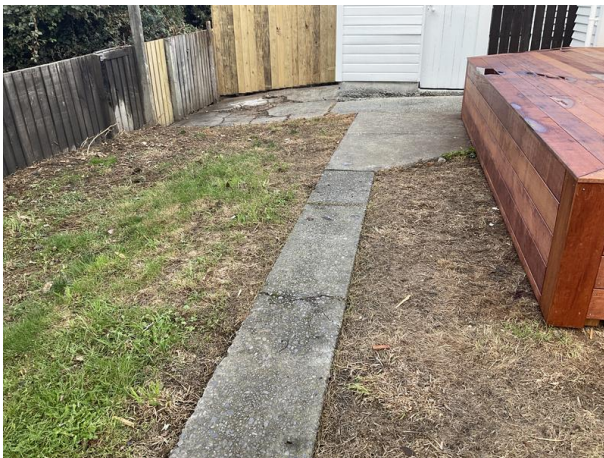
Photo 83
Concrete path on the east side of the deck. Cracked and broken areas visible.
