12A Forth Street

House Damage Assessment

Job No. 17431

December 2019

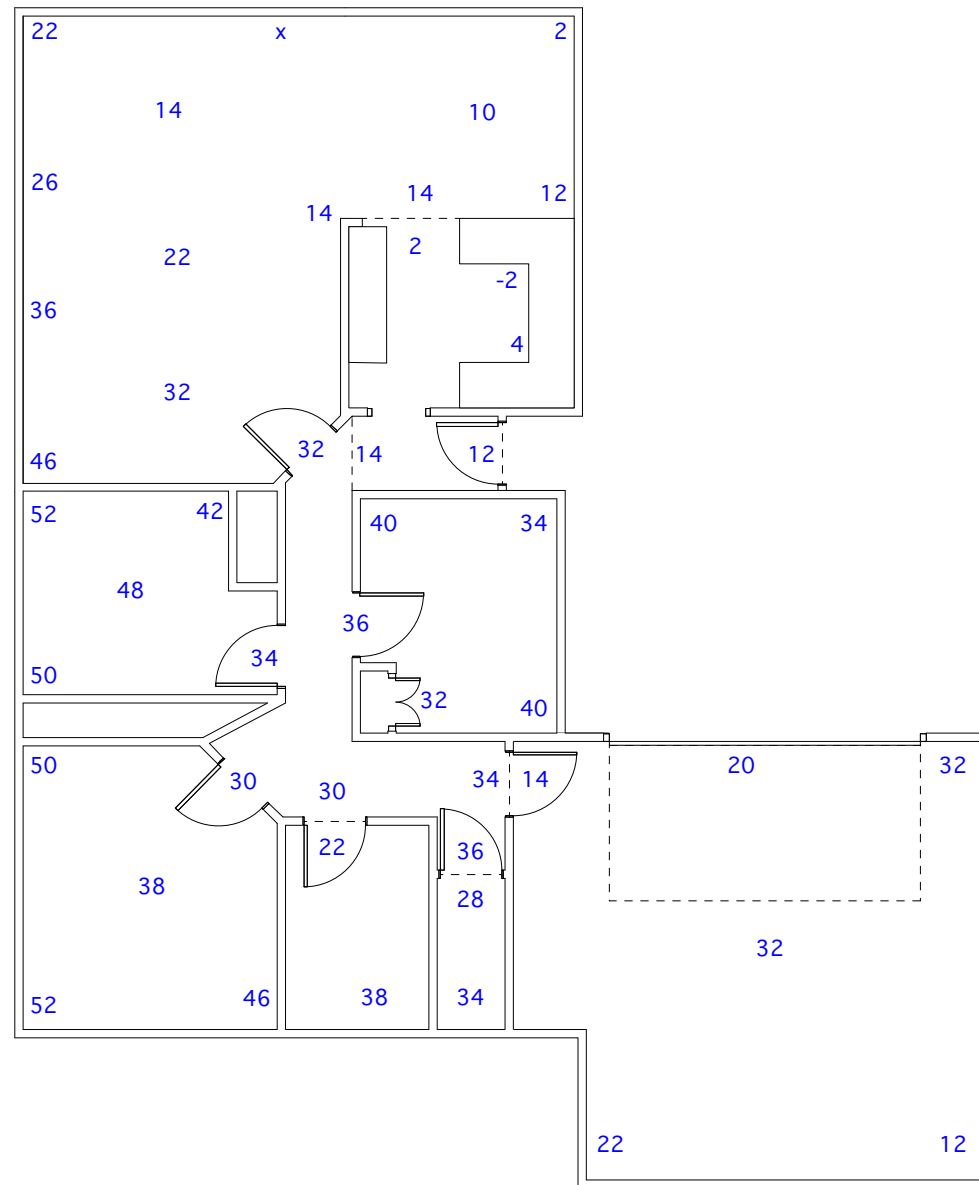
Floor Plan

- 52 mm differential settlement over the dwelling floor, refer to the floor plan in Appendix B.
- Floor slopes exceed 1:200 over distances greater than 2 m in the lounge, west bedrooms and study.

- The floor requires releveling. This can be carried out by pouring floor levelling compound (FLC) throughout the affected areas. Due to the position of joinery, some may require removal and reinstallation following the levelling process. If releveling using FLC becomes unfeasible, underpinning may be considered.
- To restore floors levels in accordance with MBIE guidance, the total differential settlement across the dwelling must be less than 50 mm and there must be no floor slopes greater than 1:200 over distances greater than 2 m.
- Following releveling, repairs to any exterior or interior damage may be completed where necessary.
- The driveway and paths are in a functional condition and do not require repair.
