# GEOTECHNICAL INVESTIGATION REPORT

## PROPOSED SUBDIVISION

**11 GARIN HEIGHTS  
BROOKLANDS  
NELSON  
Lot 1 DP 504728**

**Reference:** 26014  
**Prepared:** 22 April 2026  
**Revision:** 1  
**Issued to:** Steve Rolston  
*steve@srlbuild.co.nz*

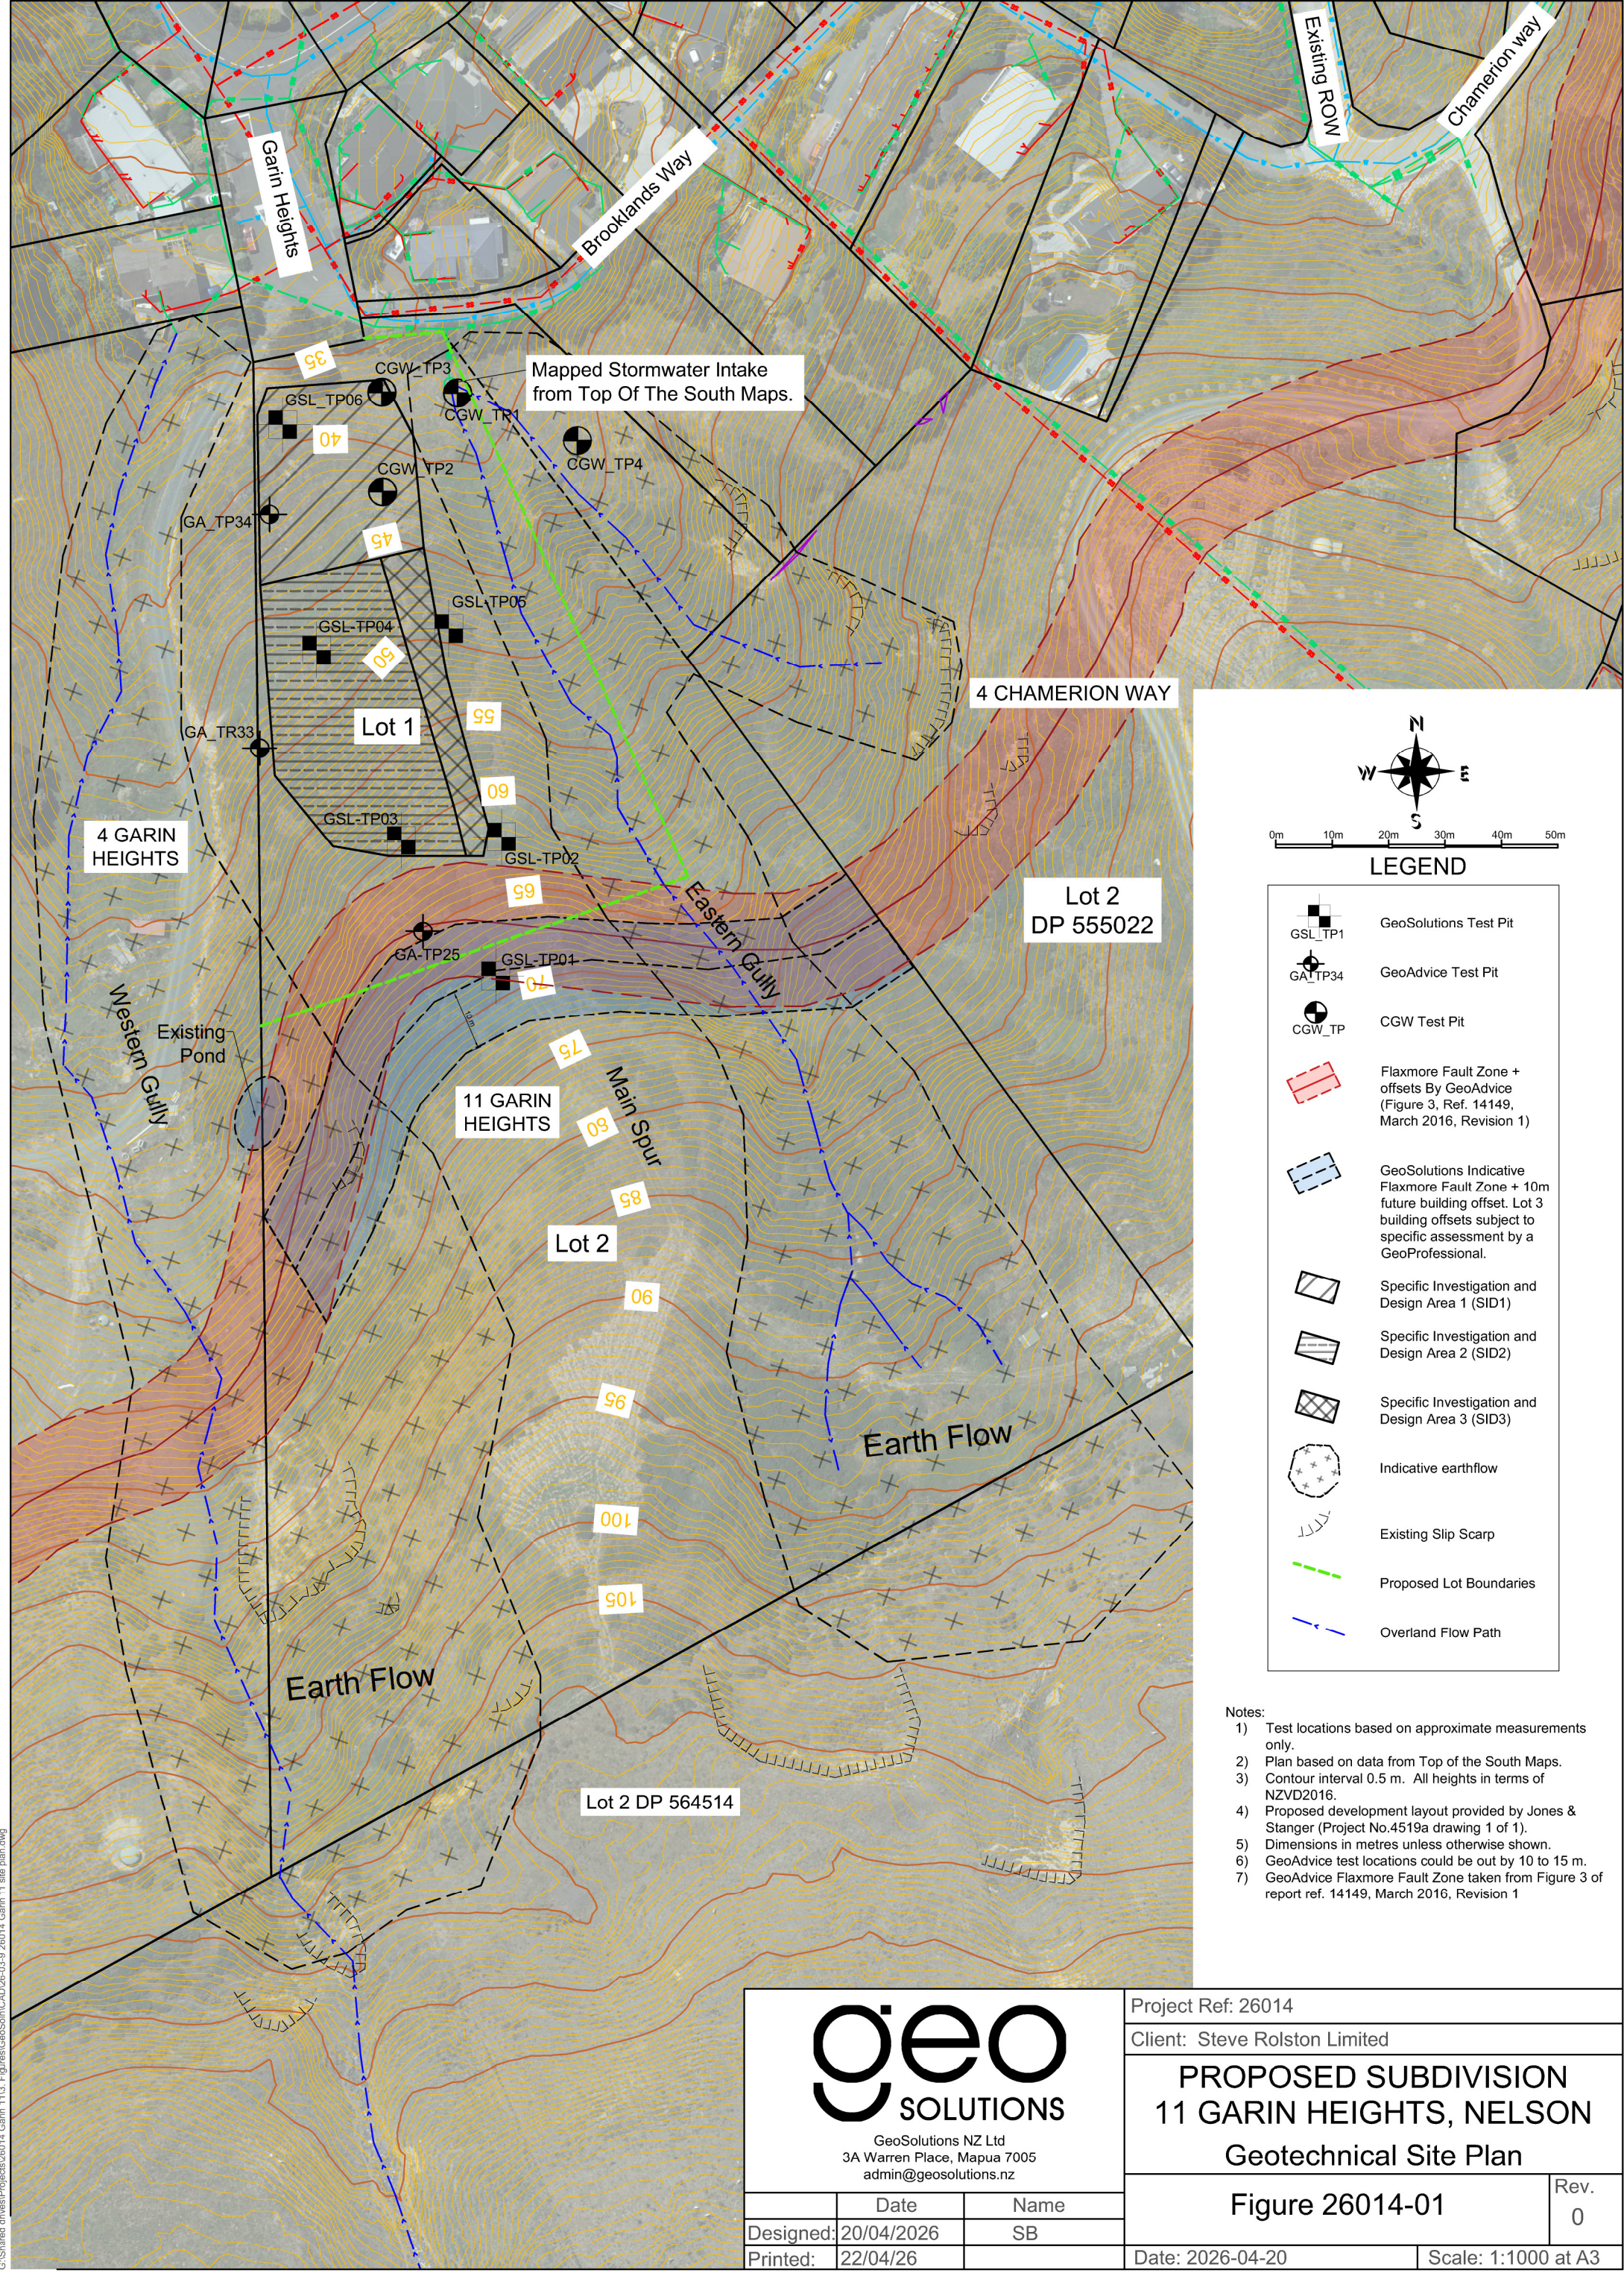
Survey by Jones and Stanger Ltd established that TP01, and therefore TR25, are positioned approximately 15 metres southeast of the location shown on GeoAdvice Figure 2 (Ref. 14149, March 2016, Rev 1). This puts some doubt on the recorded locations of the other GeoAdvice test pits and therefore of the Fault Hazard Zone mapped by Beca, which relied on those test pits. A revised Fault location is shown on the attached Figure 26014-01, along with updated offsets.

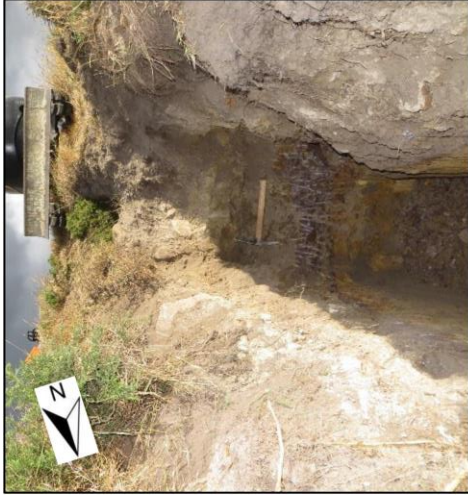
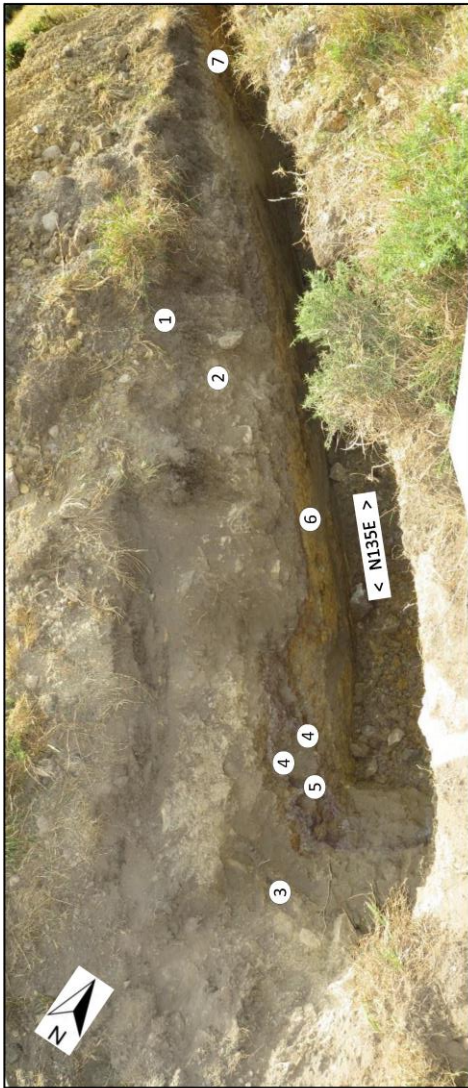
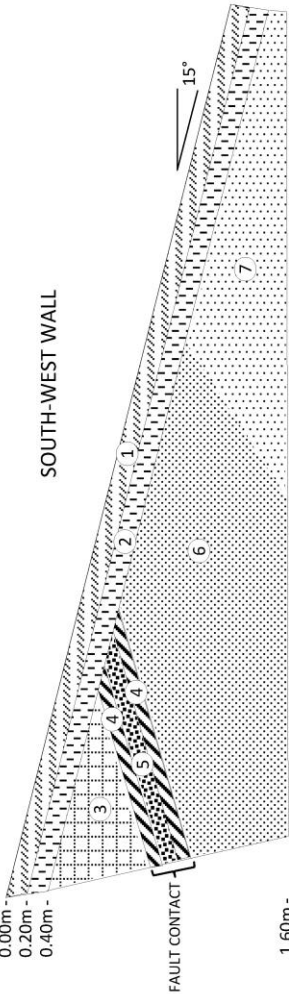
**TEST ID: TR13**

TYPE: FLAXMORE FAULT TRACE EXPOSURE

- ① Topsoil
- ② Gravelly SILT, light grey (slope debris)
- ③ MARYBANK FORMATION BRECCIA? Densely packed clayey angular GRAVEL, yellowish grey. Hard, dry, slightly plastic
- ④ FLAXMORE FAULT SHEAR ZONE CLAY, dark blueish grey. Very stiff, dry, highly plastic with slickensided faces
- ⑤ FLAXMORE FAULT SHEAR ZONE Gravelly CLAY, yellowish brown. Stiff, dry, moderately plastic
- ⑥ PORT HILLS GRAVEL FORMATION Yellowish brown SILTSTONE with fine rounded gravel, weak
- ⑦ PORT HILLS GRAVEL FORMATION Densely packed rounded GRAVEL with clayey matrix, yellowish brown. Very stiff becoming hard with depth, dry, slightly plastic.
