Consent No: **24009002**

Site Address: **7 Whitehaven Street, Weston**

Work Type: **Construction of a 4 bedroom, 2 bathroom dwelling with media room and attached garage.**

Inspection Type: **Pre Line - Building/Plumbing**

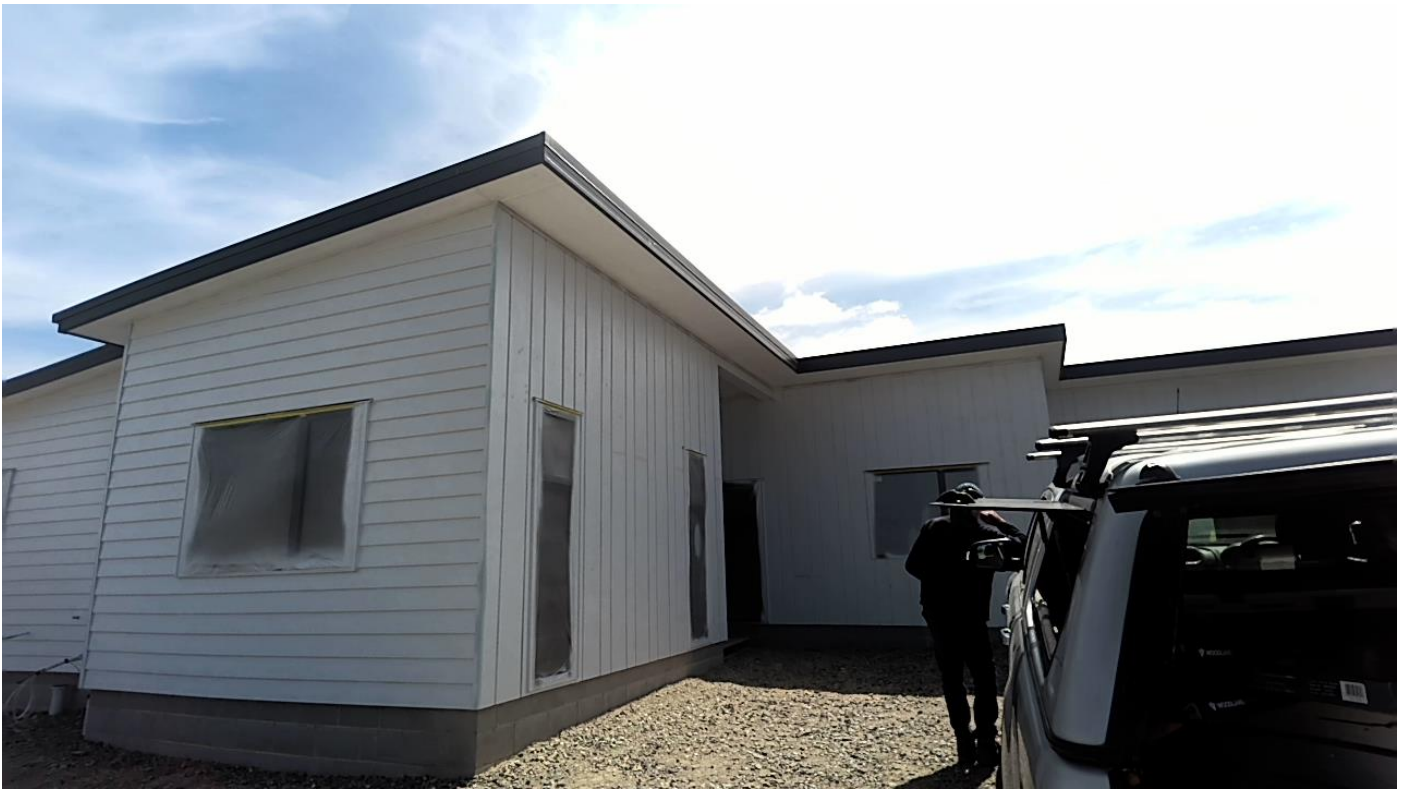
| Inspection Element | Status |
|---|---|
| <b>Exterior cladding has been completed and building is considered weather tight.</b> | |

**Building weathertight for pre line build**  
Taken at 12:56 PM on Thursday 17/10/2024

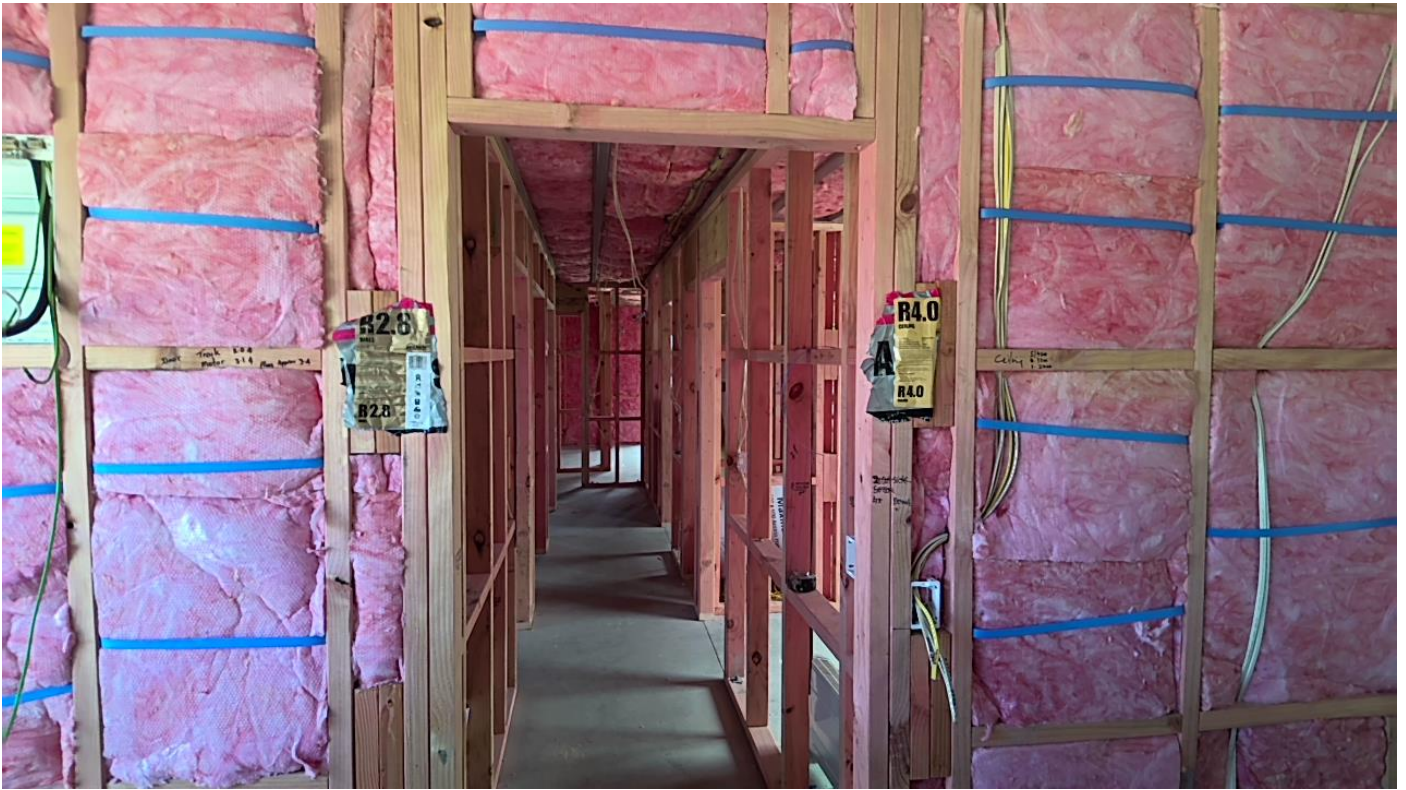
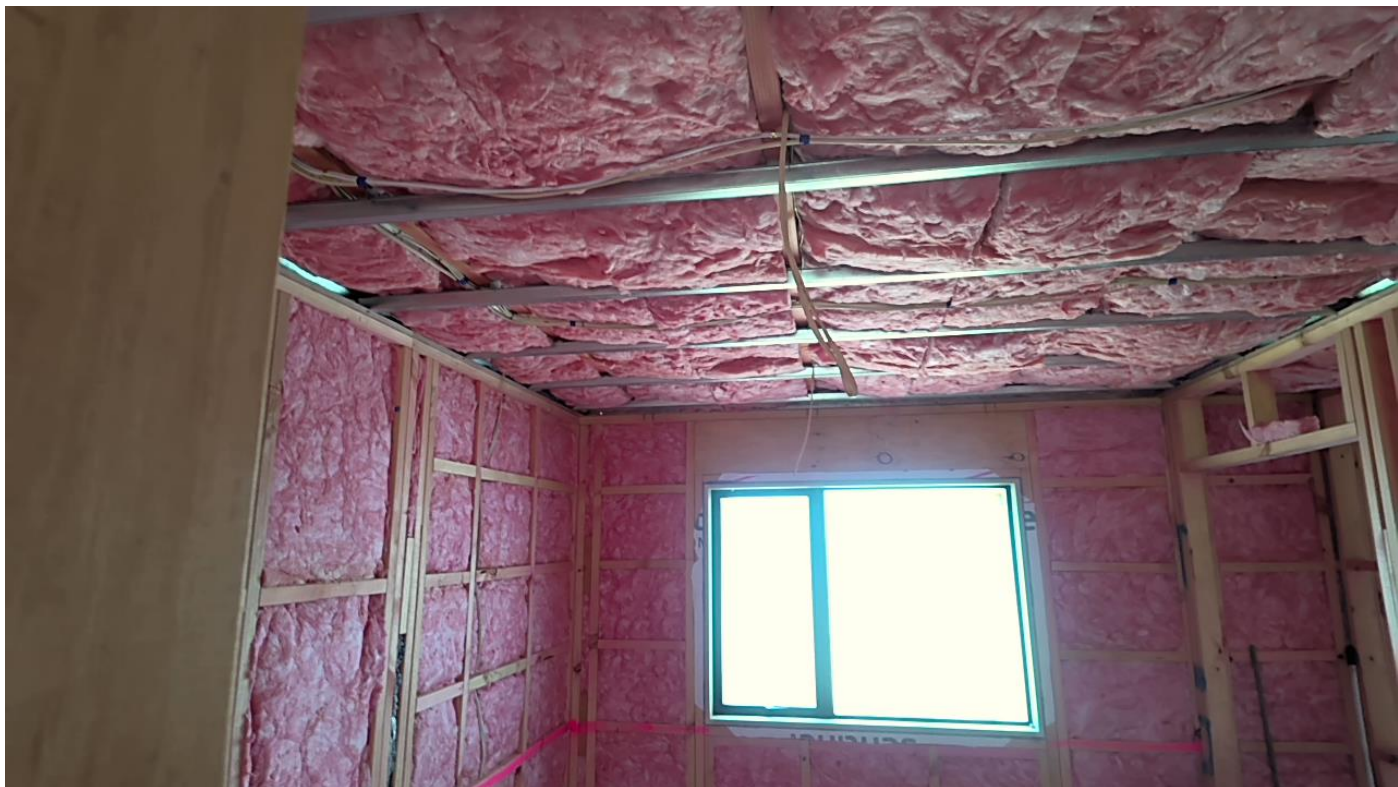
| Inspection Element | Status |
|---|---|
| <b>R3.2 has not been installed to the 140 framed walls as required by the consented plans sheet 1.</b> | |
| <b>Correct R-value of R4 for ceiling and R2.8 to 90mm walls has been achieved with consent approved insulation.</b> | |

**Insulation installed**  
Taken at 12:58 PM on Thursday 17/10/2024

**Insulation installed**  
Taken at 1:17 PM on Thursday 17/10/2024

| Inspection Element | Status |
|---|---|
| <b>On site at the next inspection please supply a series of photos showing this completed.</b> | |
| <b>1. Bag of H3.2 insulation.</b> | |
| <b>2. 140 walls insulation removed.</b> | |
| <b>3. 140 walls insulation in place.</b> | |
| <b>4. Photo of H3.2 bag with insulation used.</b> | |

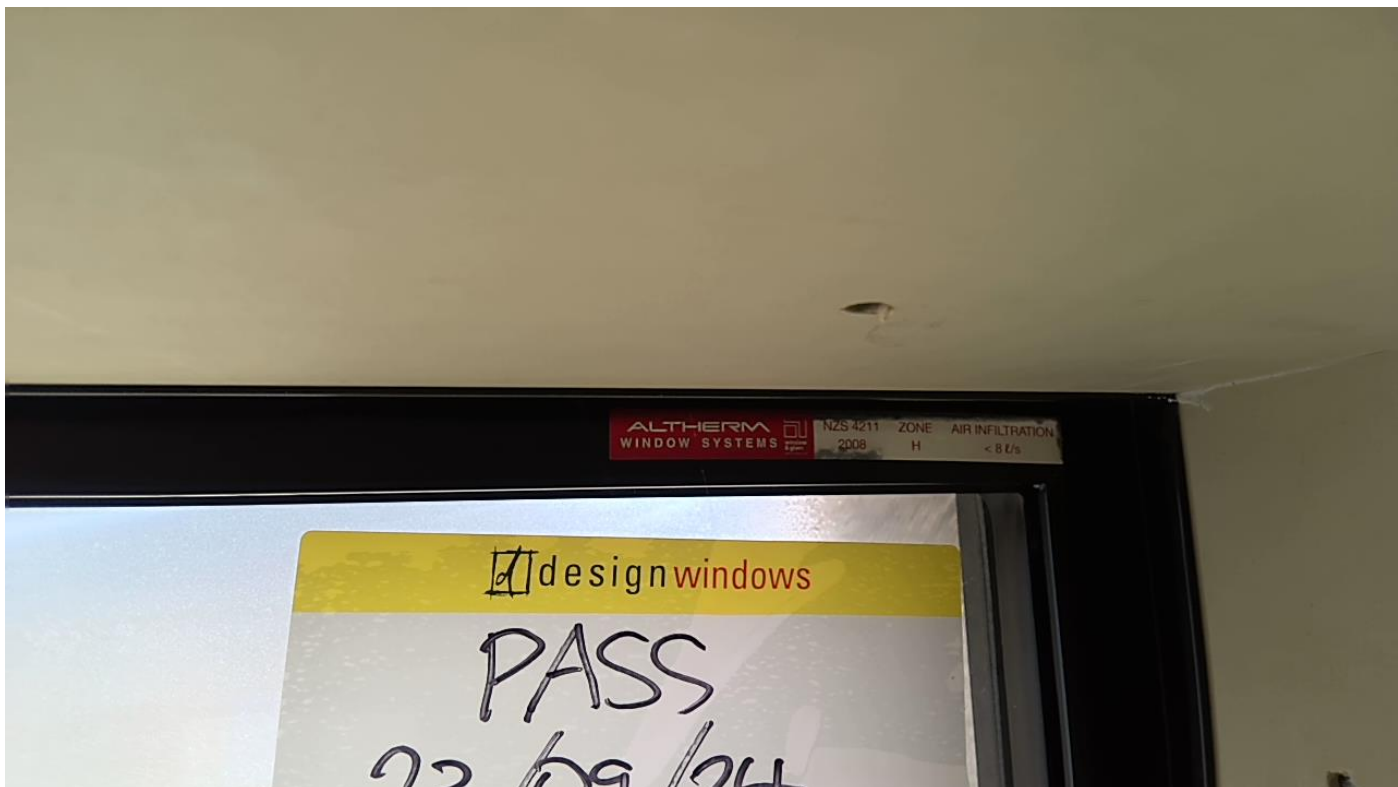
| <b>Joinery rated at H which is the correct rating for the wind zone it is located in.</b> | |

**Joinery H wind zone markings**  
Taken at 1:18 PM on Thursday 17/10/2024

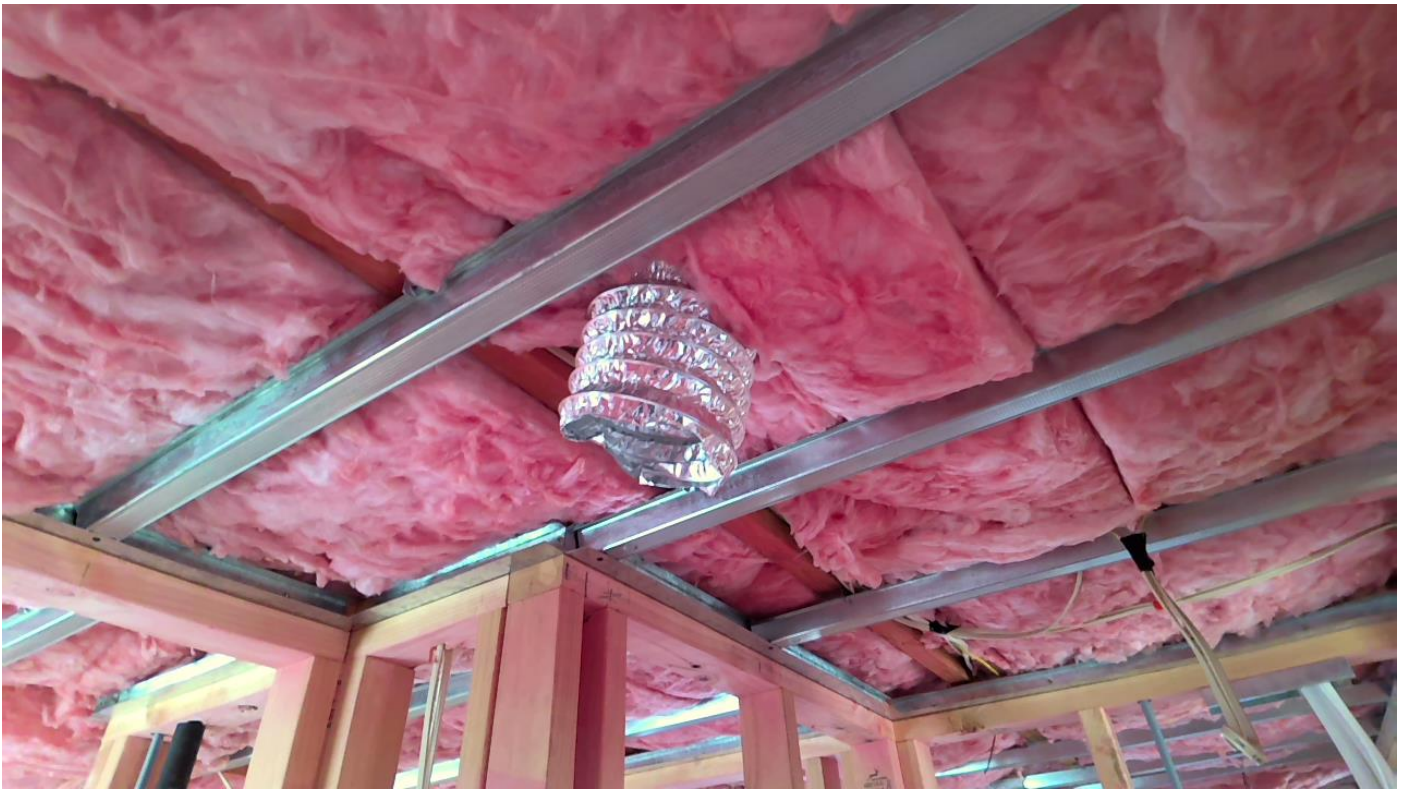
| <b>Ducting was in place for the rangehood/bathroom extracts.</b> | |

**Ducting in place**  
Taken at 1:19 PM on Thursday 17/10/2024

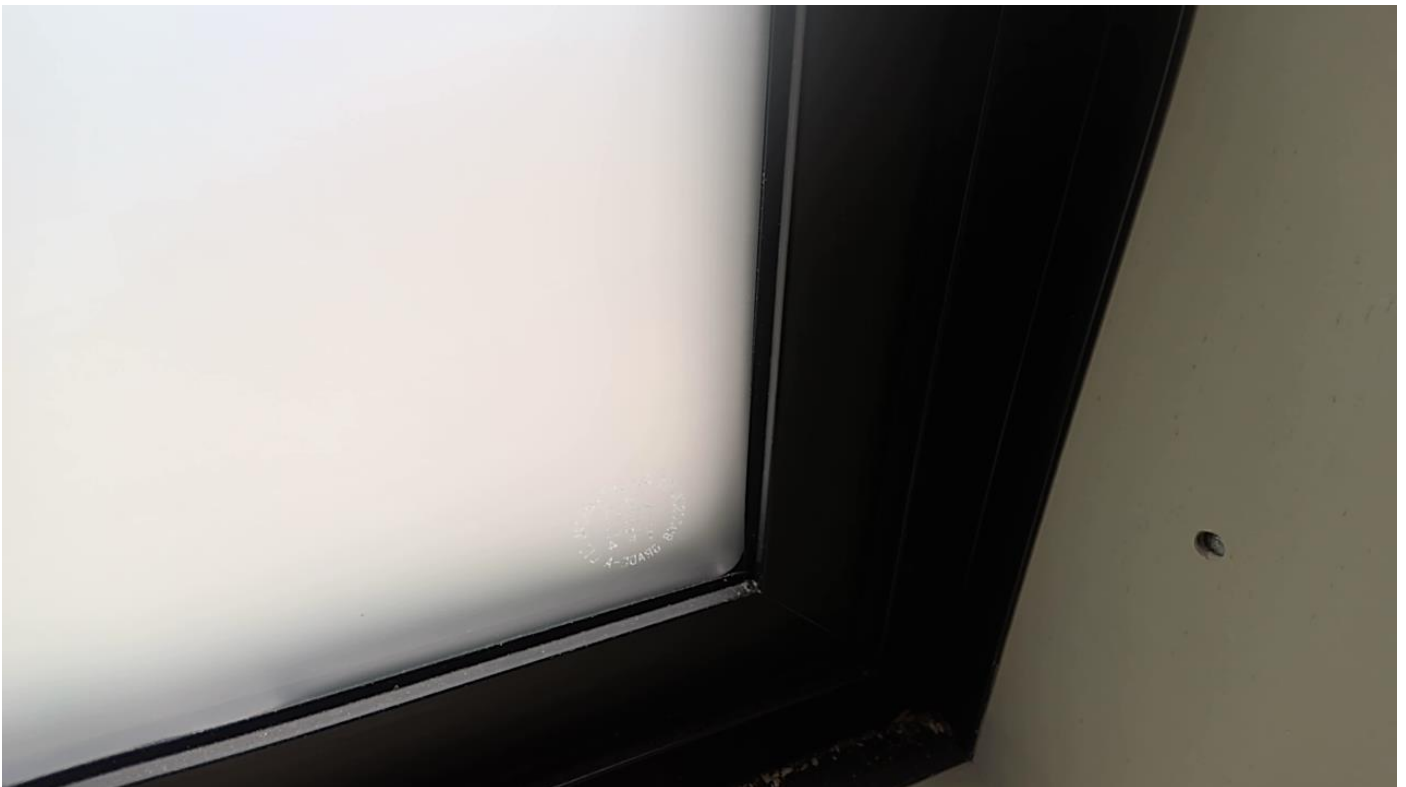
| <b>Safety glass located as required by consented documents.</b> | |

**Safety glazing etching in bathroom window**  
Taken at 1:22 PM on Thursday 17/10/2024

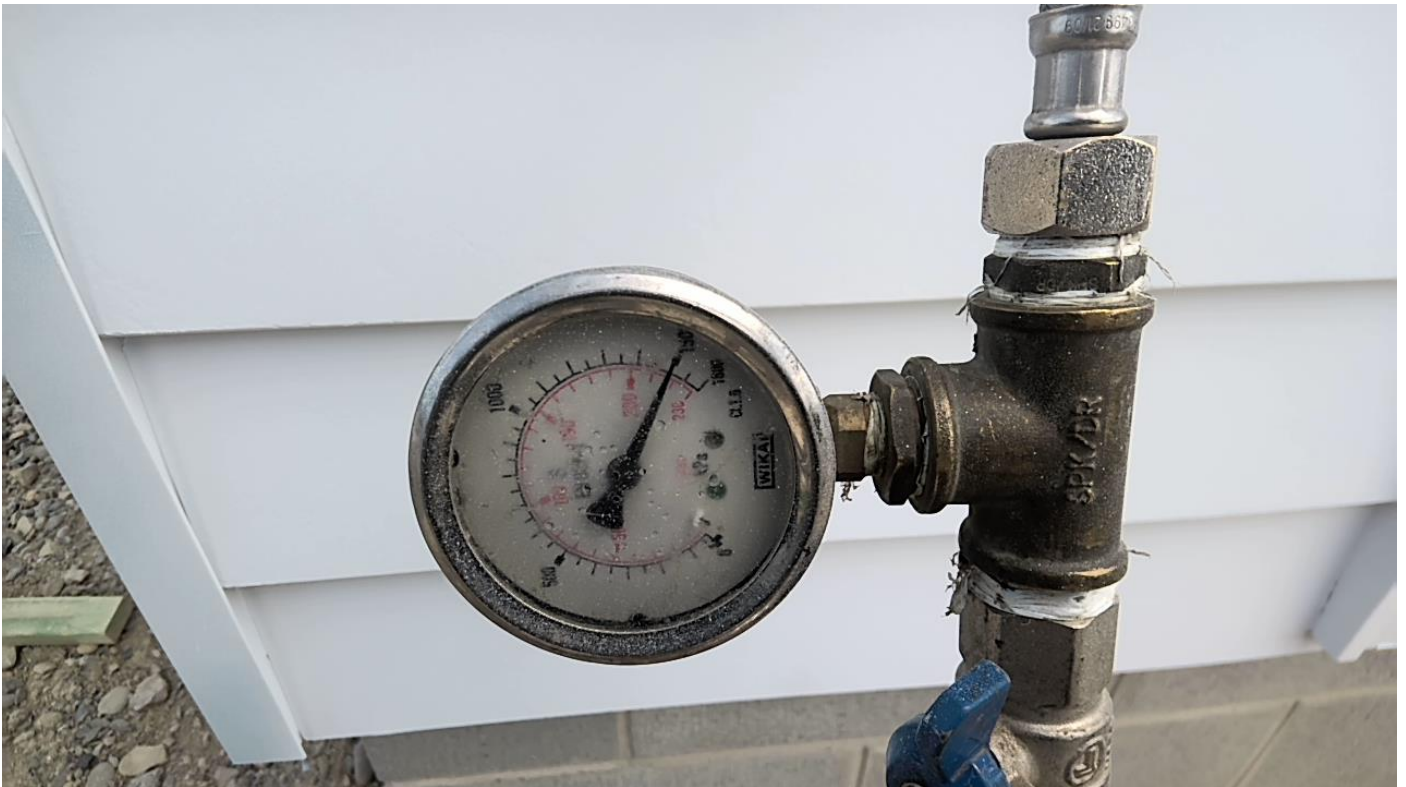
**Pressure test at 1500KPA**  
Taken at 1:28 PM on Thursday 17/10/2024

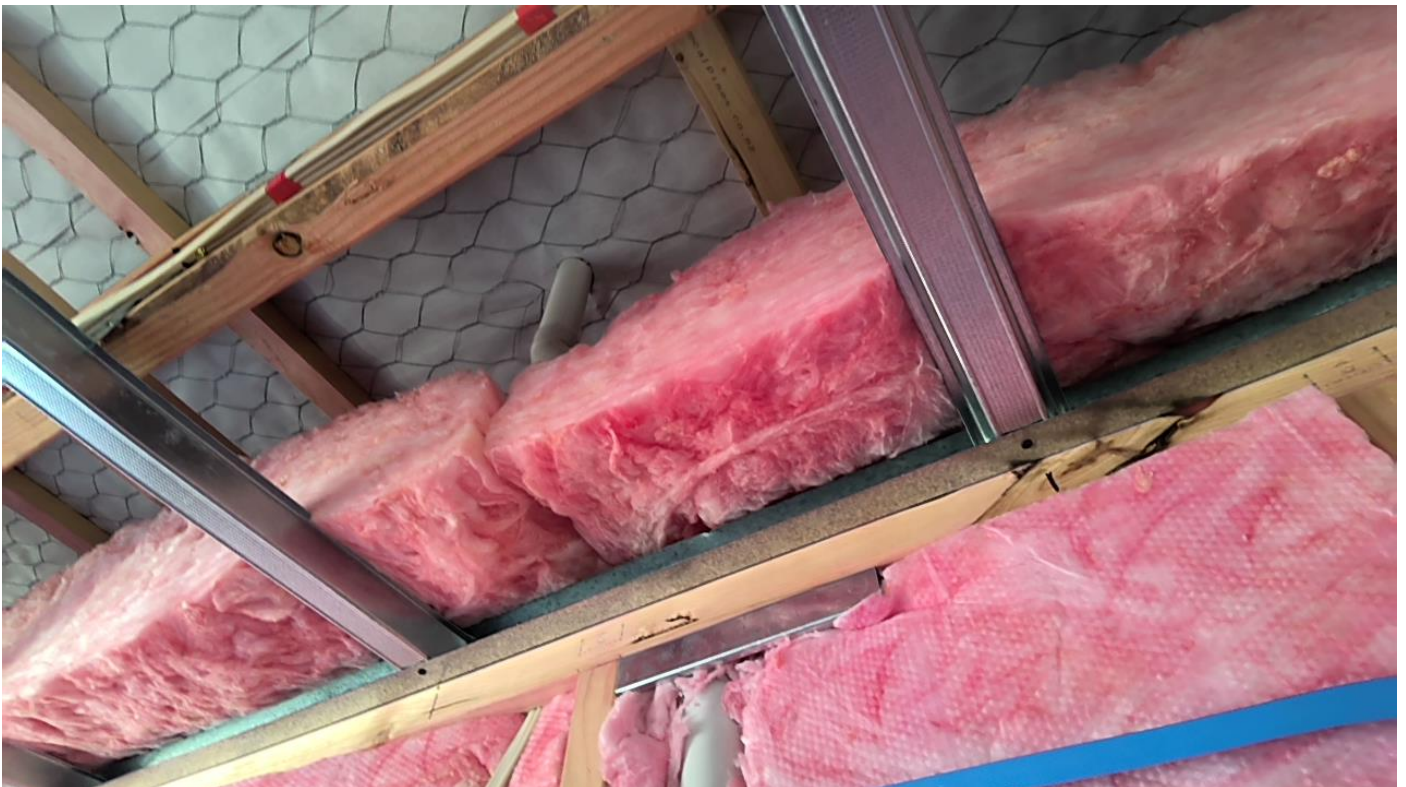
**Terminal vent penetrating roof**  
Taken at 1:28 PM on Thursday 17/10/2024
