Consent No: **24009002**  
 Applicant: **Shannon Marie Burgess**  
 Site Address: **7 Whitehaven Street, Weston**  
 Work Type: **Construction of a 4 bedroom, 2 bathroom dwelling with media room and attached garage.**

Inspection Type: **Final - Residential**  
 Inspection Status: **Fail**  
 Inspected By: **Gordon Innes**  
 Inspection Date: **16 January 2025 10:54 AM**  
 Duration: **60 minutes**

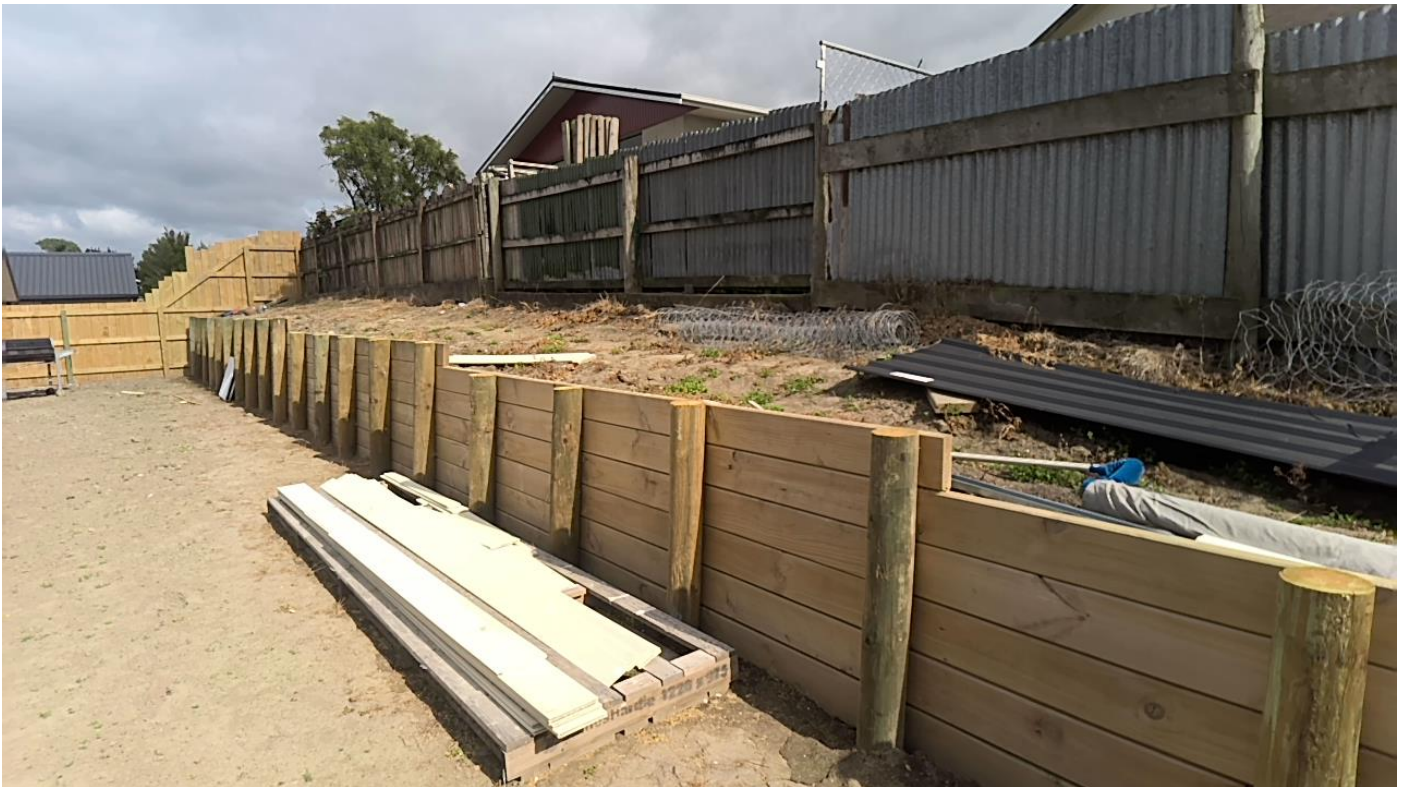
| Inspection Element | Status |
|---|---|
| Additional Site Observations<br><b>There is a wall built under schedule one that is associated with the house, the areas that have a fall over 1m require protection.</b> | Pass |

| <b>Retaining wall with falls over 1m requires adequate protection.</b> | |

**Fall over 1m requires protection, wall installed under schedule 1**  
Taken at 10:02 AM on Thursday 16/01/2025

| <b>Retaining wall with falls over 1m requires adequate protection. Please add photos to show areas over 1m are protected.</b> | |

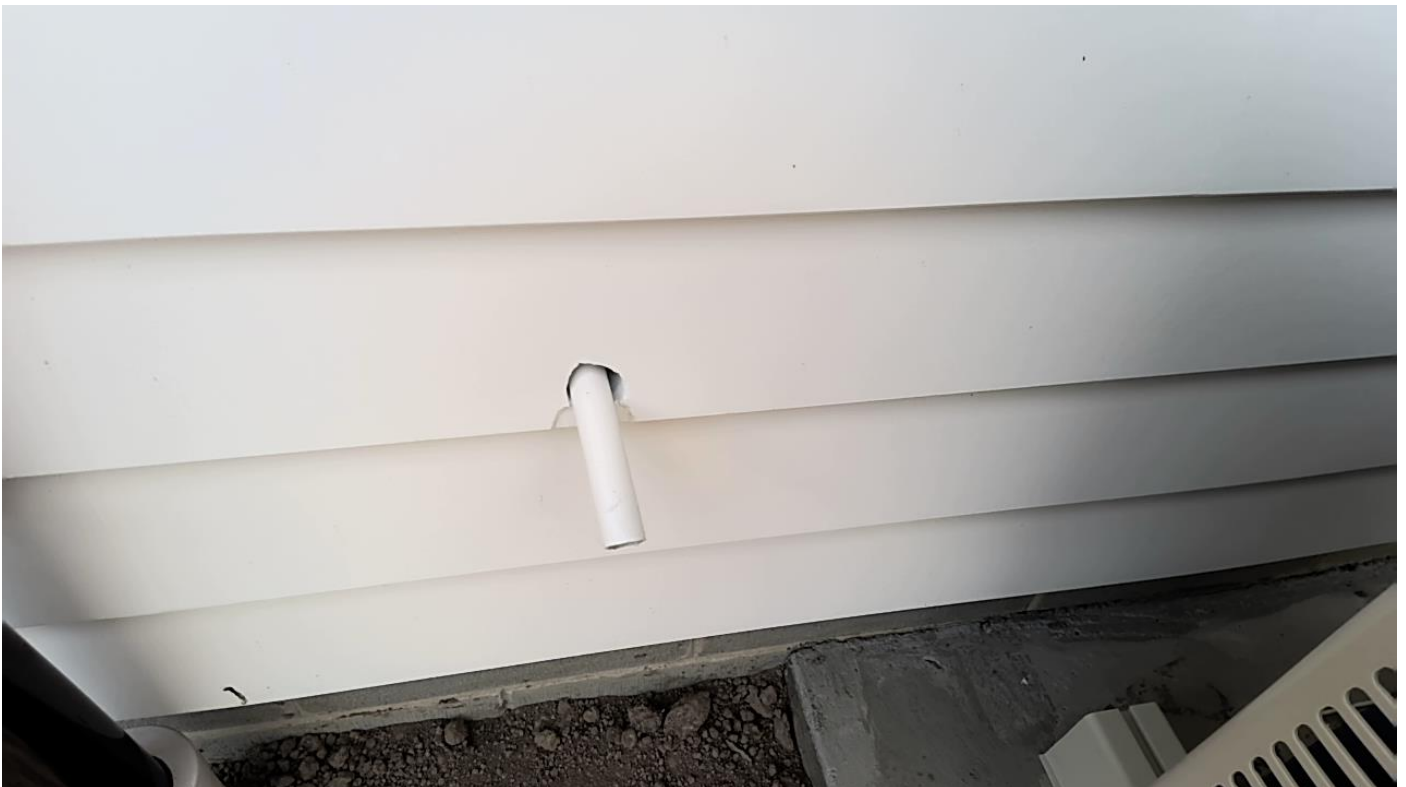
| <b>Heat pump overflow requires sealing</b> | |

**Heat pump overflow to be sealed**  
Taken at 10:05 AM on Thursday 16/01/2025

| <b>Overflow from heat pump to be sealed.</b> | |

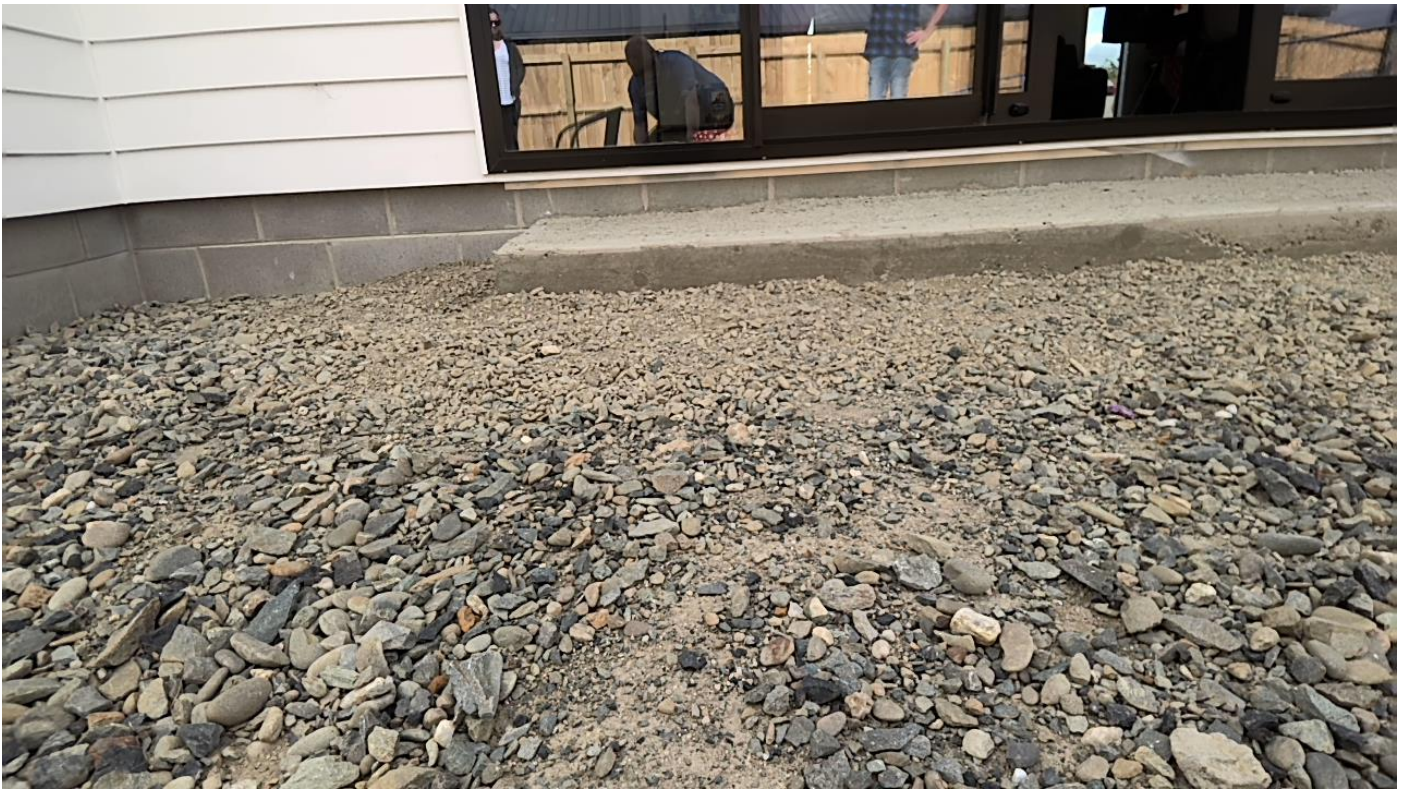
**Support bars in place under doors**  
Taken at 10:05 AM on Thursday 16/01/2025

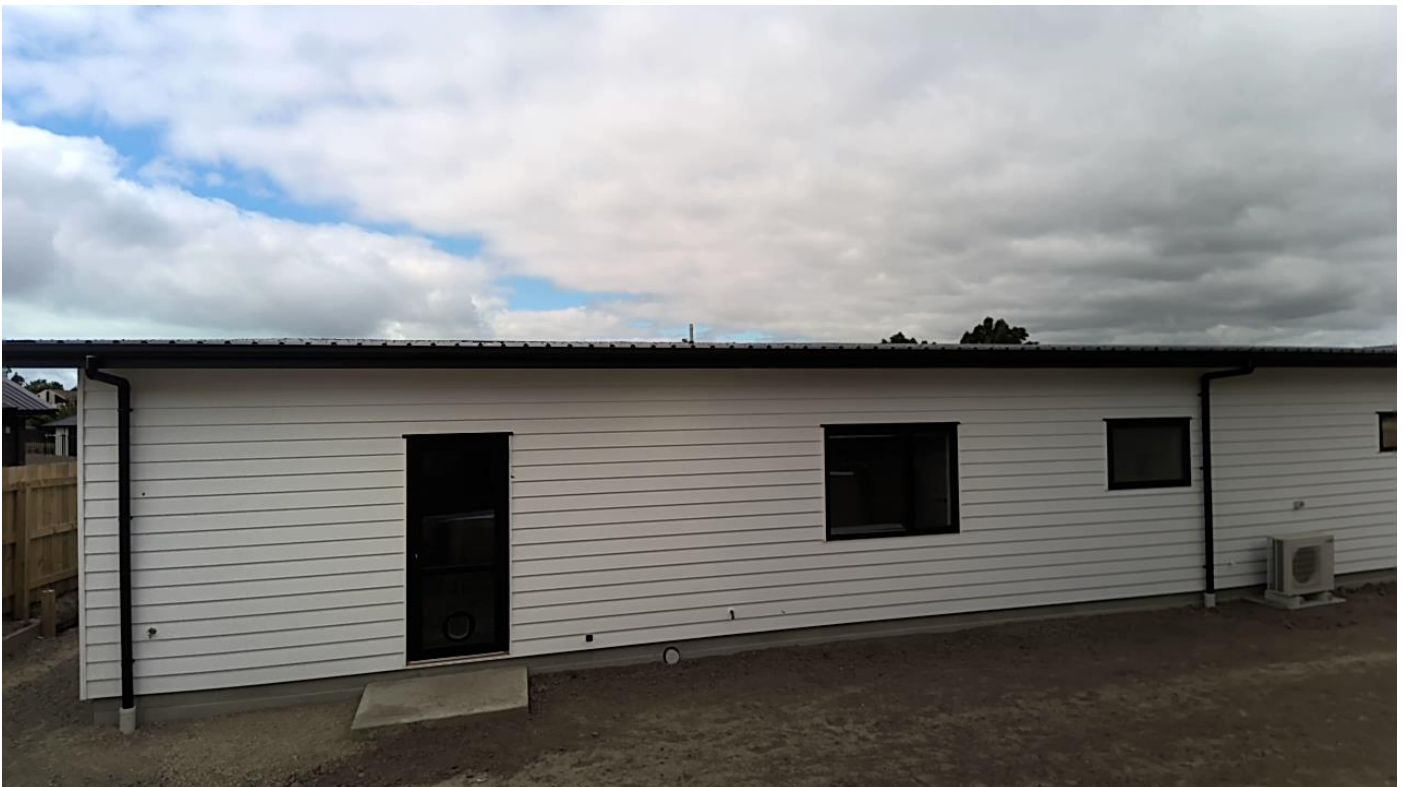
| <b>Terminal vent is sized and located in accordance with the consent documents.</b> | |

**Terminal vent with cowl**  
Taken at 10:20 AM on Thursday 16/01/2025

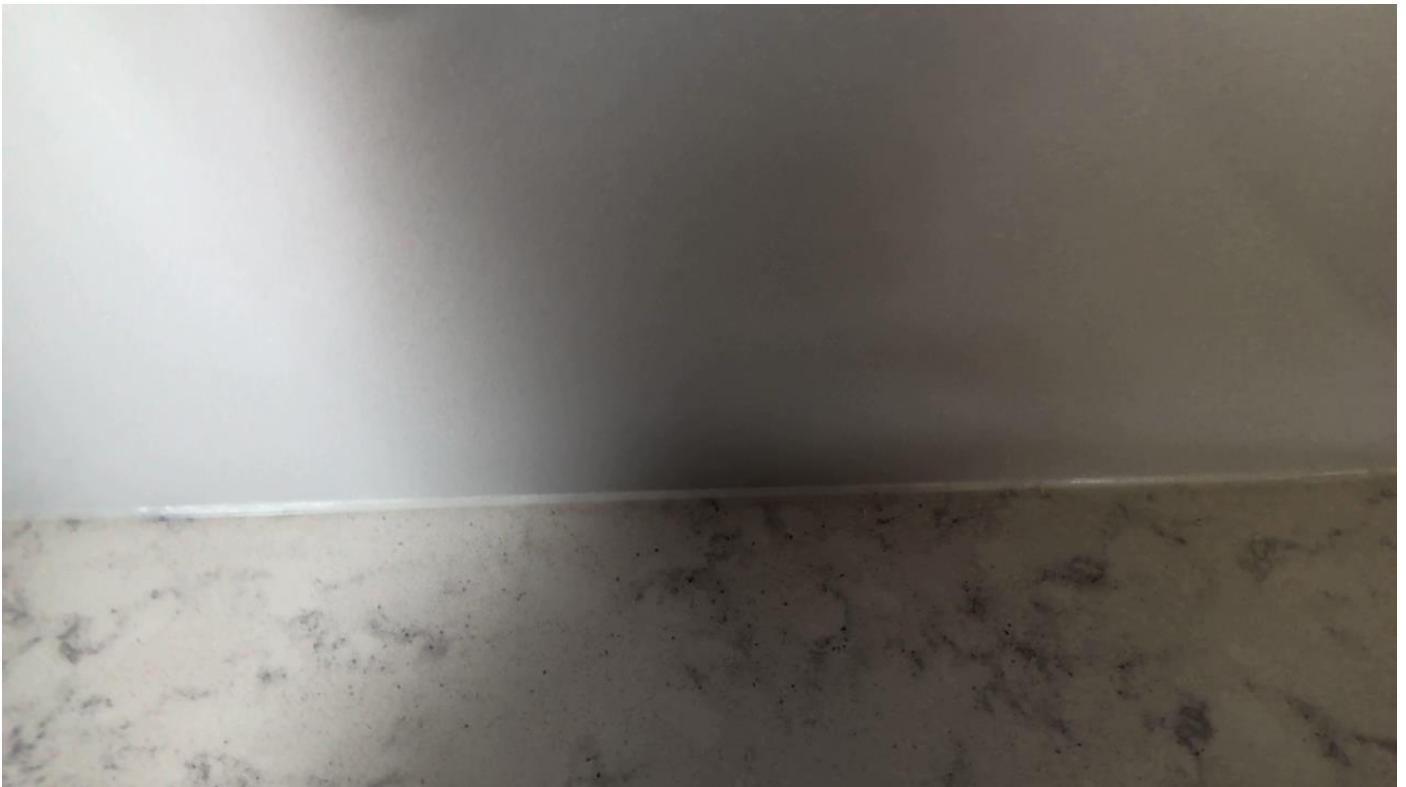
| <b>Floor finish to kitchen and sealant to bench tops completed.</b> | | |

**Work top sealed**

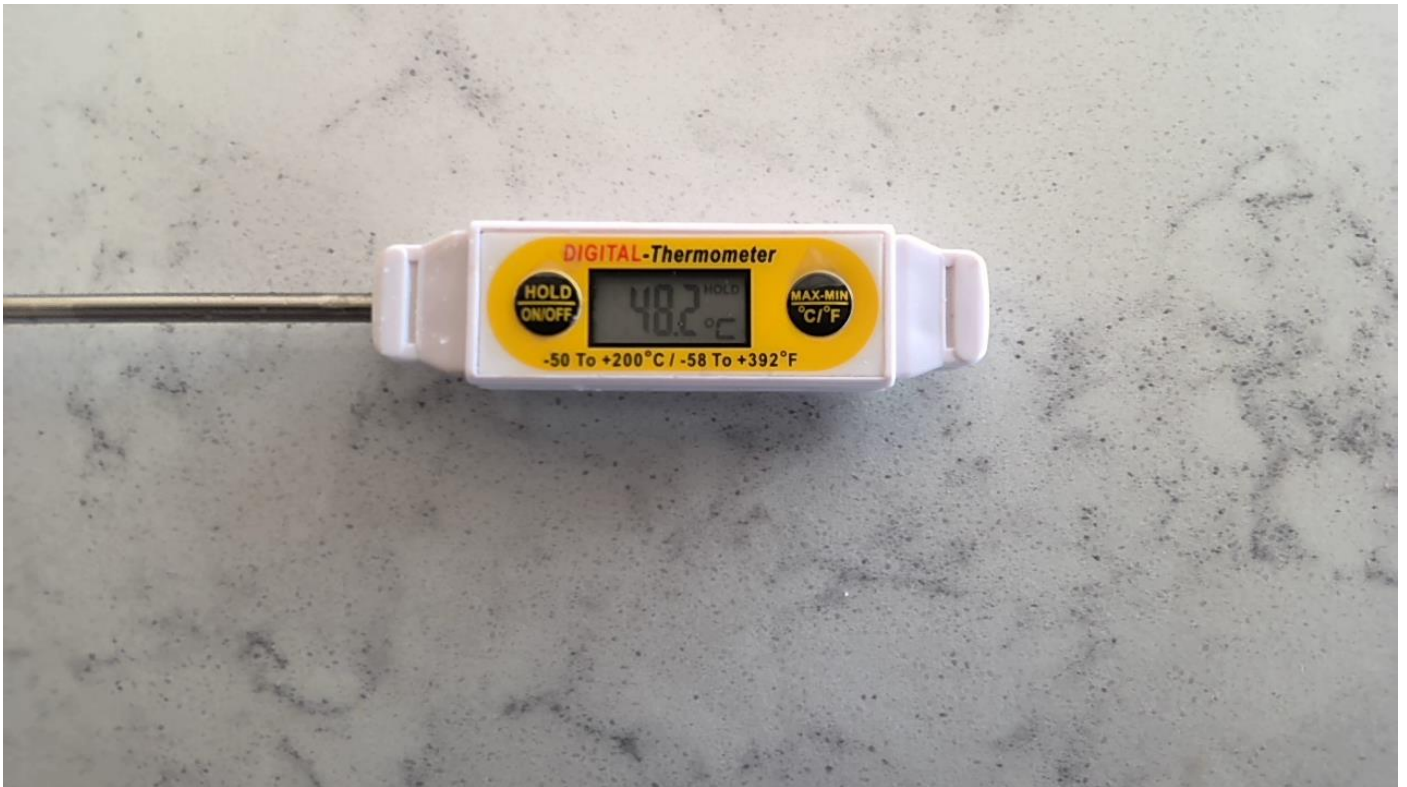
| <b>Temperature checked and ok at 48.2, TPR checked and ok.</b> | | |

**Temperature of hot water**  
Taken at 10:29 AM on Thursday 16/01/2025

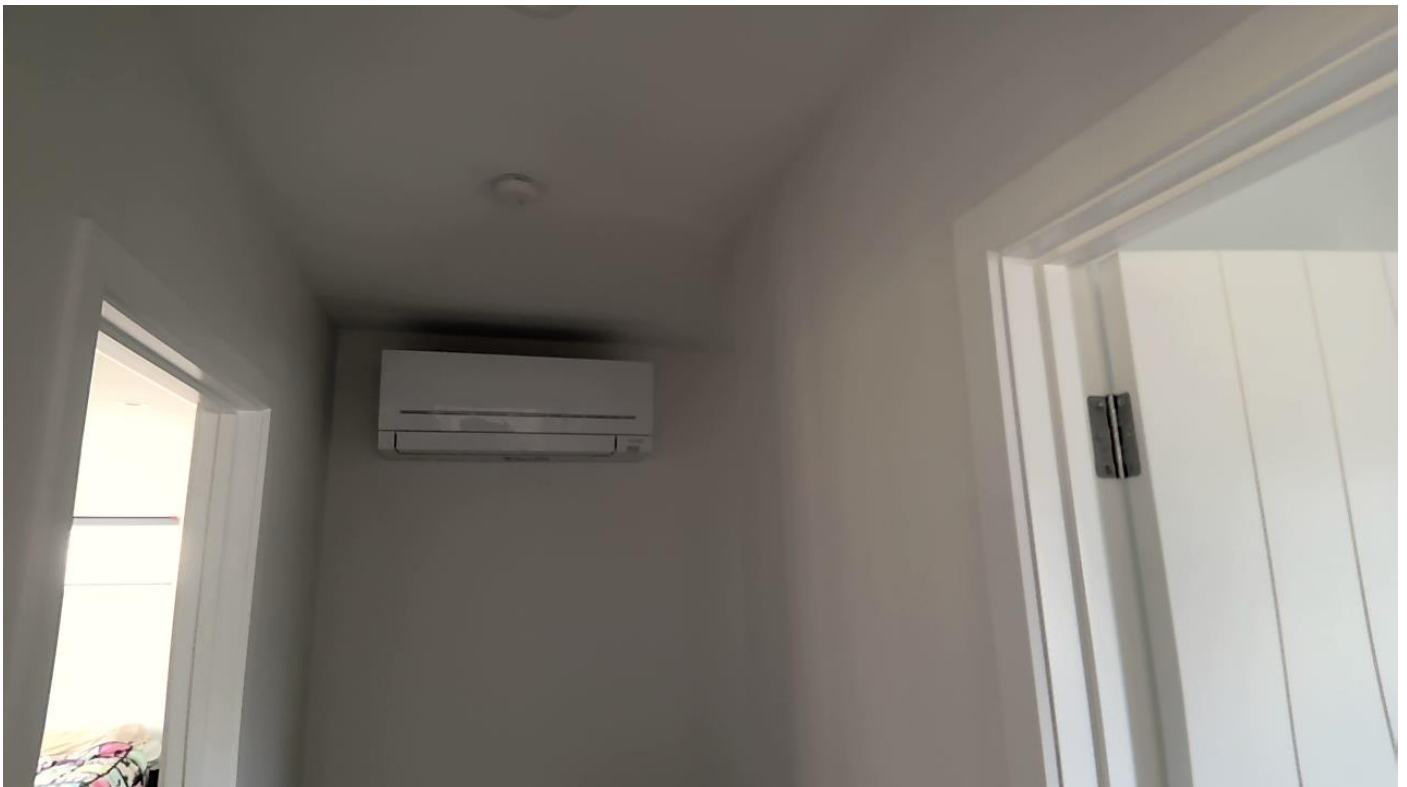
| Inspection Element | Status |
|---|---|
| Smoke alarms<br><b>Smoke alarms were located as required by the consent documents and F7/AS1, and tested as working at the inspection.</b> | Pass |

**Smoke alarm working between study and master bed**  
Taken at 10:39 AM on Thursday 16/01/2025

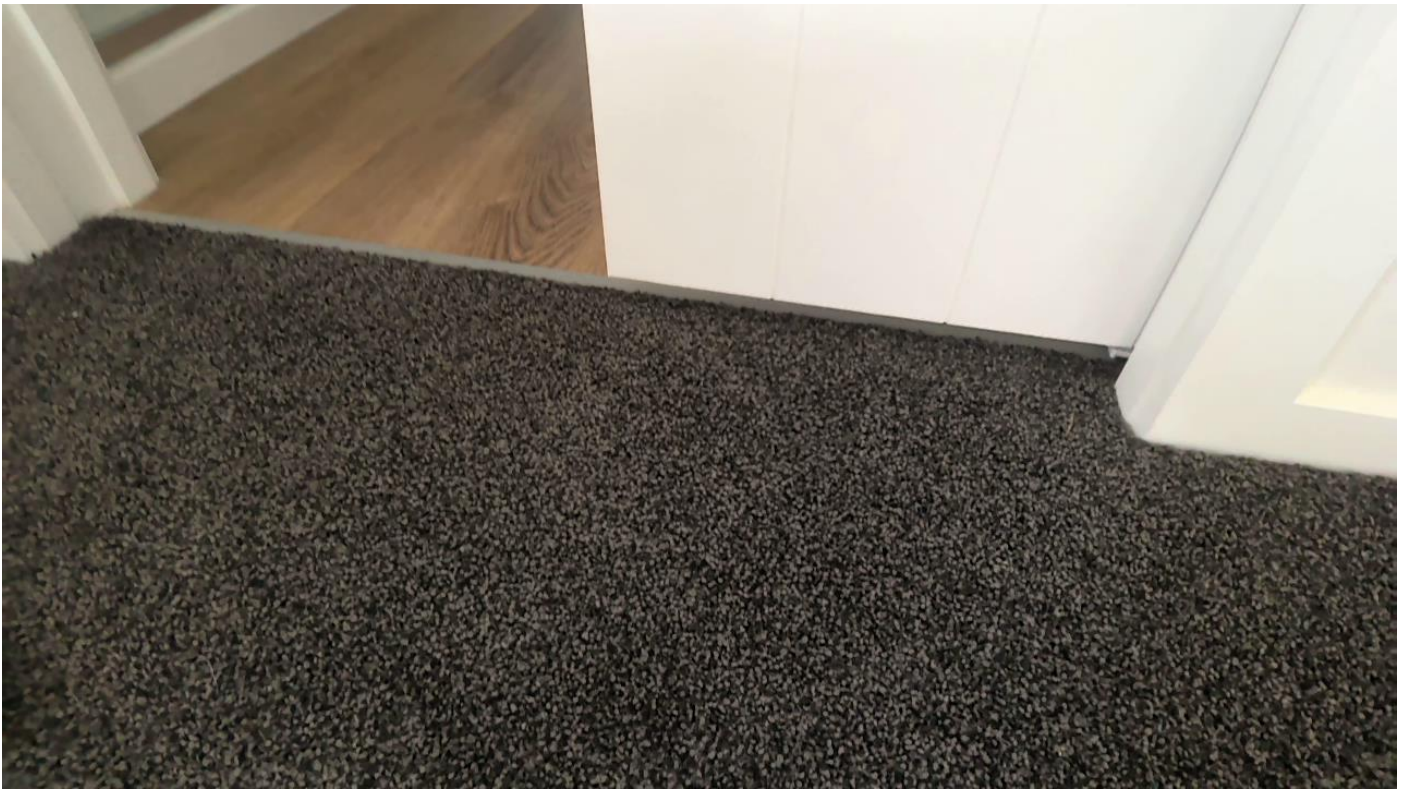
**Air gap under door**  
Taken at 10:39 AM on Thursday 16/01/2025

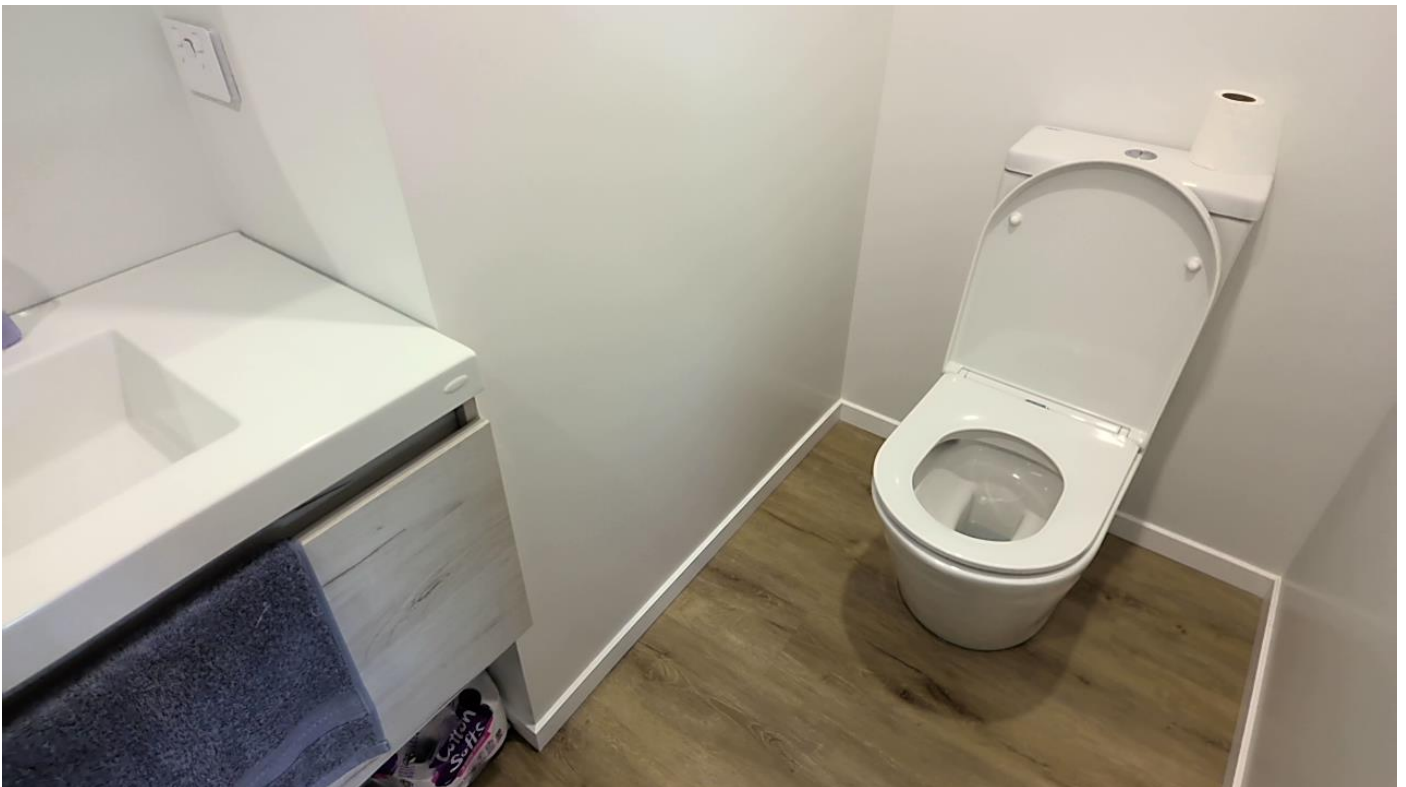
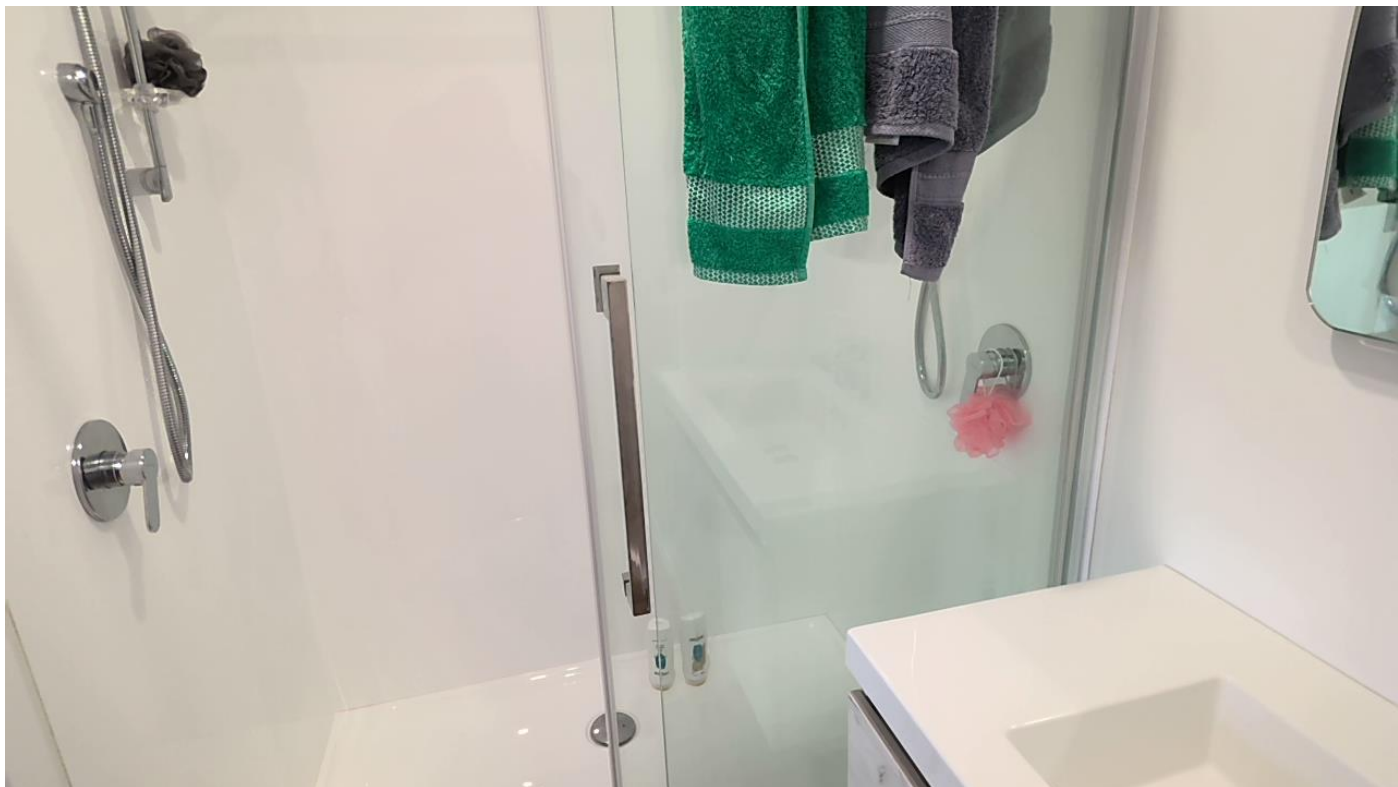
**Ensuite**  
Taken at 10:40 AM on Thursday 16/01/2025

| <b>The ensuite leaks to the vanity side bottom corner, I have spoken with the builder and owner and Warren will seal this and check it is not leaking, the owner is happy to make sure this is suitably sealed, I am SORG that this will be completed as required as Warren is an LBP who I have worked with and trust to carry out this level of work.</b> | | |

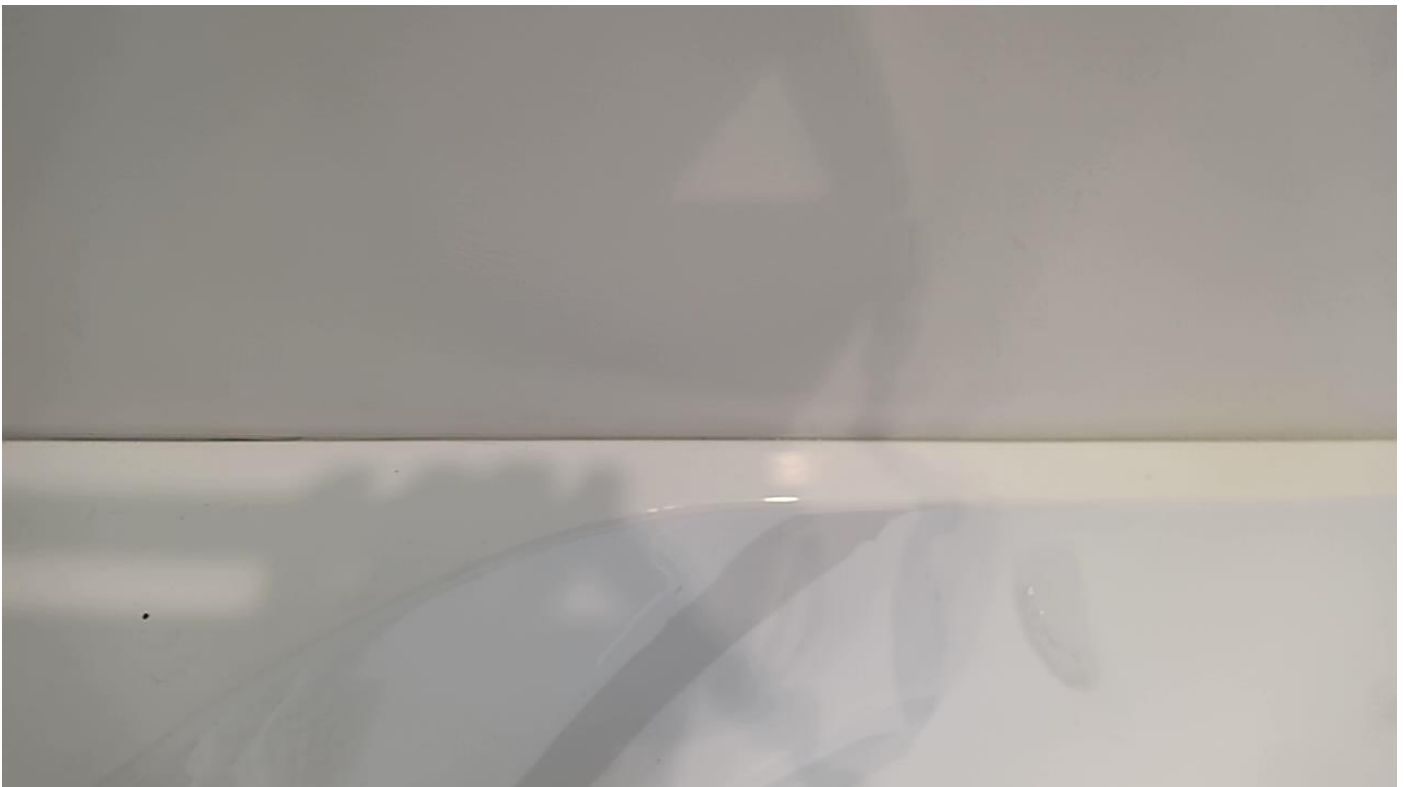
**Bath sealed**

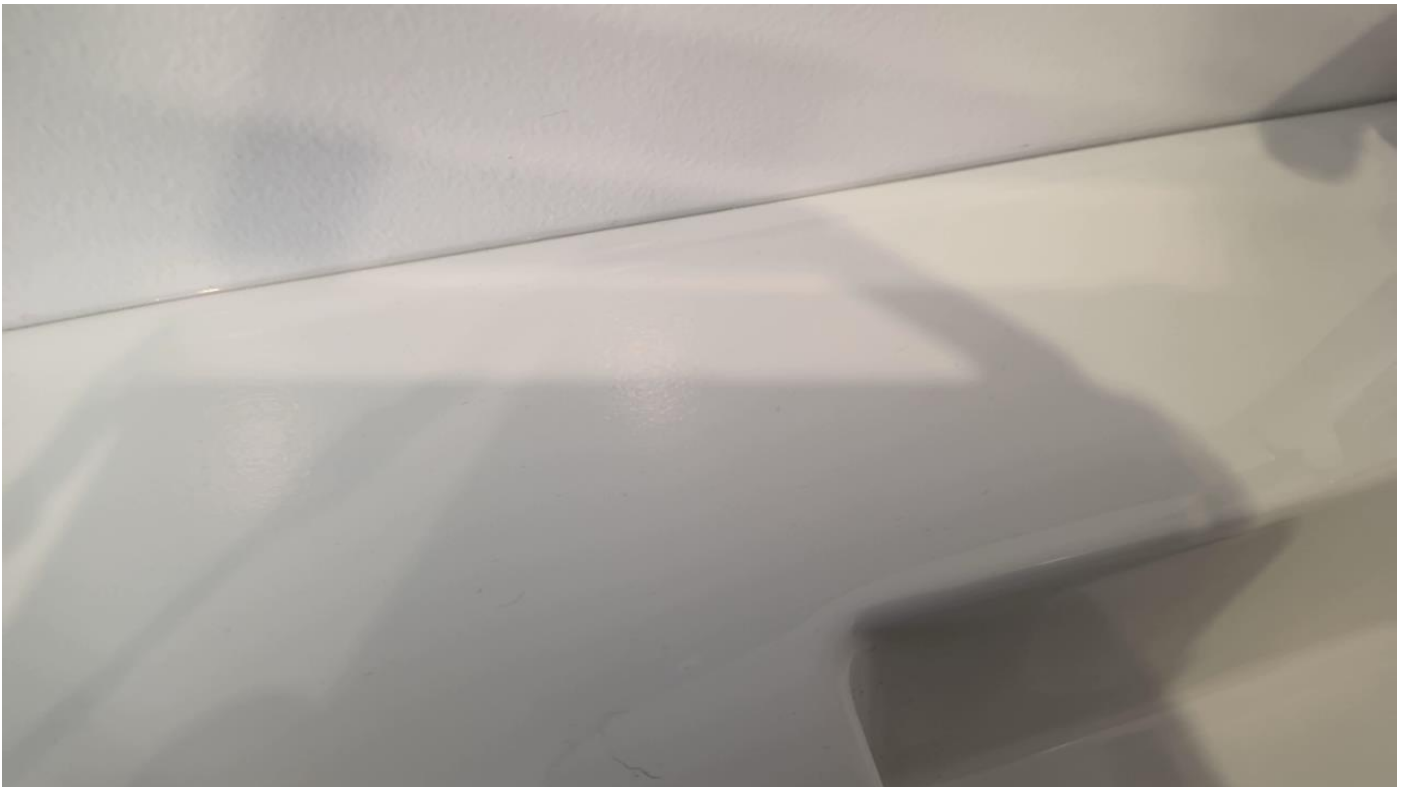
**Vanity sealed**  
Taken at 10:43 AM on Thursday 16/01/2025

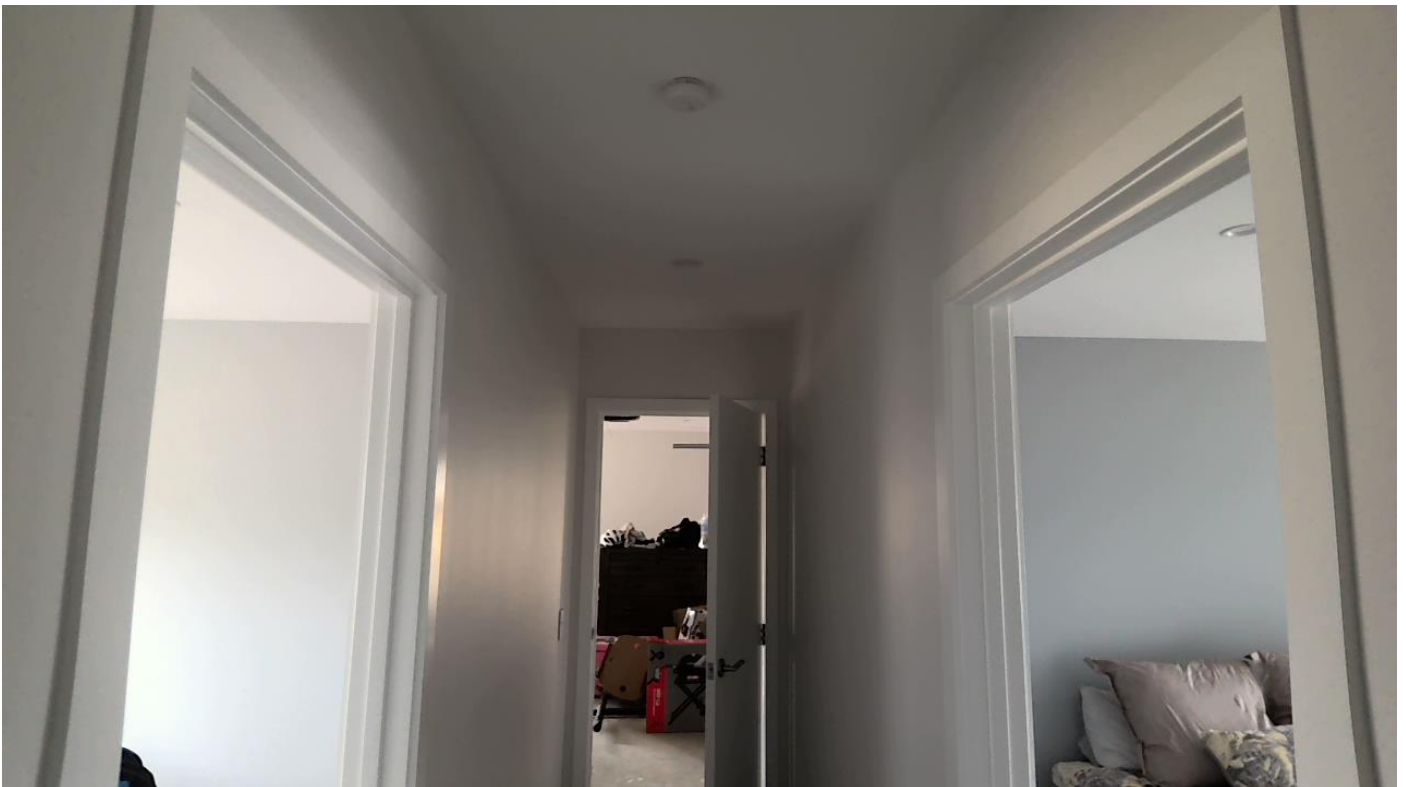
**Working smoke alarm between beds 2 and 3**  
Taken at 10:44 AM on Thursday 16/01/2025
