Whakatane District Council

Ohope Escarpment Condition Survey  
Nos 63 to 71 West End Road, Ohope

**June 2011**

**T&T Ref: 851478**

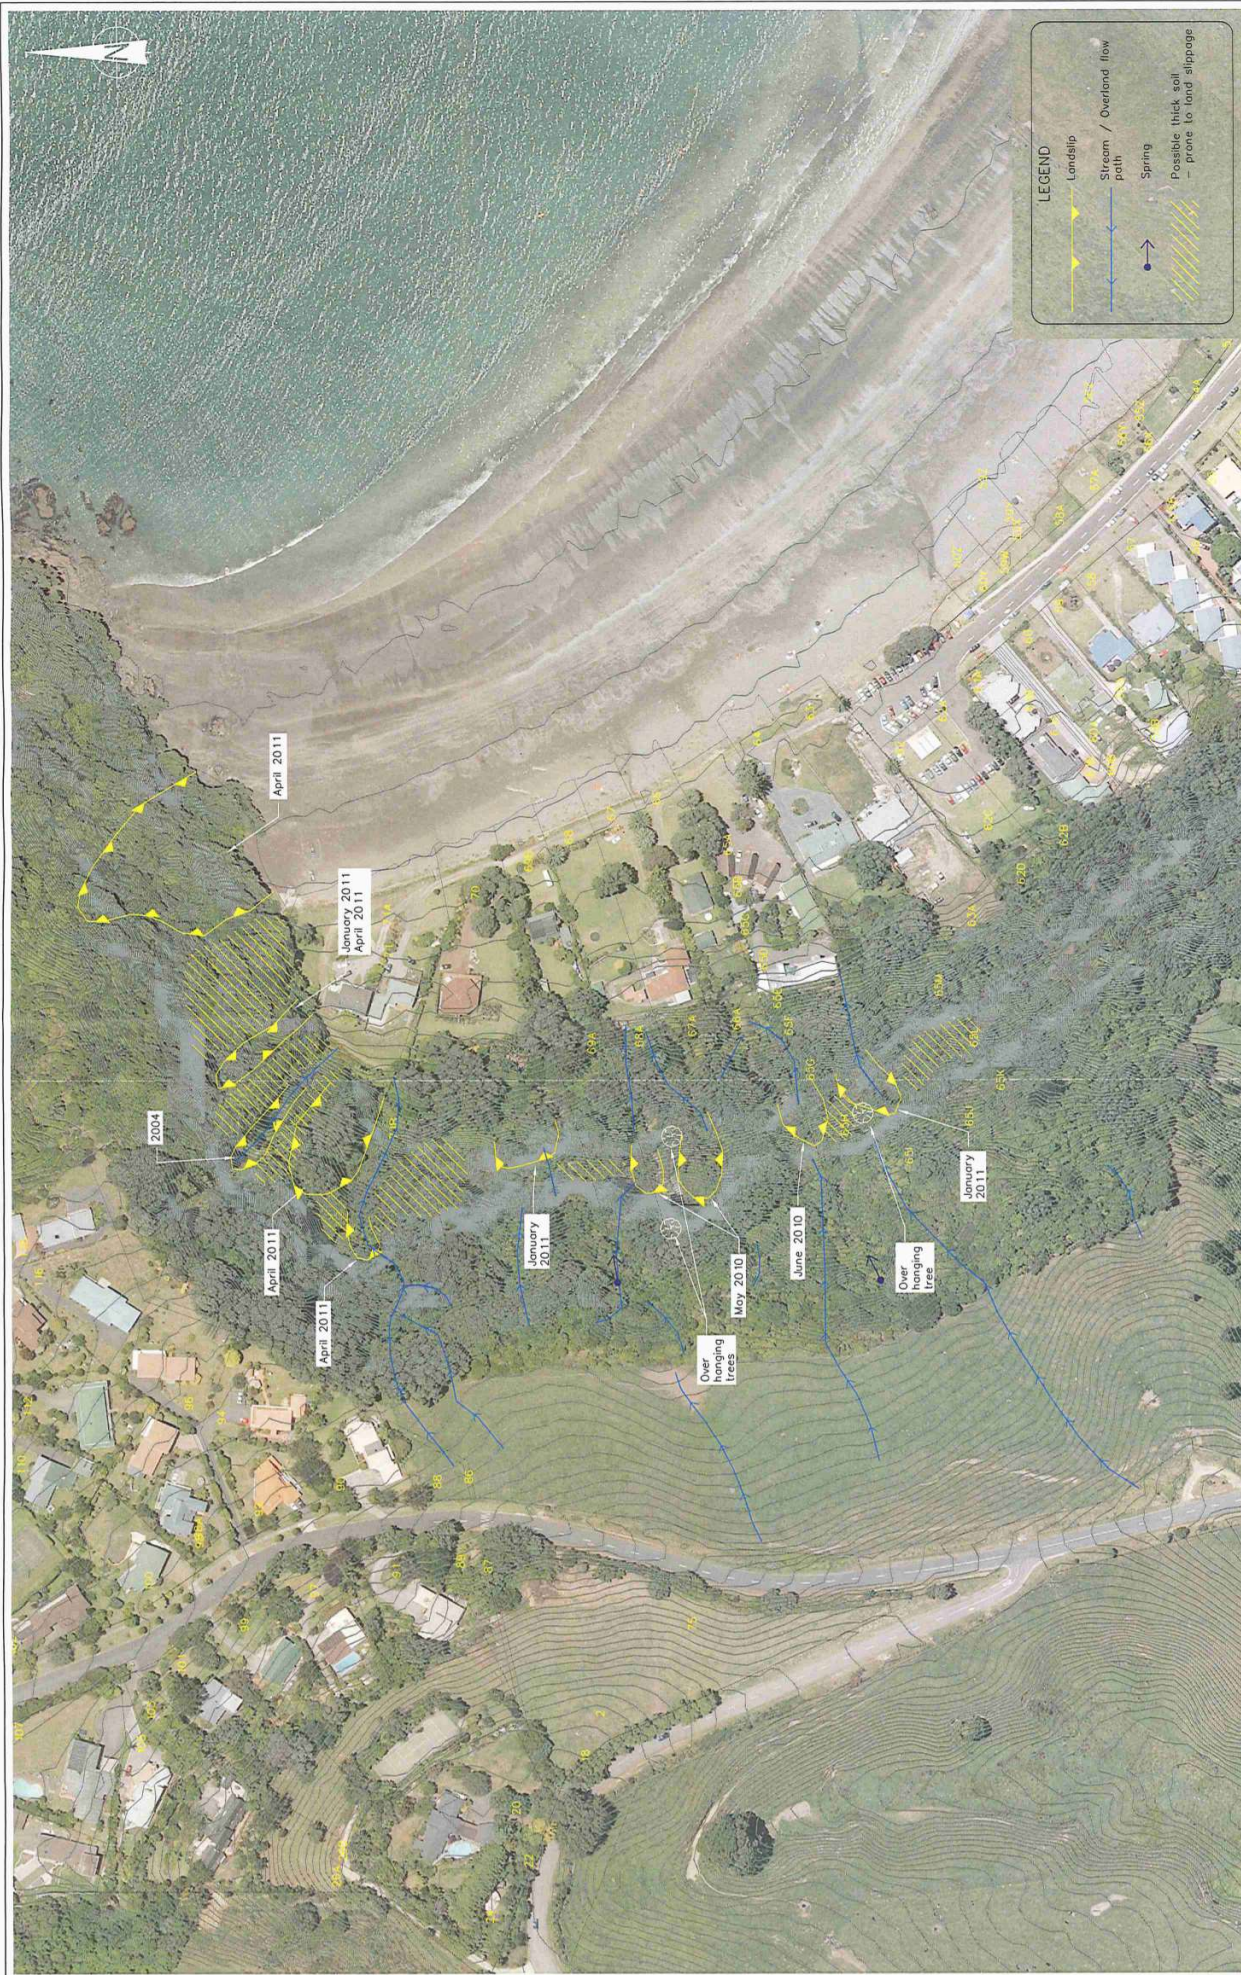
Figure 1

Water was observed to be running in areas all along the face between Nos 65 and 71. This water concentrated into streams behind Nos 65 to 68, No. 70 and No. 71/71A.

Water flowing down the escarpment comes from three sources. The first of these are springs that emanate from the Rotoiti Breccia (pumice gravel) that overlies the Ohope Beds. This deposit would have infilled the old erosion surface on the top of the Ohope Beds. Water flowing through the pumice is likely to flow along the old infilled gullies and now emerges approx 15 m vertically below the crest of the escarpment. Two of these springs were observed during our walkover and are marked on Figure 1.

The second source of water is direct overland flow of water during high intensity rainfall events affecting the area. Anecdotal evidence suggests that runoff from above the cliff forms significant waterfalls down the cliff face. Approximate overland flow paths are shown on Figure 1.

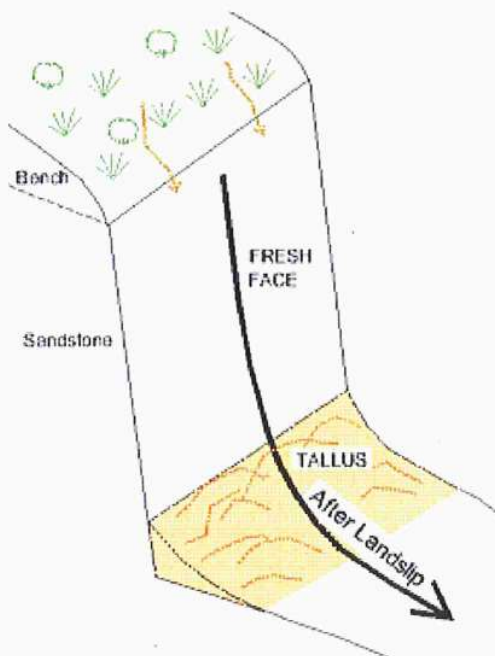
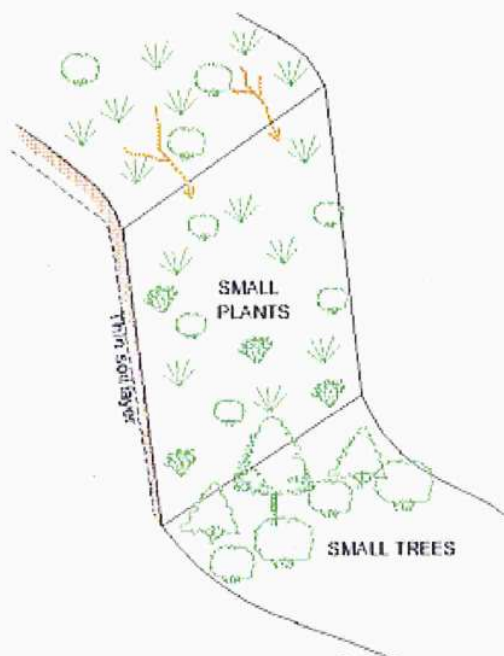
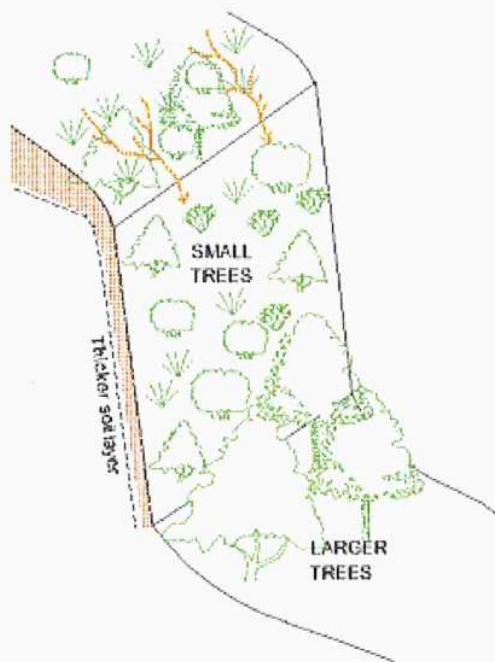
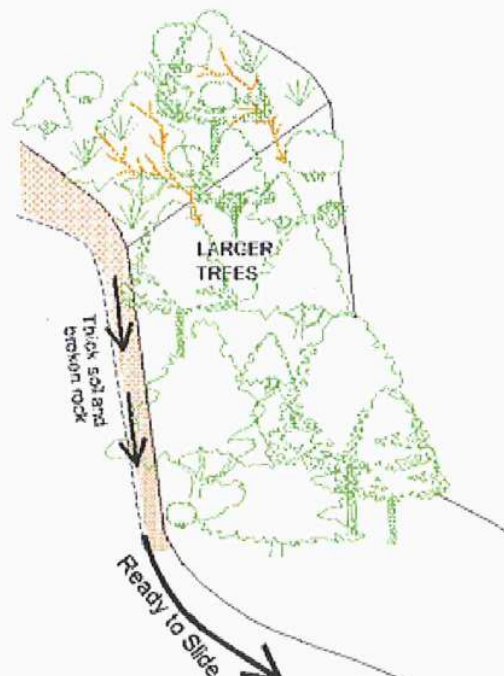
FIG. No. Figure 2

The weathering and landslipping processes of the Ohope escarpment are described in Report 2. It is summarised here. Figure 2 shows the natural weathering and erosion cycle of the escarpment. Following the landslide, a fresh face of bare rock is exposed. Gradually small plants colonise the face as the rock weathers and soil begins to accumulate. The soil gradually thickens and larger plants and trees begin to grow. At the same time, the underlying rock weathers as it is affected by carbonic and humic acids. Larger plants also affect the rock mass as roots grow into joints and cause them to open. Eventually the slope becomes overloaded and prone to landslips.

The process illustrated on Figure 2 will be cyclical. There are likely to be extended periods of soil and vegetation build up on the slopes. Once the soil thickness and vegetation density reaches a critical level then landslipping will become more frequent. Landslipping will eventually remove much of the soil and the process will start again.
