## Visual Non-Invasive Property Inspection

| Inspection Date | 31/07/2026 |

Address 197 williams Street Kaiapoi

### INSPECTION INSTRUCTIONS Visual Non-Invasive Pre-Purchase Property Inspection

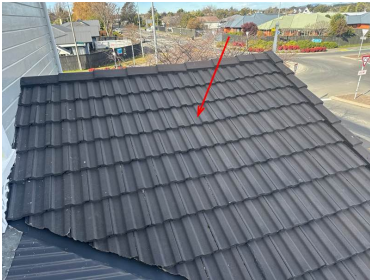
Concrete tiles

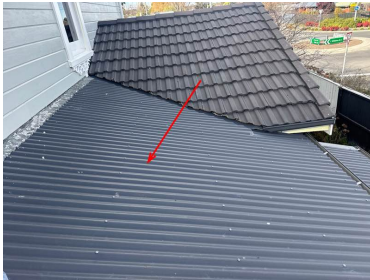
Corrugated colour steel roofing

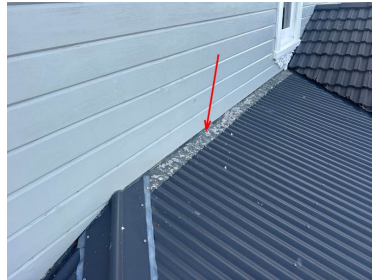
Apron flashing

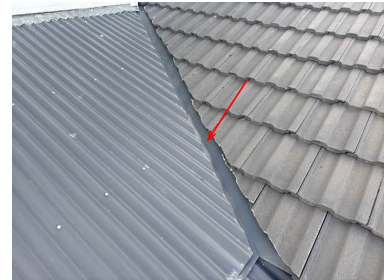
Valley flashing

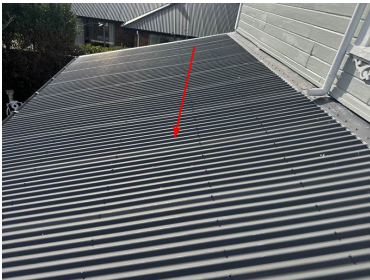
Corrugated colour steel roofing

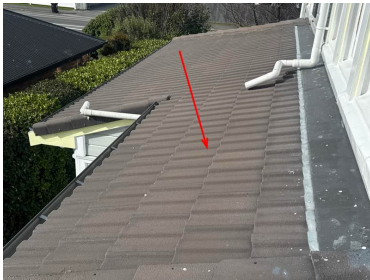
Concrete tile

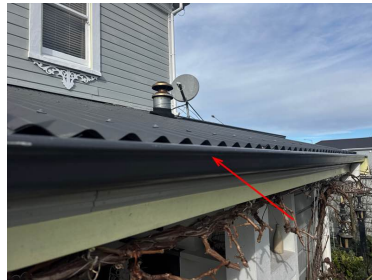
Colour steel gutter system

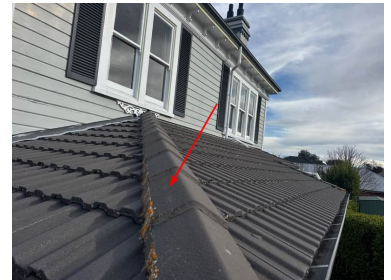
Hip cappings

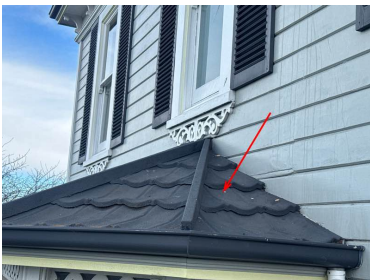
Decramastic tiles

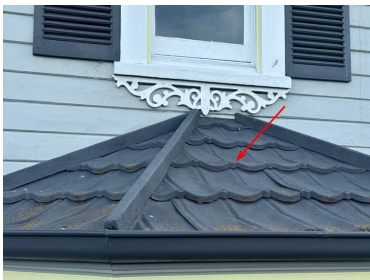
Decramastic tiles

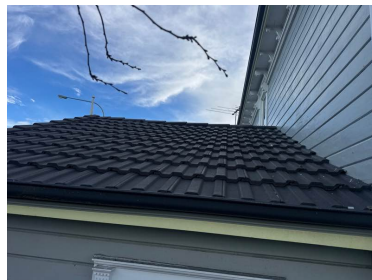
Concrete tile top roof

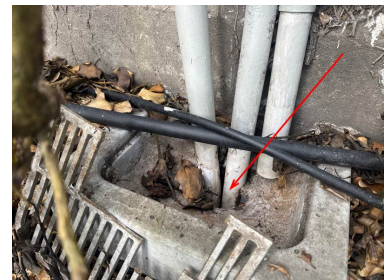
Gully trap

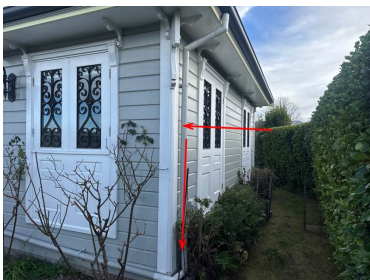
All downpipes directed into stormwater as intended

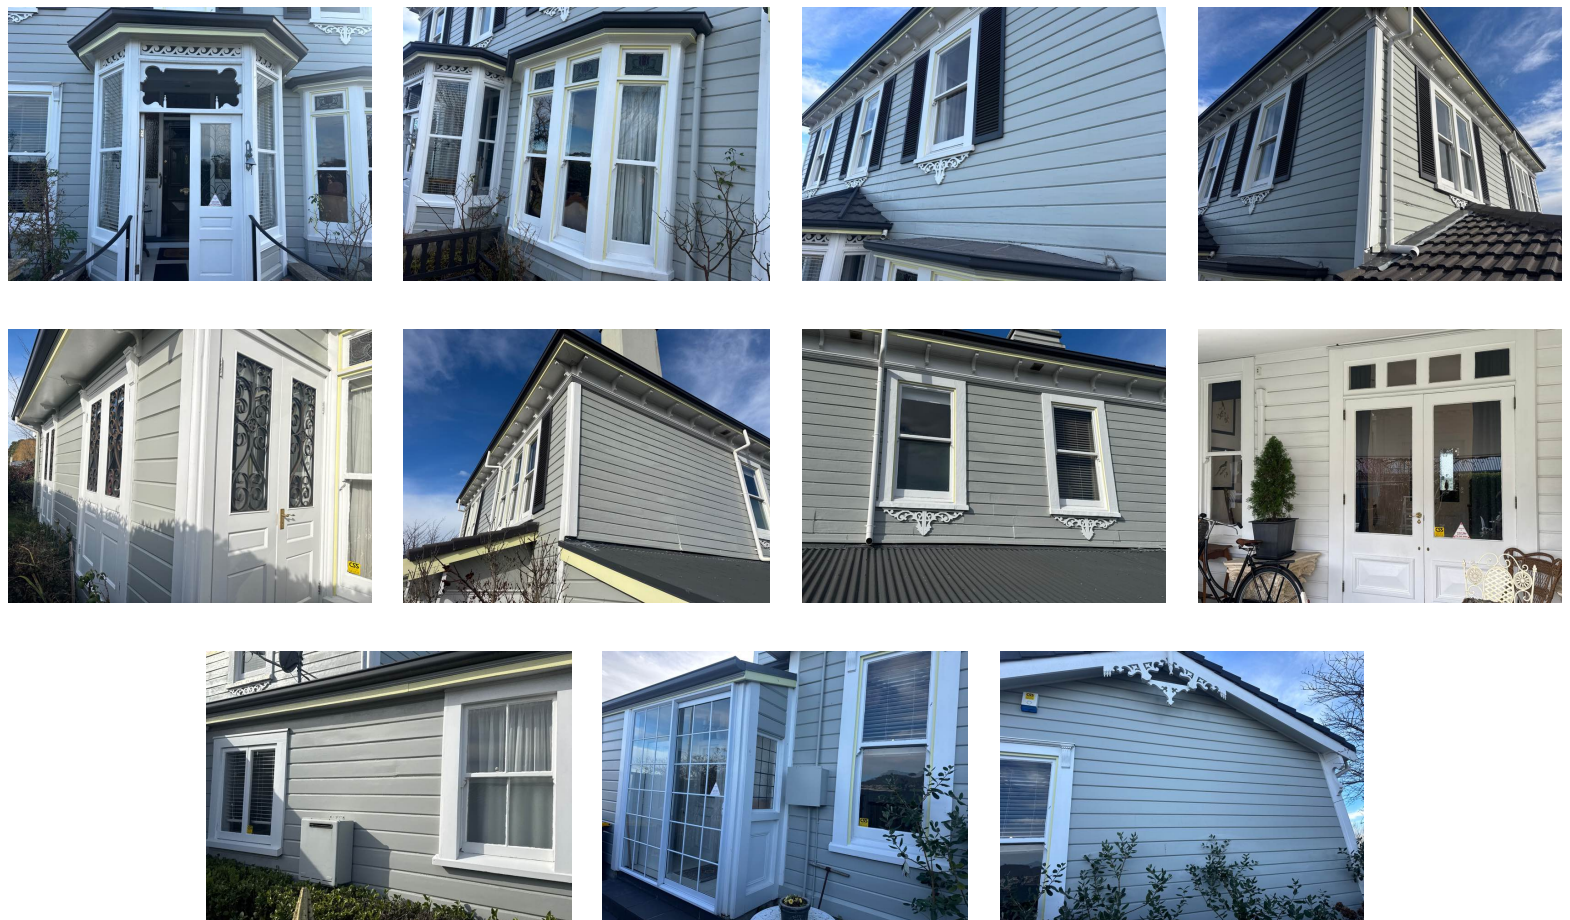
### Cladding and Windows

| Comments | <p>Cladding</p> <p>The dwelling is clad with horizontal timber weatherboards. The exterior has been recently repainted, presenting in a clean and well-maintained condition. Given the age of the dwelling, some minor surface imperfections and age-related characteristics remain evident, which is typical for a home of this era and not considered unusual.</p> <p>At the time of inspection, the weatherboards appeared to be in generally good condition, with no significant defects observed. The recent paintwork provides good protection to the timber cladding. Continued routine inspection and maintenance, together with repainting as required over time, will help preserve the cladding in good condition.</p> <p>Windows</p> <p>The dwelling has timber single-glazed windows. The exterior timber joinery has also been recently painted and appeared clean, tidy, and well maintained at the time of inspection. No significant deterioration or visible soft rot was observed to the accessible exterior joinery.</p> <p>The exterior of the dwelling appeared to be adequately sealed, with no visible signs of moisture ingress through the cladding or window joinery at the time of inspection.</p> <p>Risk: Low</p> |

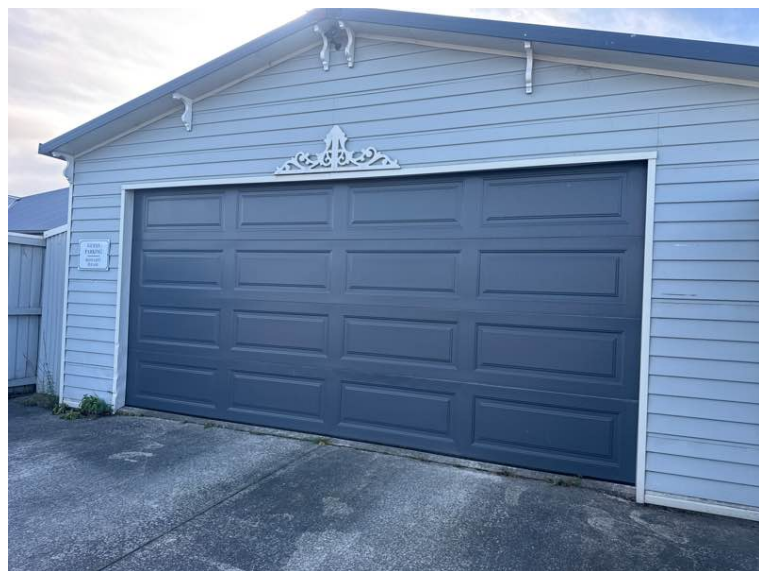
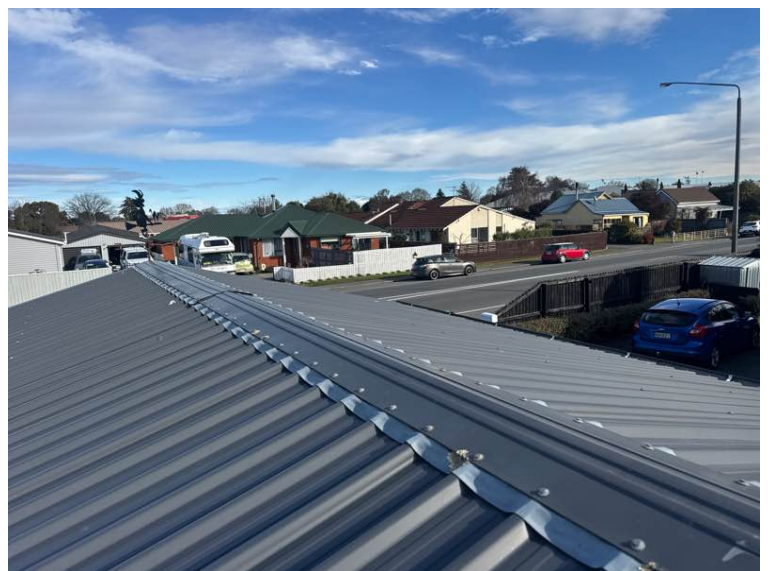
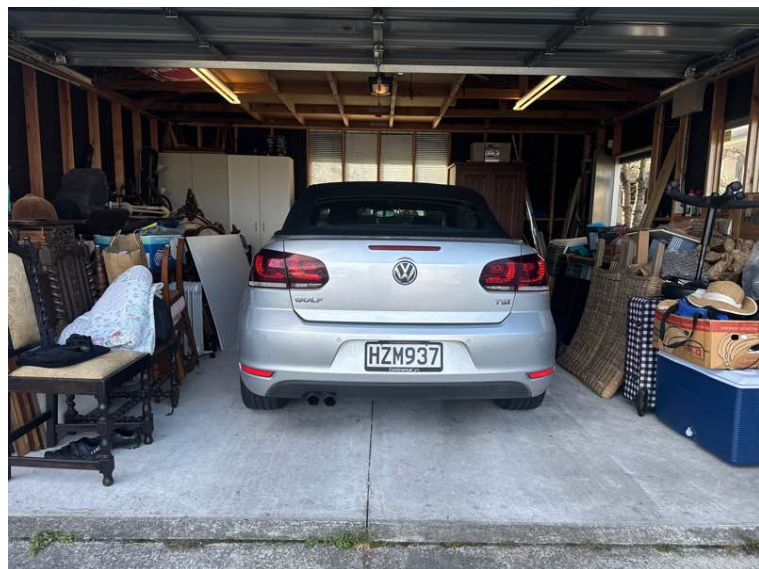
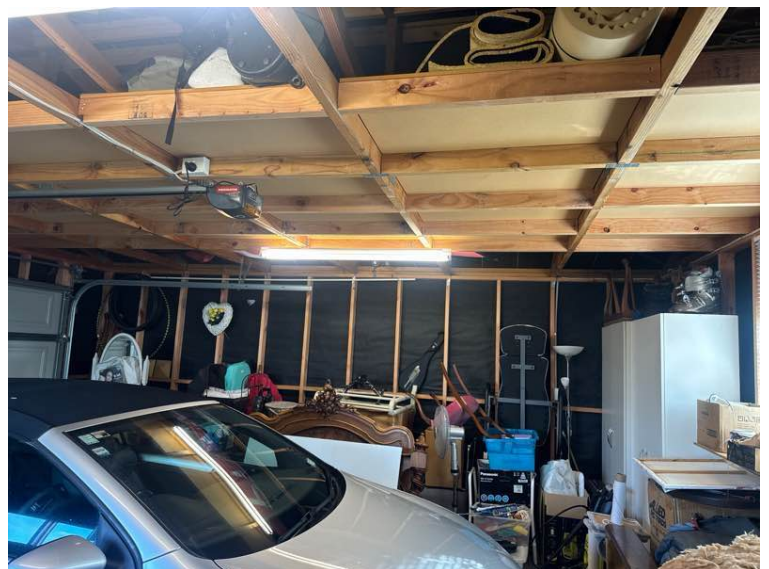
### Garage

| Comments | <p>detached two-car garage is located on the property. The garage is clad with Coloursteel cladding and finished with a corrugated Coloursteel roof. Both the cladding and roofing appeared to be in good condition at the time of inspection, with no significant defects observed.</p> <p>The Coloursteel sectional garage door and automatic door opener operated smoothly during testing and were functioning as intended.</p> <p>Internally, the timber framing appeared clean and in good condition. The concrete slab floor appeared stable, with no visible significant cracking of concern. No visible water staining, moisture ingress, or water damage was observed within the garage at the time of inspection.</p> <p>Risk: Low</p> |

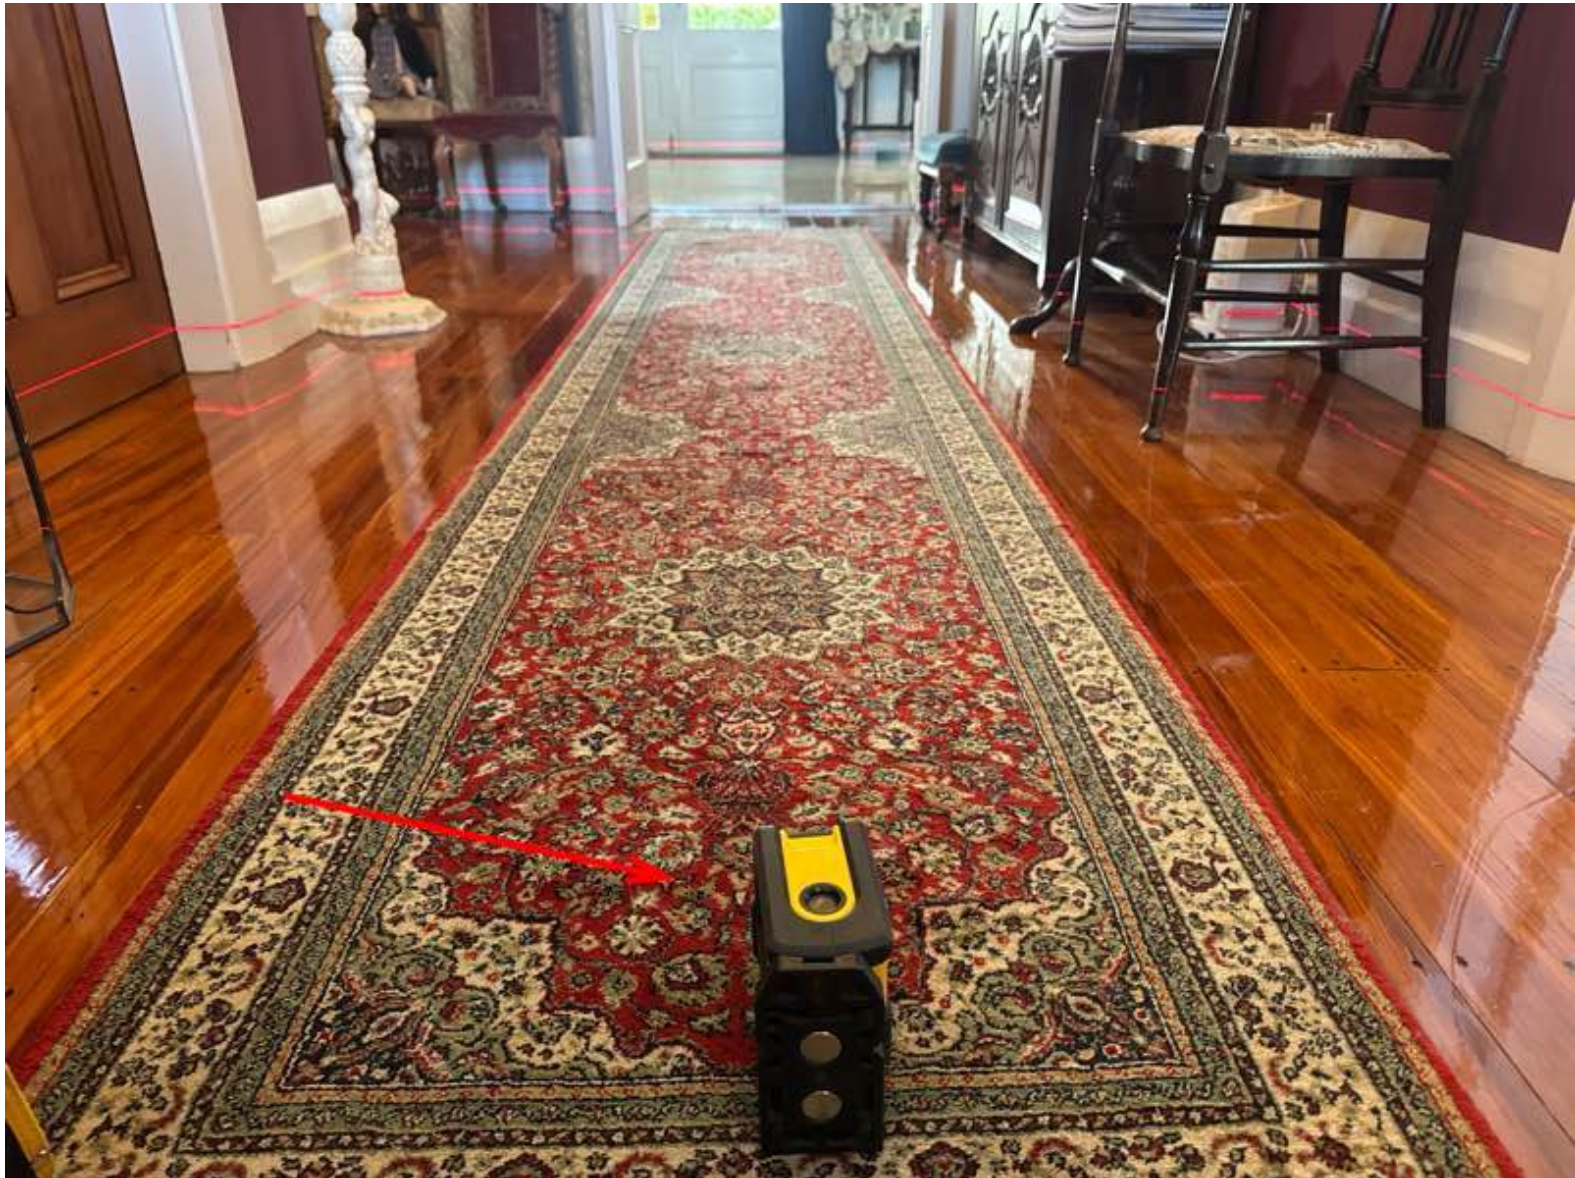
### Foundation

| Comments | <p>Foundation &amp; Floor Levels</p> <p>The dwelling is of an age where underfloor access is not available, which is typical for this style of construction.</p> <p>Floor level measurements were carried out using a DeWalt laser level. My findings identified a maximum variation of approximately 35 mm across the footprint of the dwelling, with no floor slopes exceeding 10 mm over 2 metres. These results are considered very good for a dwelling of this age and are within the MBIE guidance for Christchurch, which allows up to 50 mm variation across the footprint and no floor slopes exceeding 10 mm over 2 metres.</p> <p>The minor variations recorded are considered consistent with historical settlement that commonly occurs in older dwellings. Based on this visual, non-invasive inspection, no visible concerns were identified at time of inspection.</p> <p>Risk: Low</p> |

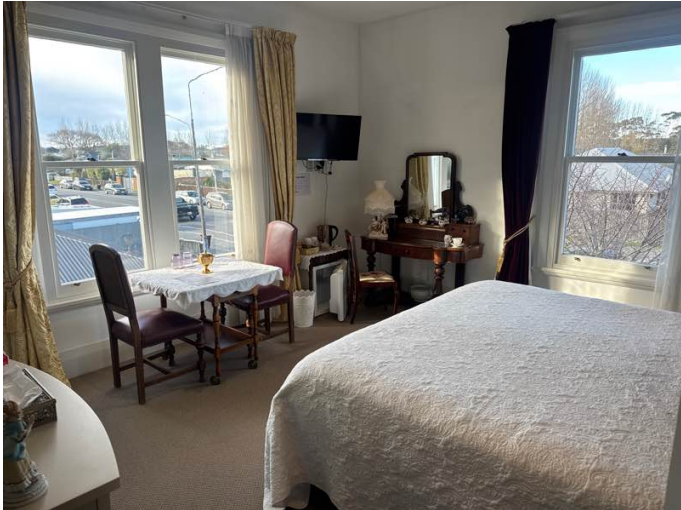
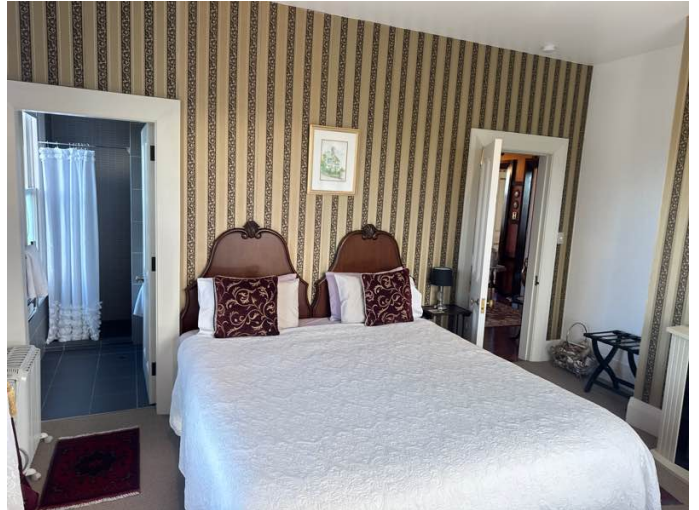
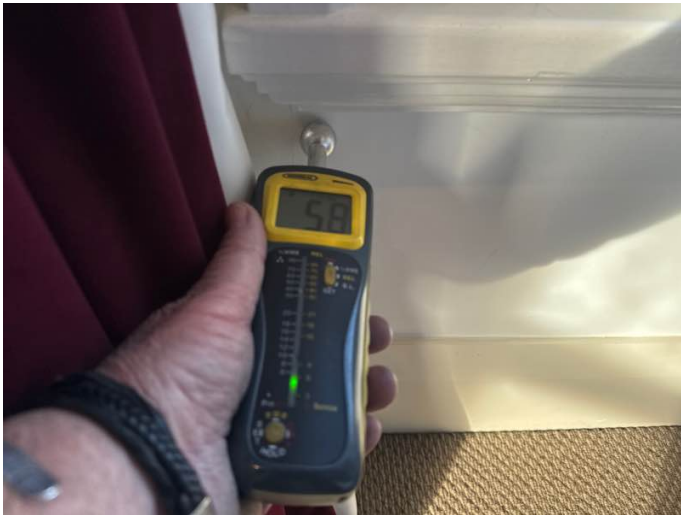
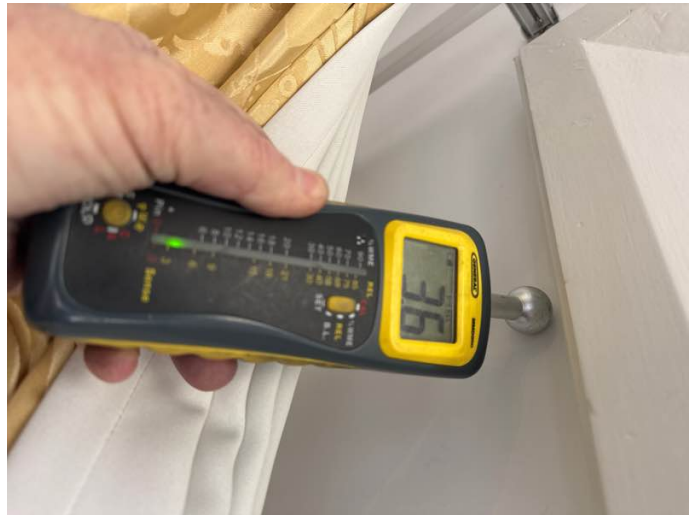
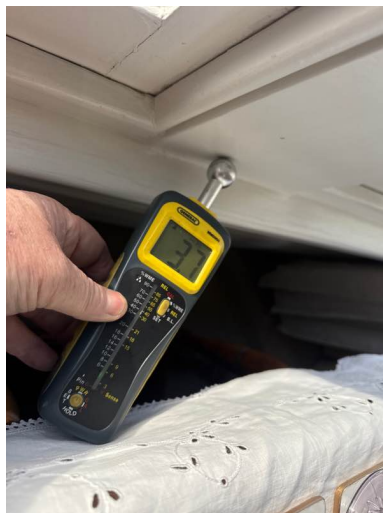
**Master Bedroom**

| Comments | <p>The master bedroom bed 3 was observed to be in very good condition and presented clean, tidy, and well maintained at the time of inspection. Wall, ceiling, and floor surfaces were all in good condition, with no significant defects observed.</p> <p>Moisture testing to accessible exterior wall areas returned readings below 17 (green), indicating dry conditions. No visible water staining, moisture damage, or signs of water intrusion were observed.</p> <p>No significant issues were identified within the master bedroom at the time of inspection.</p> <p>Risk: Low</p> |

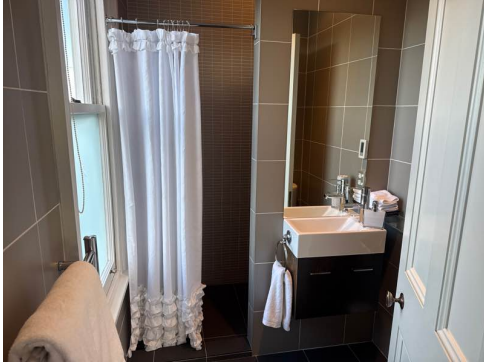
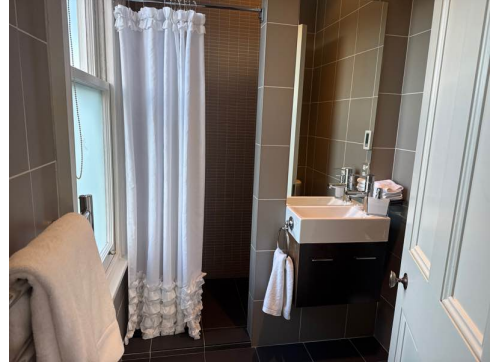
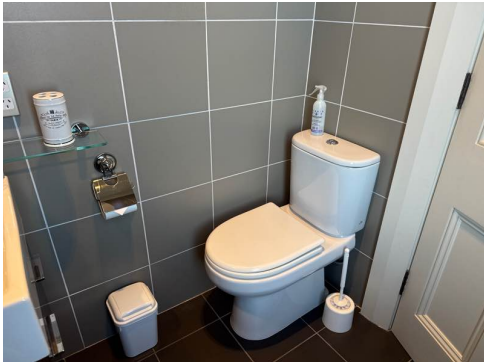
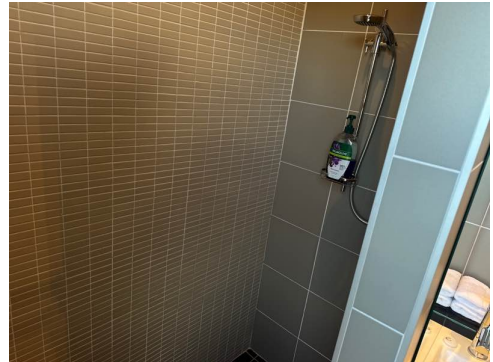
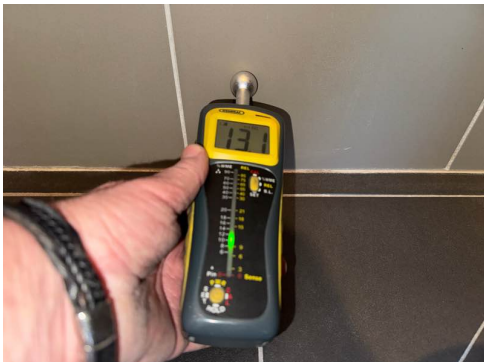
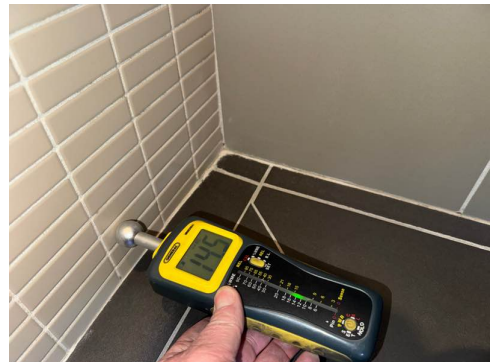
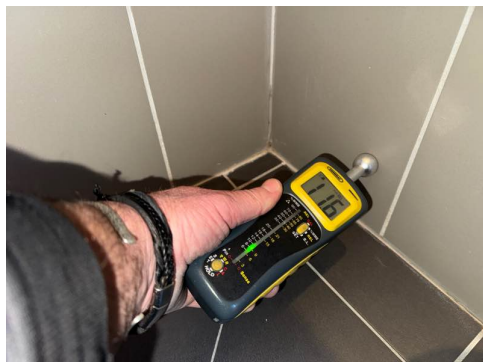
### Ensuite

| Comments | <p>The master bedroom ensuite is finished with fully tiled walls and floors and comprises a tiled shower, vanity, and toilet. The ensuite was observed to be in very good condition and presented clean, tidy, and well maintained at the time of inspection.</p> <p>The vanity, toilet, shower, and tapware were all functioning as intended. Tiles, grout, and visible fixtures were in good condition, with no significant defects observed.</p> <p>No visible leaks were detected beneath the vanity. Moisture testing around the tiled shower and vanity returned readings below 17 (green), indicating dry conditions. No visible water staining, moisture damage, or signs of water intrusion were observed.</p> <p>No significant issues were identified within the ensuite at the time of inspection.</p> <p>Risk: Low</p> |

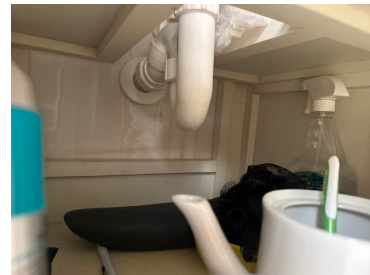
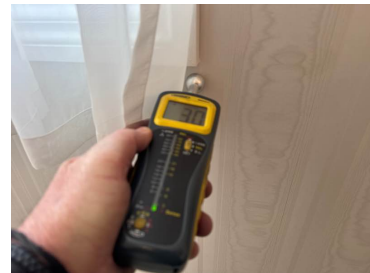
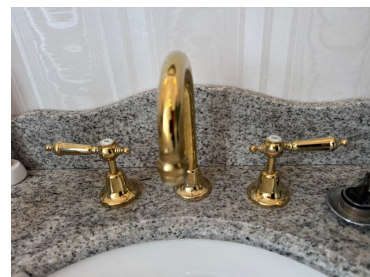
### Master Bathroom

| Comments | <p>Main Bathroom (Downstairs)</p> <p>The main downstairs bathroom is presented in very good, clean, and well-maintained condition. It comprises a bath, toilet, and vanity, with tiled flooring and wallpaper walls and painted ceiling finishes, all of which were observed to be in very good condition.</p> <p>The bathroom features classic-style tapware and a classic vanity, both of which were functioning as intended at the time of inspection. No visible leaks were detected beneath the vanity.</p> <p>Moisture testing around the vanity returned readings below 17 (green), indicating dry conditions. No visible water staining, moisture damage, or signs of water intrusion were observed.</p> <p>No significant defects were identified within the bathroom at the time of inspection.</p> <p>Risk: Low</p> |

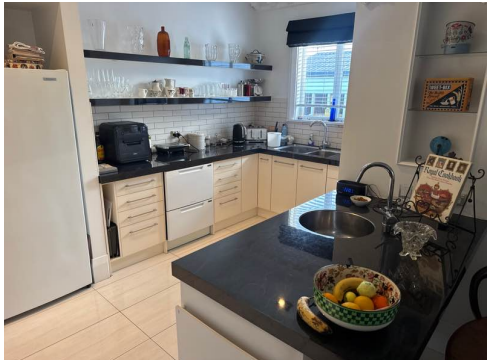
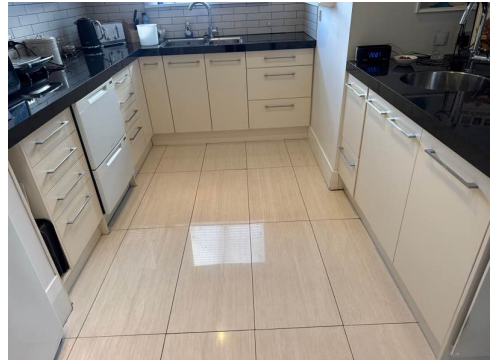
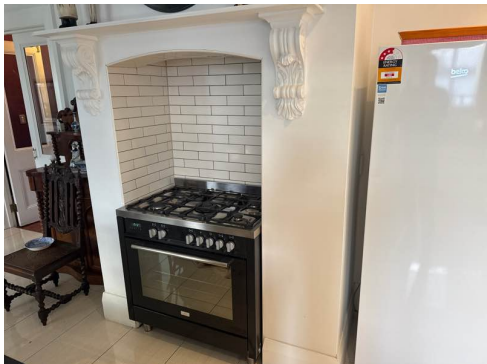
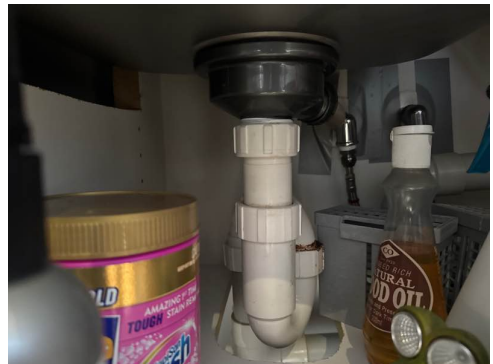
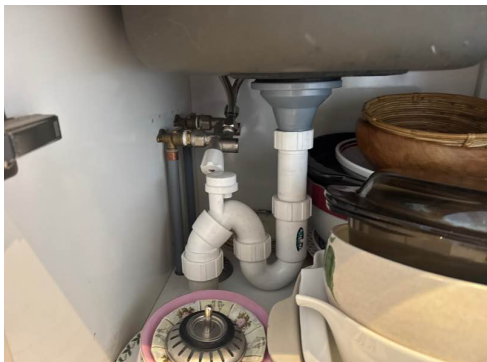
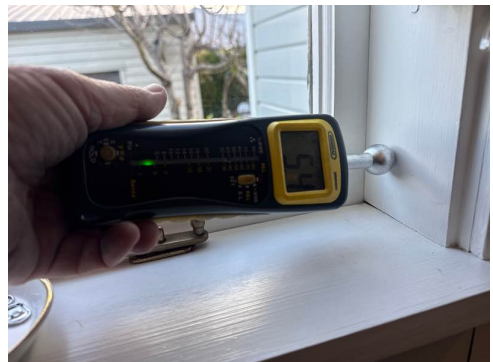
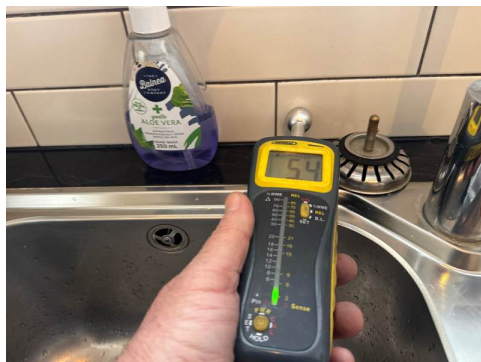
### Kitchen

| Comments | <p>The kitchen was observed to be in good condition and appeared clean, tidy, and well maintained at the time of inspection. Cabinetry, benchtops, sink, and visible fixtures were in good condition, with tapware operating as intended.</p> <p>No visible leaks were detected beneath the sink or within the accessible cabinetry during the inspection. Moisture testing returned readings below 17 (green), indicating dry conditions. No visible water staining, moisture damage, or signs of water intrusion were observed.</p> <p>Kitchen appliances were visually inspected only and were not functionally tested.</p> <p>Risk: Low</p> |

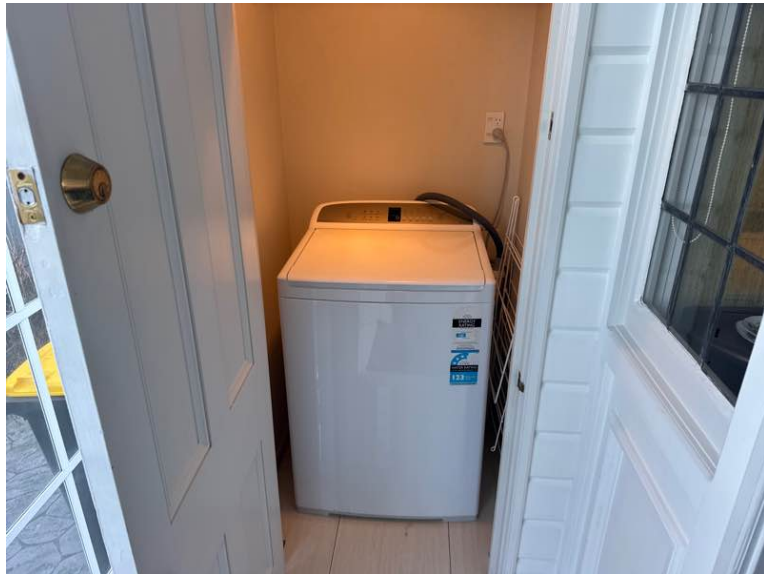
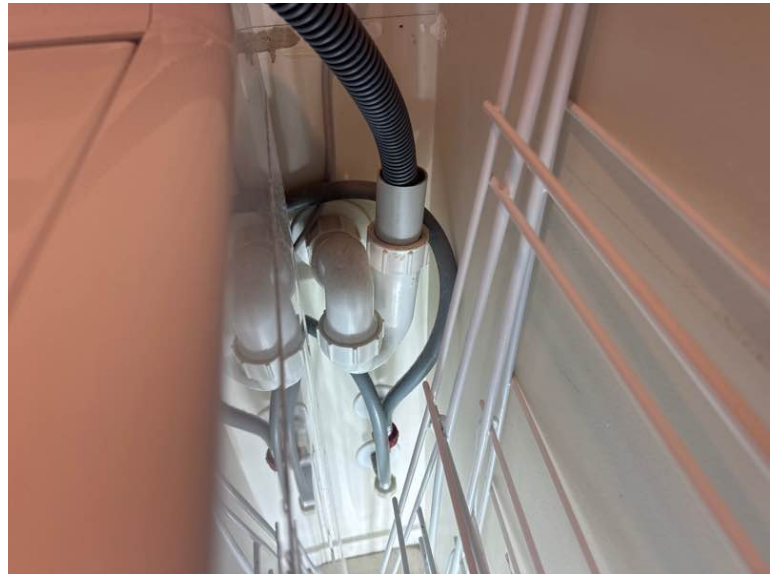
### Laundry

| Comments | <p>A laundry space is provided within a dedicated cupboard, with provision for a washing machine. Waste pipe and plumbing connections were present and appeared to be functioning as intended at the time of inspection.</p> <p>The laundry area is finished with a tiled floor and appeared clean, tidy, and well maintained. All visible surfaces were in good condition, with no visible water damage, moisture issues, or defects observed.</p> <p>Risk: Lo</p> |

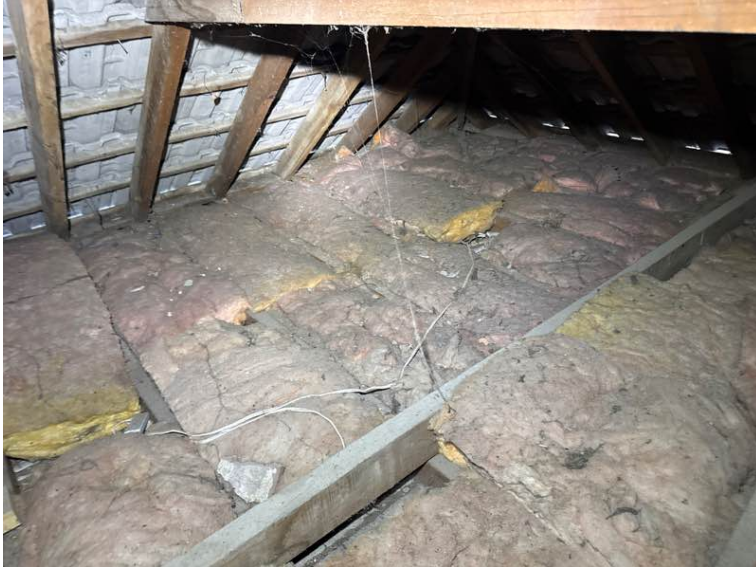
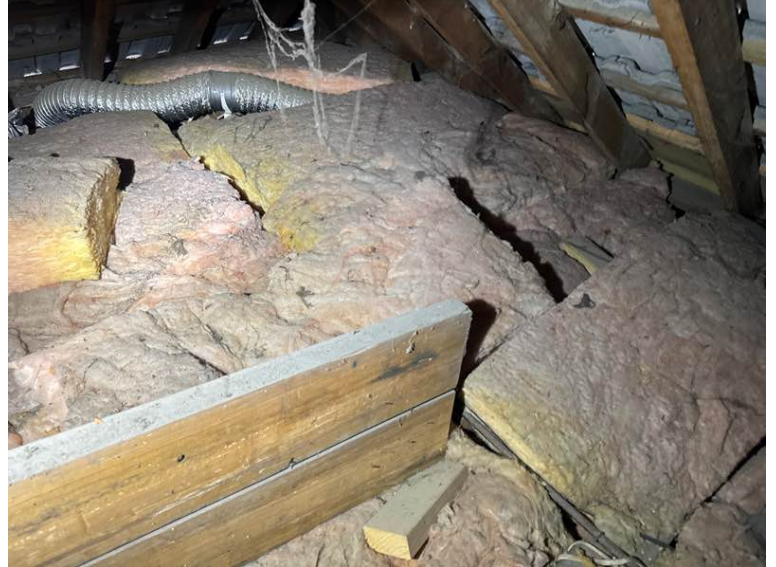
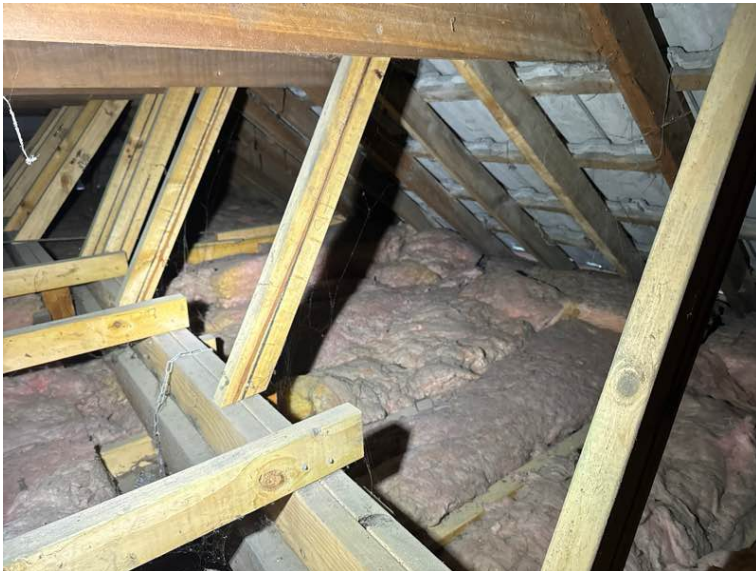
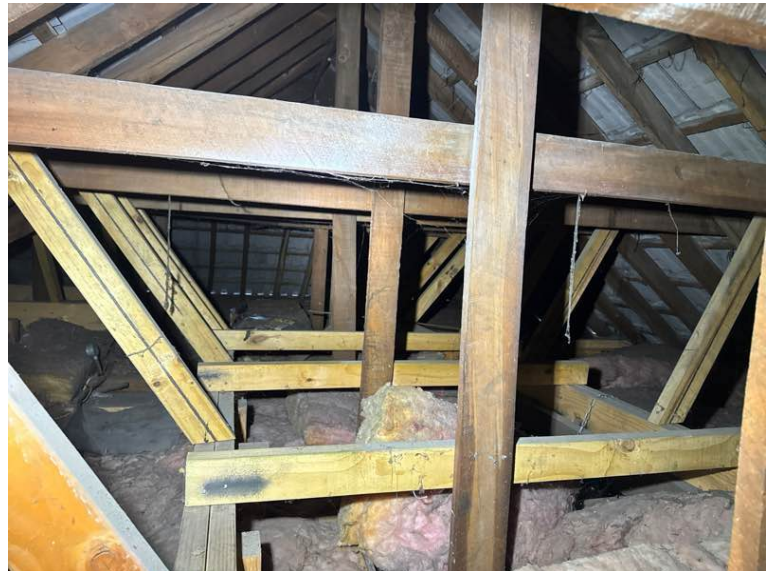
### Insulation

| Comments | <p>Insulation and roof space:</p> <p>Pink Batts insulation was observed within the roof space and appeared to be in good condition, providing good coverage and sufficient thermal protection.</p> <p>Evidence of strengthening work to the roof framing was observed. It was also apparent that the concrete tile roof is not original and that the dwelling has been re-roofed at some stage in the past. The strengthening work appears consistent with the roof replacement and no concerns were identified in relation to these alterations at the time of inspection.</p> <p>Overall, the roof framing and roof space appeared to be in good condition. No visible water staining, moisture ingress, or other significant issues were observed during the inspection.</p> <p>Risk: Low</p> |

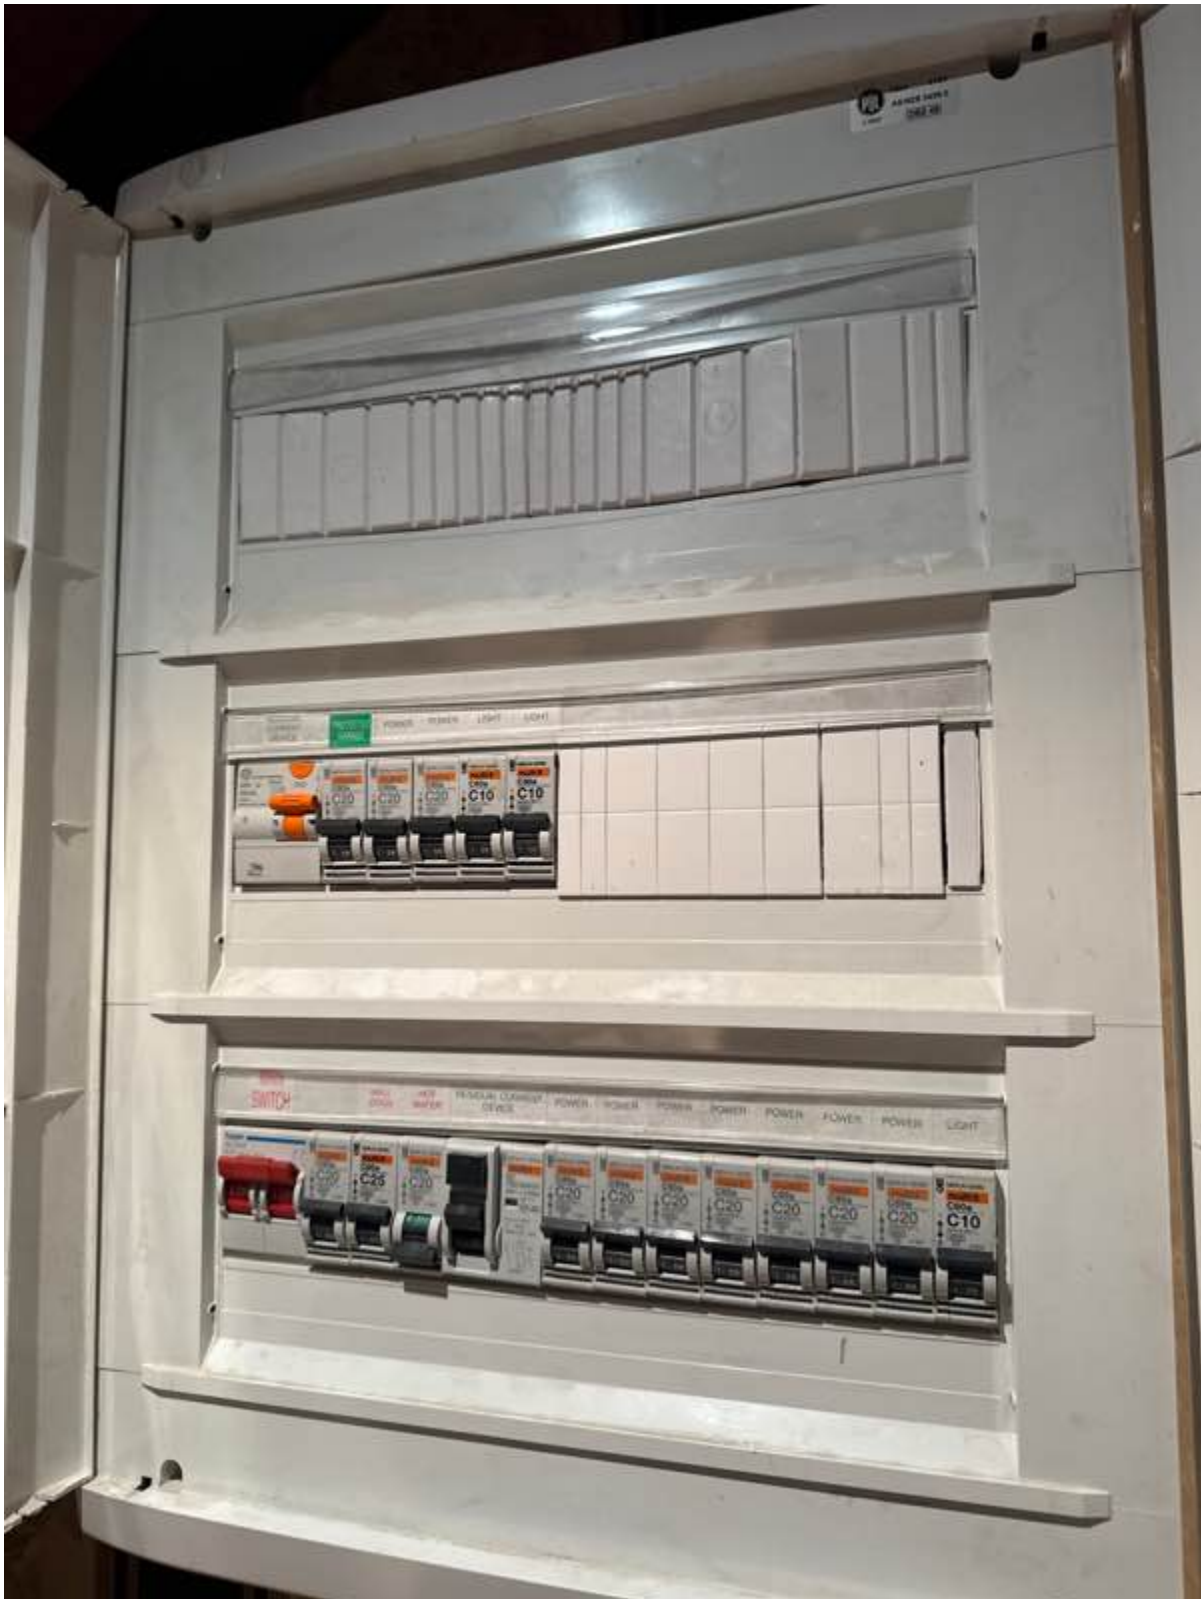
Electrical

| Comments | <p>The switchboard is not original, indicating that the electrical system has been updated since the dwelling was constructed. At the time of inspection, the switchboard appeared to be in good condition, with no visible defects observed.</p> <p>A visual inspection of accessible switches, power outlets, and light fittings identified no significant issues unless otherwise noted elsewhere in this report. A comprehensive electrical inspection is outside the scope of this visual building inspection. If complete assurance is required regarding the condition and performance of the electrical installation, assessment by a registered electrician is recommended.</p> <p>Risk: Low</p> |

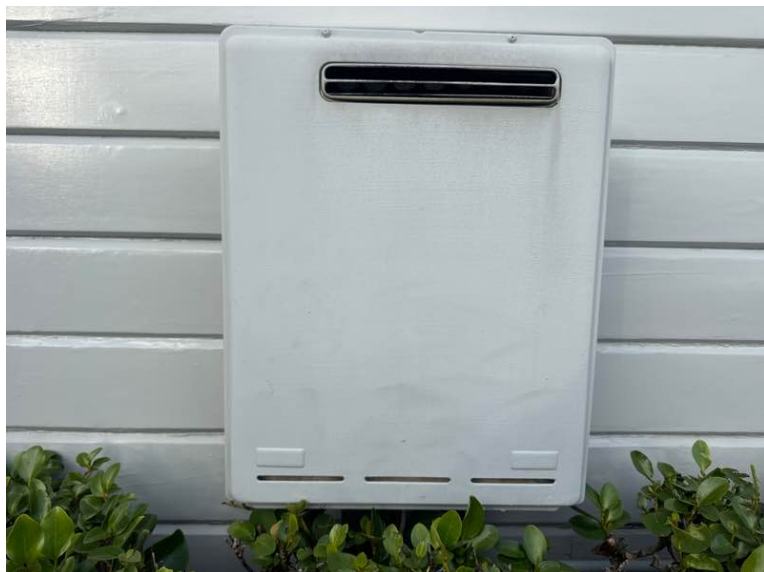
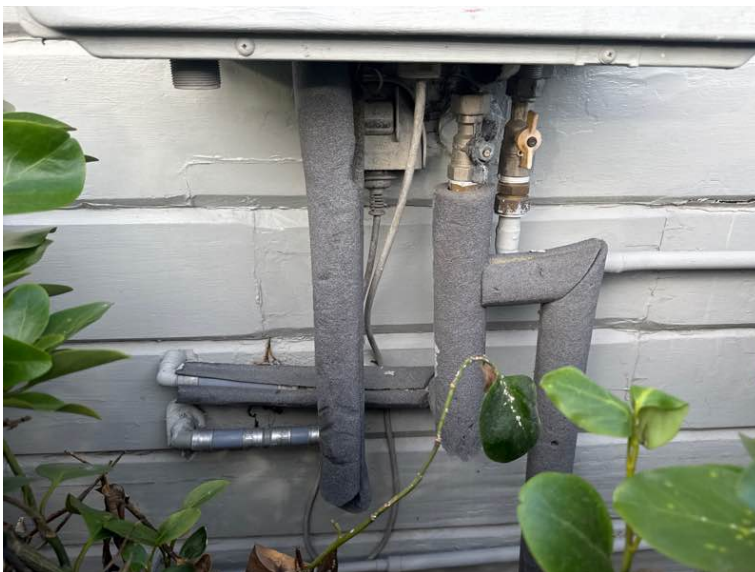
### Hot Water

| Comments | <p>A gas hot water system is installed with the Califont unit attached to the exterior of the house. The unit appeared stable and in generally good condition at the time of inspection, with no visible signs of deterioration, damage, or leaks observed. All adjoining pipework appeared secure and in good condition, with no visible signs of leakage at the time of inspection.</p> <p>This assessment is based on a visual inspection only. A more thorough inspection of the hot water system and associated plumbing is outside the scope of this inspection. A qualified plumber or registered gasfitter should carry out routine servicing and maintenance in accordance with the manufacturer's recommendations.</p> <p>Risk: Low</p> |
