**Information request – 427 Armagh Street, Linwood, Christchurch 8011**

## TR001: Technical Report – Desktop Technical Review & Structural Inspection

## **Canterbury Claims – Assessment Report**

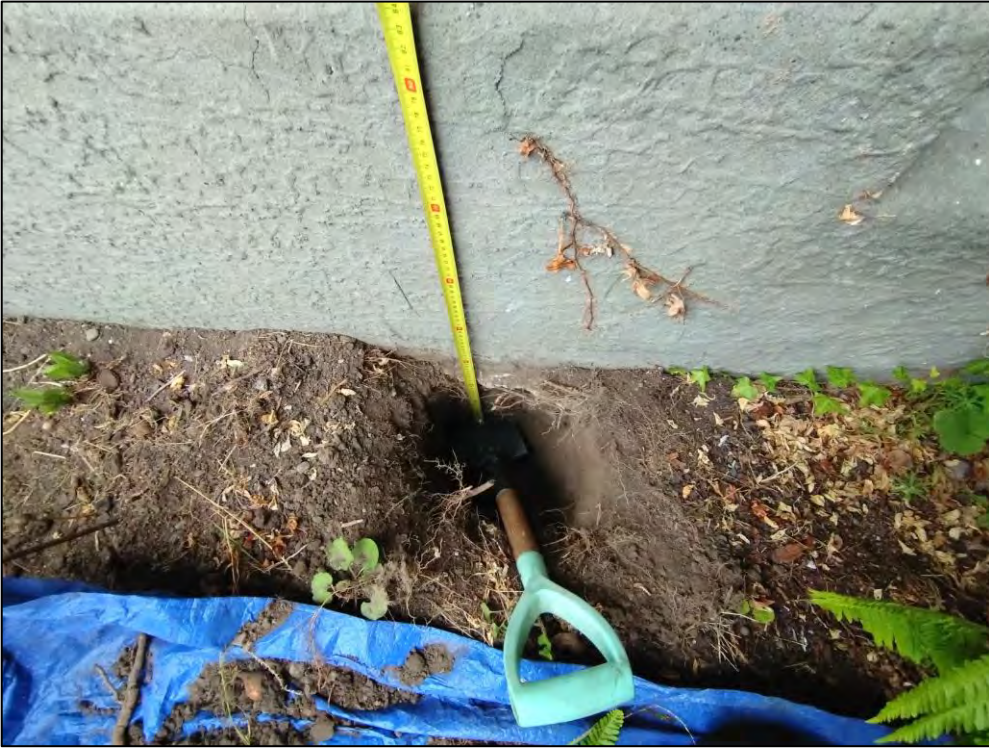
Photo 3A – 350mm Perimeter Foundation embedment depth along the west elevation.

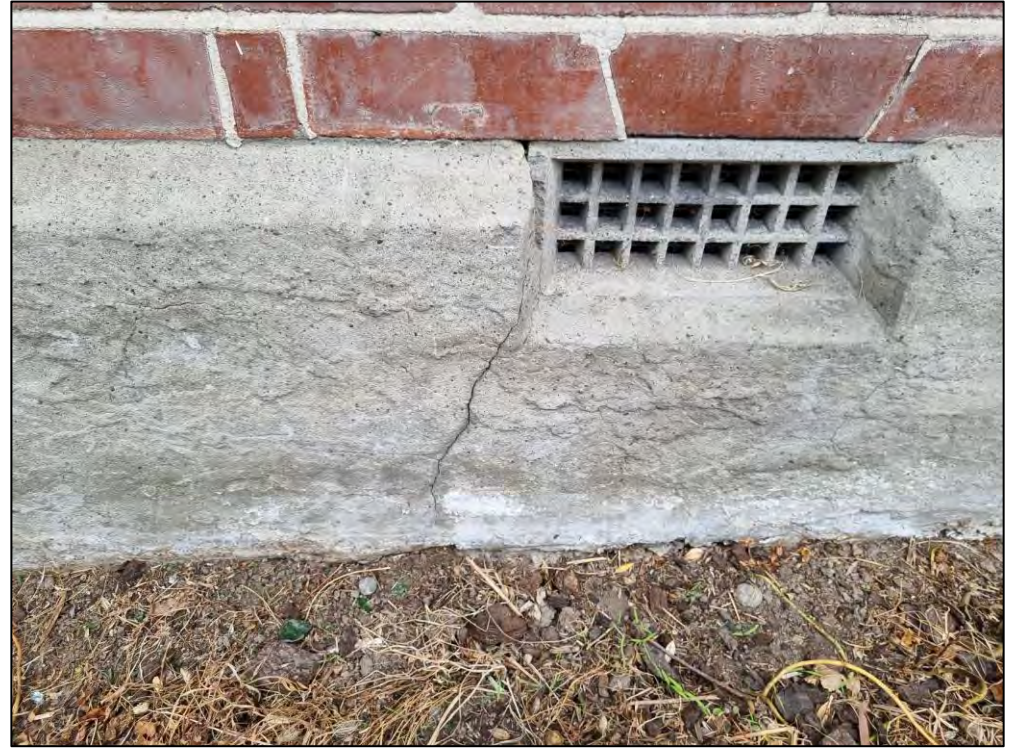
Photo 3B – Foundation crack at vent along the east elevation.

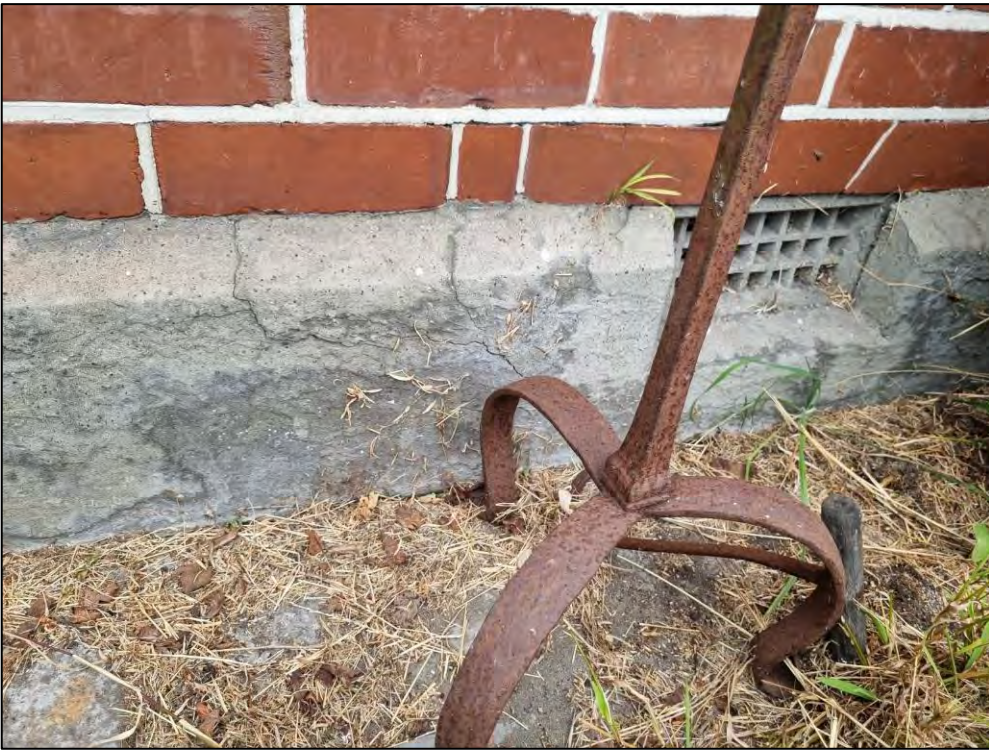
Photo 3C – Plaster and foundation cracks along the north elevation

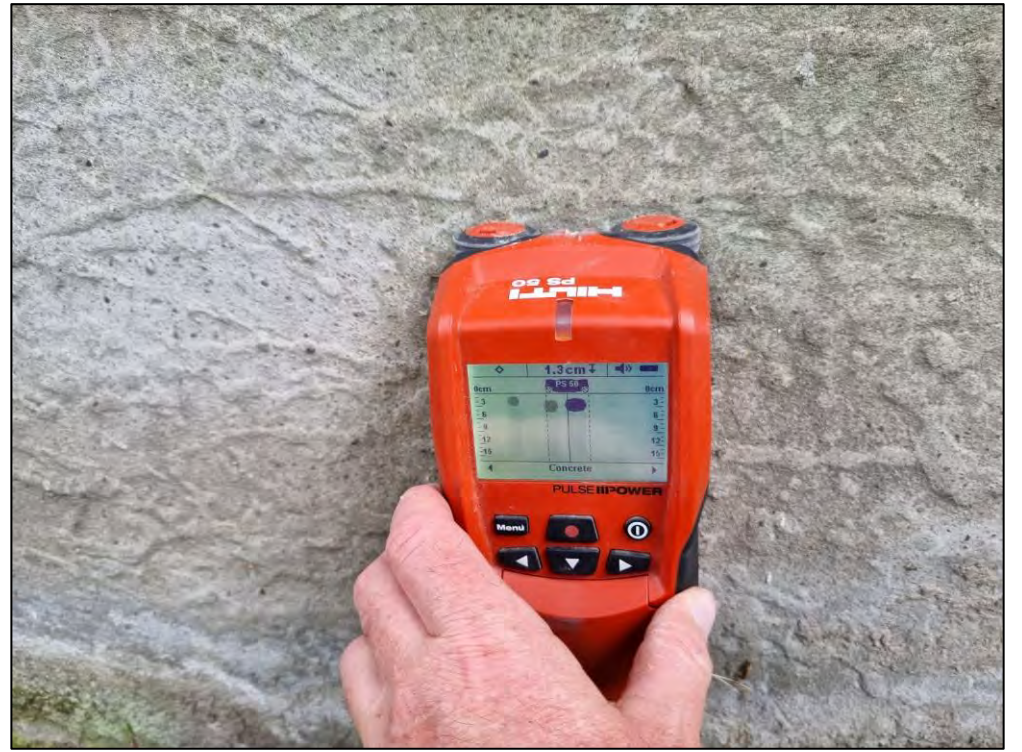
Photo 3D – No reinforcing was detected in the perimeter foundation wall.

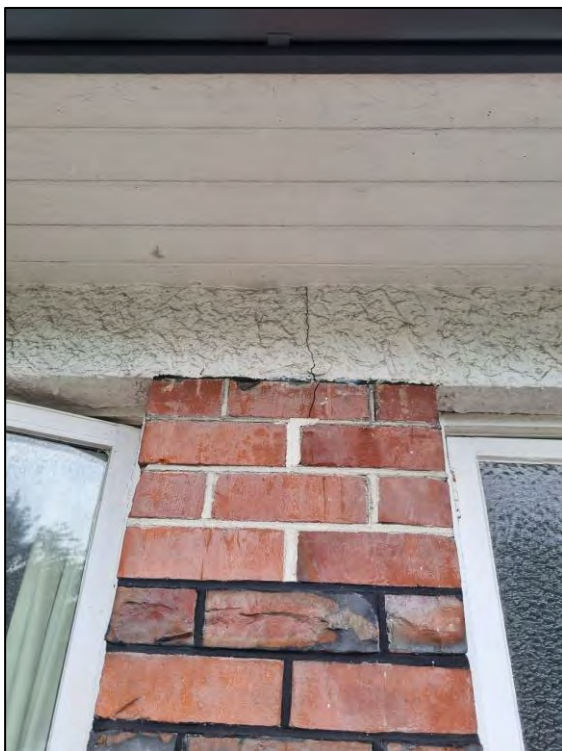
Photo 3E – Separation of the concrete beam above the cladding panel and cracking through the top brick. New mortar suggest recent cladding settlement cracks repairs along the east elevation.

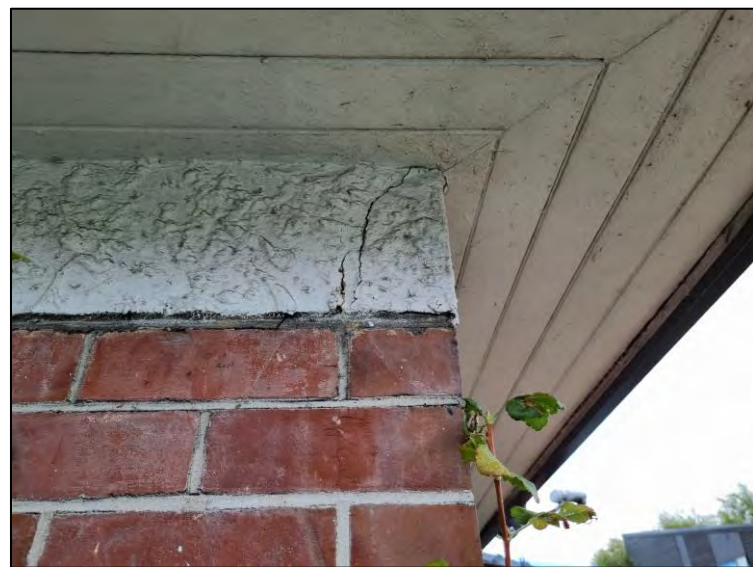
Photo 3F – Separation at the corner joints of the precast concrete beam above the veneer panels at the exterior north east corner of the kitchen.

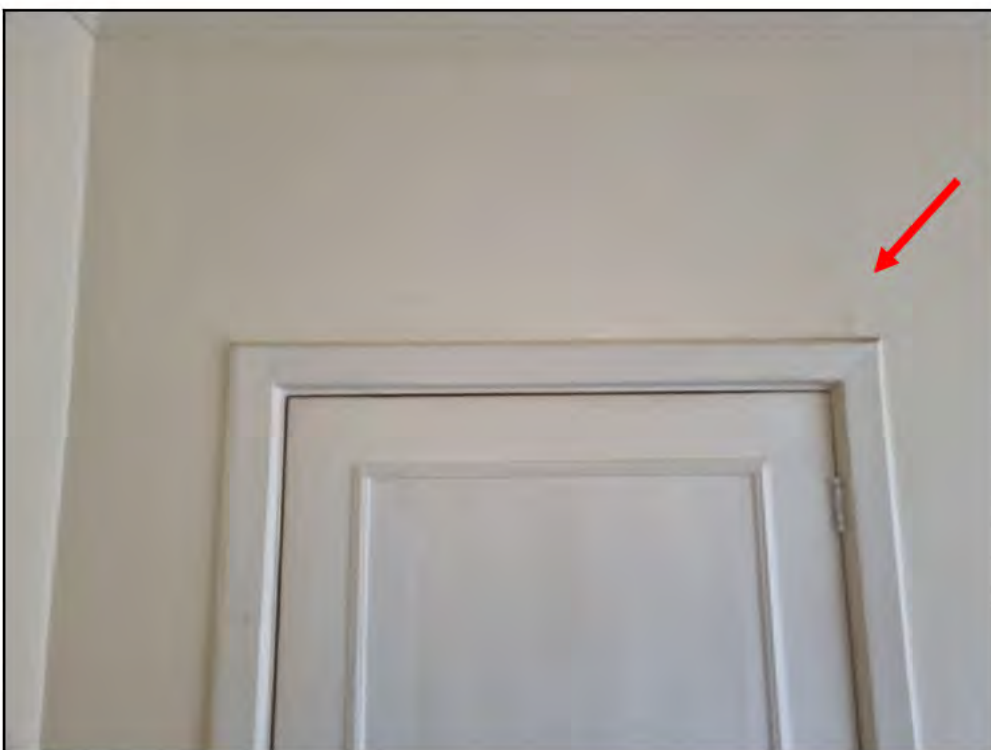
Photo 4E –Minor wall lining damage above the lounge door indication of foundation settlement and racking of the internal wall framing.

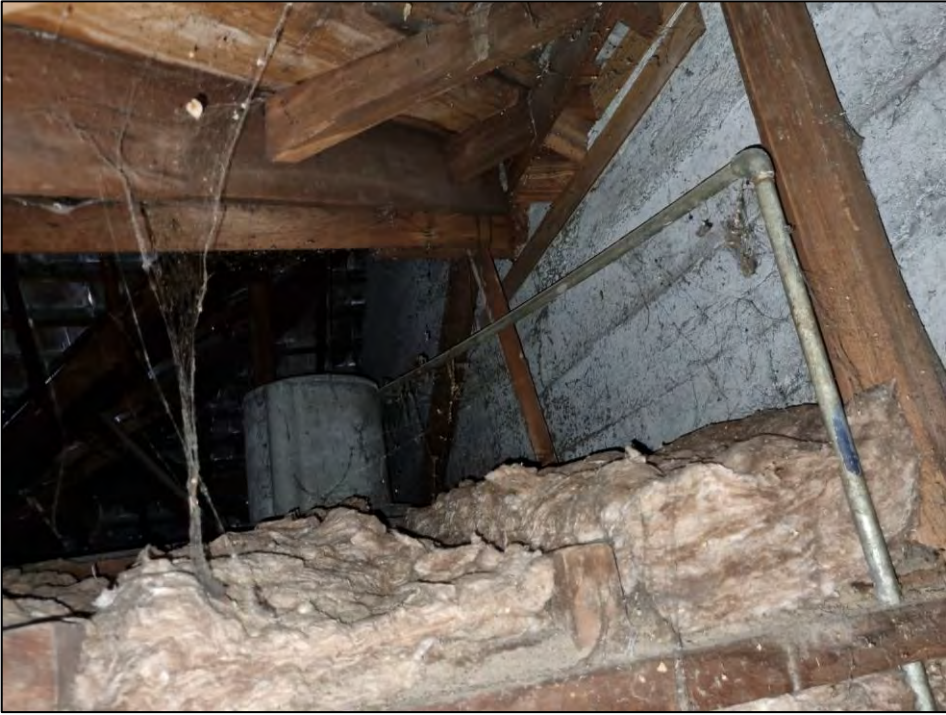
Photo 6A – Unrestrained Concrete water tank in the roof space .

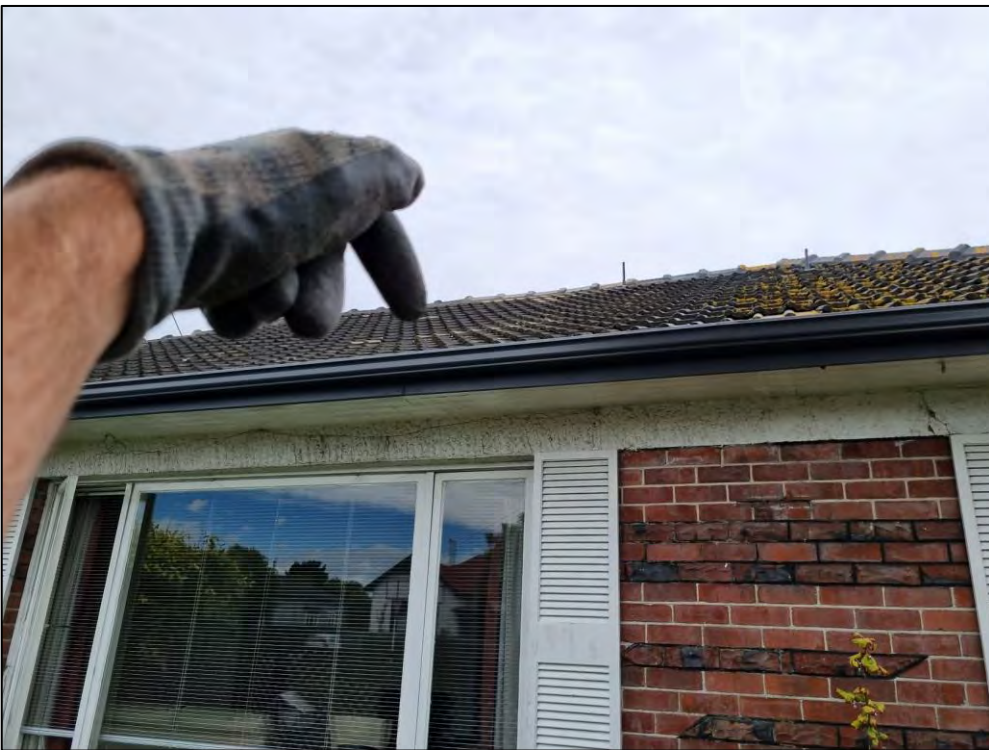
Photo 6C – Roof plane sagging towards the middle due to inadequate roof framing underpurlin support .

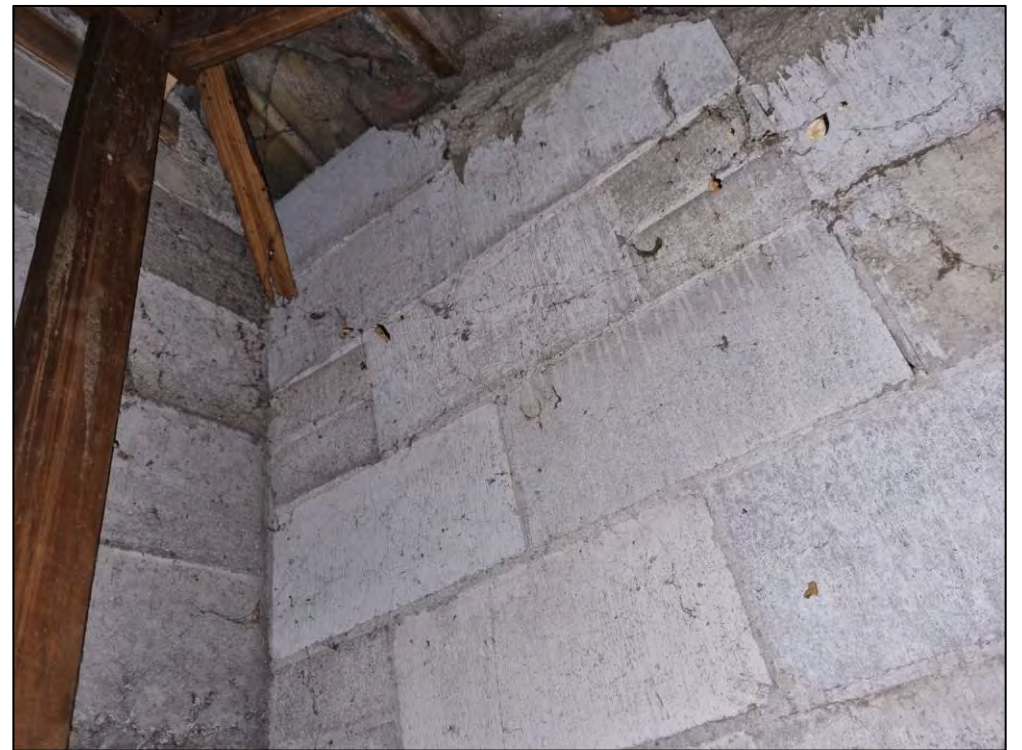
Photo 6D – Newer masonry block wall ( Partition wall extension) above the Laundry extending to the roof tiles constructed circa 1987.

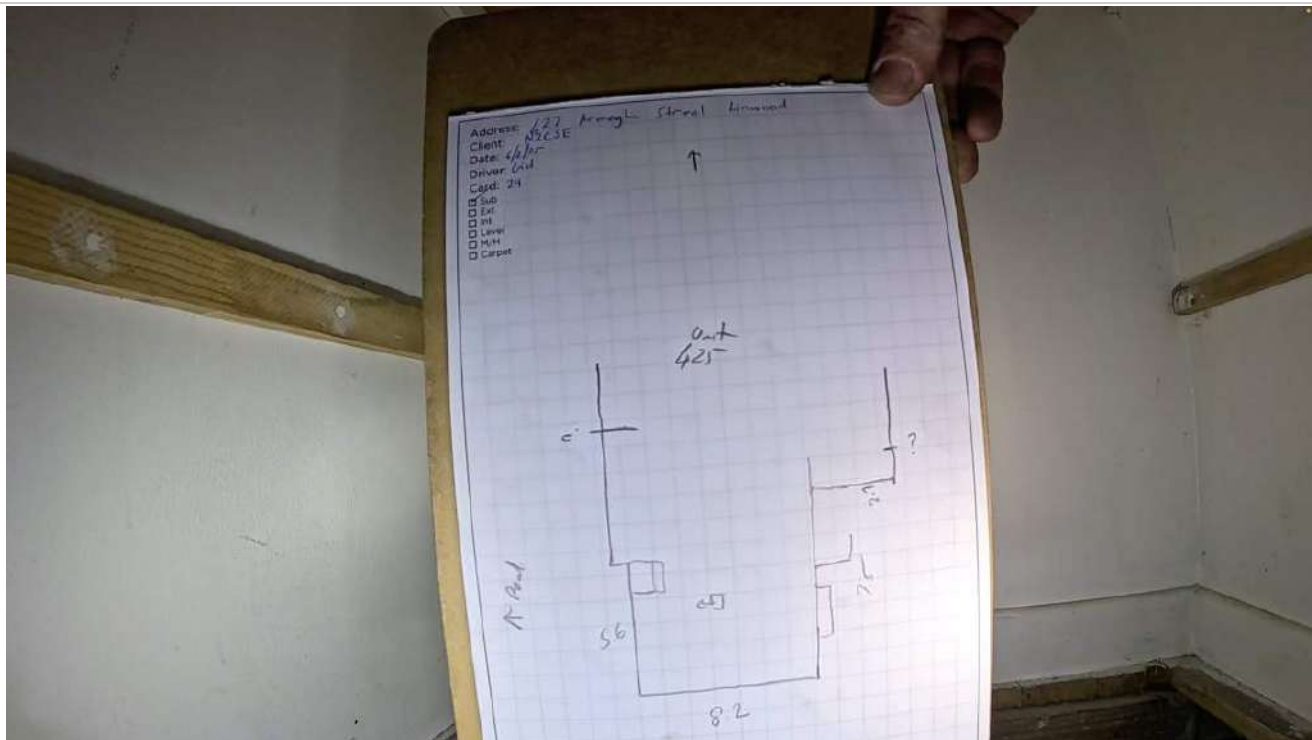
2: The foundations are average quality type "B" foundations. There is a lack of fine sand and cement along with spider webs in some areas, making it hard to discern finer cracks, if they exist. There is also a high level of borer in some of the subfloor timber, as seen here.

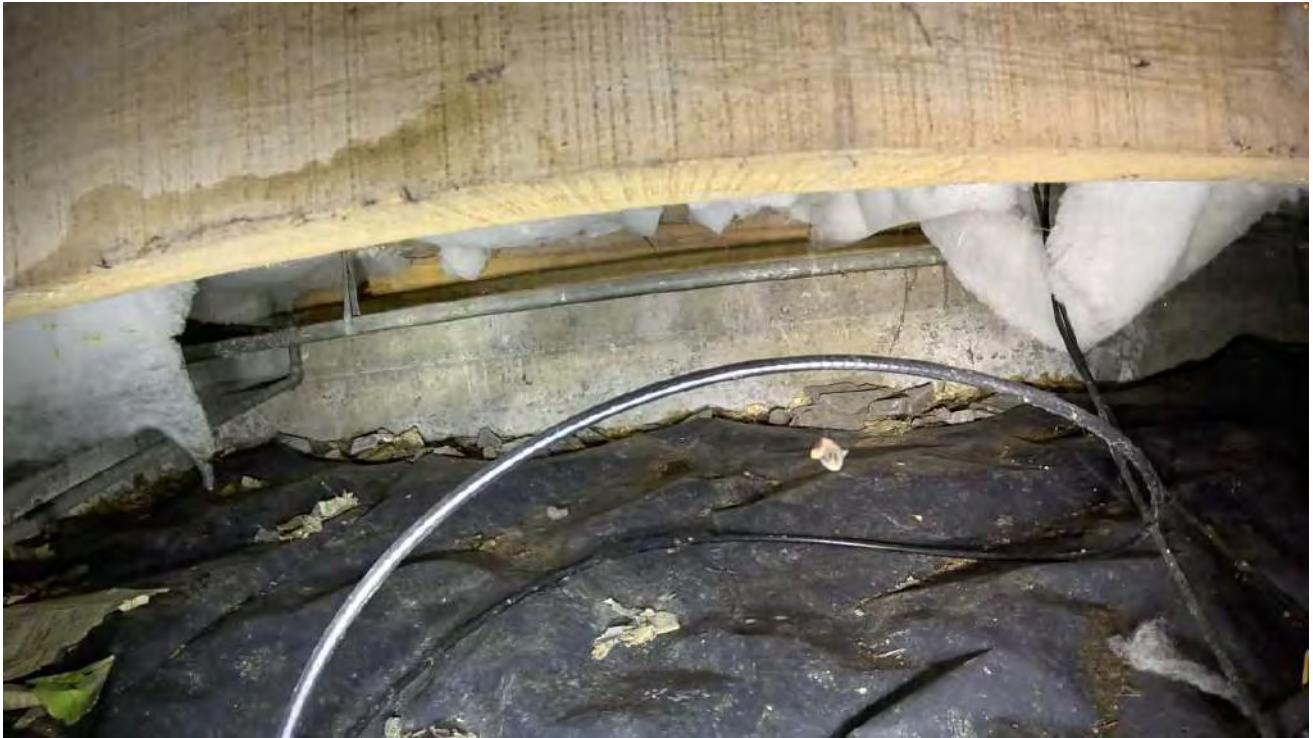
6: The home has precast concrete piles. These maybe concreted into the ground but the polythene obscures this. They are not connected to the bearers. None appear damaged or to have moved from their original positions although this does not preclude changes in height.

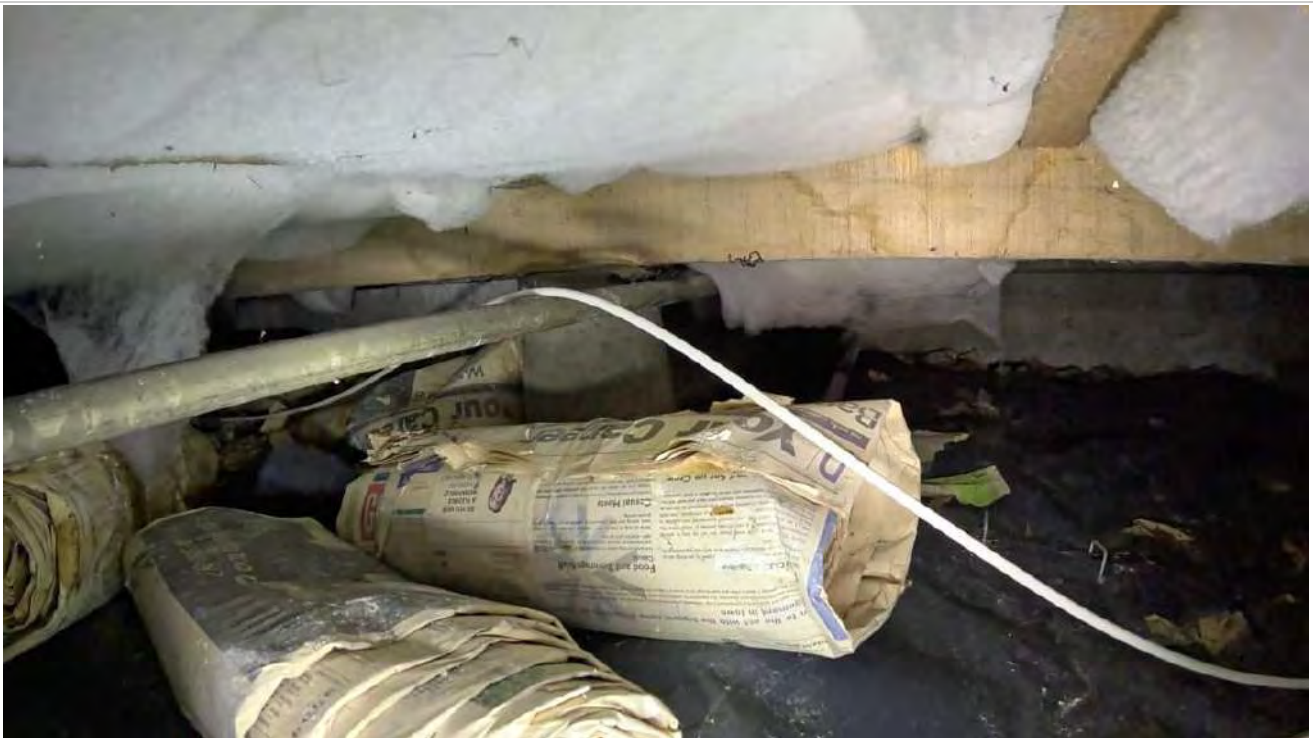
7: Precast concrete pile with no connection.

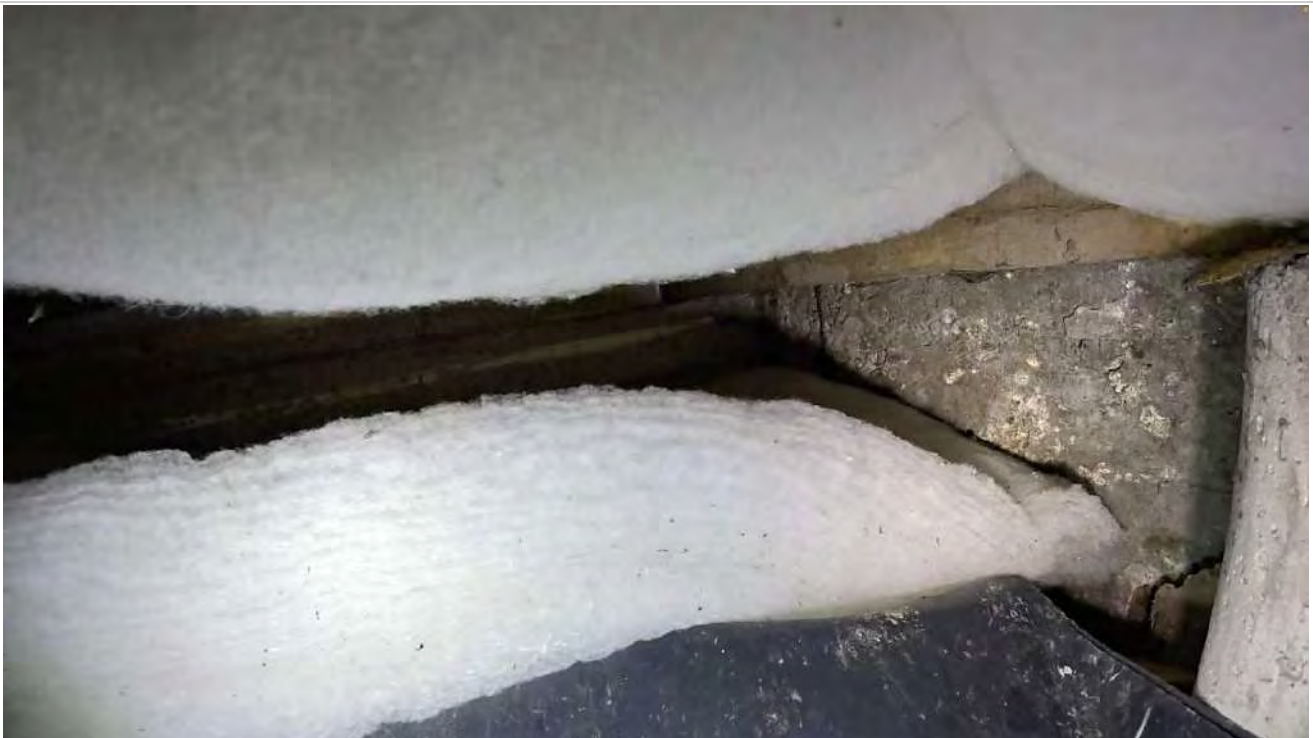
13: Precast concrete pile with no connection. It is important to note that rodents have been using the insulation for nesting. The yellow marks represent their urine, and they have also caused many of the batts to fall down.

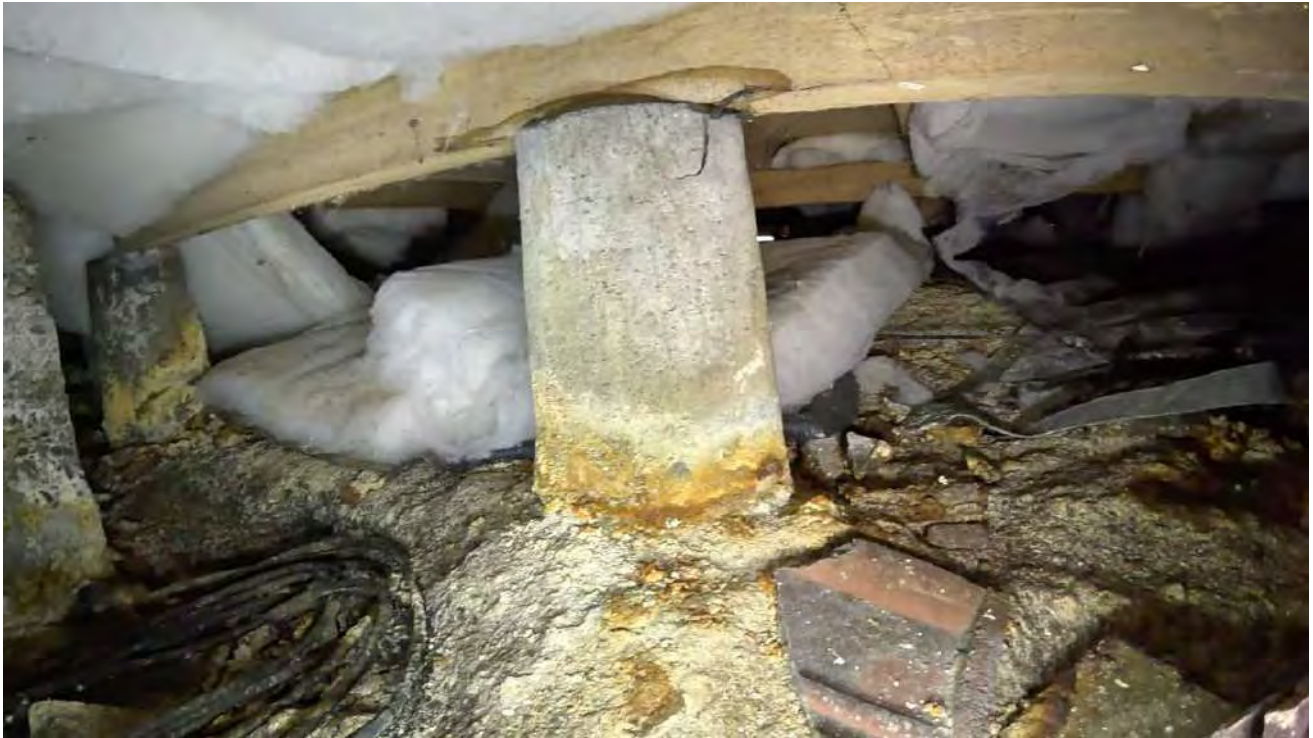
32: There are some non-compliant issues with the wiring seen in this home. They could also be a significant hazard to anybody operating under the floor. This relates specifically to unclipped wires. An electrical inspector could be consulted regarding this. The communication cables have also not been laid in a compliant manner and would easily be damaged by people accessing the subfloor.

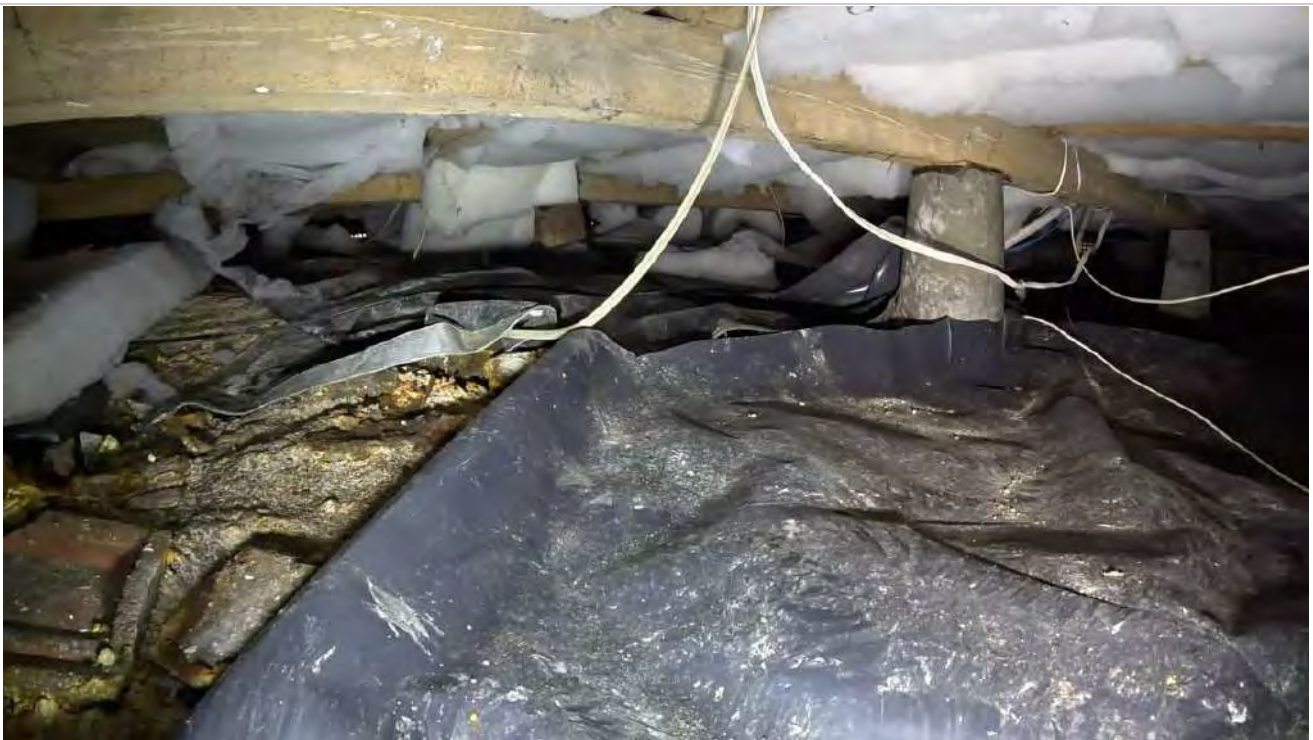
33: Precast concrete pile with no connection. Here we see a heat pump drain. It is discharging to ground but should be vented to the outside.

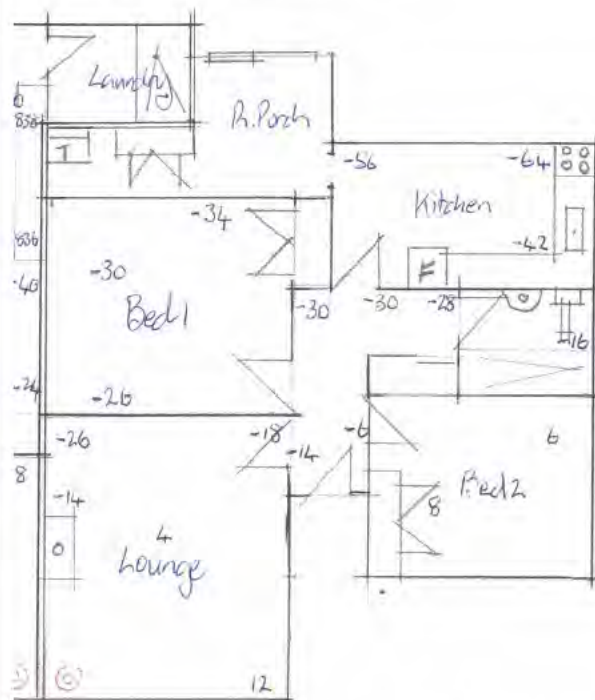
The plan records global dislevelment of 76mm with the high point on the floor locating in the SE corner of the lounge and low point in the NE corner of the Kitchen.

This dislevelment exceeds MBIE guidance tolerance recommendations for releveling (50mm).

- The SS is to advise the customer of the findings of this report and provide any necessary assistance for the engagement of a suitably qualified Engineer to review the foundation damage.

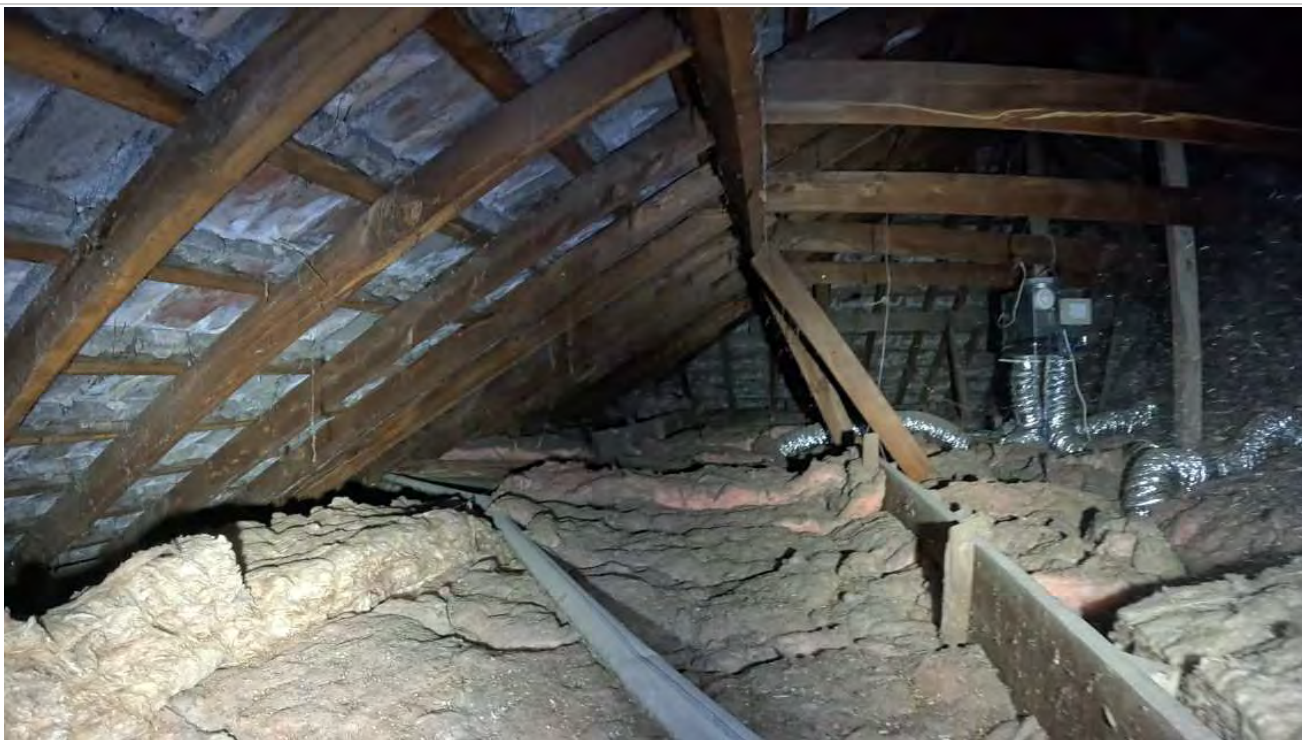
11: View of valley board with a water leak causing rot.

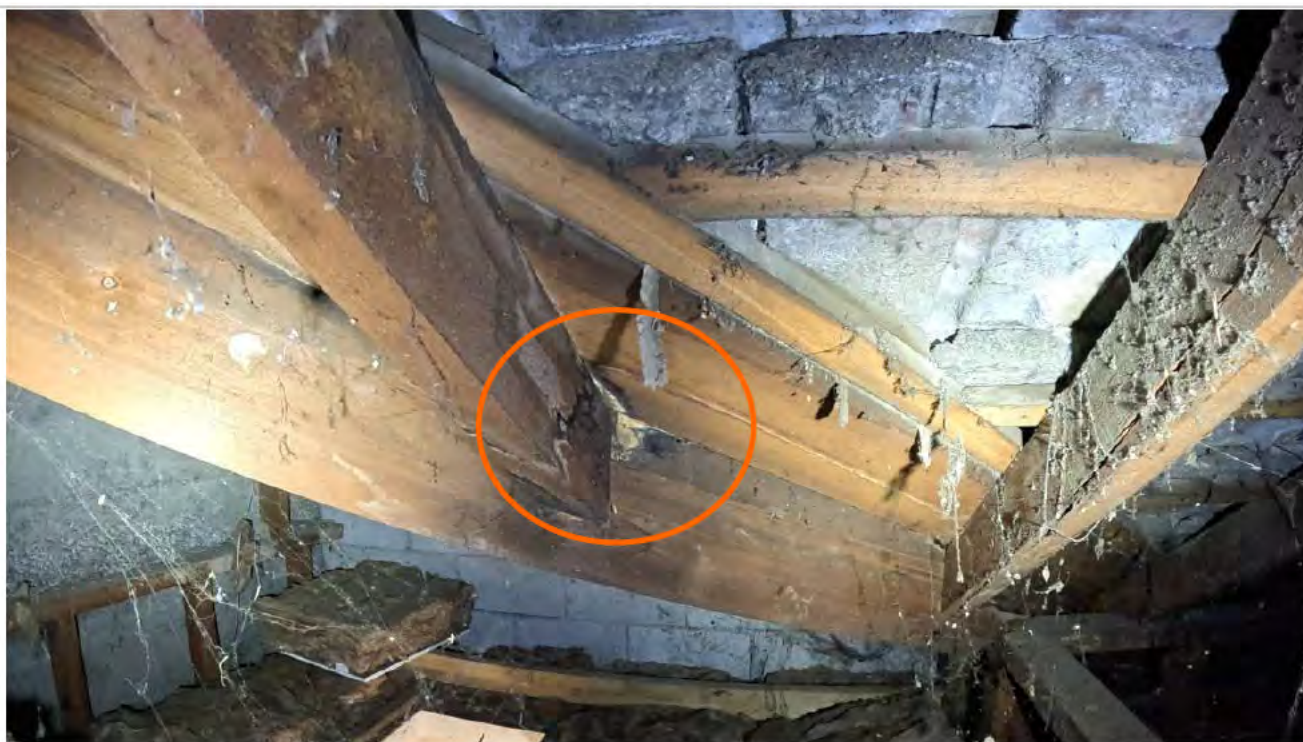
12: The support structure we see in this roof is fairly typical of a roof of this period but does leave some areas vulnerable to sagging.

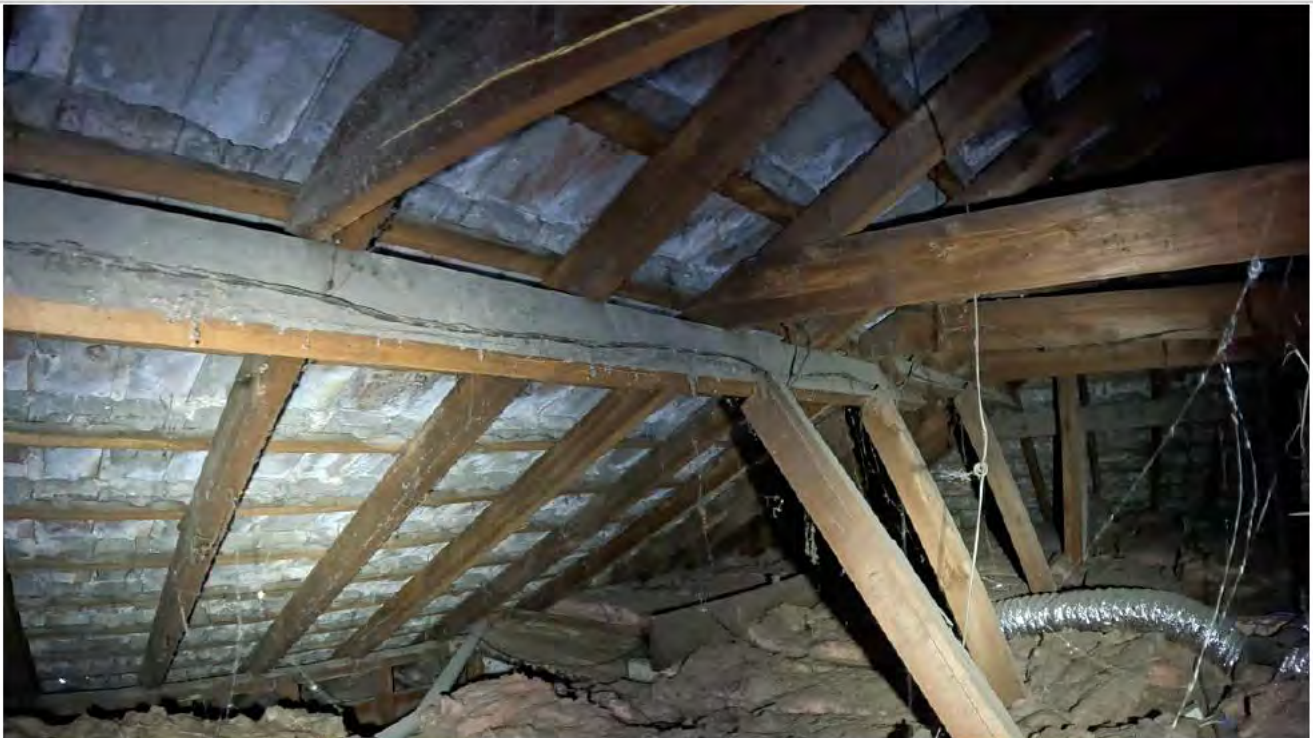
19: We do see some dislodged and broken tiles, as we see here.

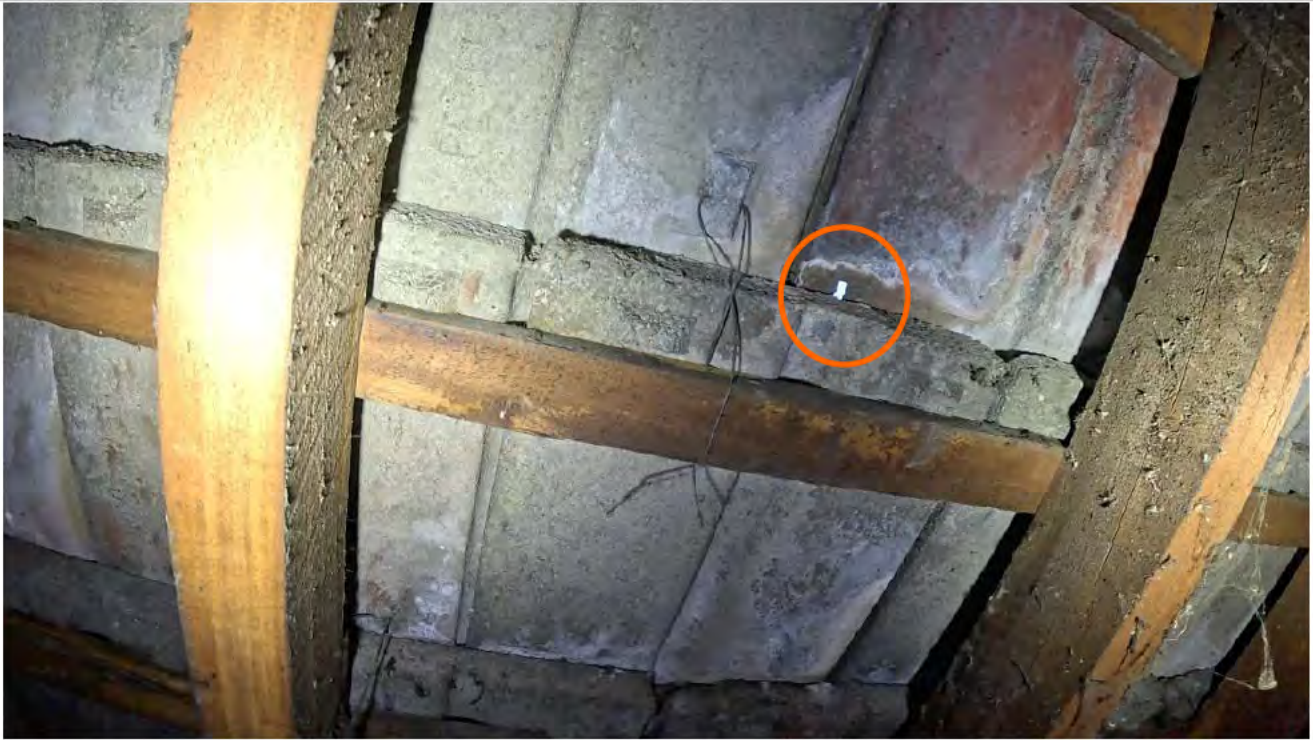
20: There are two broken tiles here.

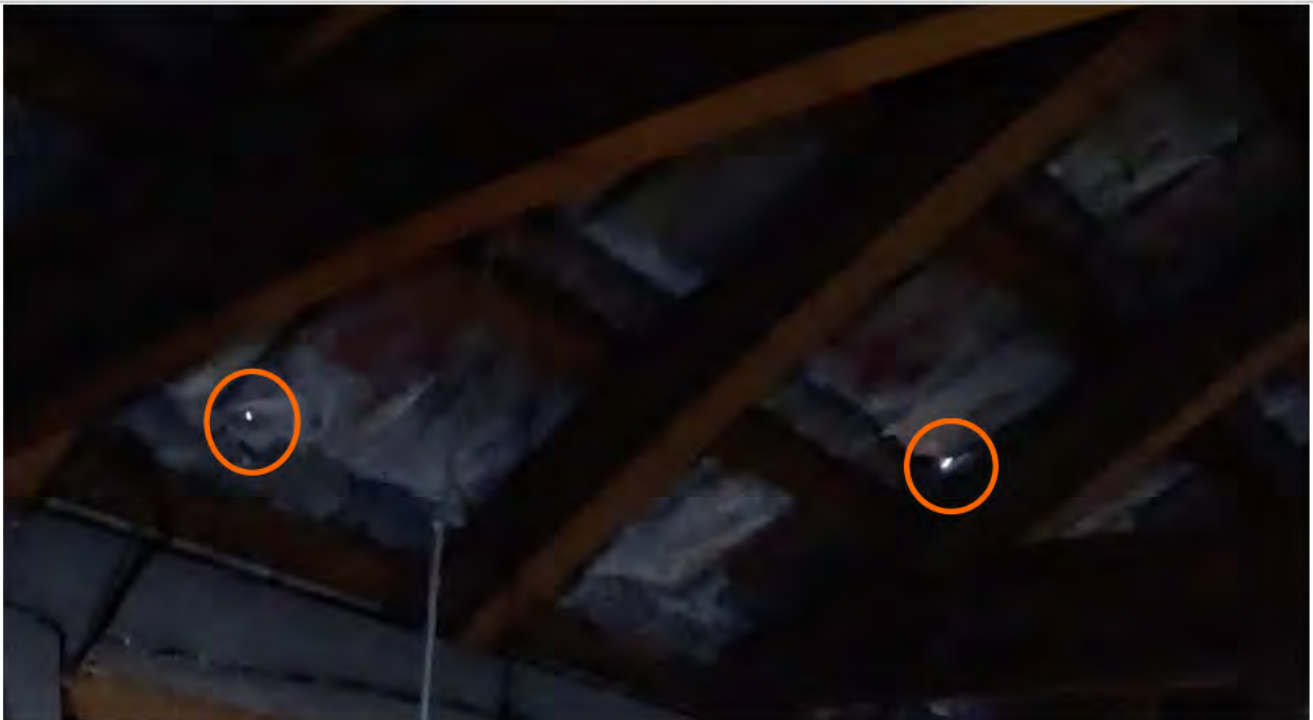
21: Generally, every second or third tile is wired off to a batten or rafter although there appears to be a few missing here.

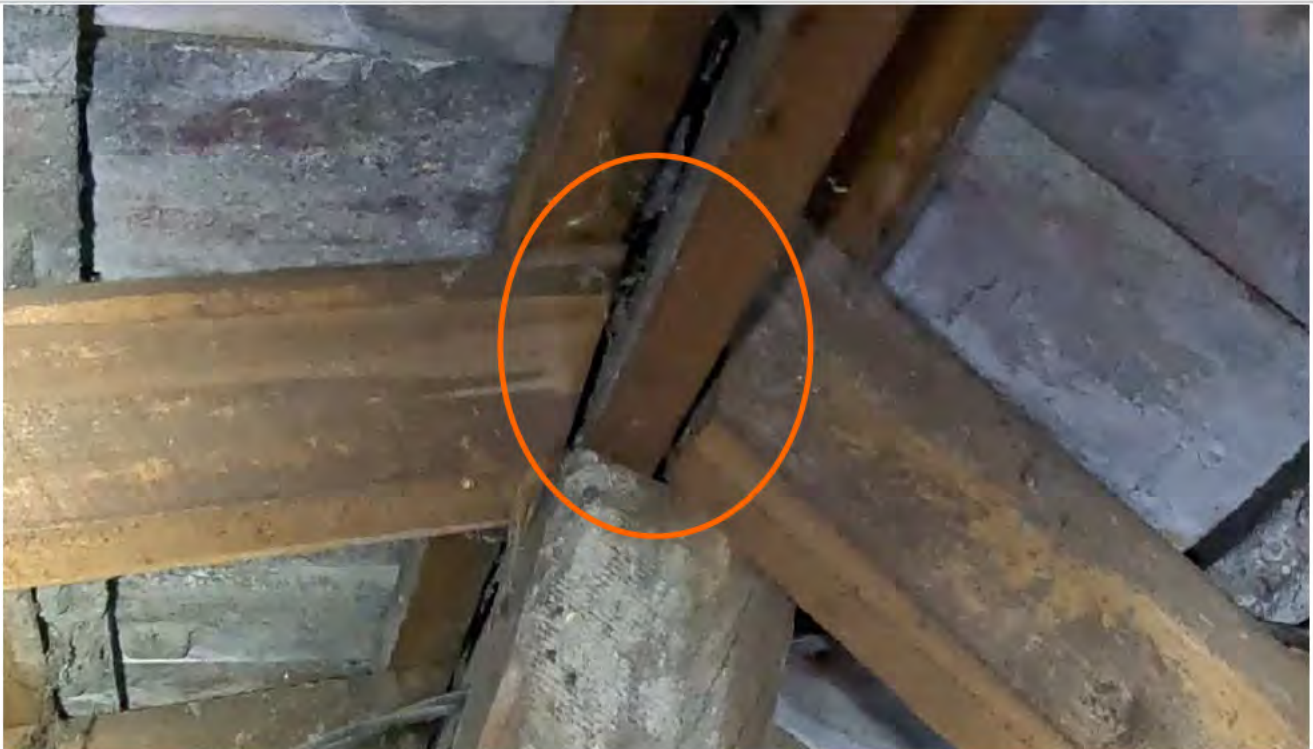
23: Here we see a broken tile and another that has dropped down.

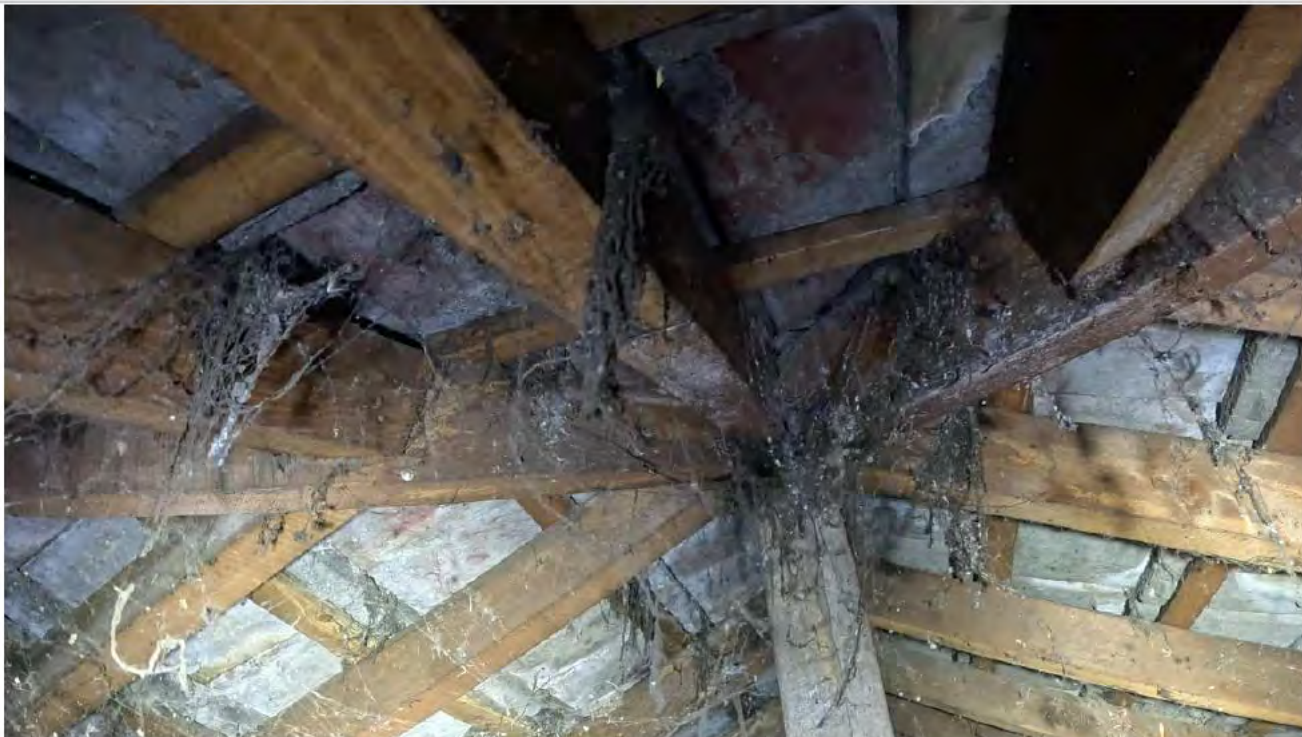
28: There is a broken tile.

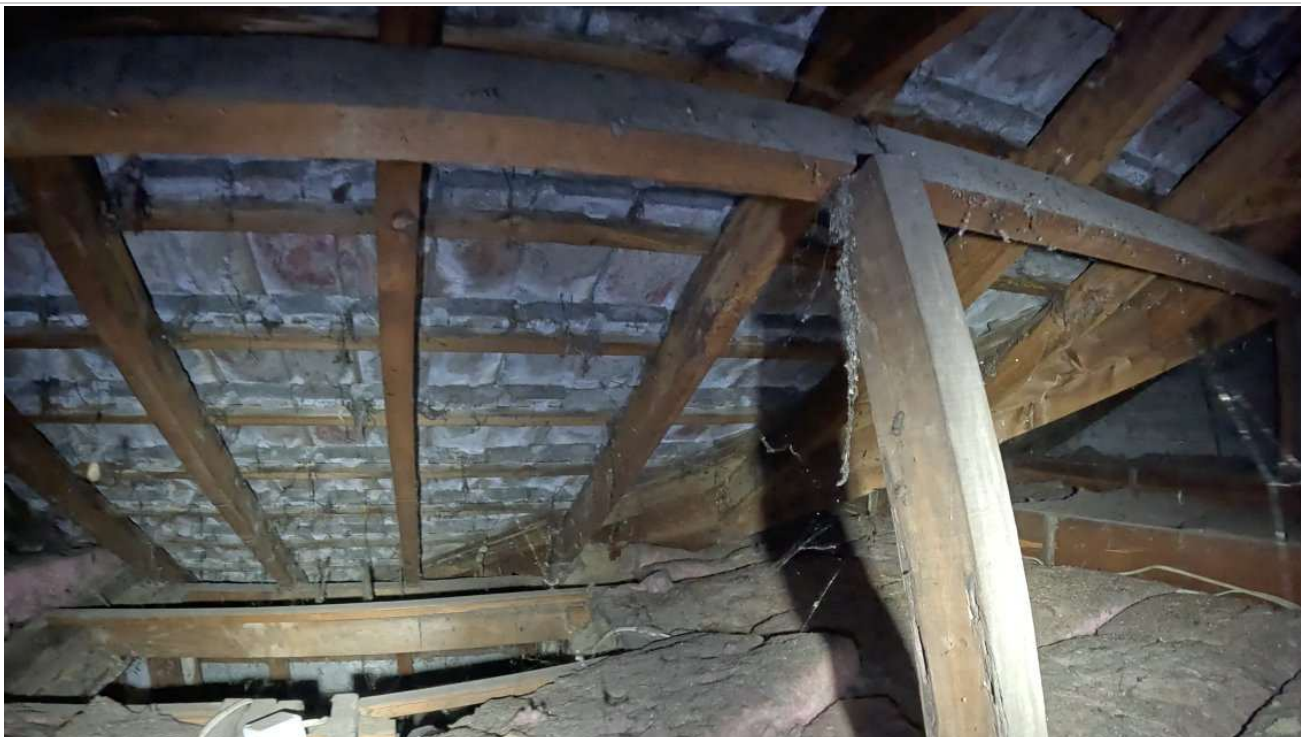
32: Here we see damage to the ridge join and the right side has moved towards the back of the home

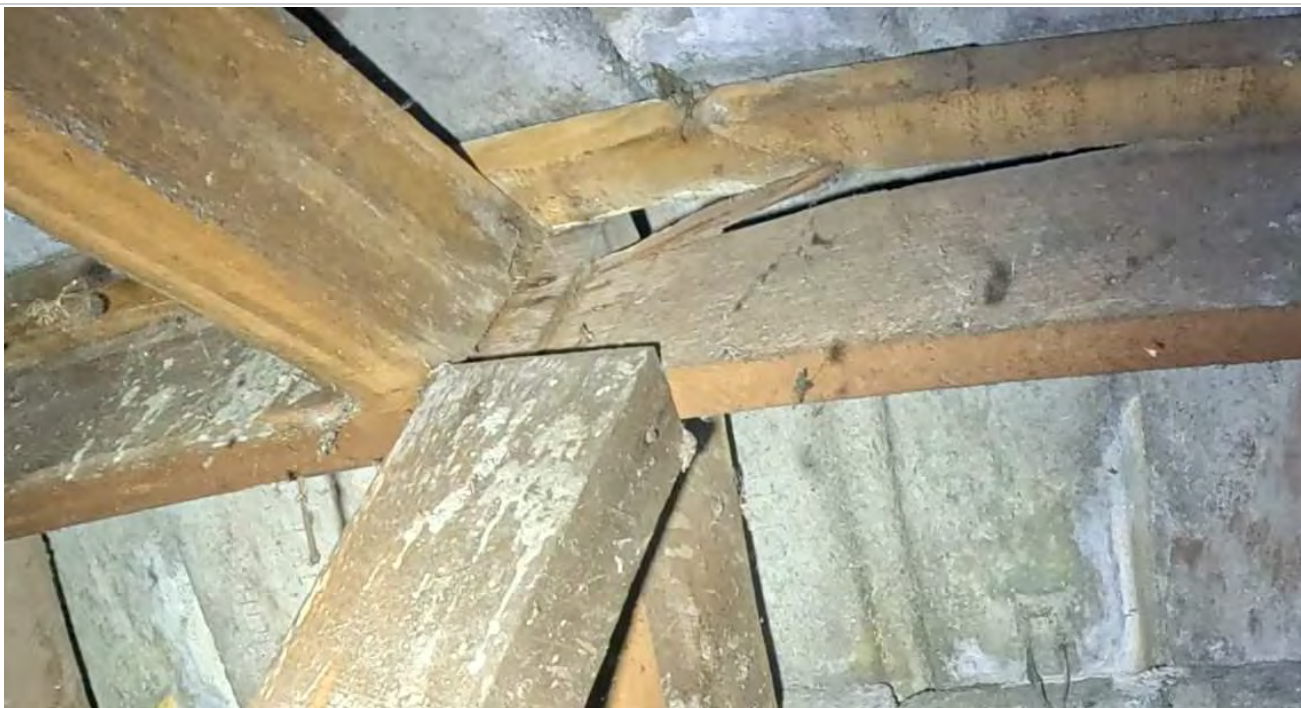
33: The ridge has moved at the bottom here.
