**Information request – 427 Armagh Street, Linwood, Christchurch 8011**

## TR001: Technical Report – Desktop Technical Review & Structural Inspection

## **Canterbury Claims – Assessment Report**

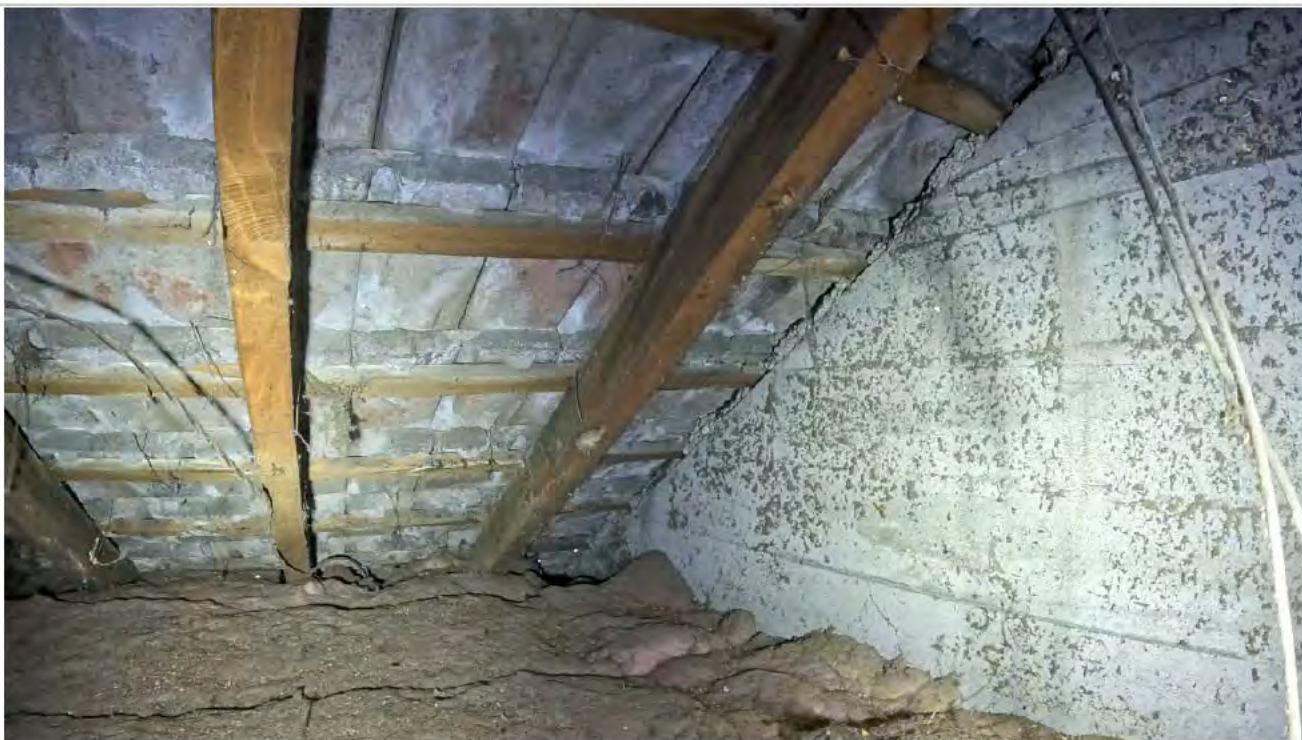
38: This is a chimney has been reduced to rafter height and it has cracked down all sides.

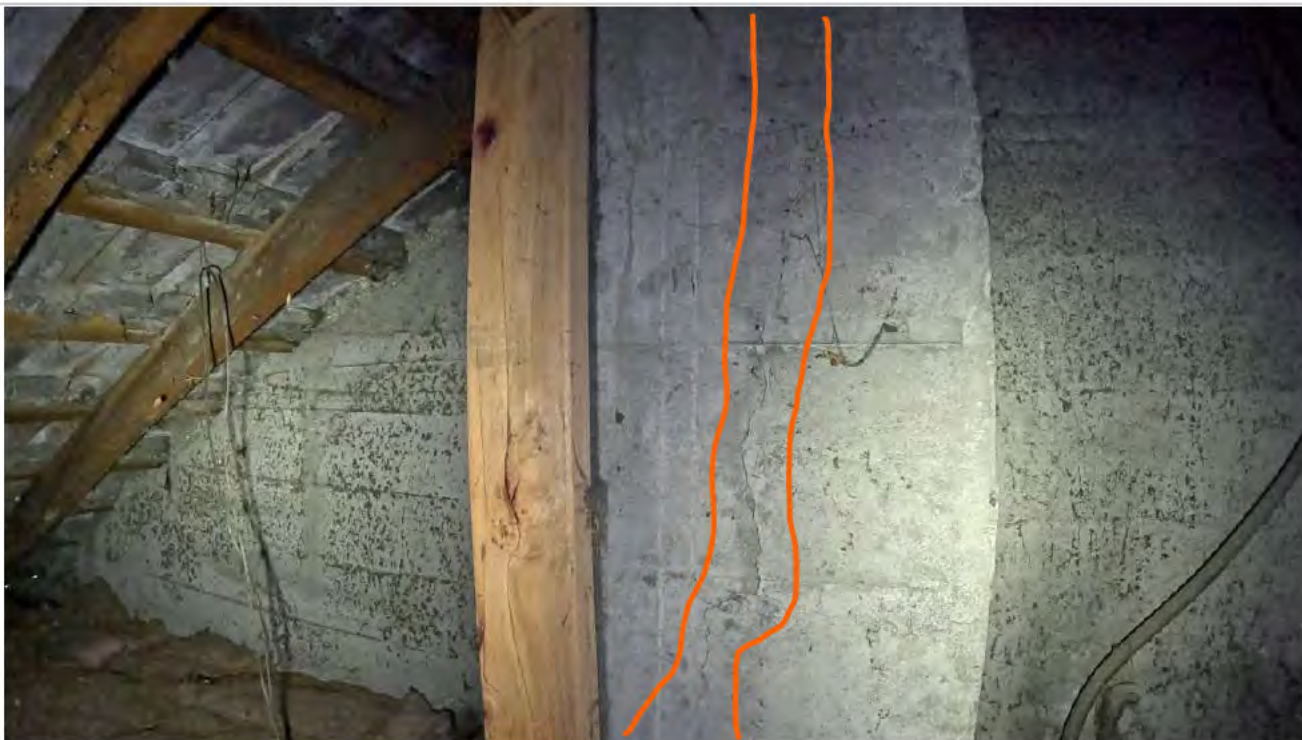
39: View of chimney with cracking. The prop is a latter addition.

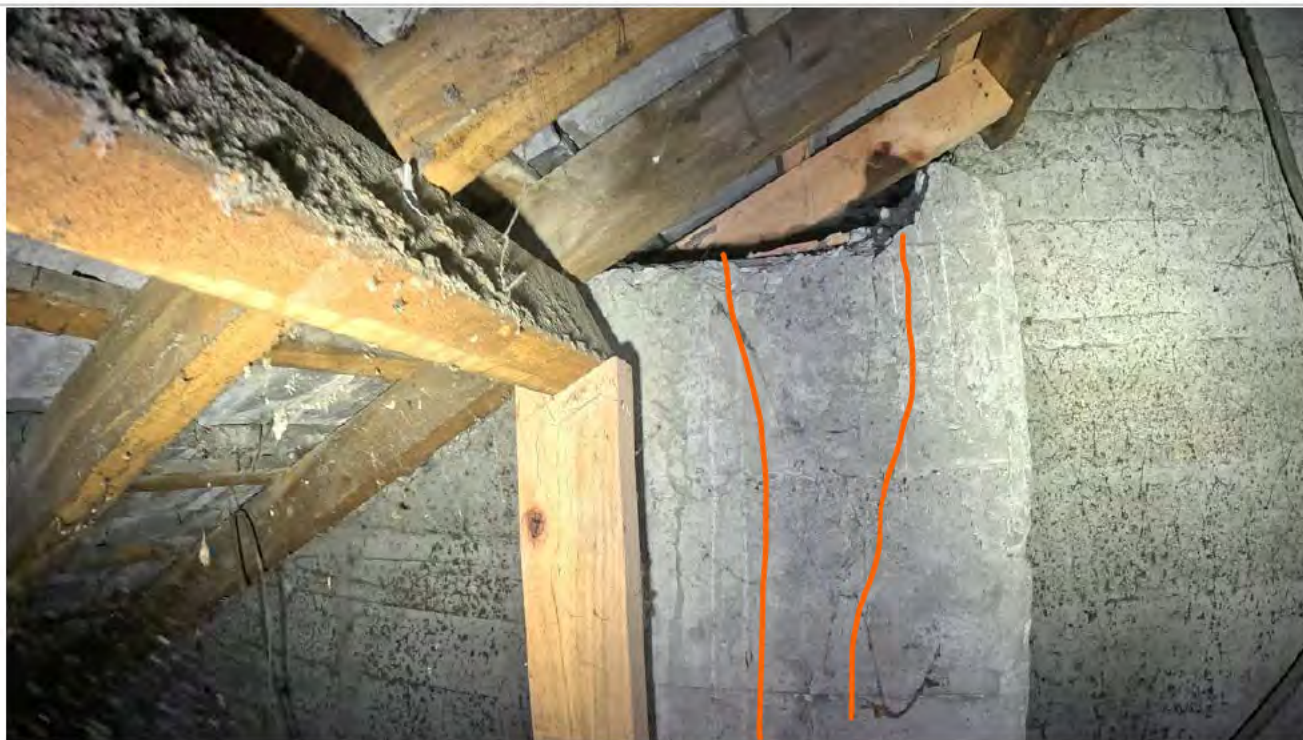
40: View of chimney with cracking.
