# CASH SETTLED CLAIM(S)

## Statement of Claim Checklist

Date: 22/10/10Author: Taw BatchelorClaim No.: 290 / 036482Claimant: A McCartneySituation of Loss: 4 Evans PlaceKaraparLA: Taw BatchelorEstimator: Paul Burns

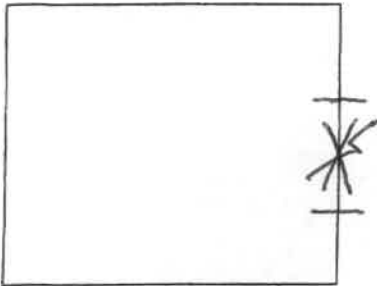
Outbuildings/Garage

| Item | | Event Damage | Description of Damage | Appoint Engineer |
|---|---|---|---|---|
| Outbuildings | | Y | Garage staircase cracking North/West side | |

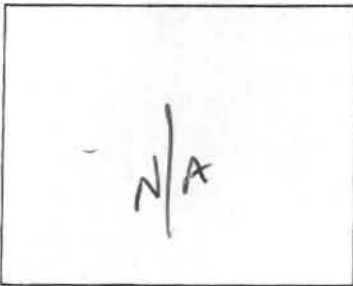
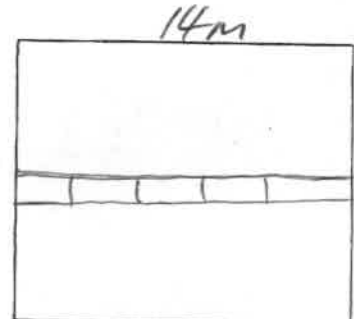
CONSERVATORY

| Room | Damage | Walls | Ceiling | Floor | Description of Damage |
|---|---|---|---|---|---|
| Other | Y | | | | Crack in window of Conservatory.<br>• Shed no damage |

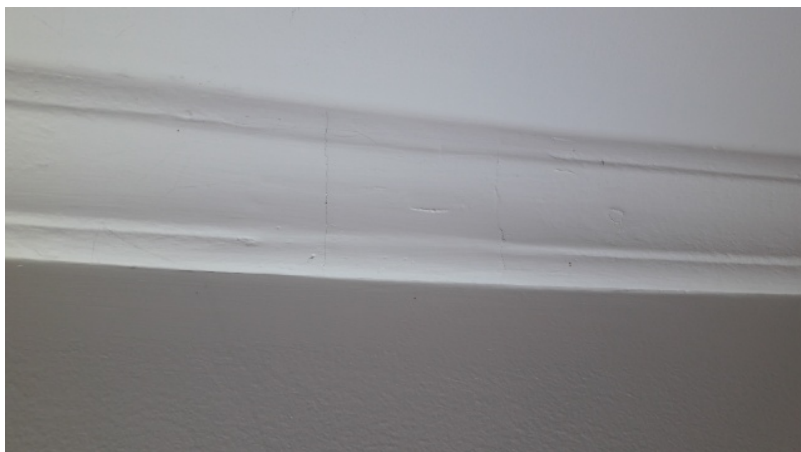
Figure 1 : Cornice damage Lounge area

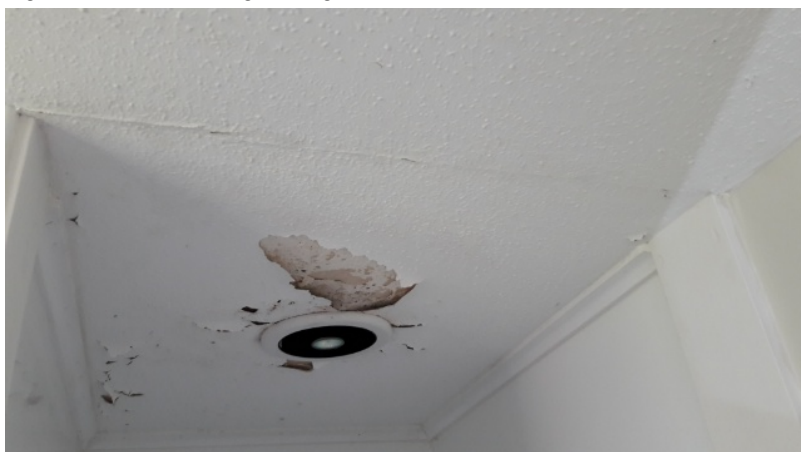
Figure 2 : Historical ceiling damage Bathroom area

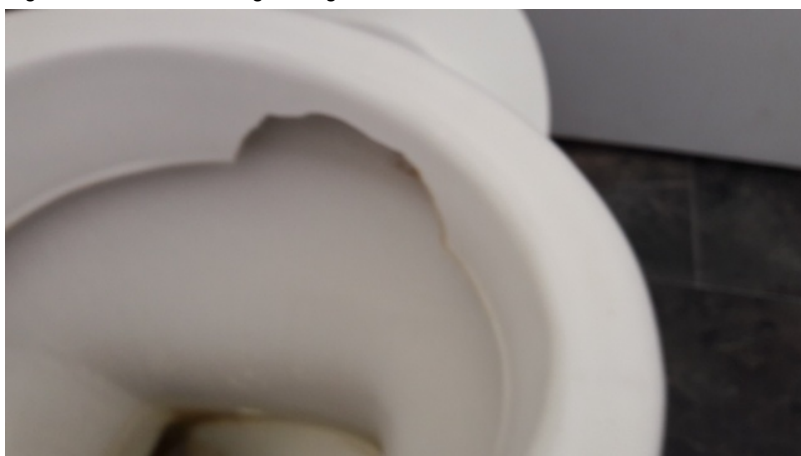
Figure 3 : Pan damage Toilet area

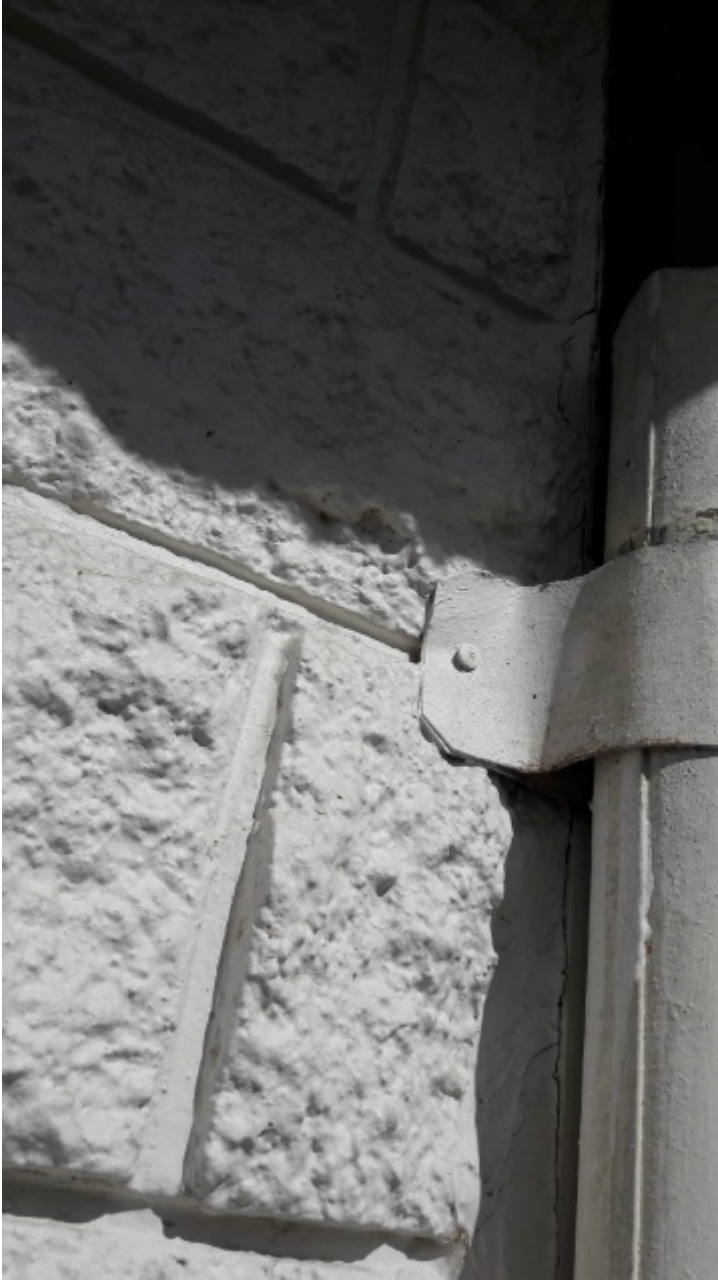
| Item | | Event Damage | Description of Damage | Appoint Engineer |
|---|---|---|---|---|
| External Walls | North | Y | cracks in brick mortar where conservatory joins wall. | |

Figure 5 : Cracking between Sunroom and brick veneer, north side of dwelling.

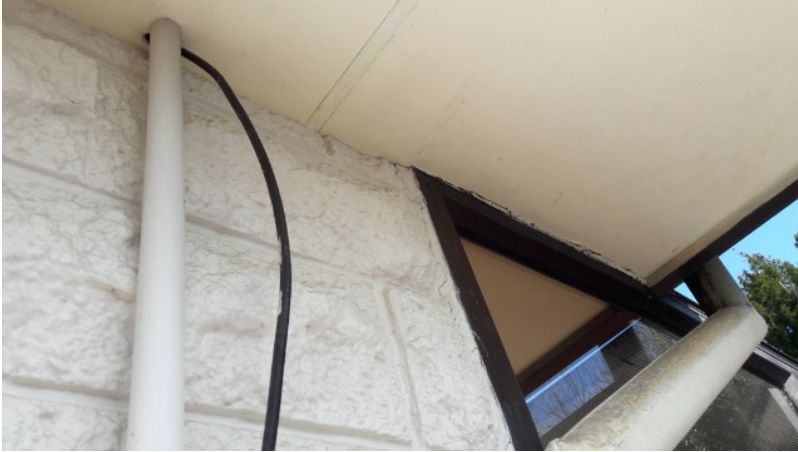
Figure 6 : Cracking between Sunroom and brick veneer, north side of dwelling.

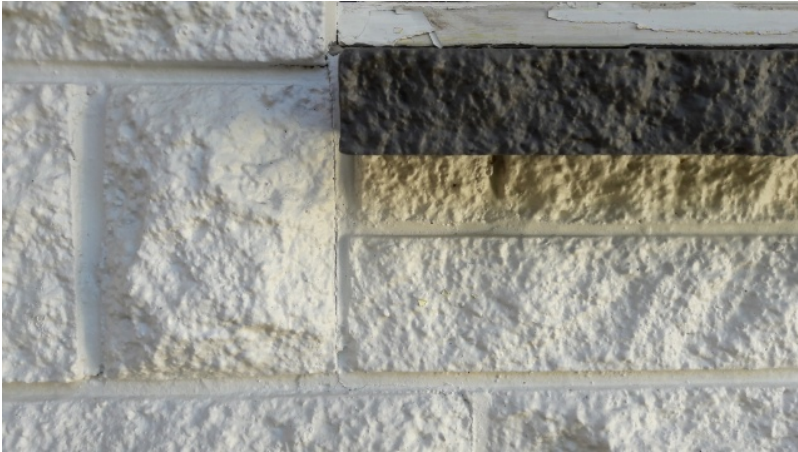
| Item | | Event Damage | Description of Damage | Appoint Engineer |
|---|---|---|---|---|
| | West | Y | cracking in west wall mortar, brick loose. | |

Figure 7 : Cladding damage west side of dwelling.

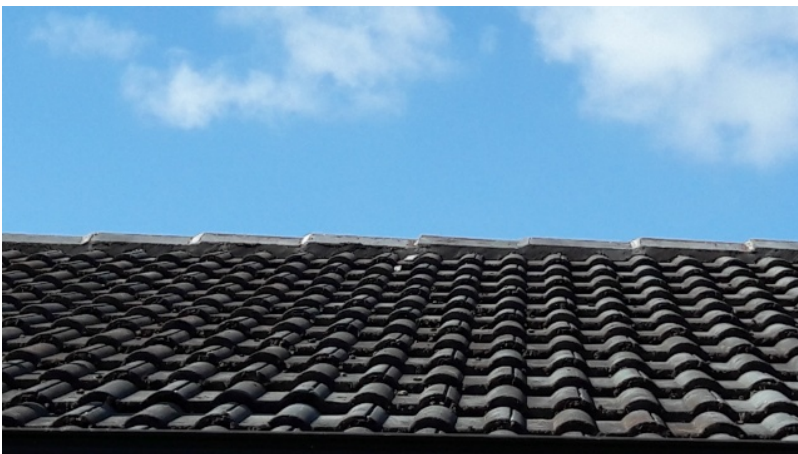
| Item | | Event Damage | Description of Damage | Appoint Engineer |
|---|---|---|---|---|
| Roof | | Y | Roof ridge capping broken | |

| Roof: | Framed <input checked="" type="checkbox"/> Trussed<br>Type: Clay Tiles <input checked="" type="checkbox"/> Concrete tiles <input checked="" type="checkbox"/> Metal tiles Rolled Metal Other<br>Damage:<br>POINTING ON RIDGE CAPPING. |

Figure 8 : Loose pointing on roof ridge capping.

| Element | Damage | Repair | |
|---|---|---|---|
| Roof Covering (Cladding (Ext Sheeting) - Concrete tile - 105.40 m2) | Impact damage | Repoint ridge capping | 4.00 l/m |

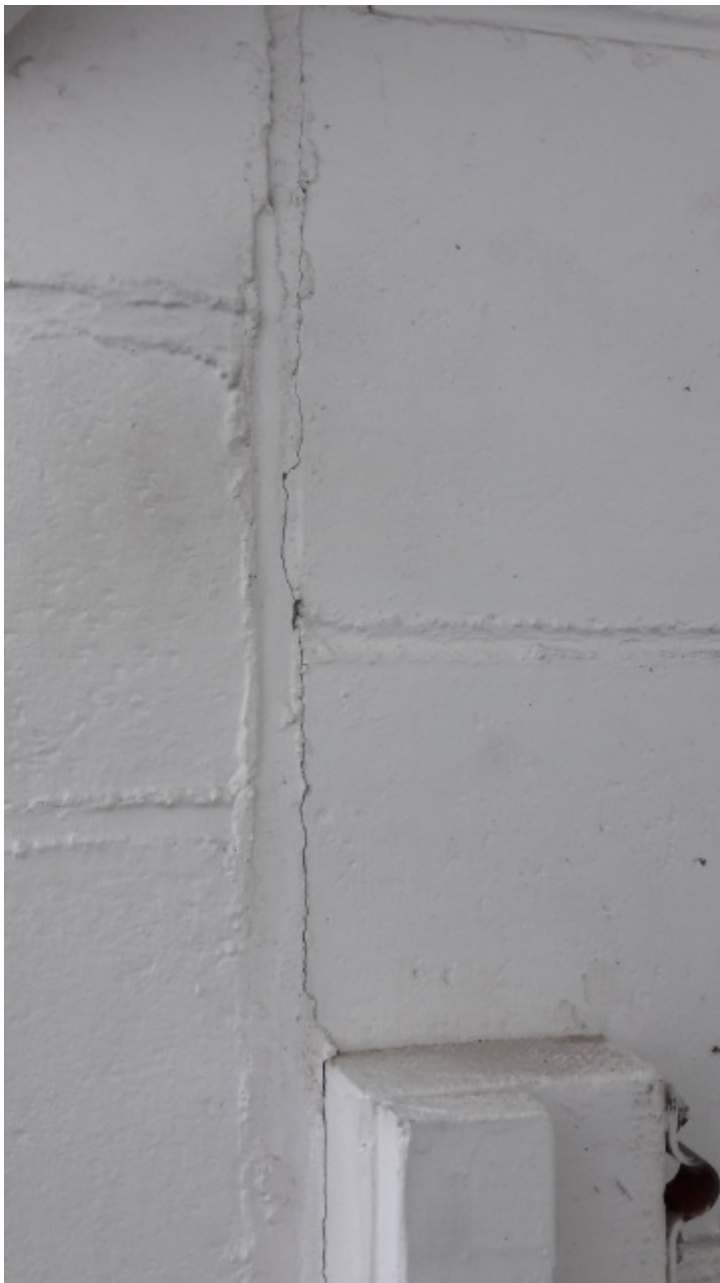
There are also cracks in the North and East walls of the garage and one window in the conservatory is broken.

Figure 9 : Mortar line cracking north side of Garage.
