# RESIDENTIAL PROPERTY INSPECTION

| <b>Inspection Address:</b> | 47A Queen Street, Rangiora |
| <b>Inspection Date:</b> | Wednesday 29 July 2026 |
| <b>Inspector Name:</b> | Sam Thomson |

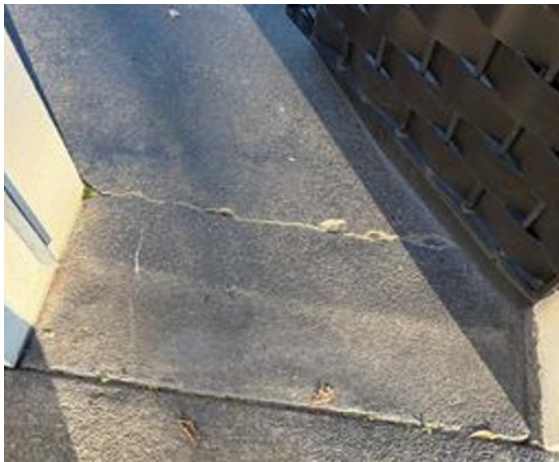
| ITEM ASSESSED | DEFECT | COMMENTS/NOTES |
|---|---|---|
| Steps, Handrails, Paths, Driveway | Minor | Cracking noted in concrete paths. |
| Ground Movement/cracking | Minor | Cracking to paths |

Cracking to paths

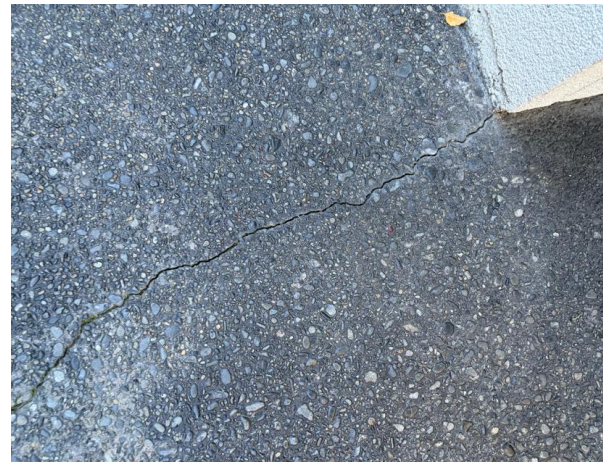
Cracking to paths

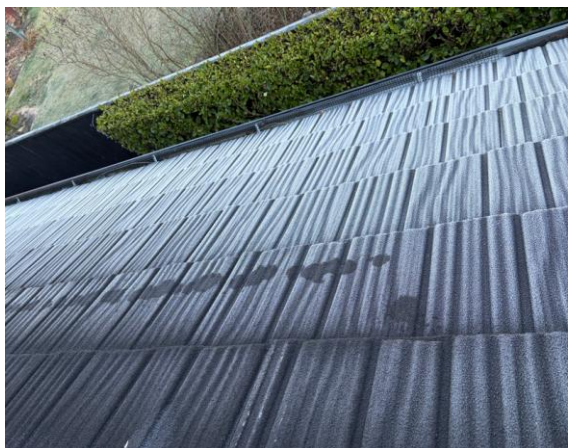
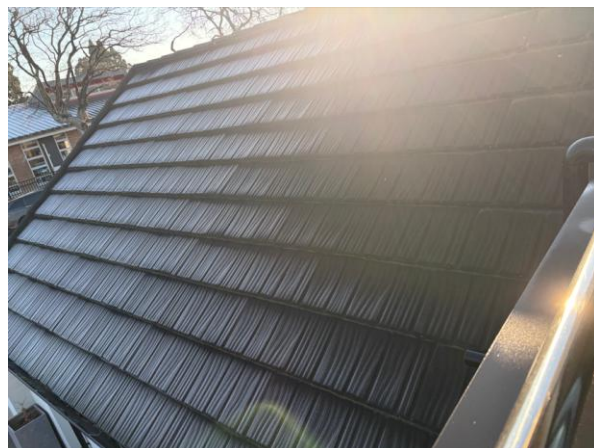
| ITEM ASSESSED | DEFECT | COMMENTS/NOTES |
|---|---|---|
| Roof condition | Minor | Good condition overall, minor mould/lichen build-up to tiles. The second-storey roof was not closely inspected due to the height off the ground, access & H&S requirements. |

Roof – general view

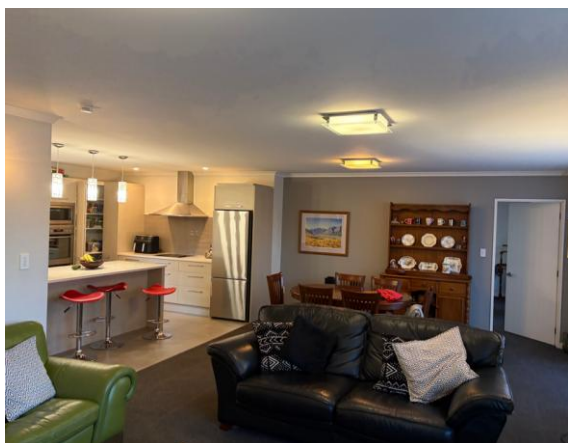
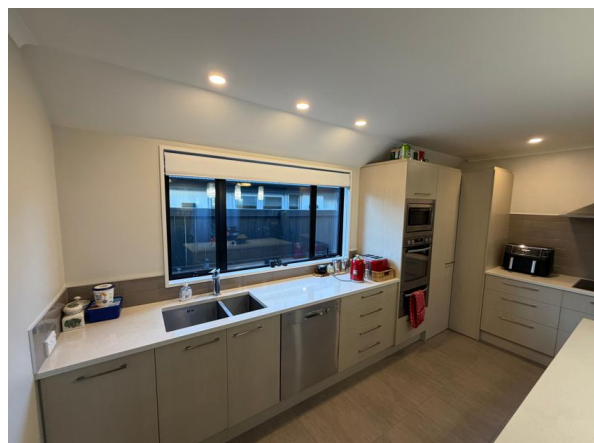
| ITEM ASSESSED | DEFECT | COMMENTS/NOTES |
|---|---|---|
| Walls – condition, defects. | Minor | Some cosmetic imperfections noted generally throughout interior. |

Walls and ceilings – general view

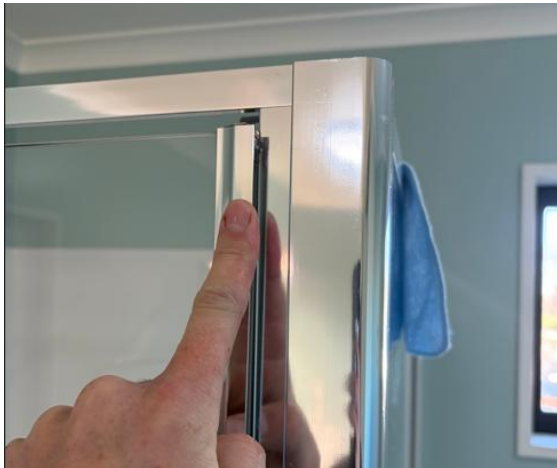
| ○ Shower | Minor | Shower door in upstairs bathroom doesn't shut. Discolouration to the silicone in the shower |

Shower door doesn't easily shut

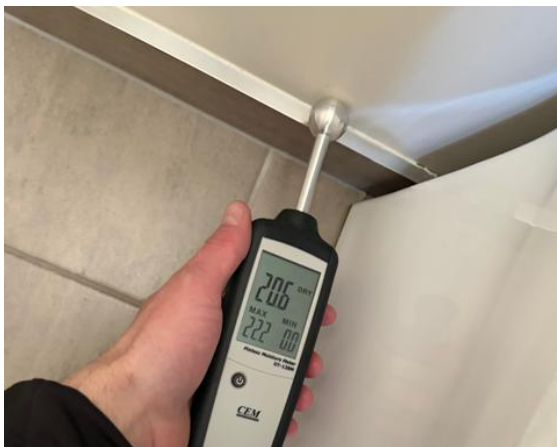
The moisture readings were between 13.4 and 29.8 – these are in the dry range.

Moisture readings – dry range

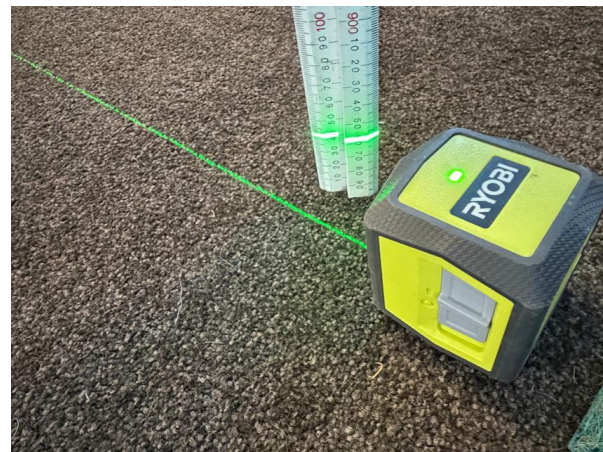
| ITEM ASSESSED | DEFECT | COMMENTS/NOTES |
|---|---|---|
| Concrete Floors | | Measurements were taken with a laser level device across the floor plan measured across the greatest available distance, and the variation was minimal. The MBIE Guidelines for the level variations of the floor plan have set the limit at 50mm. |

Laser floor level assessment.
