28 June 2024

| Damage Causation Report | |
| <b>Address:</b> | Units 27 & 28, 595 Laurie Southwick Parade, Gulf Harbour, Auckland |

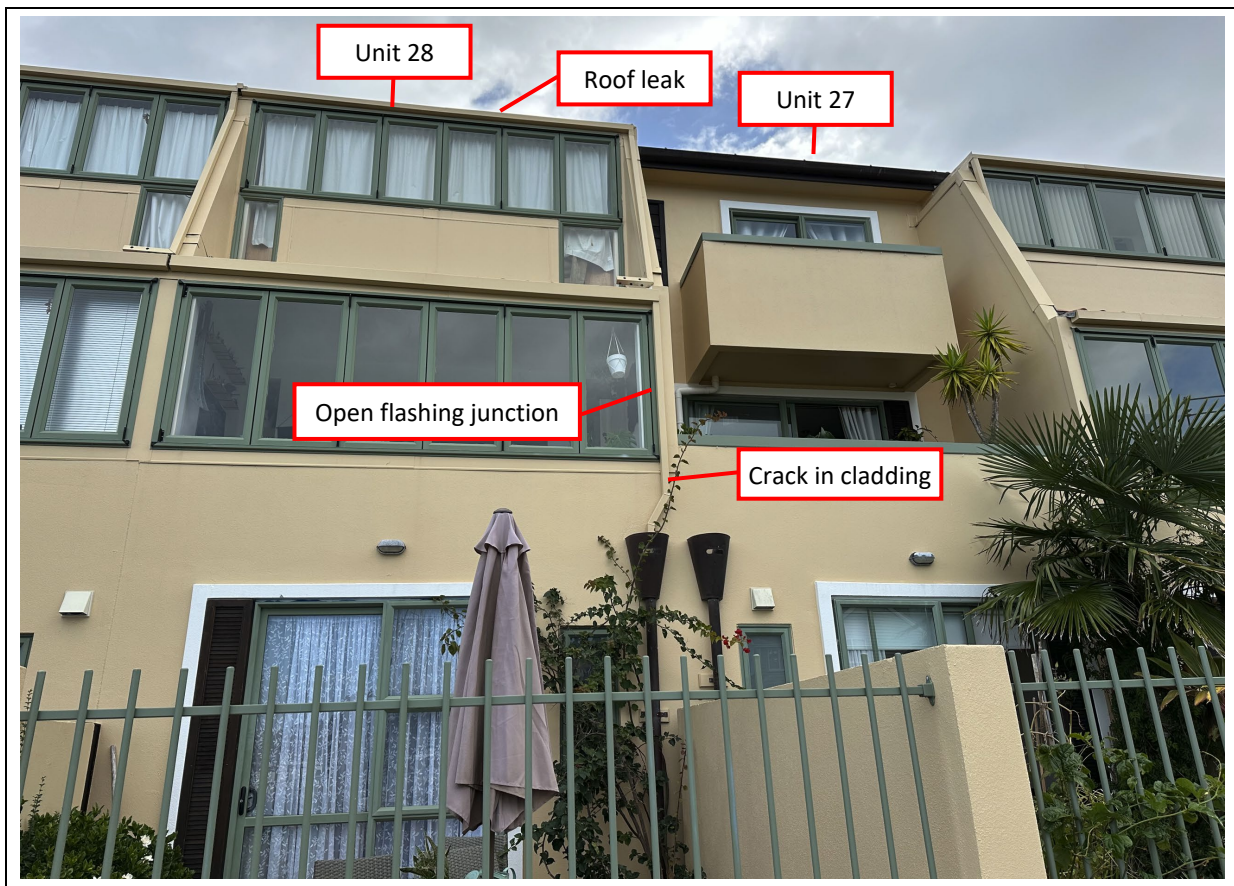
6.1 Overview of the Units with areas of concern arrowed.

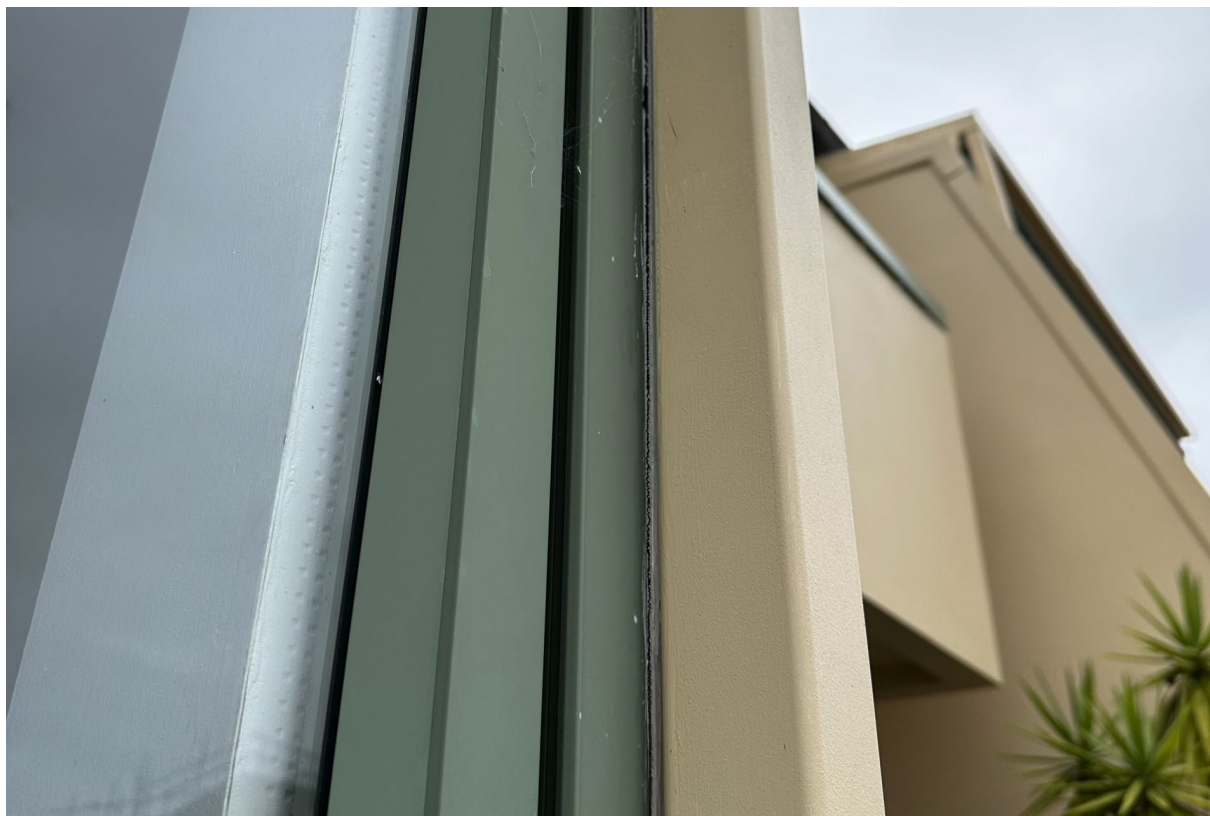
- 5.1. The junction between the jamb flashings and conservatory joinery on the first-floor level of Unit 28 appears misaligned with separation visible between the flashing and joinery.

6.2 Open flashing junction beside window joinery

There are two cladding defects providing points of entry for rainwater. The first defect is where the junction between the first-floor conservatory joinery and jamb flashing has opened up allowing water to penetrate beside the window joinery and track down to the framing below. The second defect is the cracking of the cladding immediately below the defective window joinery junction. Both defects result in water passing through the building envelope and into the framing of the exterior wall directly beside the intertenancy wall. From there the water pools and spreads across the bathroom floor in Unit 28, into the kitchenette and laundry area and into the bathroom in Unit 27 as is observed from the recorded moisture content readings and spread of fungal growth and timber decay laterally along the base of the walls and wall linings.

We recommend that immediate action is taken to remedy the construction defects in the exterior cladding as identified in this report. If these defects are not addressed water ingress will continue to occur leading to further degradation of the structure and elevated risk to the health and safety of the occupants.

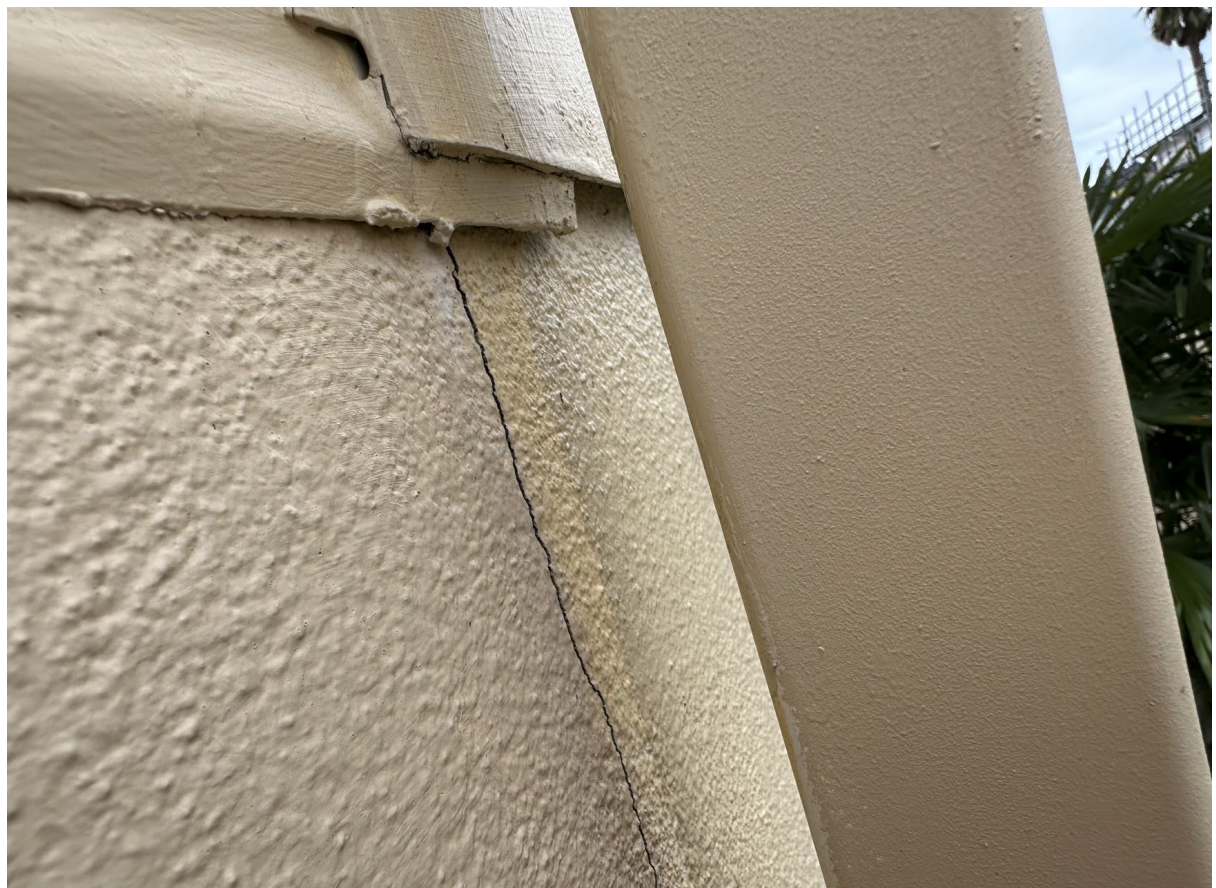
- 5.2. There is vertical cracking to the exterior wall cladding immediately below the sill of the conservatory joinery on the first-floor level of Unit 28 close to the intertenancy wall with Unit 27 and behind the downpipe. The cracking opens wider towards the upper end and tapers to a hairline crack as it extends downwards. The crack is the full depth of the fibre cement sheet cladding.

6.3 Cracking in exterior cladding

The cladding defects are due to poor design and poor construction. This is because the nature of a double framed intertenancy wall and separately framed structures as exist in this apartment building, requires that movement control joints be provided between Units, particularly where the wall cladding is expected to span between Units. In this case there are no movement control joints between Unit 27 and Unit 28 which has led to the cracking of the cladding and separation of the joinery/flashing junction as the structures of the Units move independently of each other during long term settlement of the supporting ground.

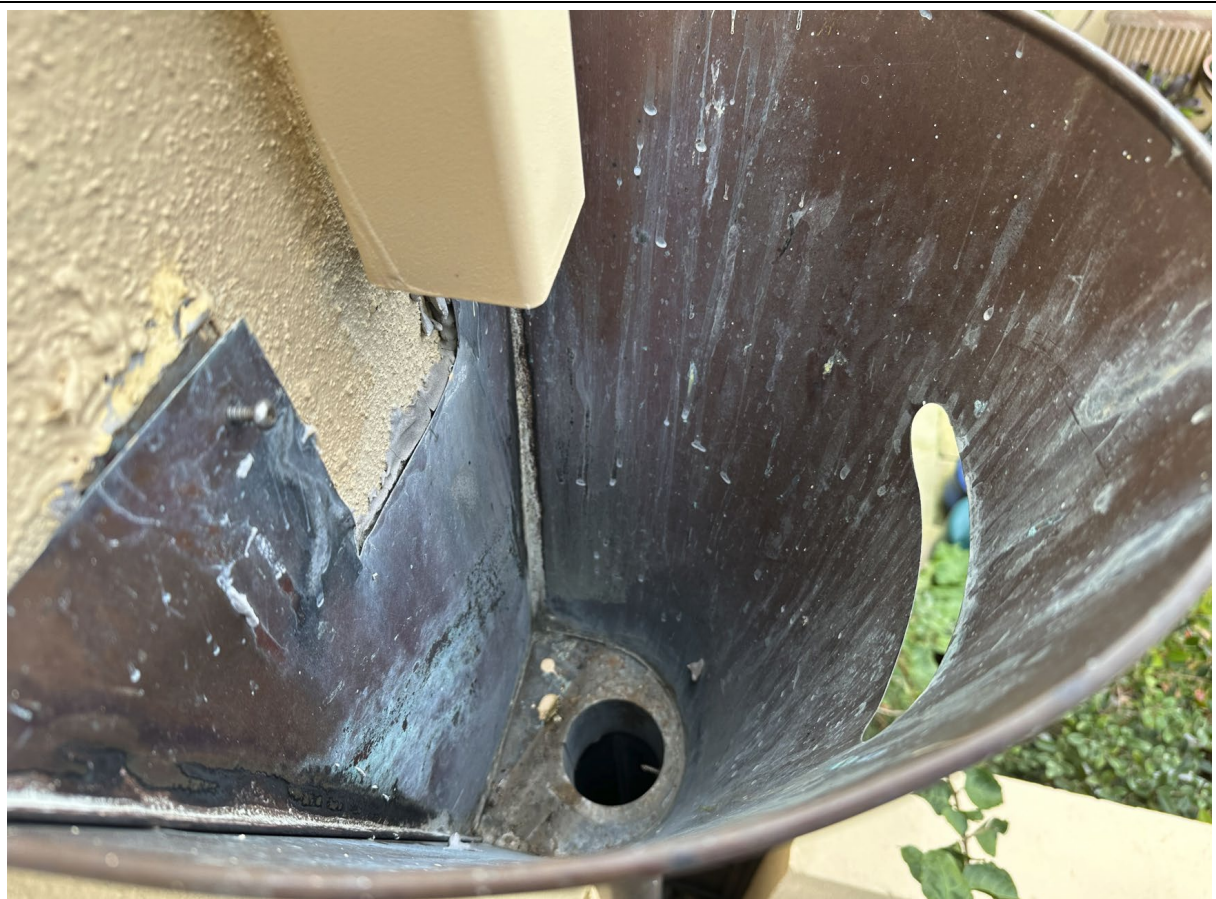
- 5.3. There is no movement control joint formed in the exterior cladding between the ground floor sections of Unit 27 & 28.
- 5.4. The rainwater heads on the ground floor level of the dwelling are poorly mounted to the exterior wall allowing surface water to penetrate behind.

6.4 Poor sealing around rainwater head

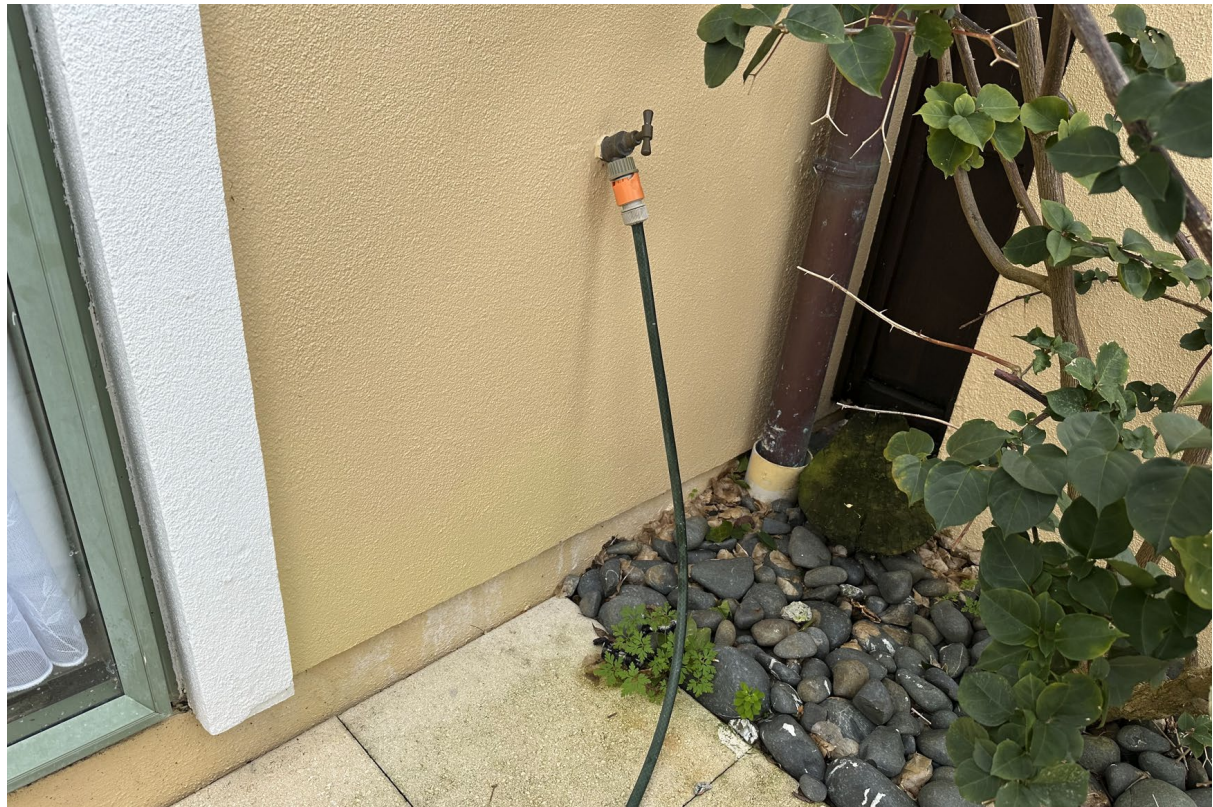
- 5.5. The exterior cladding below the bathroom window on Unit 28 was damp to the touch when compared with other nearby cladding surfaces and returned a high moisture level reading. The cladding is also discoloured at the base with efflorescence visible on the surface of the concrete foundation below.

6.5 Cladding beneath bathroom window in Unit 28 showing efflorescence and staining

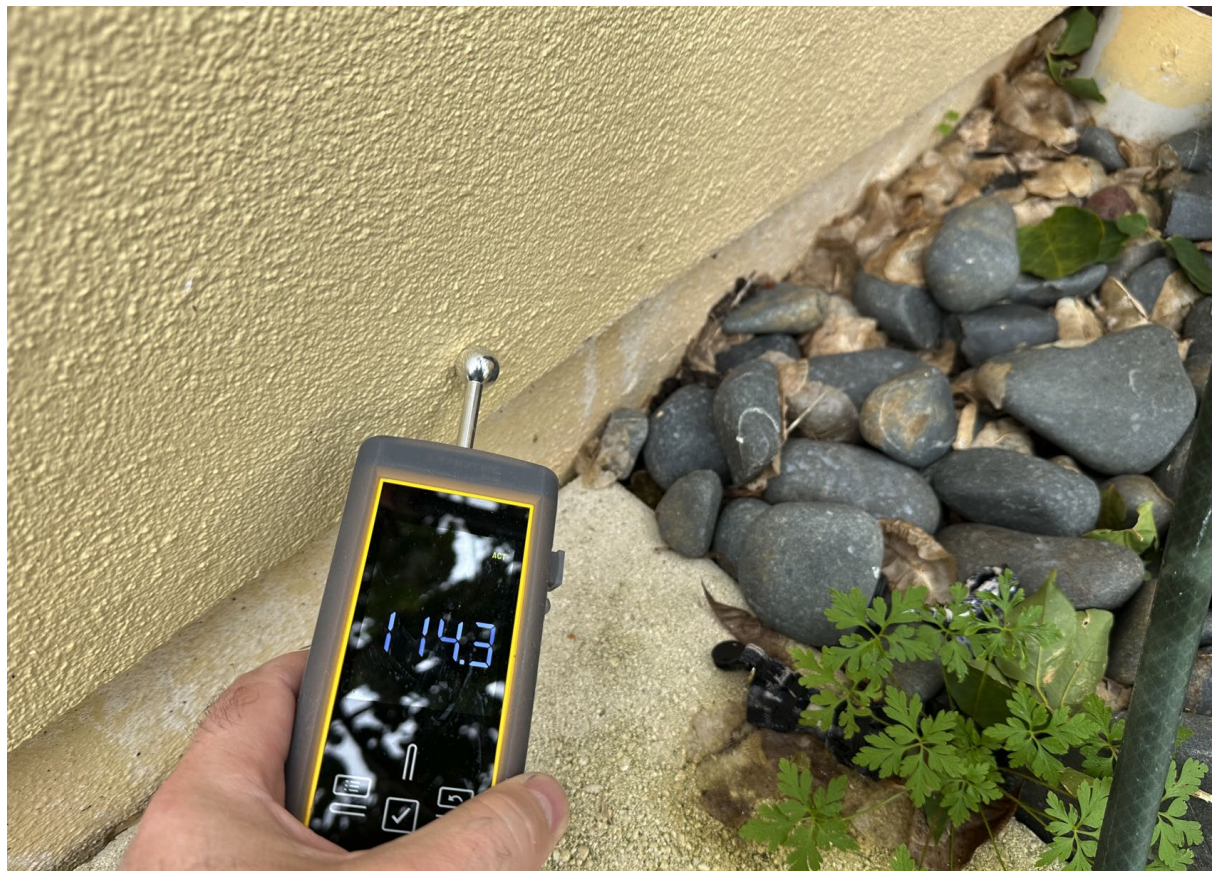
6.6 High moisture reading at cladding base

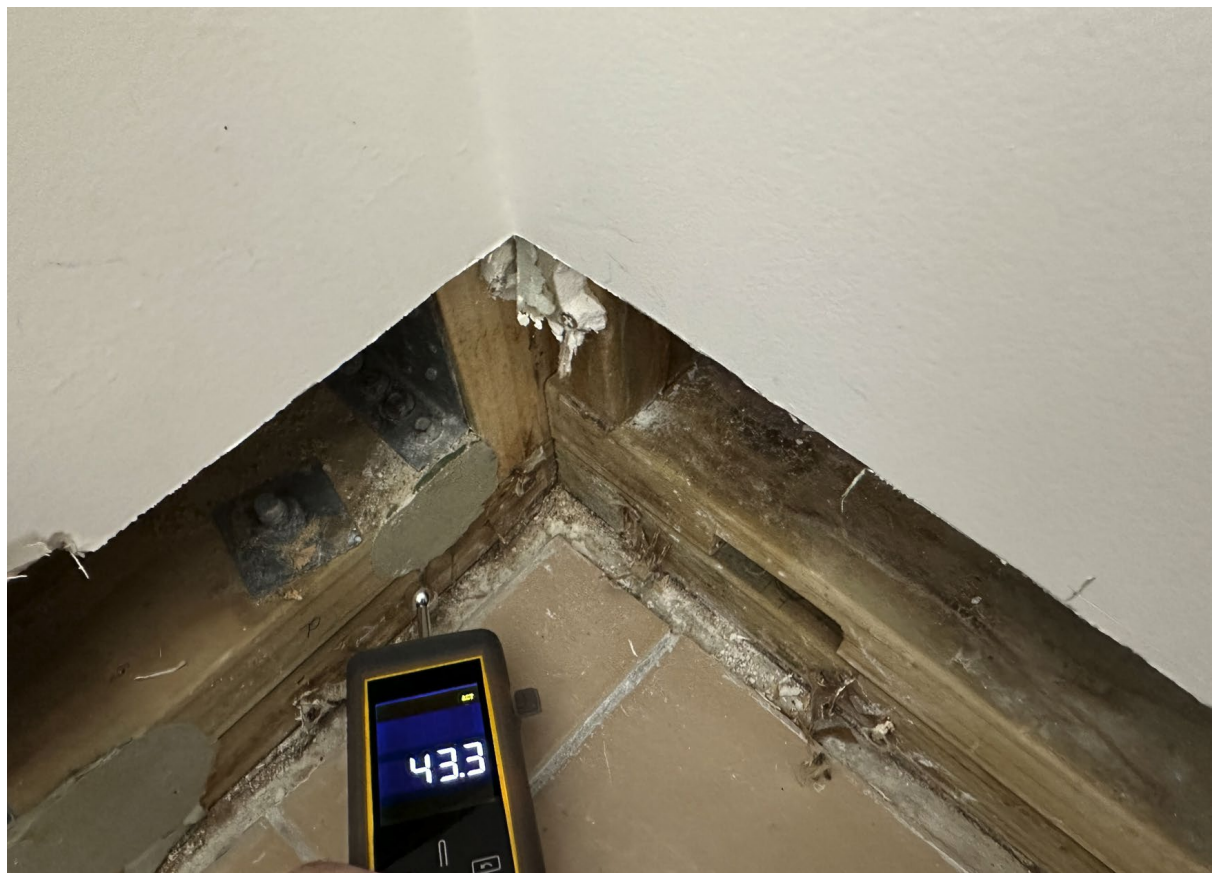
- 5.7. The bottom plate of the exterior wall framing in the bathroom on the ground floor level of the dwelling has been replaced with timber treated to meet H3.2 Hazard Class requirements. The exposed timbers have water stain marks but no fungal growth or decay present. The timber returns an elevated moisture content reading.

6.7 Elevated moisture reading of framing in Unit 27 bathroom exterior wall

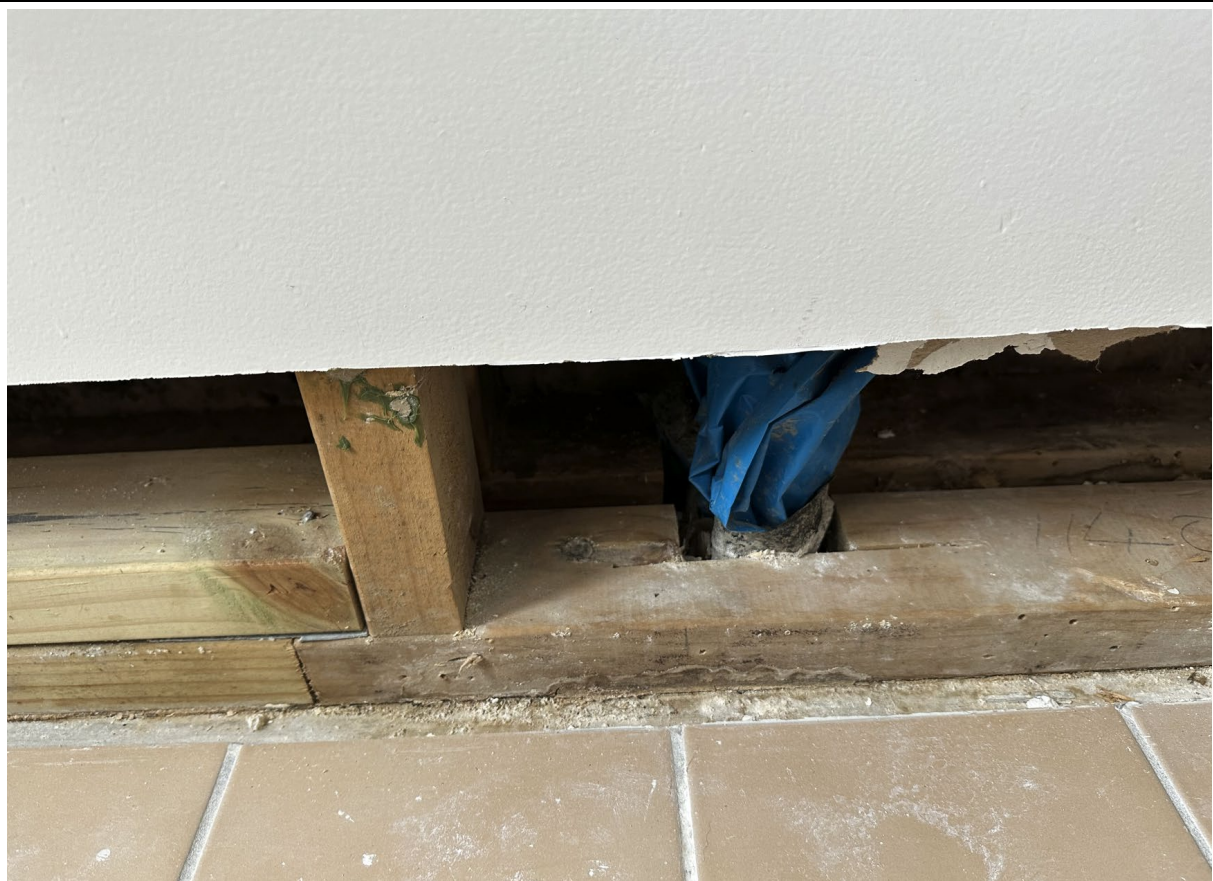
- 5.8. The intertenancy wall is of double frame construction. Approximately 1 metre away from the junction with the exterior wall the bottom plate of the intertenancy wall appears to be untreated radiata pine framing which is what was originally installed as advised by the Building Manager. This timber has an elevated moisture content and displays incidences of fungal growth and timber decay in several places further along the wall towards the shower unit.

6.8 Change in framing along intertenancy wall between Unit 27 and Unit 28

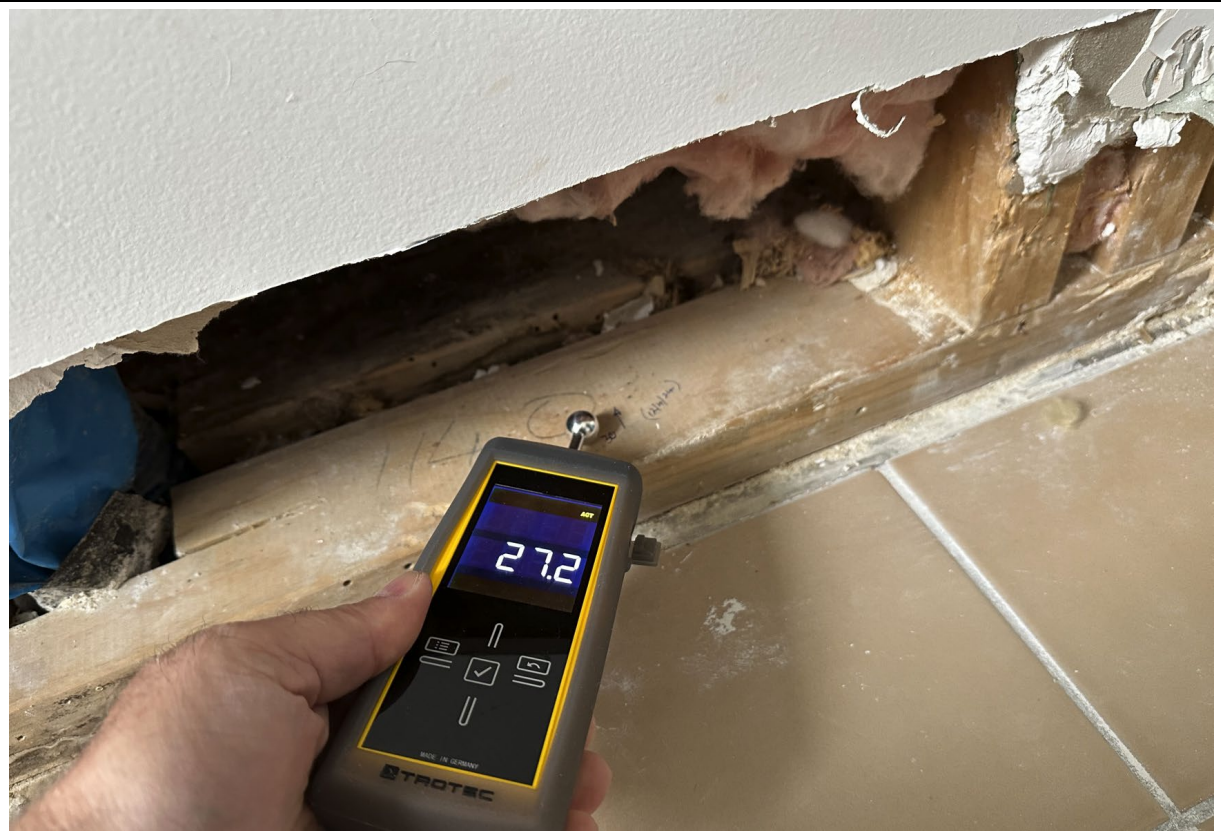
6.9 Slightly elevated moisture content in bottom plate on Unit 27 side of intertenancy wall

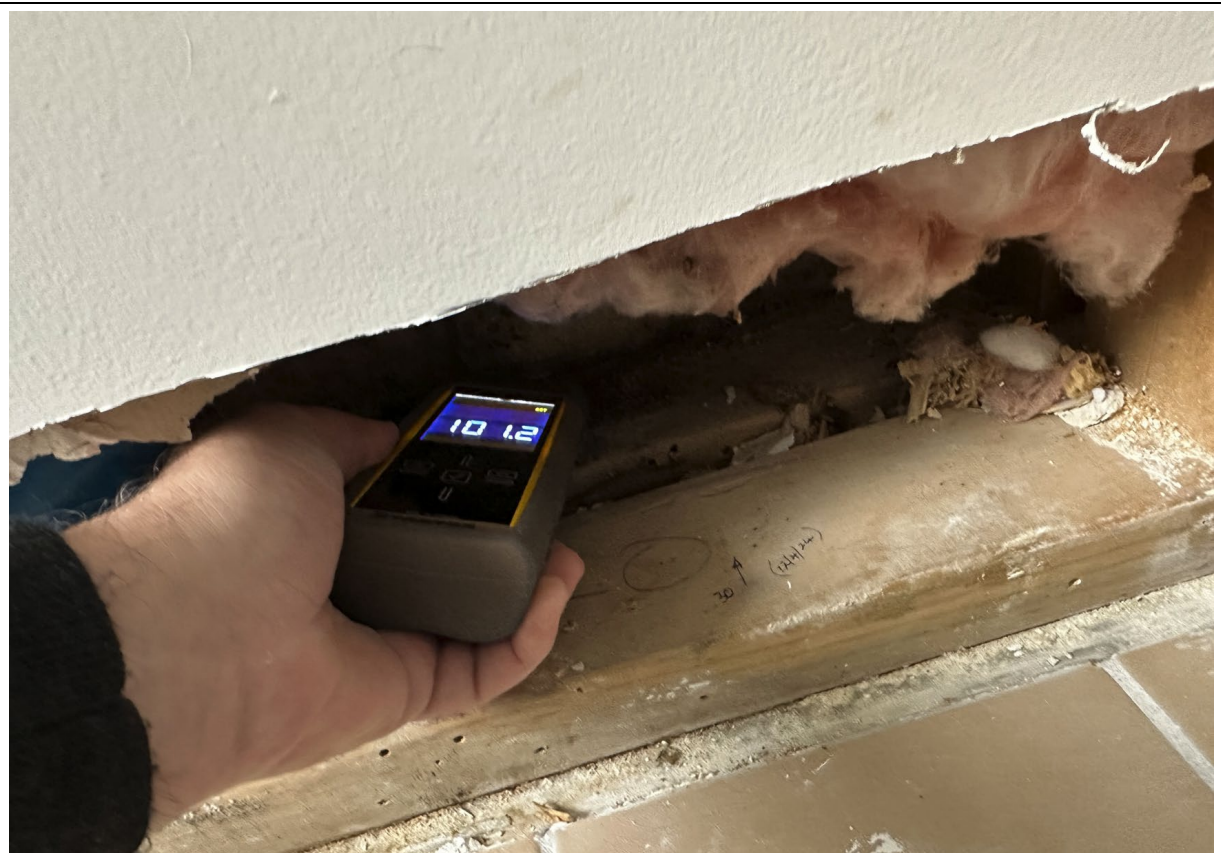
- 5.9. The bottom plate of the intertenancy wall on the Unit 28 side of the wall returns a significantly higher moisture content reading than that of the bottom plate on the Unit 27 side of the wall.

6.10 Highly elevated moisture content in bottom plate on Unit 28 side of intertenancy wall

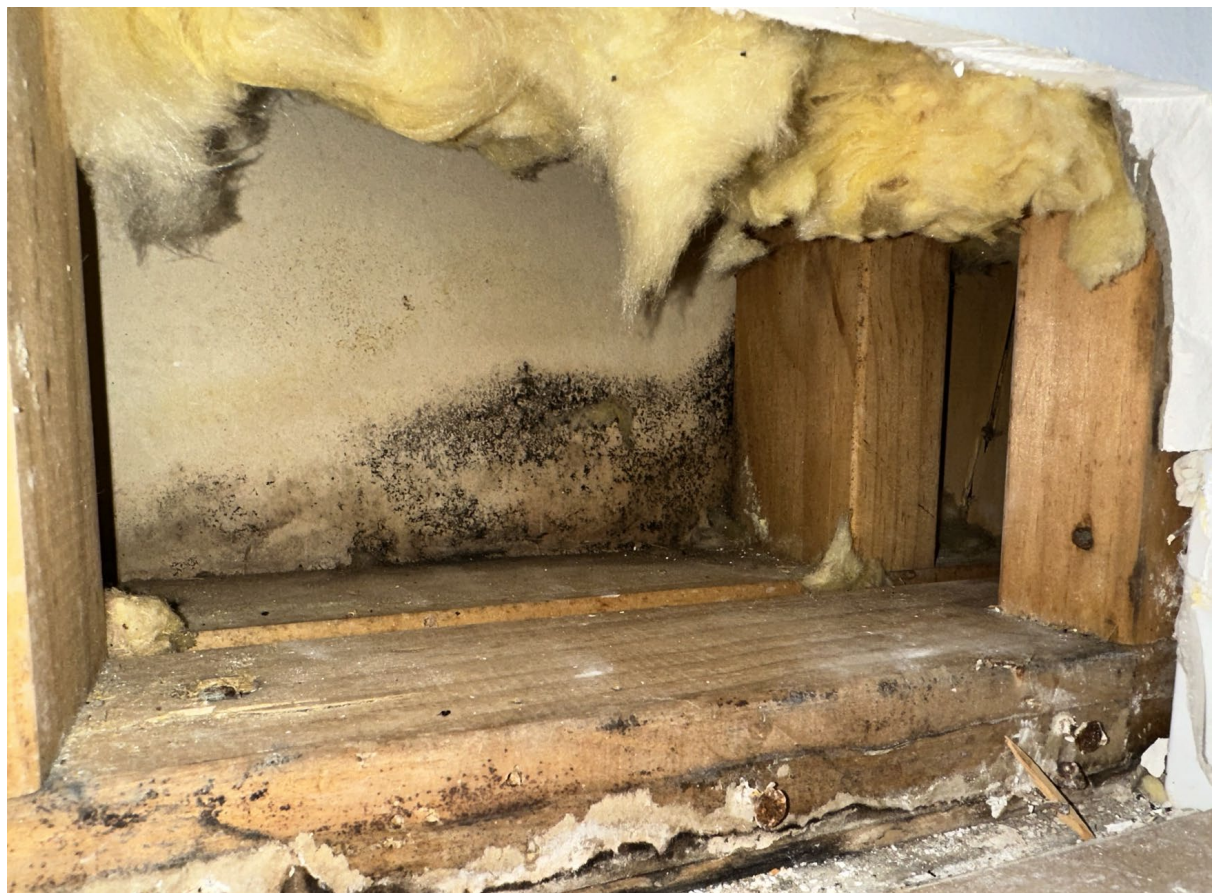
- 5.10. The plasterboard wall lining on the Unit 28 side of the intertenancy wall approximately 1.5 metres away from the exterior wall displays water staining, fungal growth and timber decay spreading upwards from the floor level. There is no visual evidence of water ingress from above such as staining that might occur from water tracking down the wall.

6.11 Fungal growth and timber decay in the bathroom intertenancy wall

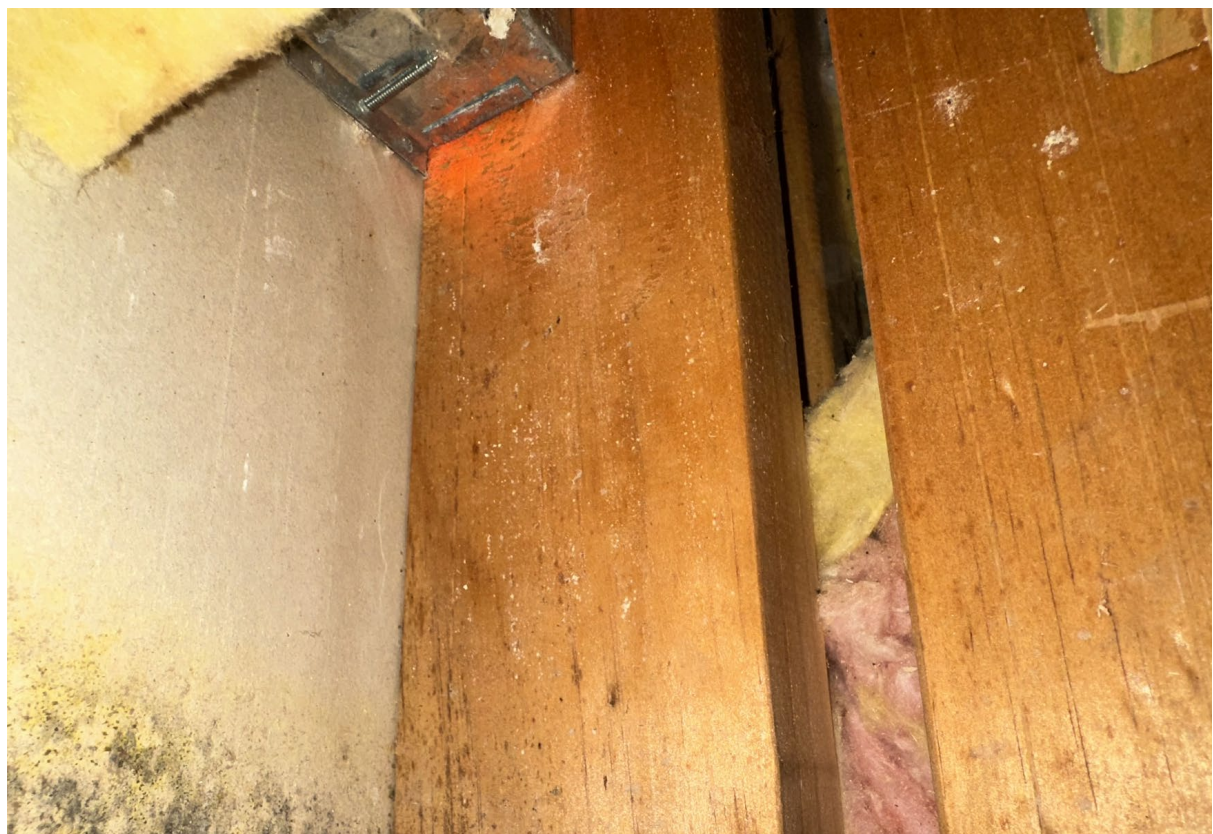
6.12 No visible water staining from above evident within the intertenancy wall cavity

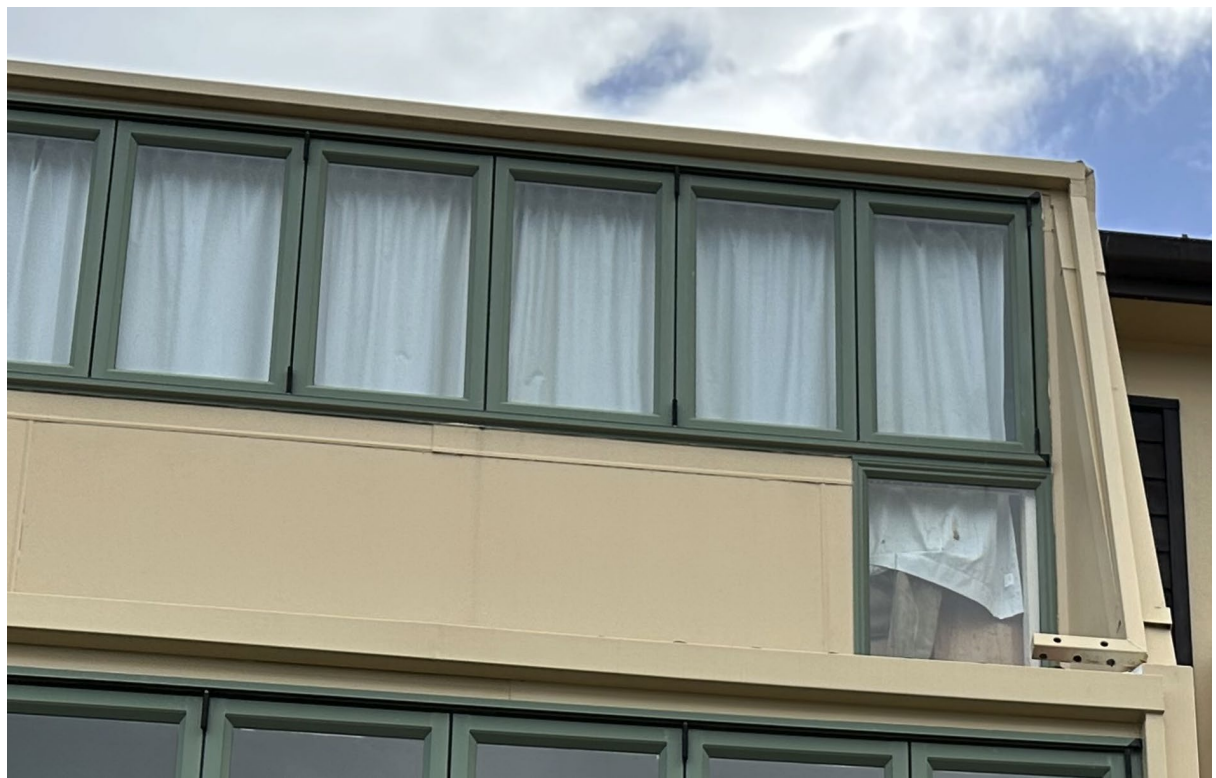
6.13 Overview of Level 2 Bedroom window joinery in Unit 28

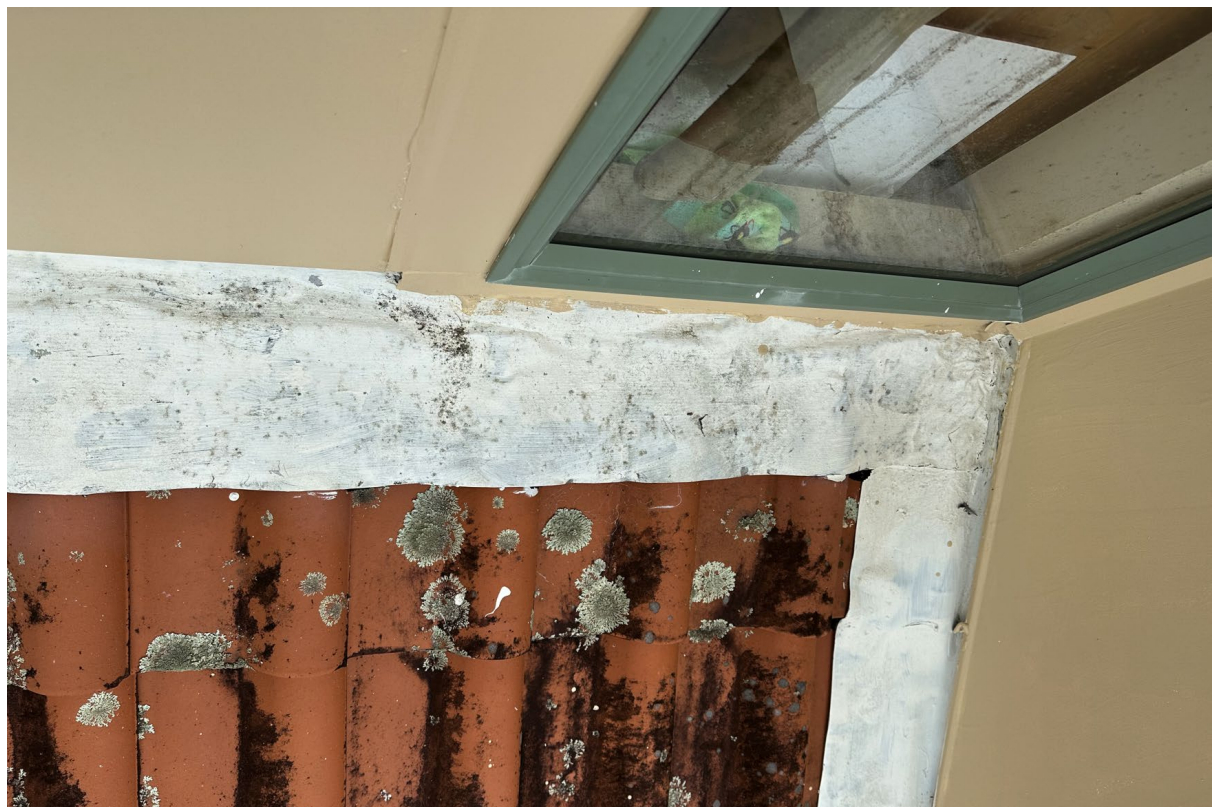
- 5.11. The window reveals of the conservatory window joinery have water stain markings. The reveals, ceiling and wall linings appear dry despite recent heavy rain.
- 5.12. The Owner of Unit 28 has supplied photos taken during the Event showing water leaking from the light fitting on the back wall of the conservatory area in the bedroom and water leaking from the window reveals at the top of the conservatory joinery.

6.14 Moisture damage to window reveals (now dry) as viewed through Level 2 Bedroom window

It is our assessment that the damage to the window reveals and wall surfaces in the Bedroom is resultant damage due to water ingress from a roof leak as occurred during the storm event in May 2023.

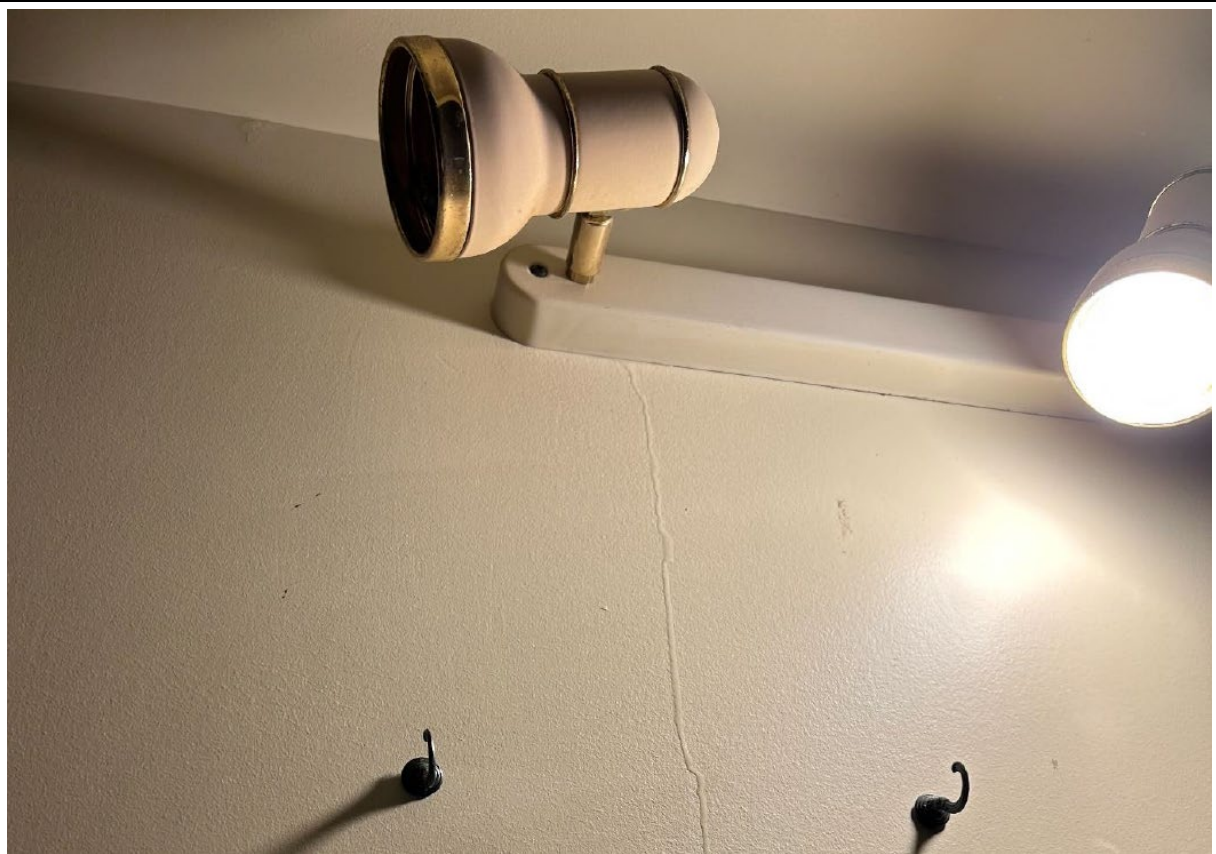
6.15 Image provided by Owner of Unit 28 showing water leak to Level 2 Bedroom wall during Event.

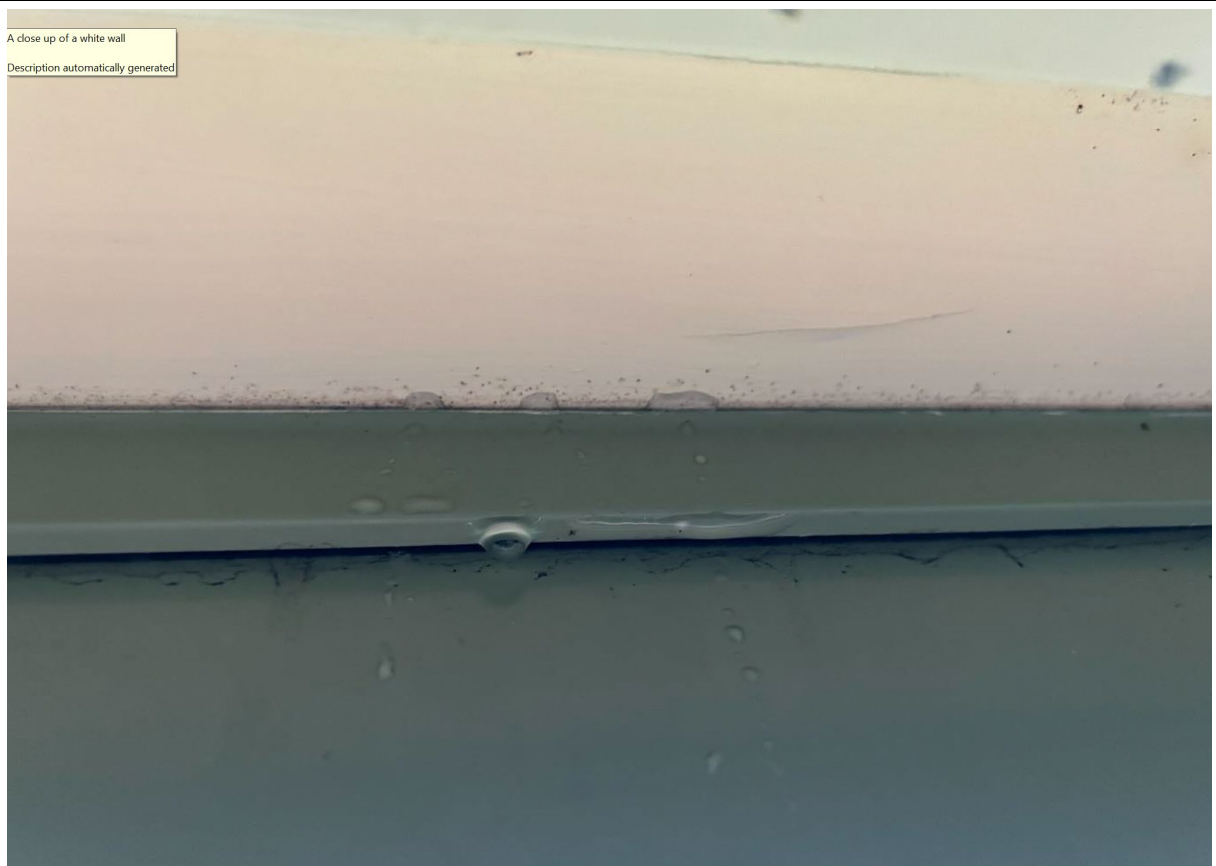
6.16 Image provided by Owner of Unit 28 showing water leak to Level 2 Bedroom joinery during Event

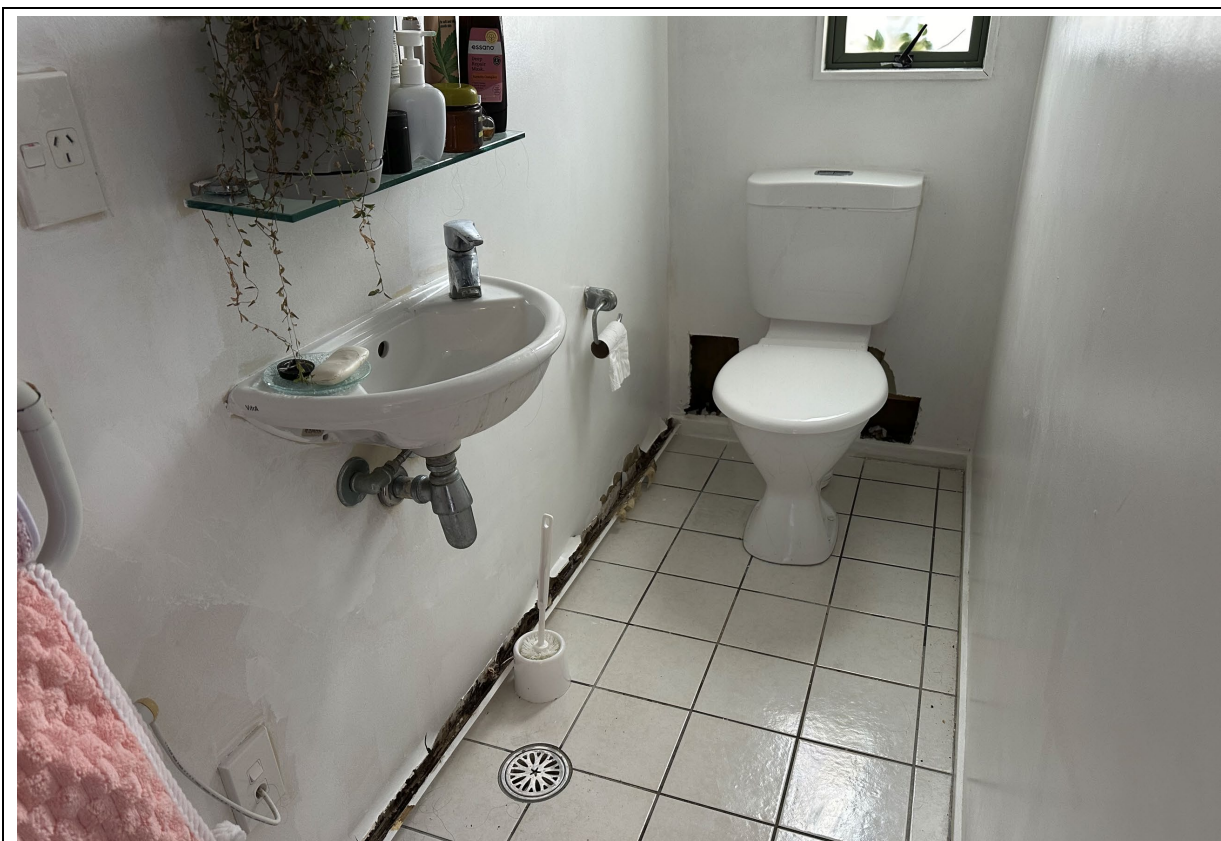
6.17 Overview of Ground Floor Bathroom in Unit 28 facing towards external wall

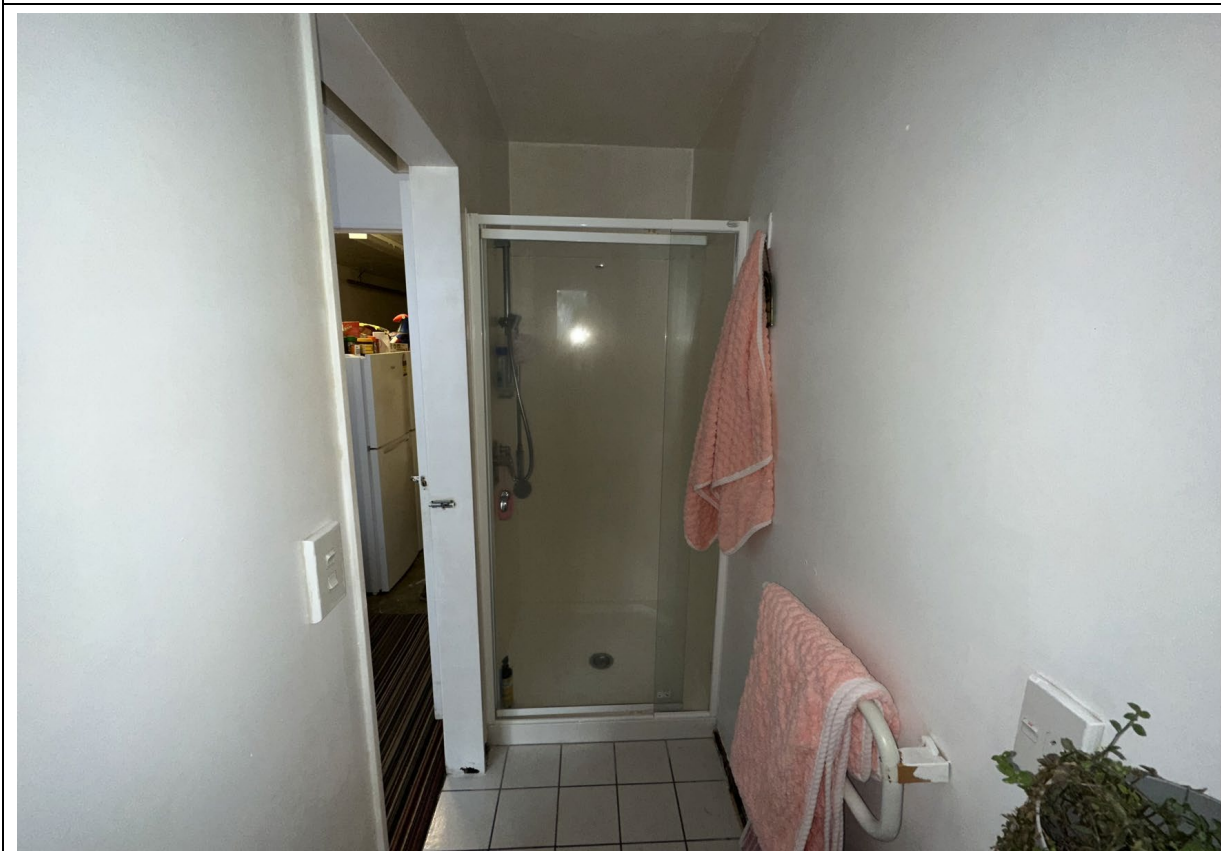
6.18 Overview of Ground Floor Bathroom in Unit 28 facing away from external wall

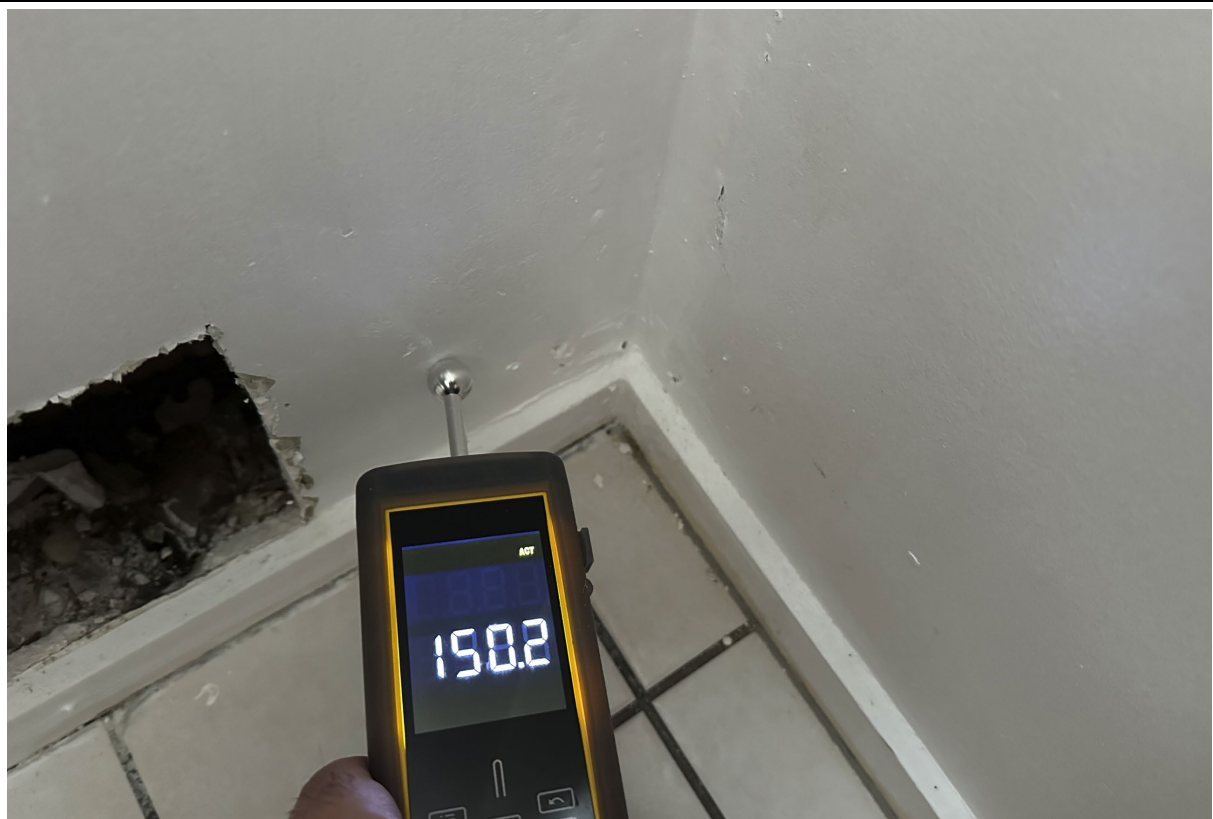
- 5.13. The bottom plate of the exterior wall framing in the bathroom has been replaced with timber treated to meet H3.2 Hazard Class requirements. The exposed timbers have water stain marks but some fungal growth present but no obvious sign of timber decay. The timber and wall linings return highly elevated moisture content readings.

6.19 Highly elevated moisture content reading in external wall of Unit 28 Ground floor Bathroom

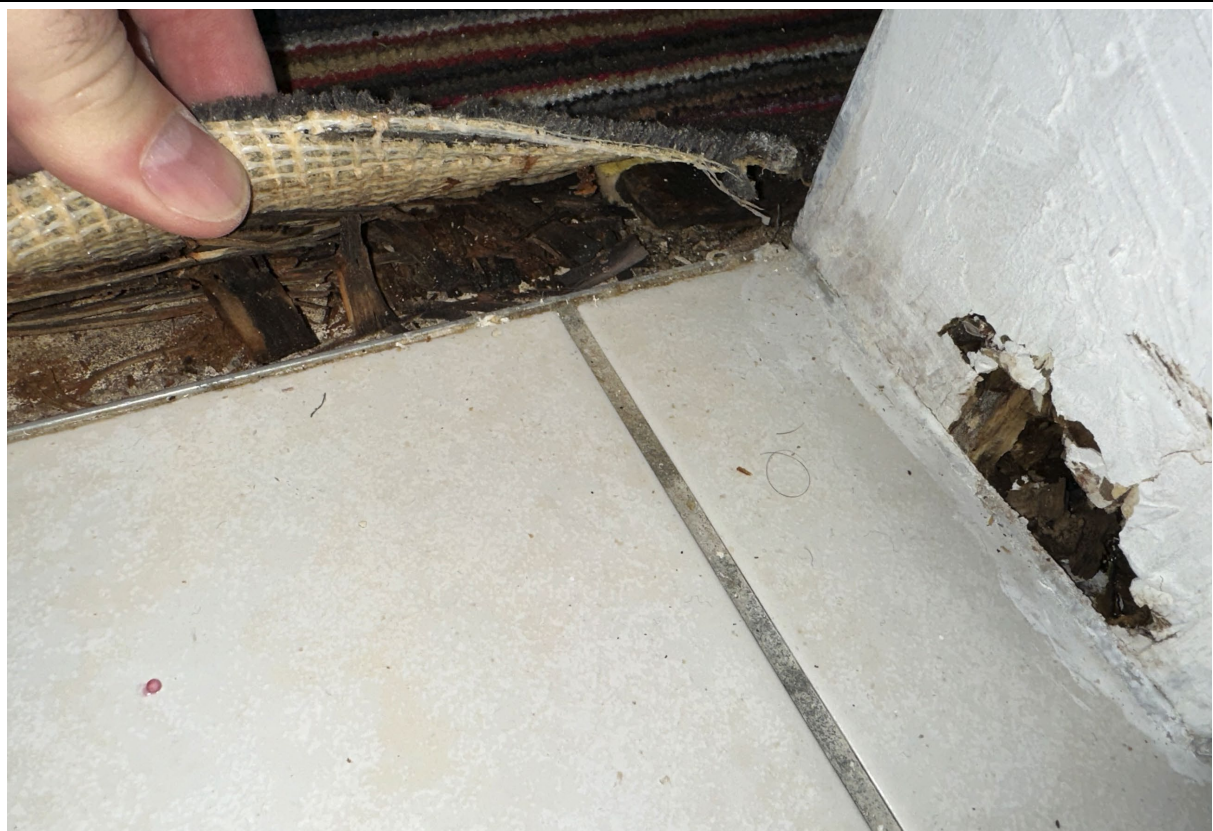
- 5.14. The door reveals and wall framing beside the shower unit at the opposite end of the bathroom from the external wall are severely decayed, as is the carpet edge strip.

6.20 Timber decay in door reveal and carpet edging near shower end of Unit 28 Ground Floor Bathroom
