28 June 2024

| Damage Causation Report | |
| <b>Address:</b> | Units 27 & 28, 595 Laurie Southwick Parade, Gulf Harbour, Auckland |

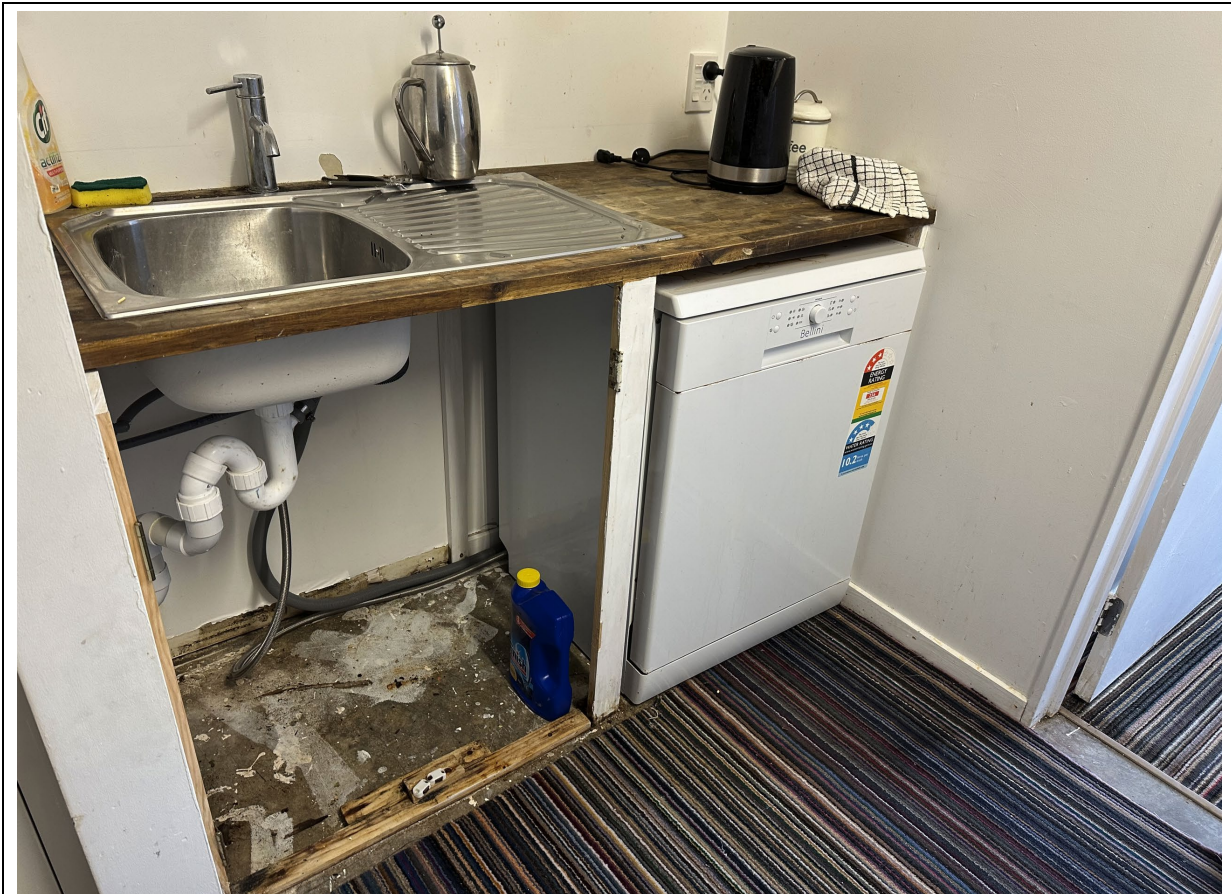
- 5.16. The kitchenette and laundry area that backs on to the bathroom (behind the shower unit) displays evidence of decay in the timber skirting and returns elevated moisture content readings at the base of the wall linings.

6.21 Overview of Kitchenette backing onto bathroom in Unit 28

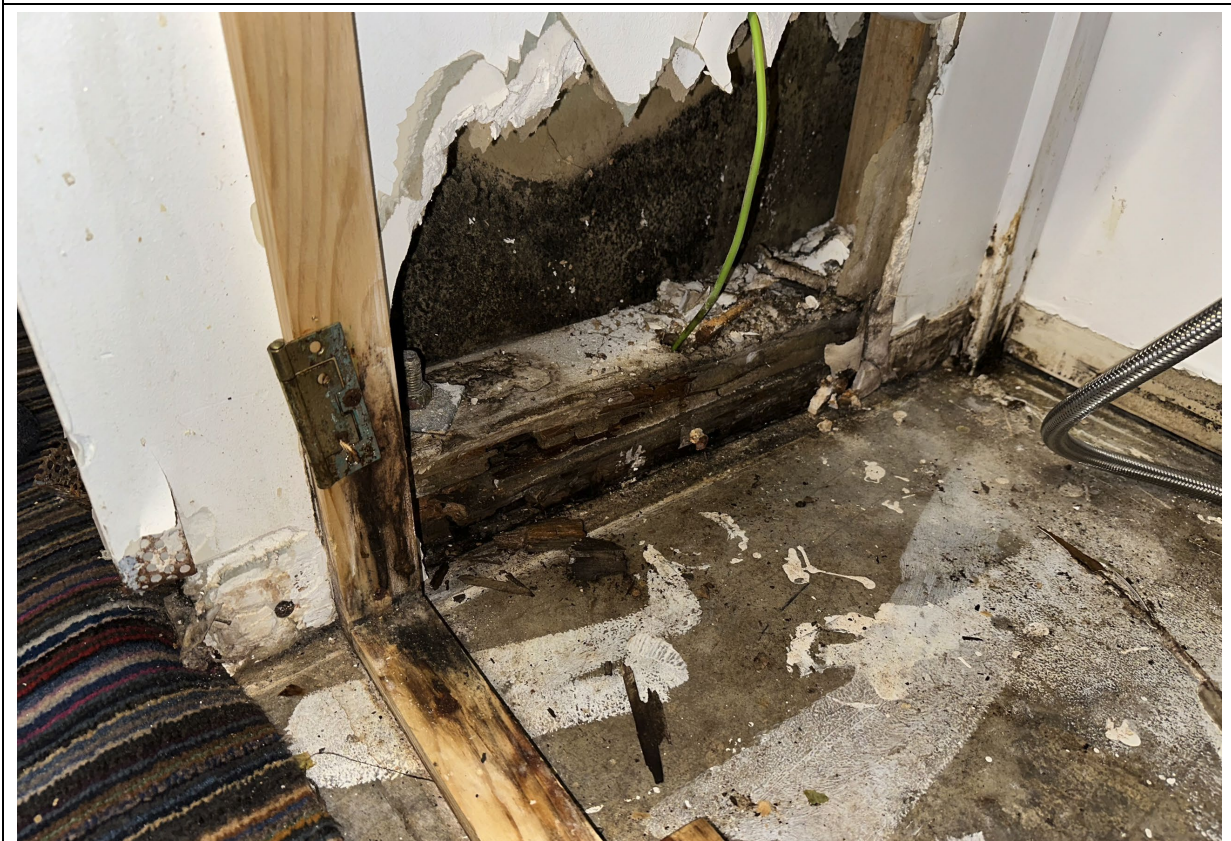
- 5.17. The timber framing between the kitchenette and the laundry is severely decayed at the base.
- 5.18. The concrete floor of the kitchenette is damp to the touch.

6.22 Close up of timber decay in framing between Laundry and Kitchenette in Unit 28
