## Visual Non-Invasive Property Inspection

22/01/2026

720 Christchurch-Akaroa Rd

### INSPECTION INSTRUCTIONS Visual Non-Invasive Pre-Purchase Property Inspection

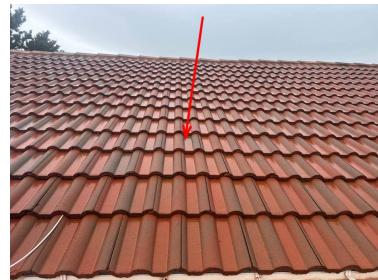
Comments      The roof is constructed of concrete tiles and appears to be in good condition overall. All tiles are intact with no visible damage or signs of dislodgement noted at the time of inspection. Hip and ridge cappings are in place, with mortar beddings appearing intact and showing no visible cracking or displacement. The chimney penetration flashing is intact and appears to be performing as intended.

Concrete tiles

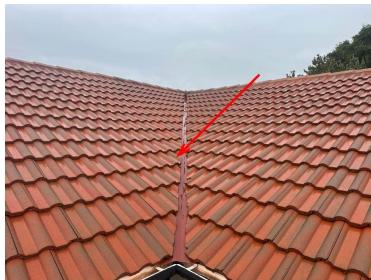
Valley flashings

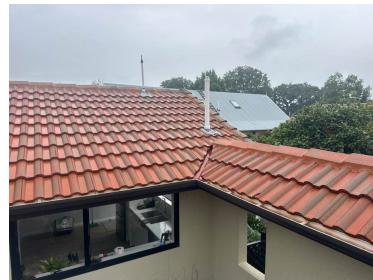
Hip and ridge cappings

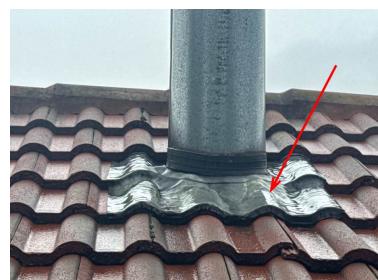
Chimney penetration flashing

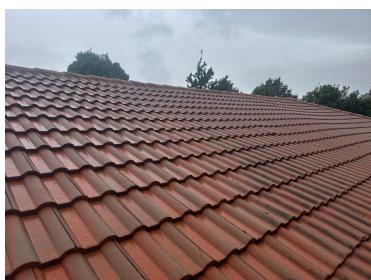
The plastic gutter system is in good condition and effectively channels roof water to the downpipes. Downpipes are stable and appear to be discharging to the stormwater system as intended. Gully traps were observed to be clear and appeared to be functioning properly. No visual defects or issues were identified with the roof covering or drainage system at the time of inspection.

Plastic gutter system

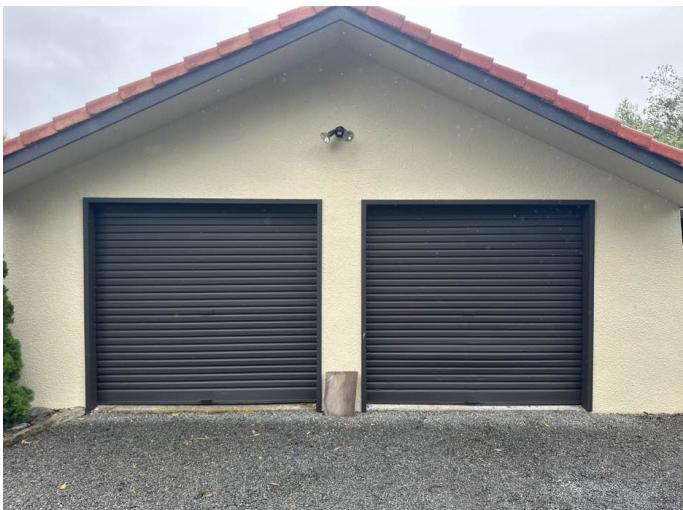
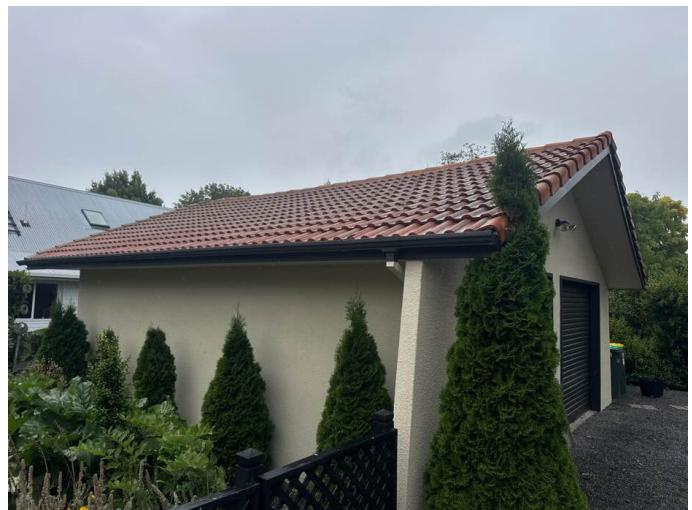
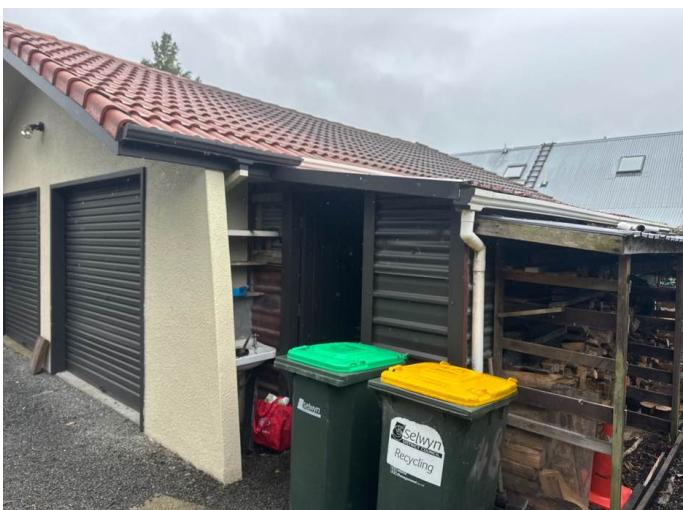
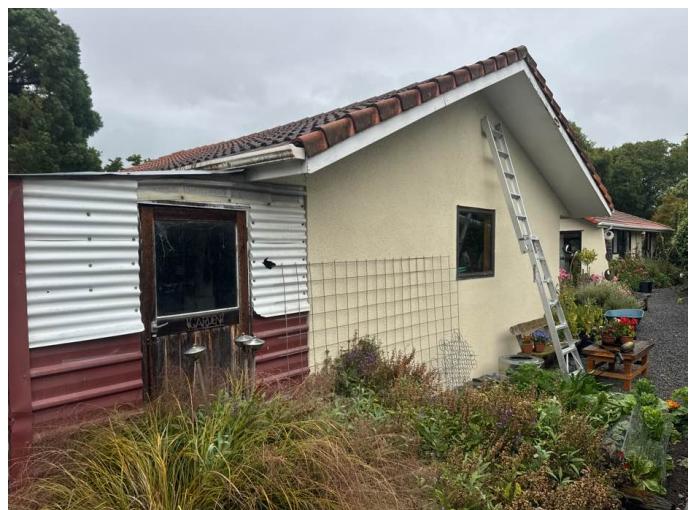
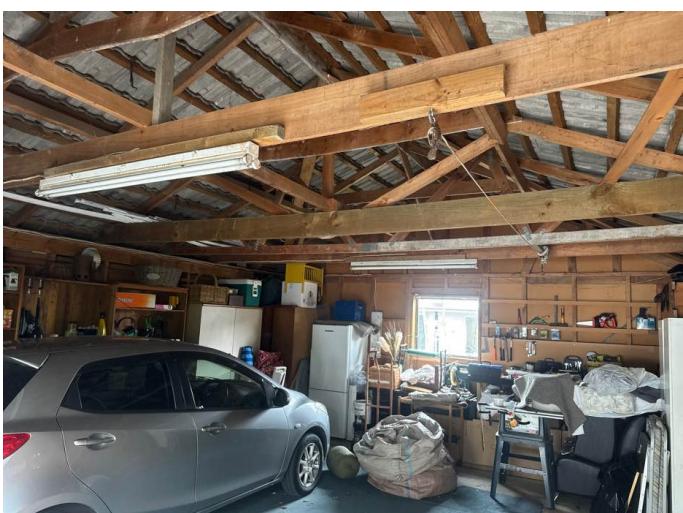
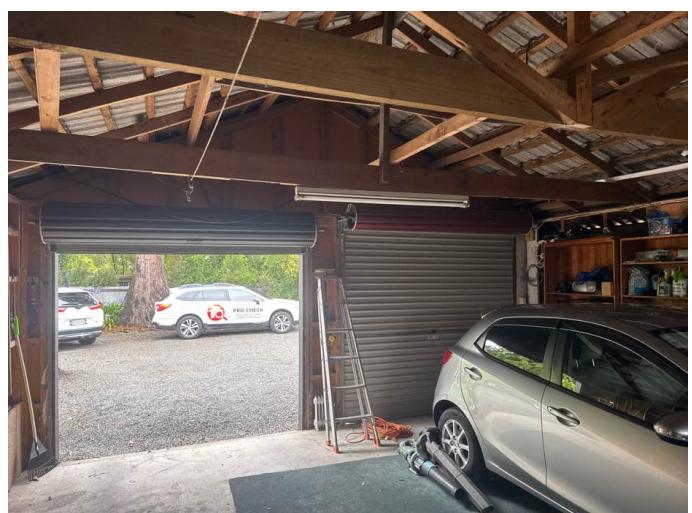
### Garage

The property includes a detached two-car garage fitted with two single-car lightweight steel roller doors. Both doors were operated manually at the time of inspection and were found to be operating smoothly. The exterior of the garage is finished in stucco plaster cladding with a concrete tile roof, consistent with the main dwelling.

Internally, the garage appears clean and tidy. During heavy rain at the time of inspection, the interior was observed to be dry, with no visible water staining or evidence of leaks noted. The structure appears stable and in good condition overall.

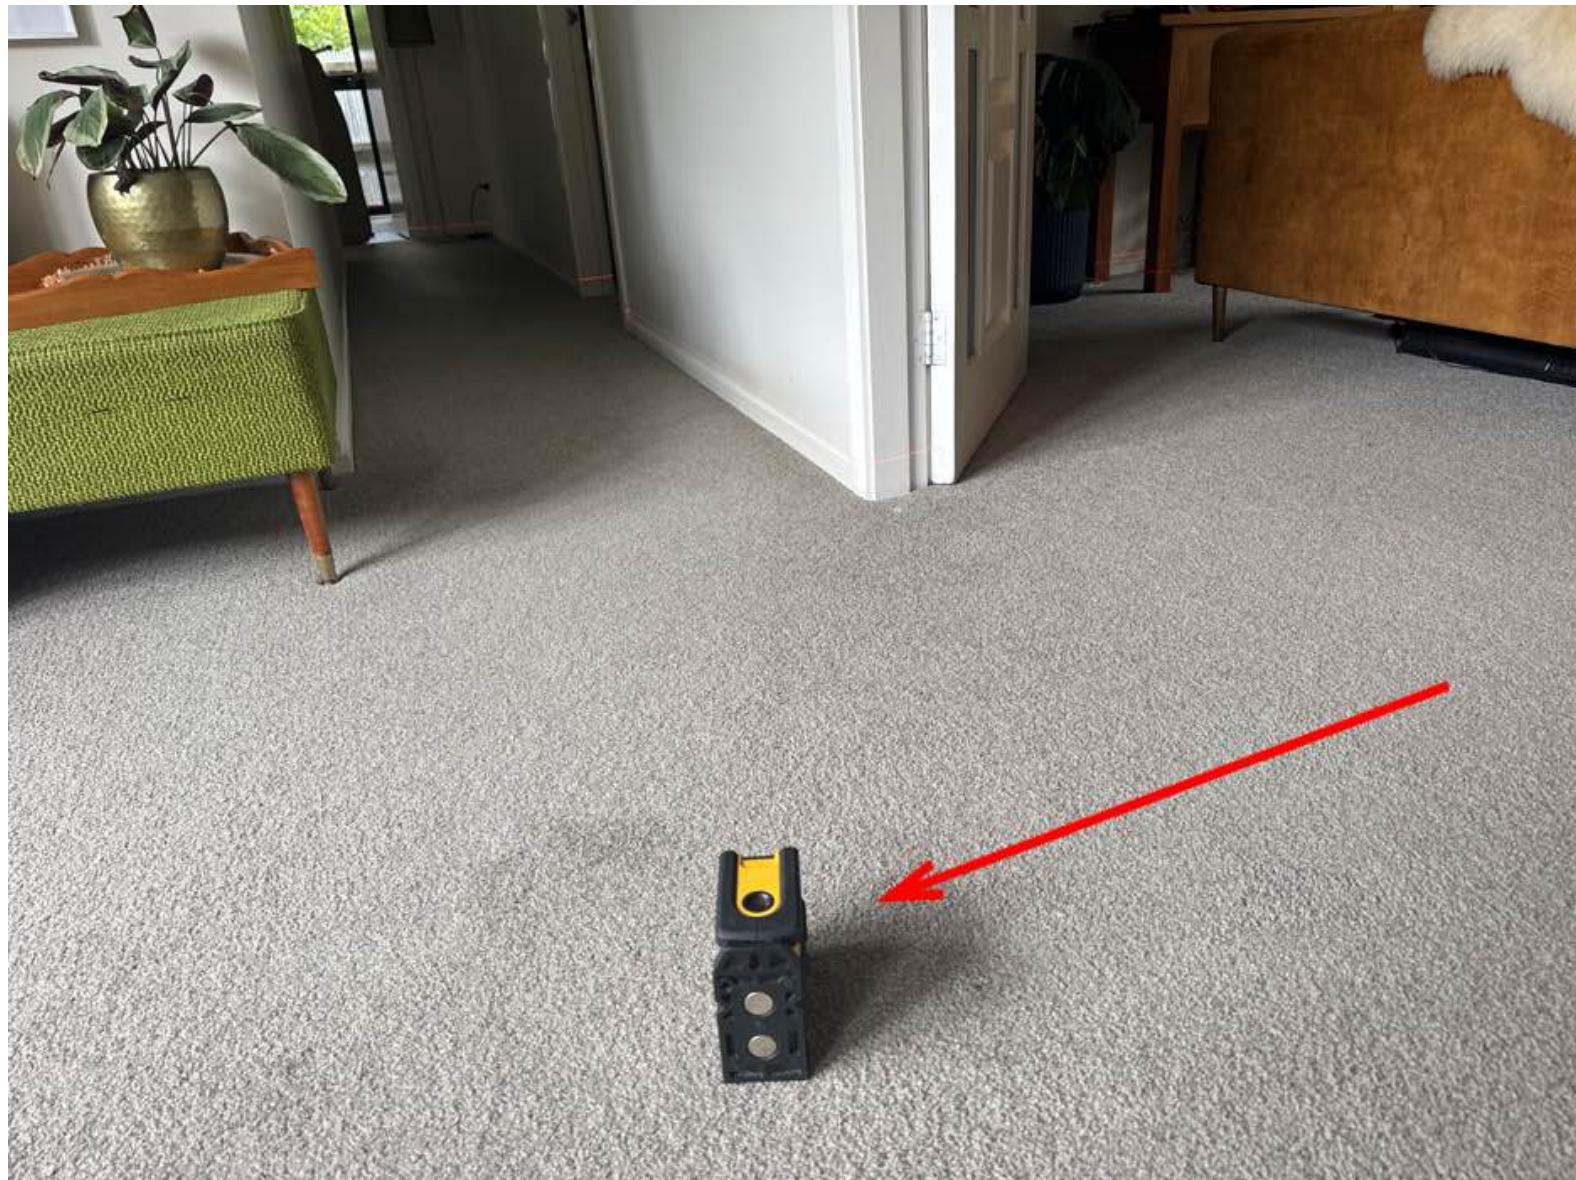
DeWalt laser level

The dwelling is constructed on a concrete foundation with a concrete slab floor. Floor level measurements were carried out using a DeWalt cross-line laser level at the time of inspection. The findings indicate that the overall footprint of the house is within 25mm of level, with no slopes exceeding 10 mm over a 2 m span recorded throughout the accessible areas of the dwelling.

These measurements fall within acceptable MBIE tolerance guidelines, which allow for up to 50 mm variation across the footprint of a dwelling and up to 10 mm over a 2 m span. Based on the readings obtained, the foundation and floor levels are considered to be within acceptable limits at the time of inspection.

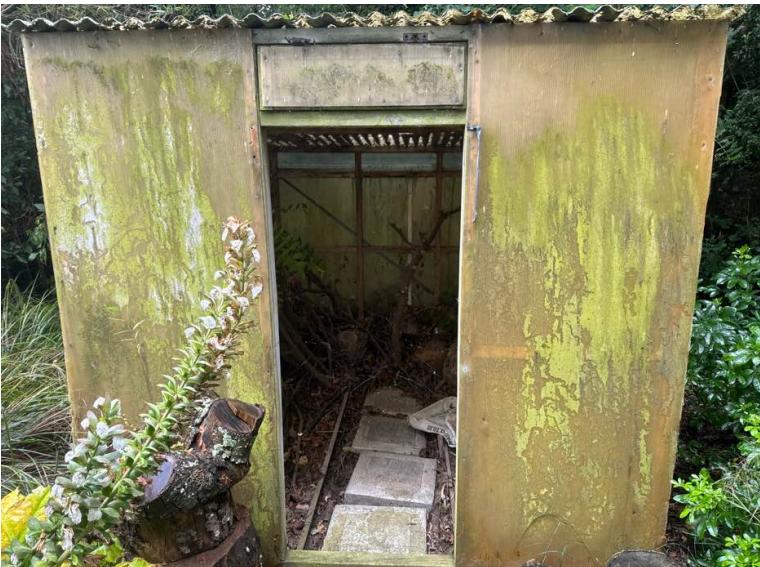
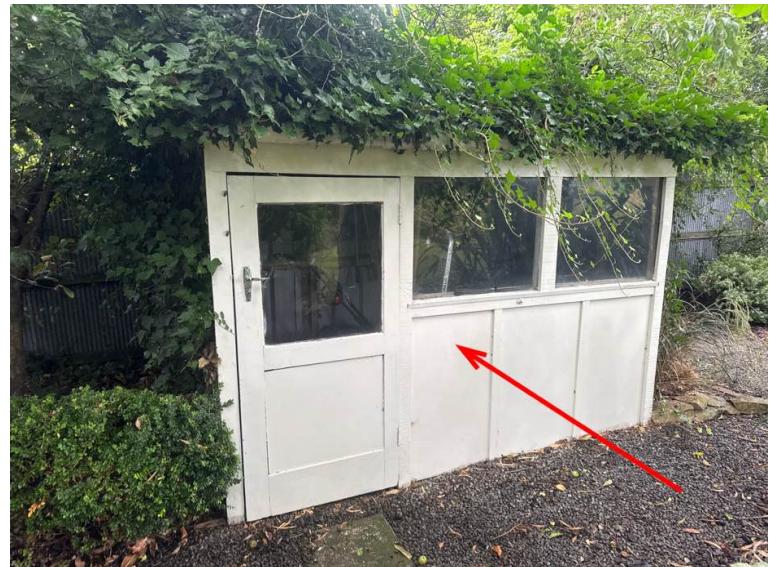
Comments      There are two garden sheds located at the rear of the section. One shed is currently used for general garden storage and contains garden tools and equipment. Despite heavy rain at the time of inspection, the interior of this shed was observed to be dry, with no signs of water ingress noted.

Garden shed in use

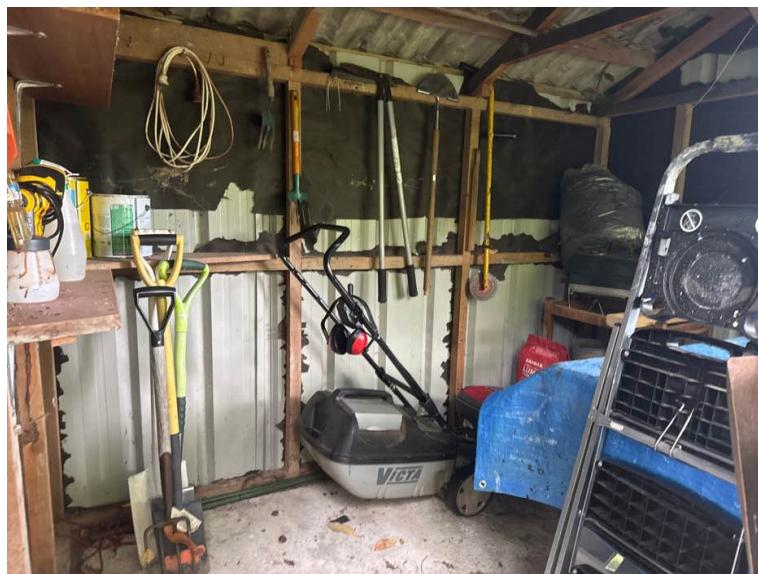
The second shed is not currently in use and was also inspected during heavy rain conditions. This shed was observed to be dry internally, with no visible evidence of leaks or moisture ingress. Both sheds appear to be serving their intended purpose at the time of inspection.

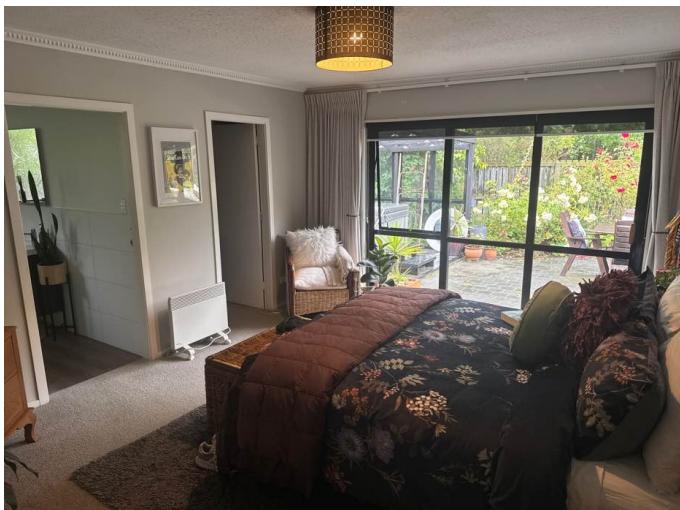
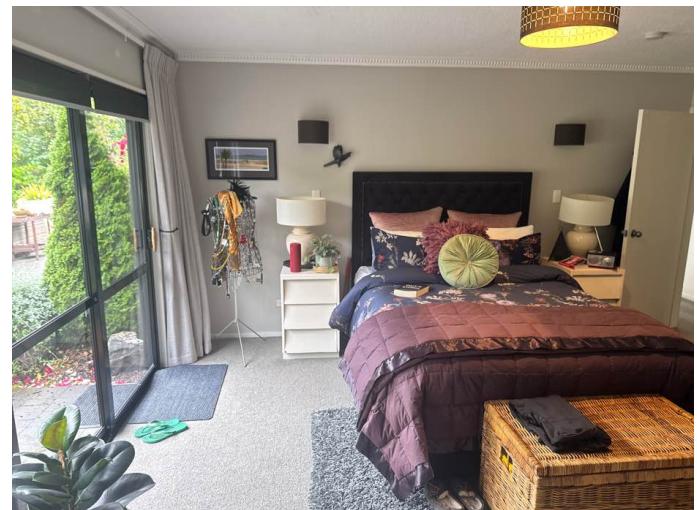
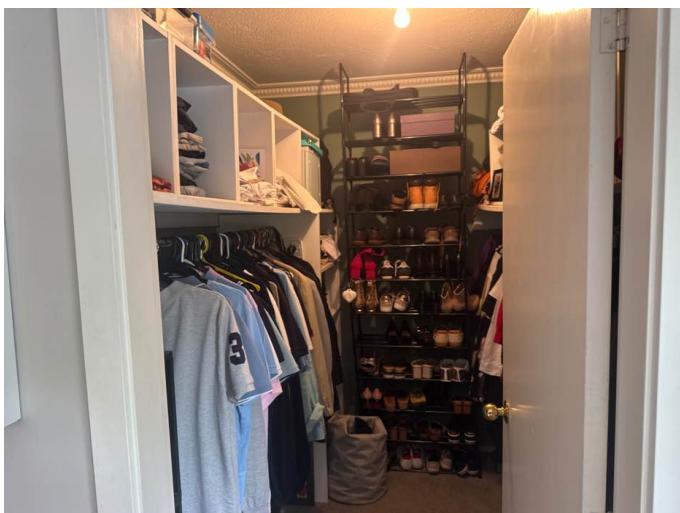
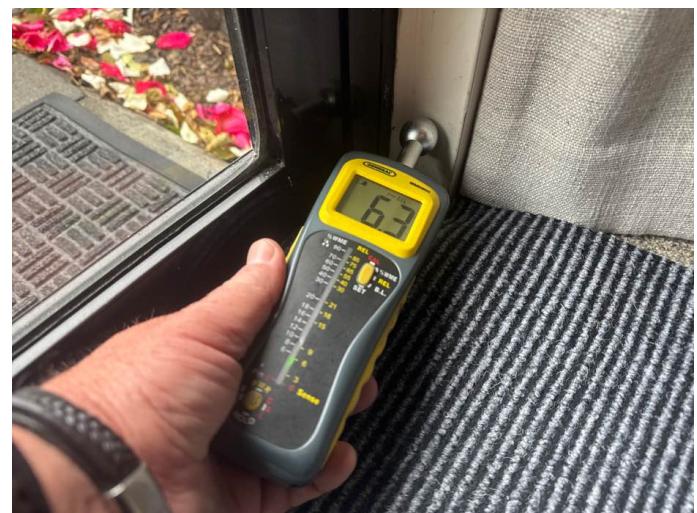
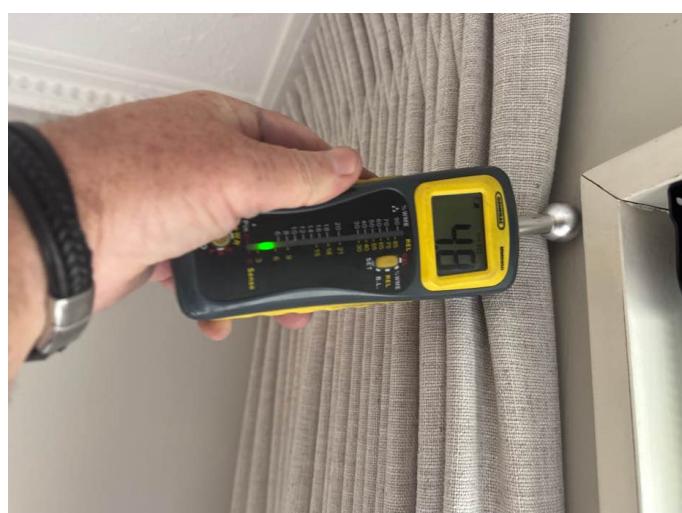
### Master Bedroom

Comments      The master bedroom is in good condition overall. Walls, ceilings, and flooring appear clean and well maintained, with no visible defects or damage noted at the time of inspection. Windows and doors were operated and were found to be functioning as intended, including the ranch slider, which was observed to open and close smoothly.

Moisture testing was carried out to typical risk areas, with readings below 15 recorded. A green light indication confirms dry conditions at the time of inspection.

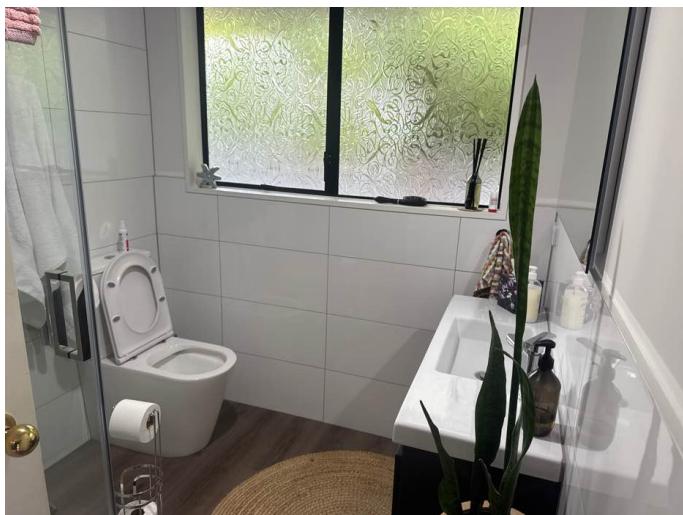
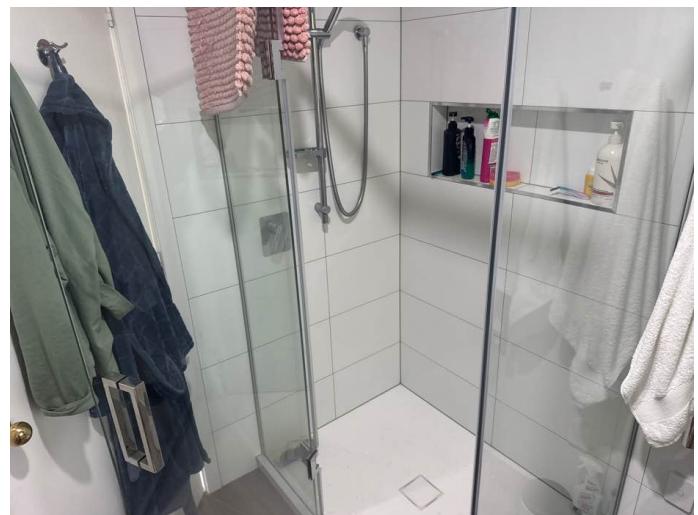
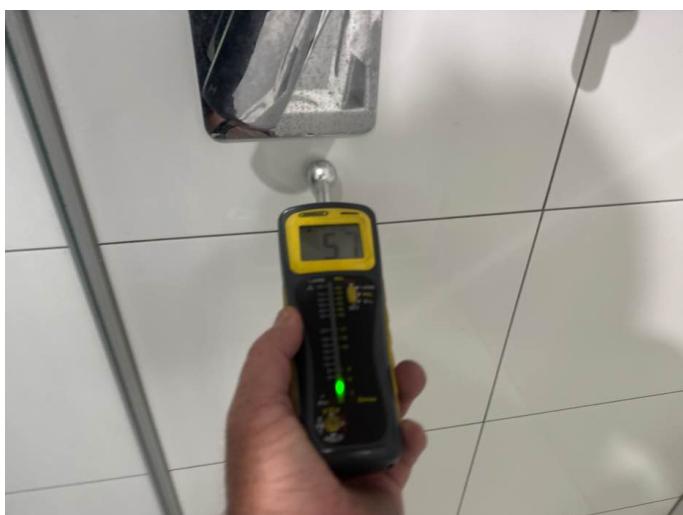
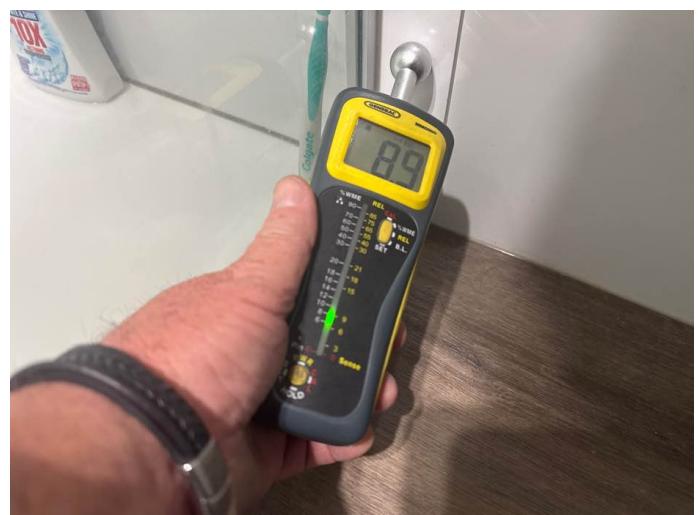
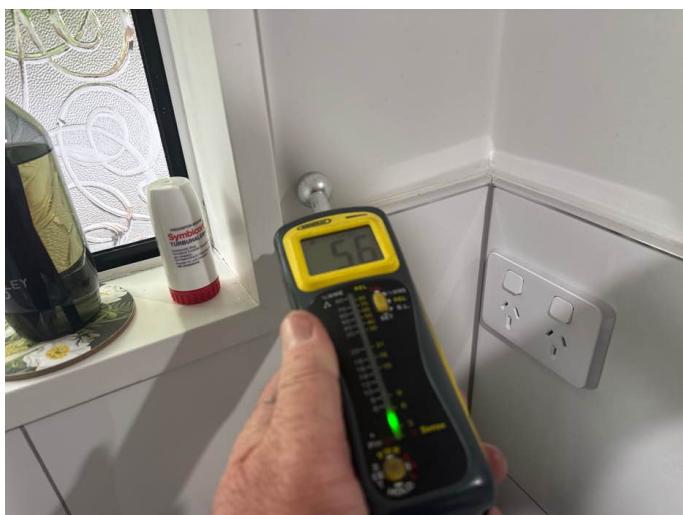
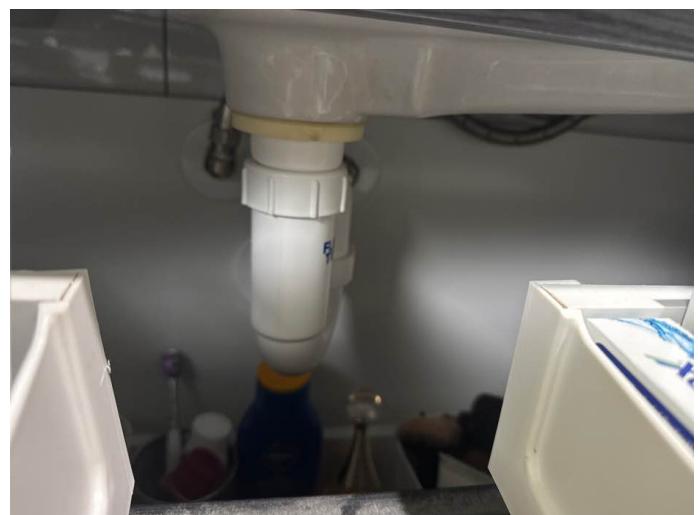
### Ensuite

Comments      The ensuite is in good condition overall. Fixtures and fittings, including the toilet, vanity, shower, tapware, and plumbing fixtures, were observed to be in good working order and functioning as intended. No leaks were detected beneath the vanity or to visible pipework at the time of inspection. Wall, floor, and ceiling surfaces appear clean and tidy, with no visible defects or areas of concern noted.

Moisture testing was carried out to typical risk areas, with readings below 15 recorded. A green light indication confirms dry conditions at the time of inspection.

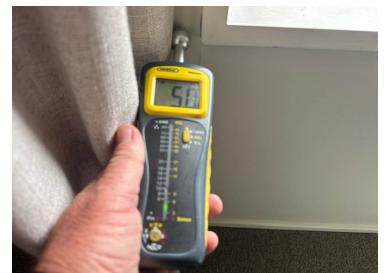
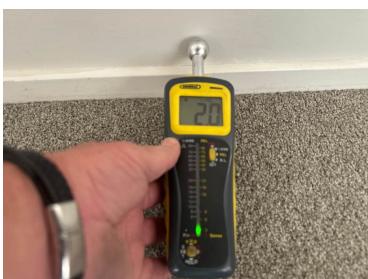
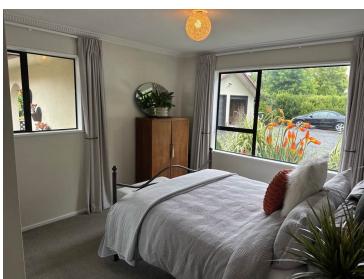
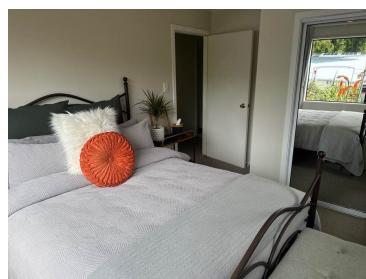
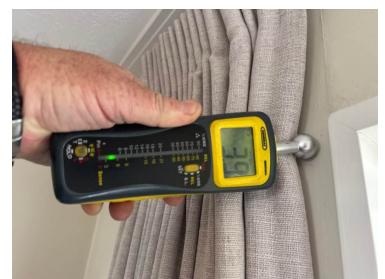
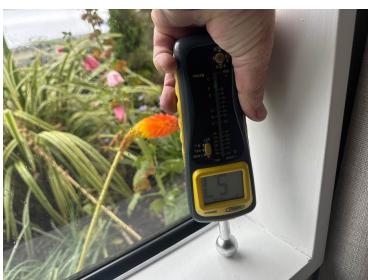
### Bedrooms

Comments      The additional three bedrooms are in good condition overall. Walls, ceilings, and flooring appear clean and well maintained, with no visible defects or damage observed at the time of inspection. Windows and doors were operated and were found to open and close as intended.

Moisture testing was carried out to typical risk areas, with readings below 15 recorded. A green light indication confirms dry conditions at the time of inspection.

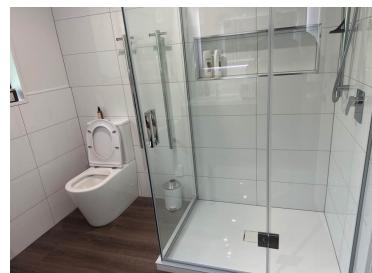
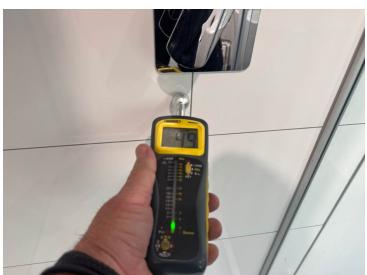
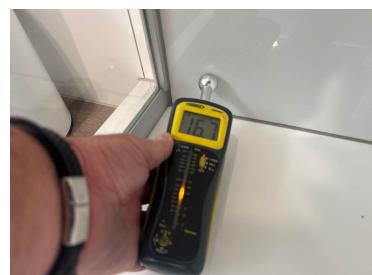
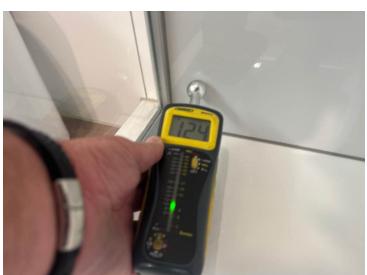
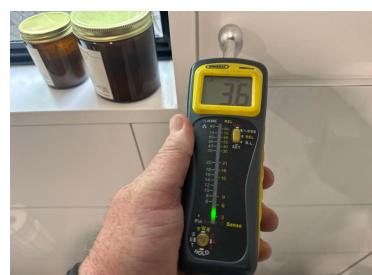
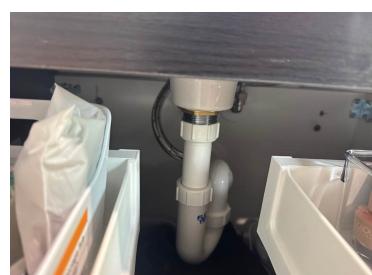
### Master Bathroom

Comments      The main bathroom is in good condition overall. Fixtures and fittings, including the toilet, vanity, shower, bath, tapware, and plumbing fixtures, were observed to be in good working order and functioning as intended. No leaks were detected beneath the vanity or to visible pipework at the time of inspection. Wall, floor, and ceiling surfaces appear clean and tidy, with no visible defects or areas of concern noted.

Moisture testing was carried out to typical risk areas, with readings below 15 recorded. A green light indication confirms dry conditions at the time of inspection.

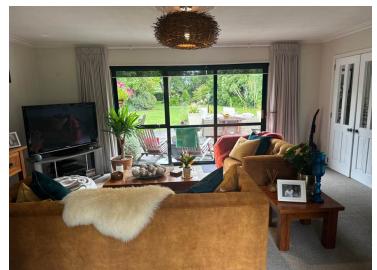
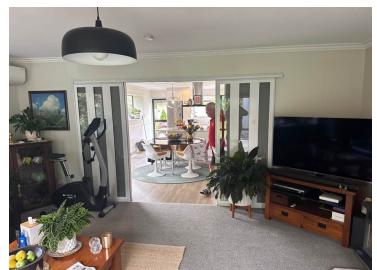
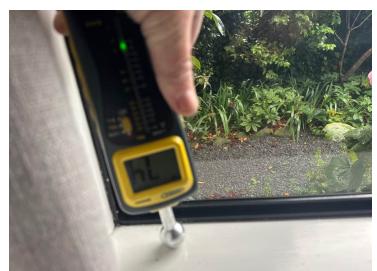
### Interior Spaces

The hallway, front door area, two living rooms, and dining area are all in good condition and appear well maintained. Walls, ceilings, and flooring throughout these areas show no visible defects, damage, or areas of concern at the time of inspection. All internal doors and windows and ranch sliders were operated and were found to open and close properly.

Moisture testing was carried out to typical risk areas, including external wall junctions, with readings below 15 recorded. A green light indication confirms dry conditions, with no moisture issues detected during the inspection.

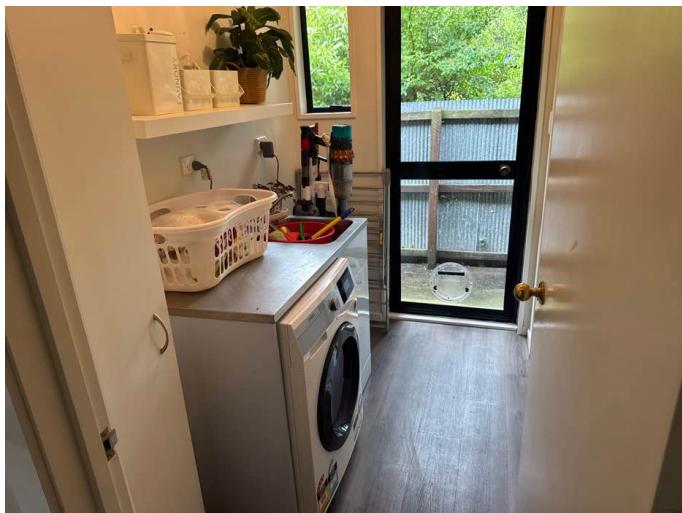
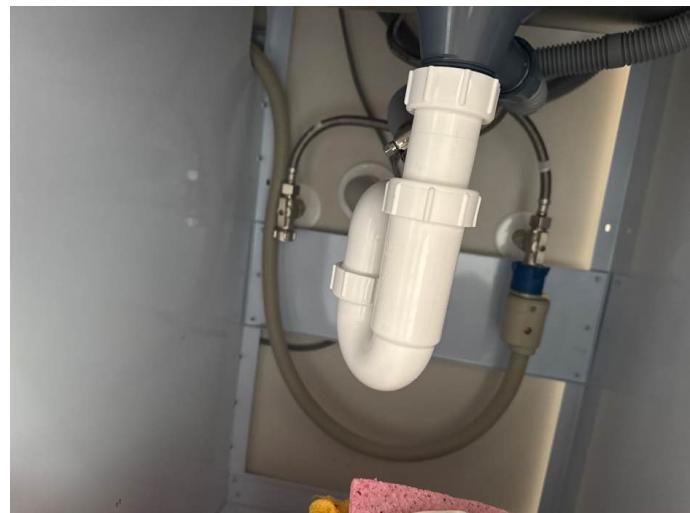
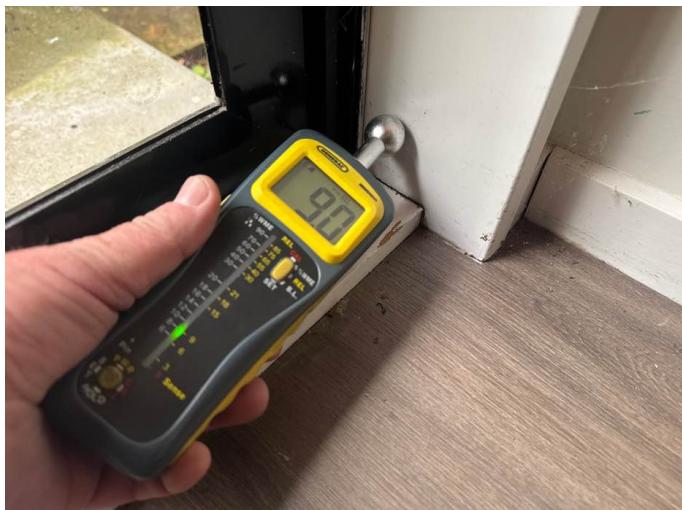
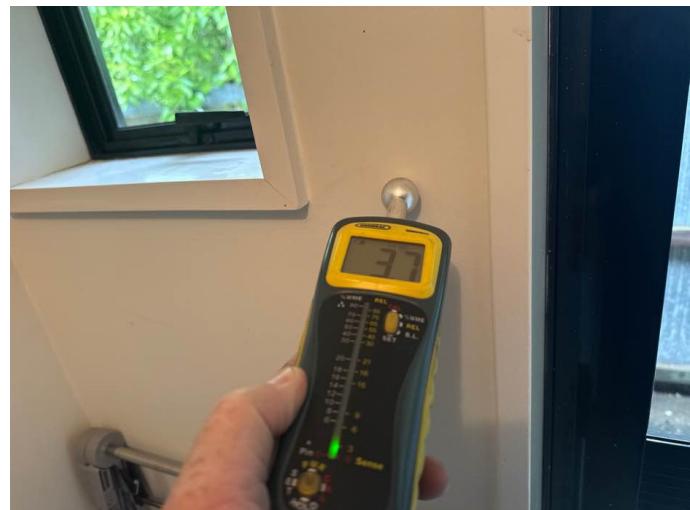
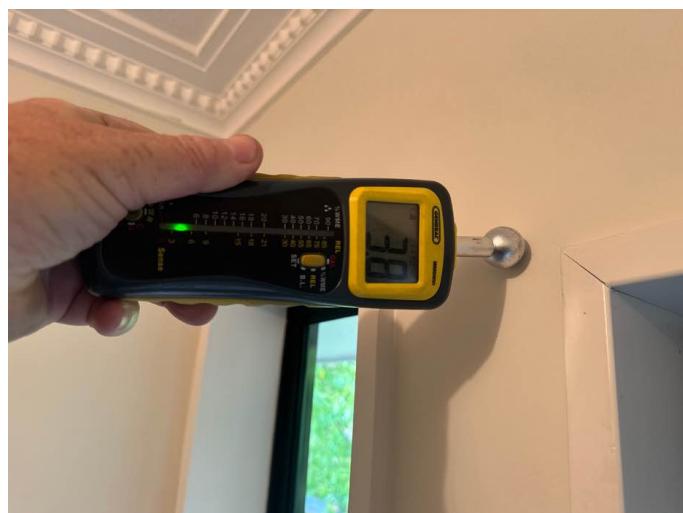
### Laundry

Comments      The laundry is in good condition overall. Tapware and plumbing fixtures were observed to be in good working order and functioning as intended. No leaks were detected beneath the sink or to adjoining pipework at the time of inspection. No visible water damage or defects were observed to surrounding surfaces.

Moisture testing was carried out to typical risk areas, with readings below 15 recorded. A green light indication confirms dry conditions at the time of inspection.

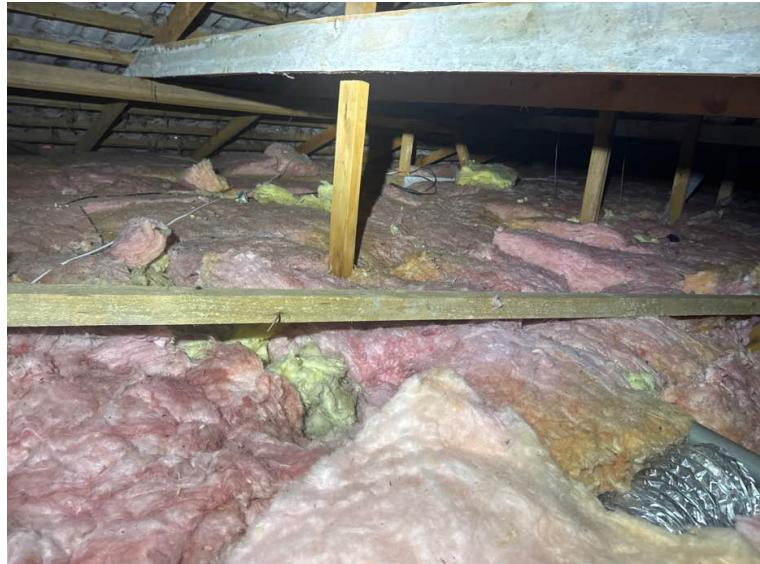
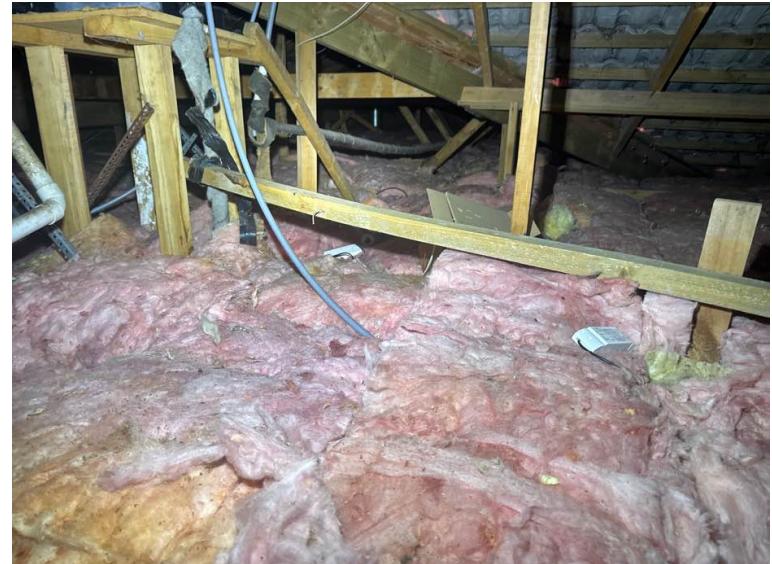
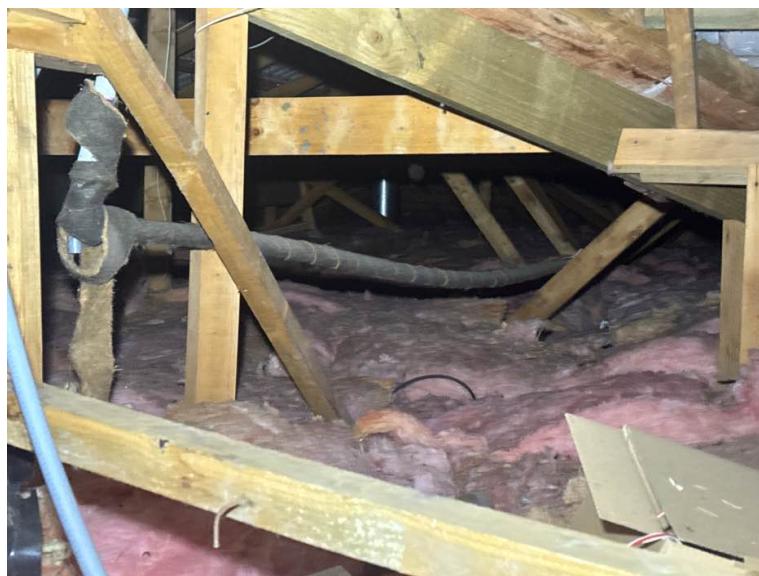
### Insulation

Comments      Pink Batts insulation was observed within the roof space and appears to be in good condition, providing good coverage and thermal protection. No areas of missing, displaced, or damaged insulation were observed in the accessible areas at the time of inspection.

The roof framing and structure within the roof space appeared clean and tidy, with no visible signs of water staining, moisture, or deterioration noted. The roof structure appeared structurally stable, with no issues identified during the inspection of accessible areas.

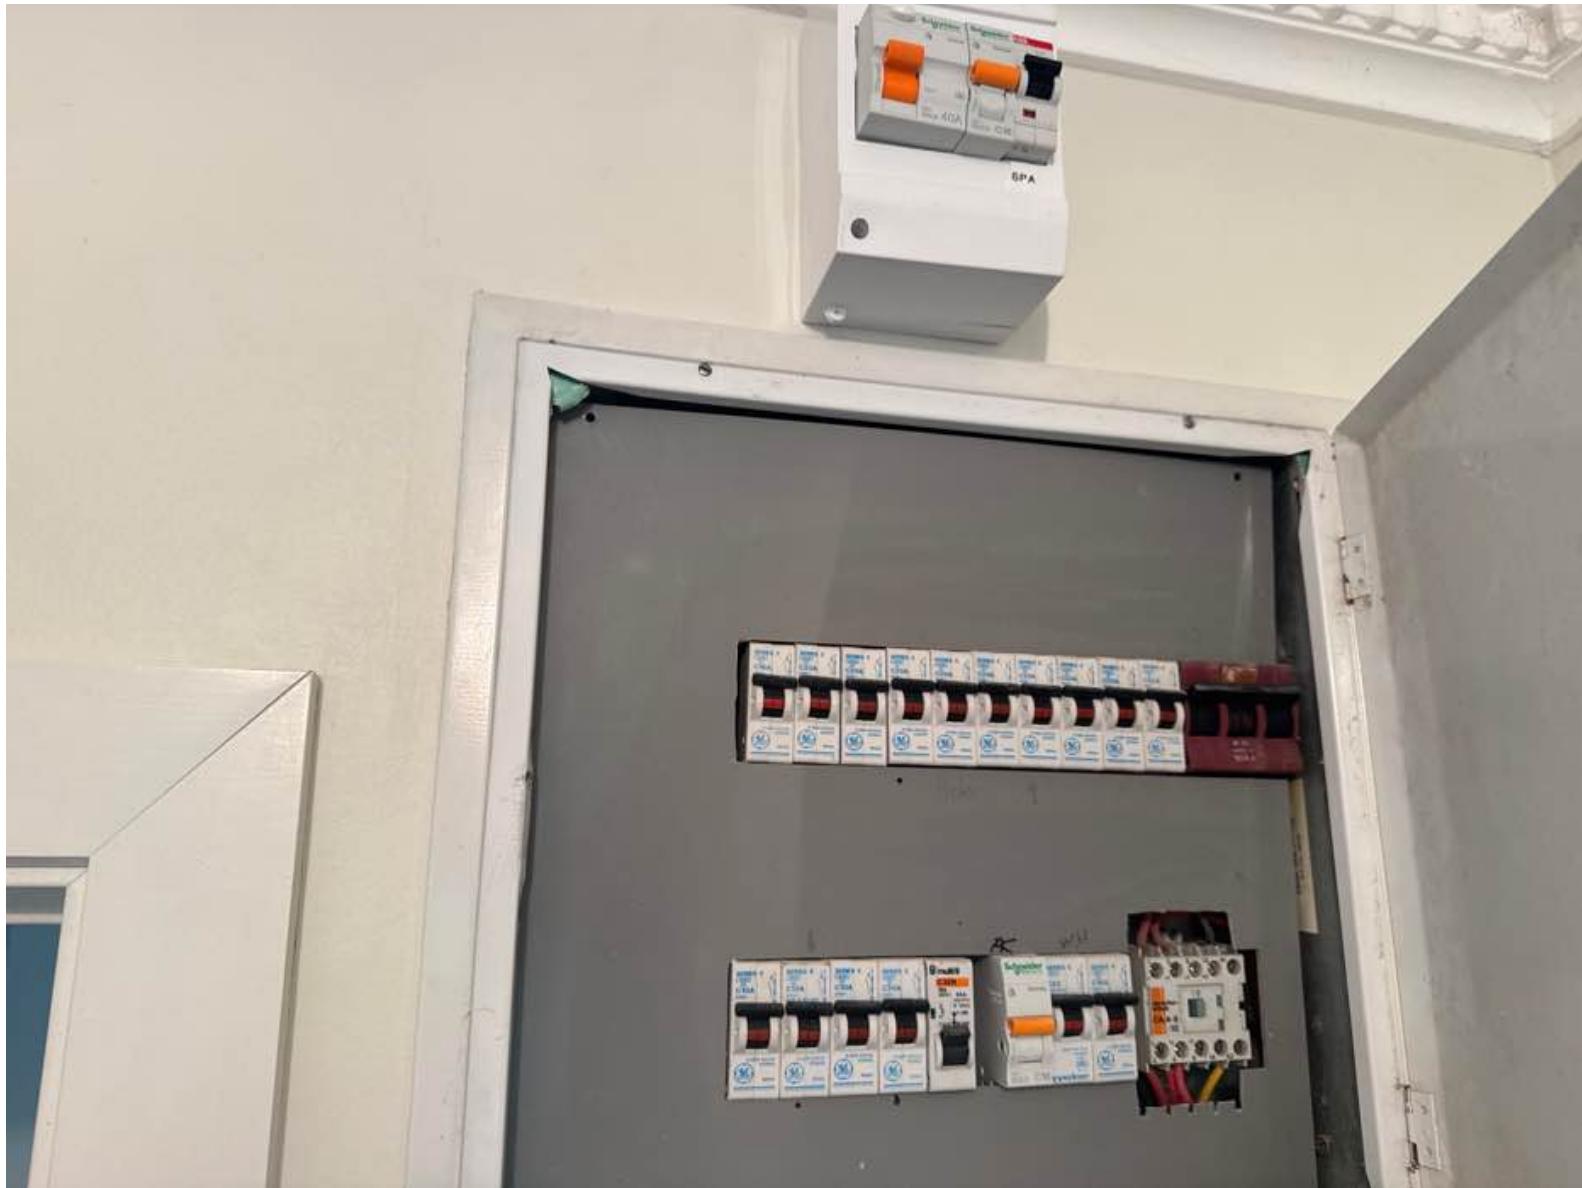
## Electrical

Comments      The main electrical switchboard was visually inspected and appears to be in good condition, with no visible defects or areas of concern noted at the time of inspection. Power outlets, light switches, and visible electrical components throughout the dwelling appeared to be in generally good condition and functioning as intended.

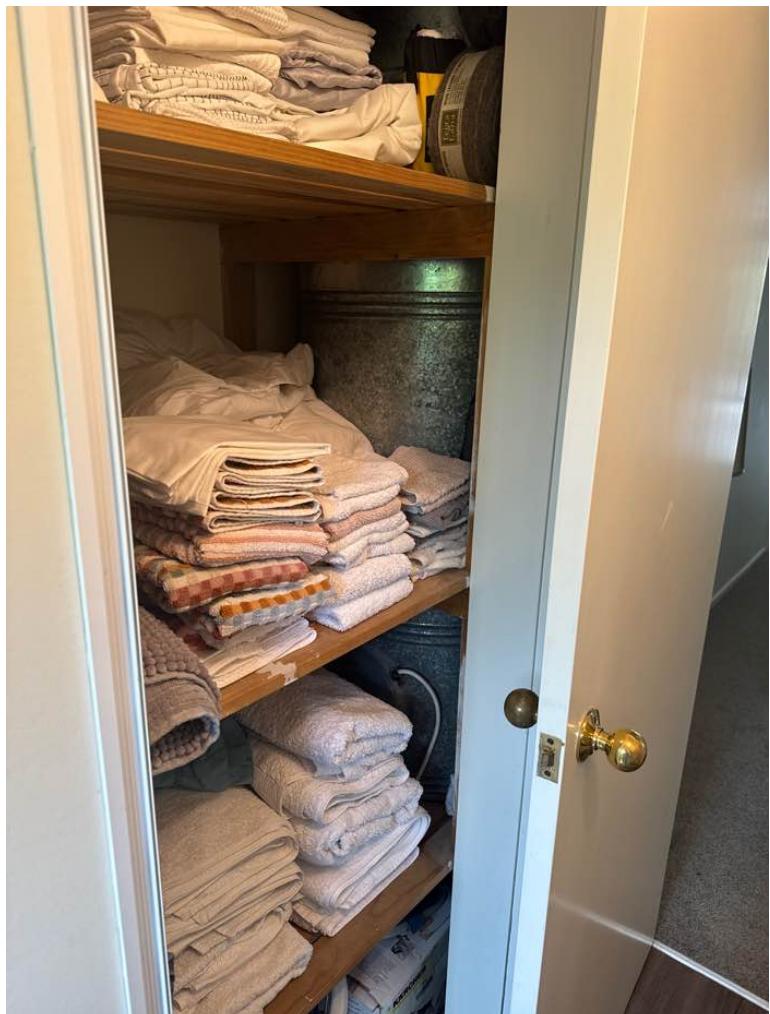
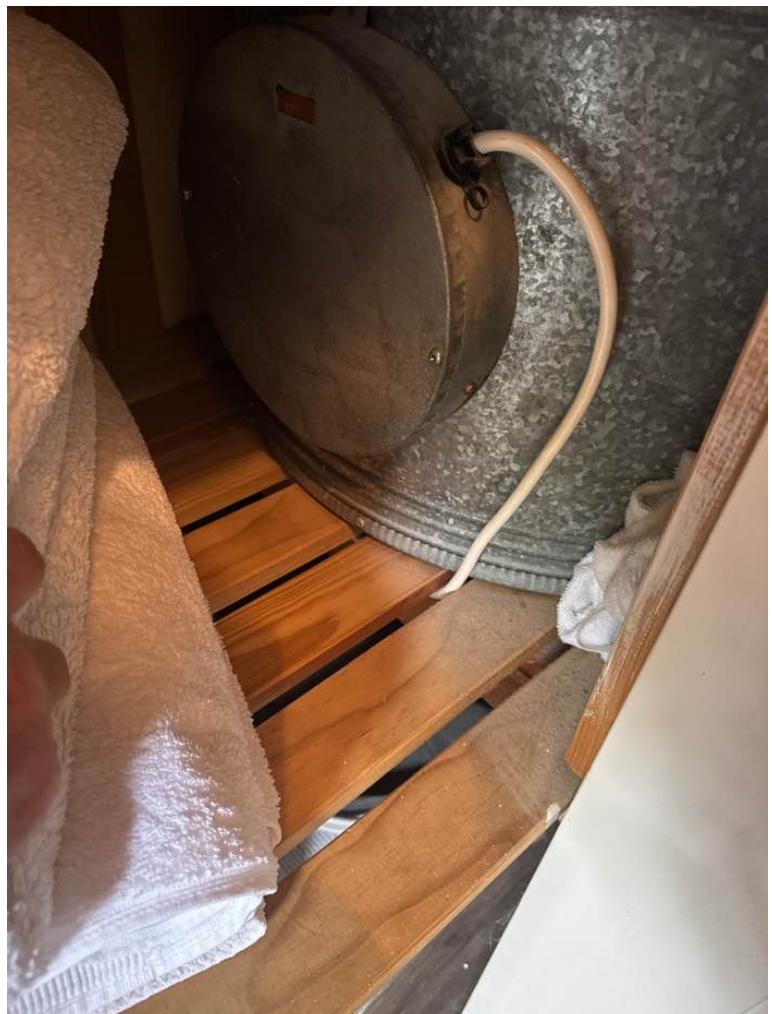
### Hot Water

Comments      The hot water cylinder was visually inspected and appears to be in good condition at the time of inspection. The cylinder is securely installed, with no visible signs of corrosion, leakage, or deterioration noted. All visible pipework and fittings appear secure and in satisfactory condition, with no issues observed during the inspection.

No moisture issues or water staining were observed in the surrounding area at the time of inspection.
