David Heard
D.C. Heard Ltd
28 Stanley Drive
Lynmore, Rotorua
(ph. 07-3455-558 hm; 027-4950-353)

Monday 07 January 2002

Geological Report: 96 Pukuatua Street

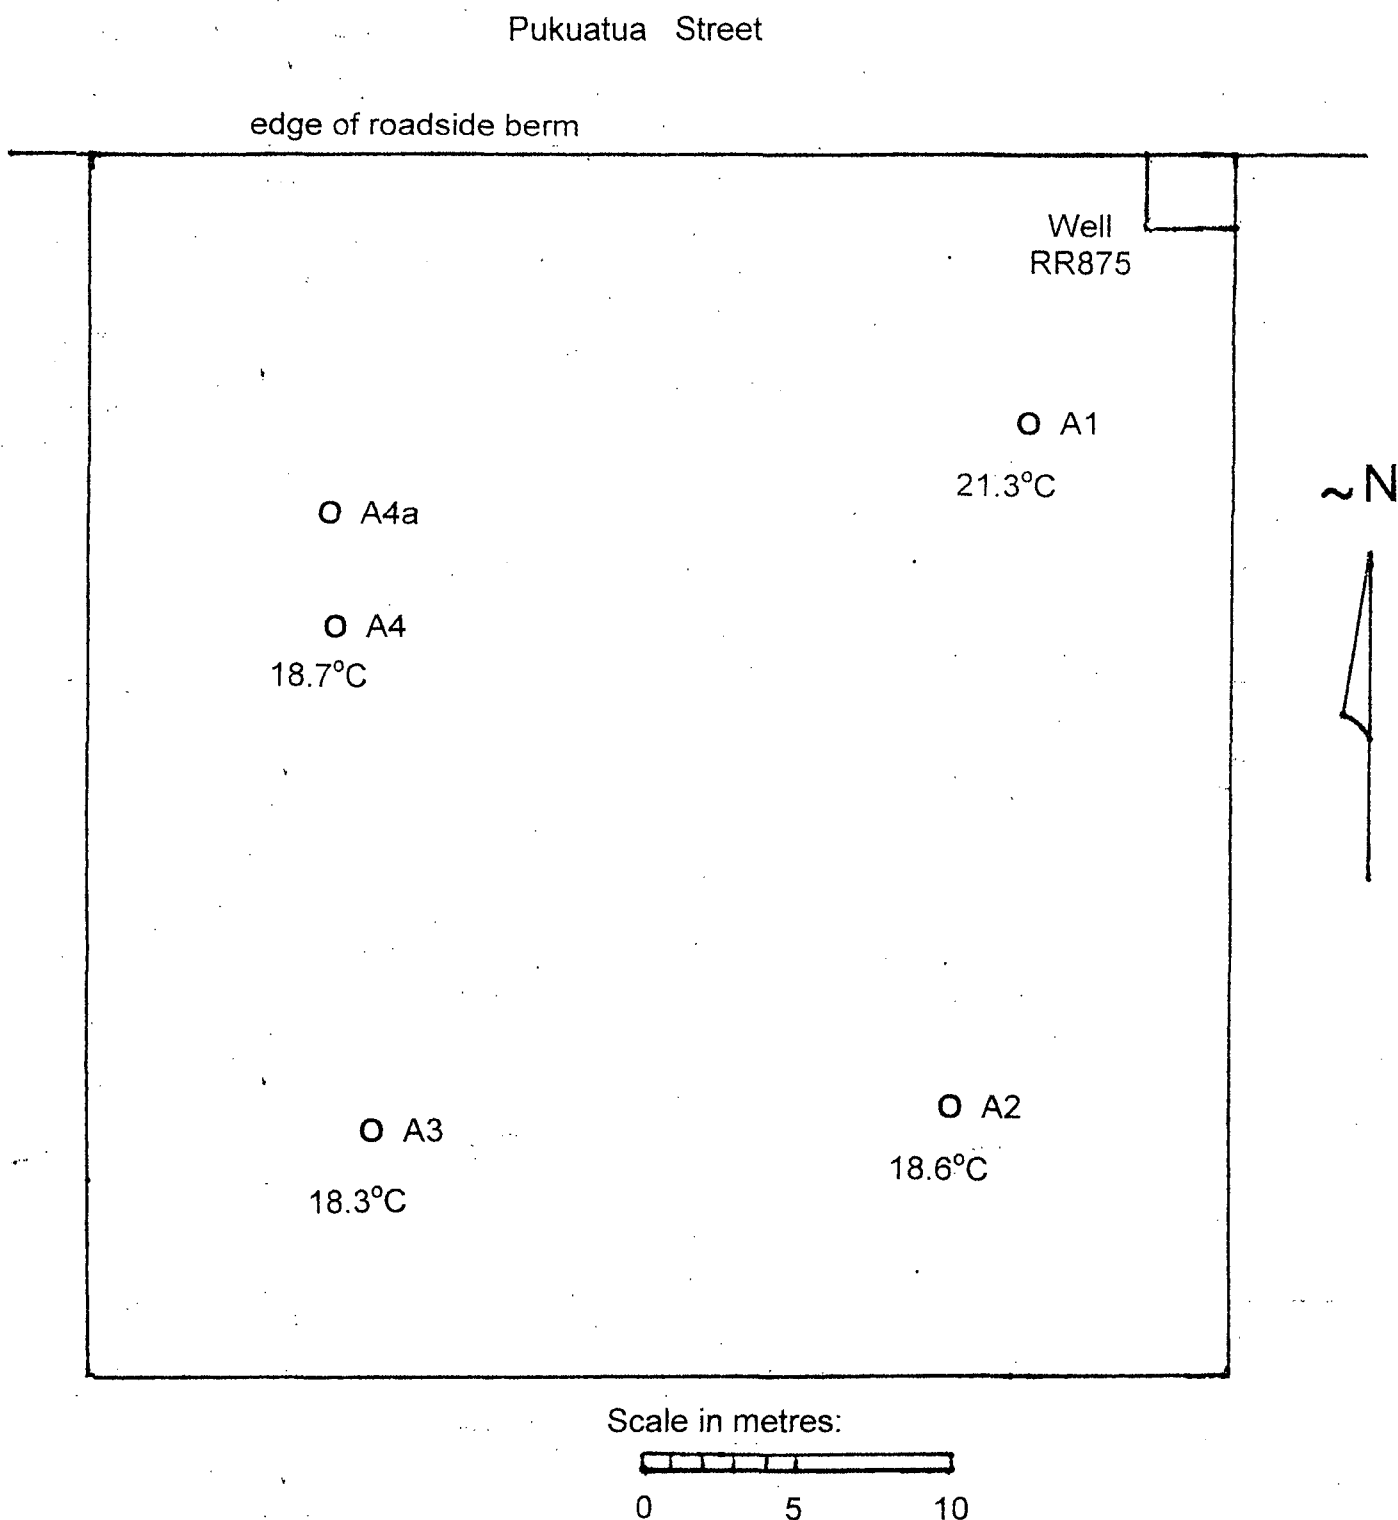
Four ground inspection holes were augered up to 2.5 metres deep at places shown in Figure 1. These holes were sited to examine the subsurface ground conditions around the section and because of the general uniformity of subsurface materials and conditions, four holes were considered sufficient.

Figure 1: Location diagram of No.96 Pukuatua Street section, showing locations of augered inspection holes (A1 – A4). Scale is 4mm = one metre. Geothermal production well RR875 in cellar at northeast corner of site. Hole A4a abandoned at 0.6m depth onto horizontally lying wide concrete slab. Ground temperatures at one metre depths also shown (°C).

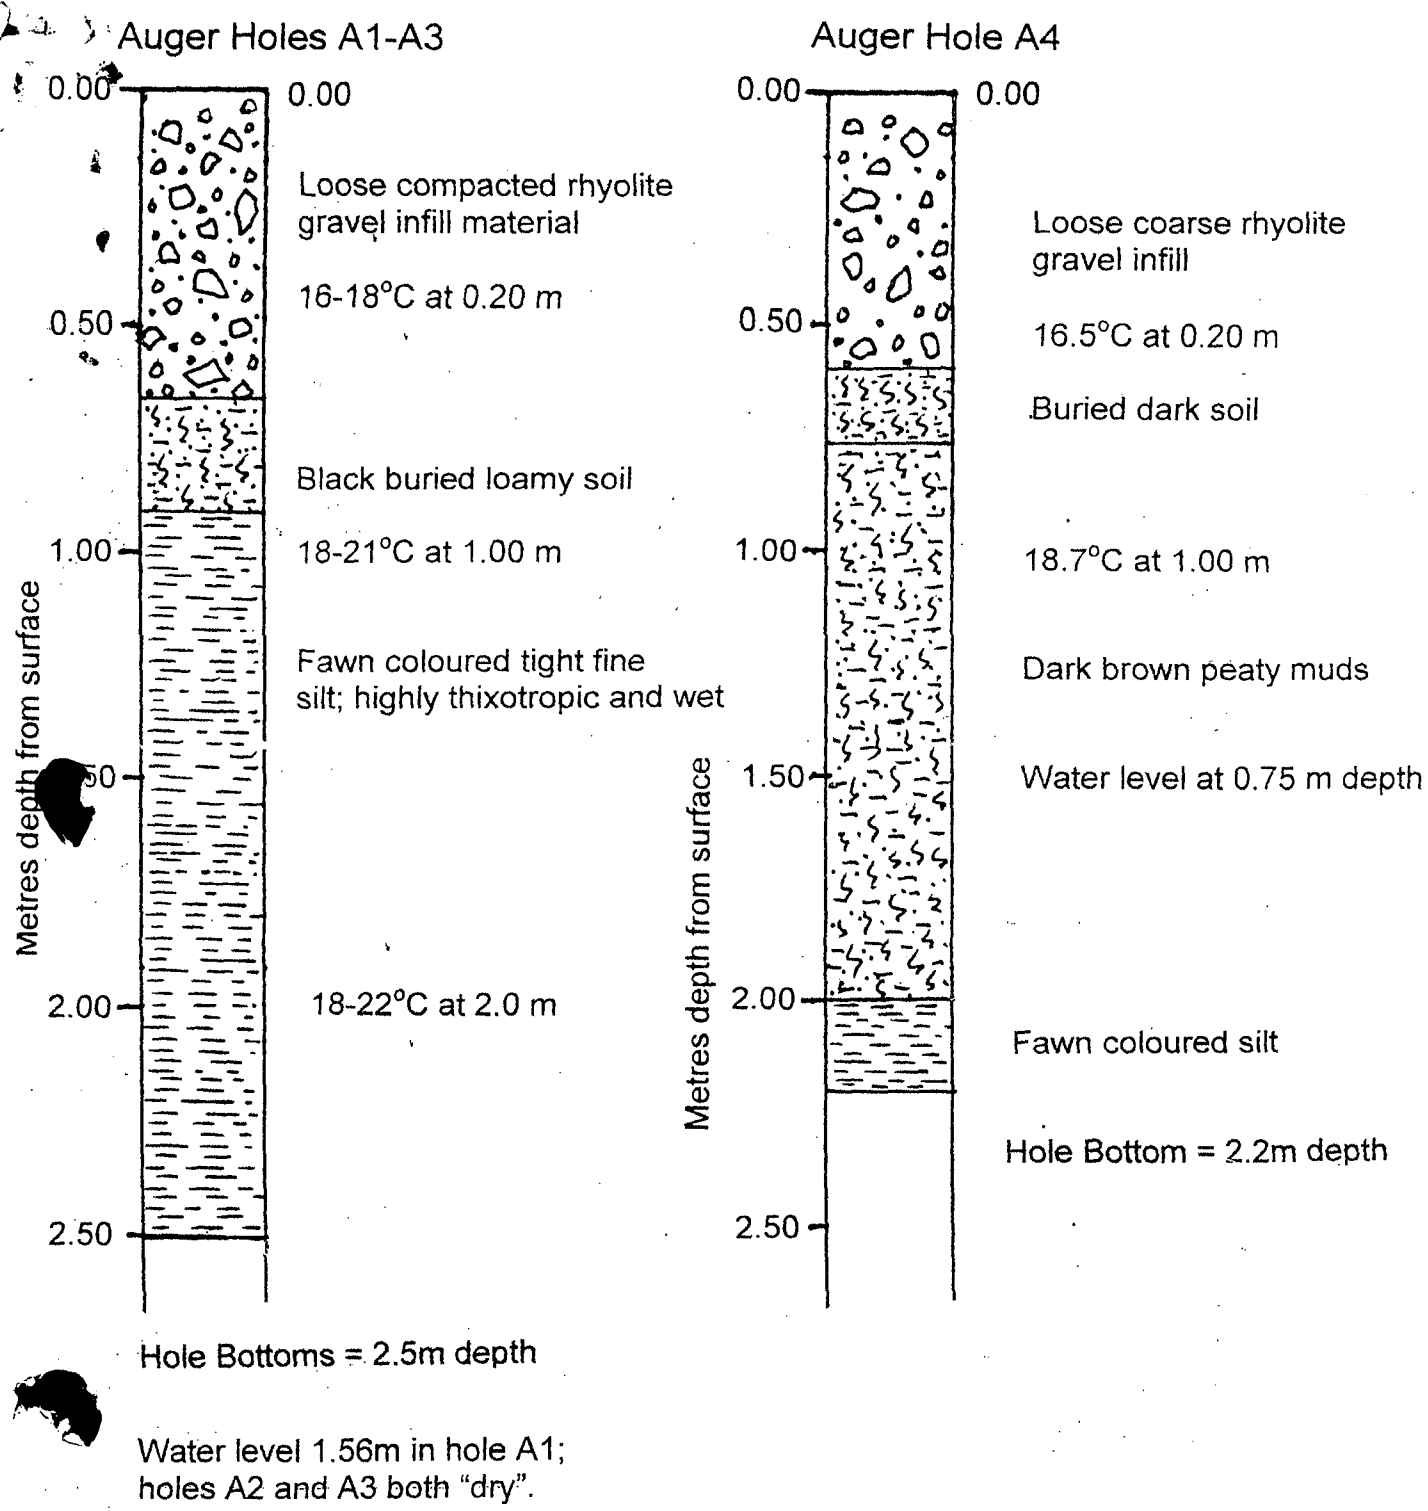
Stratigraphic summaries of these holes are shown in Figure 2, which also include notes about temperatures. Heatflows across the section have not been contoured because all results were at ambient, or non geothermal values.

Locations of augered inspection holes are shown in Figure 1 and descriptions of materials found in each hole are given in Figure 2. All holes are were of broadly similar materials, with assorted infill comprising the upper 0.5-0.7 metres of ground. This was underlain by a rich loamy black soil 0.1-.2m thick, under which was a fine grained massive silt unit.

This silt was pale fawn colour in its upper horizons but graded into pale creamy grey colour within ~0.5m or so. It contained root hairs (flax and manuka?) but no evidence of any geothermal attack or weathering. No silica sinters or cemented sediments were found, confirming the absence of geothermal activity here during the last c. 7,000 years.

Water levels were at about 2m or less depth from ground level, but these water temperatures were all ambient and the waters non mineralised; ie. it *drainage?* was recent rain waters only. The silt was not penetrated to its base, but from well drilling information is expected to be in the order of 30-100m thick.

Auger hole profiles (Figure 2) show measured temperatures at indicated depths. All 0.2m and one metre depth temperatures measured were at ambient or non geothermal ground values of 16-18°C. at 0.2m depth and of 18-22°C at one metre depth.

Figure 2: Ground geology in augered holes A1 – A4. Left hand profile is for all holes A1 – A3 due to close similarity of conditions and depths. Right hand profile is of hole A4, which contained a thick sequence of peat and artesian water. WL = waterlevel in metres.
