# Statement of Claim Checklist / Repair Strategy

CLM/2010/011408

( V A McKelvey  
( 80B MCCORMACKS BAY ROAD  
( MOUNT PLEASANT  
( CHRISTCHURCH  
S  
..

# Shared Land Damage Allocation Summary SOW

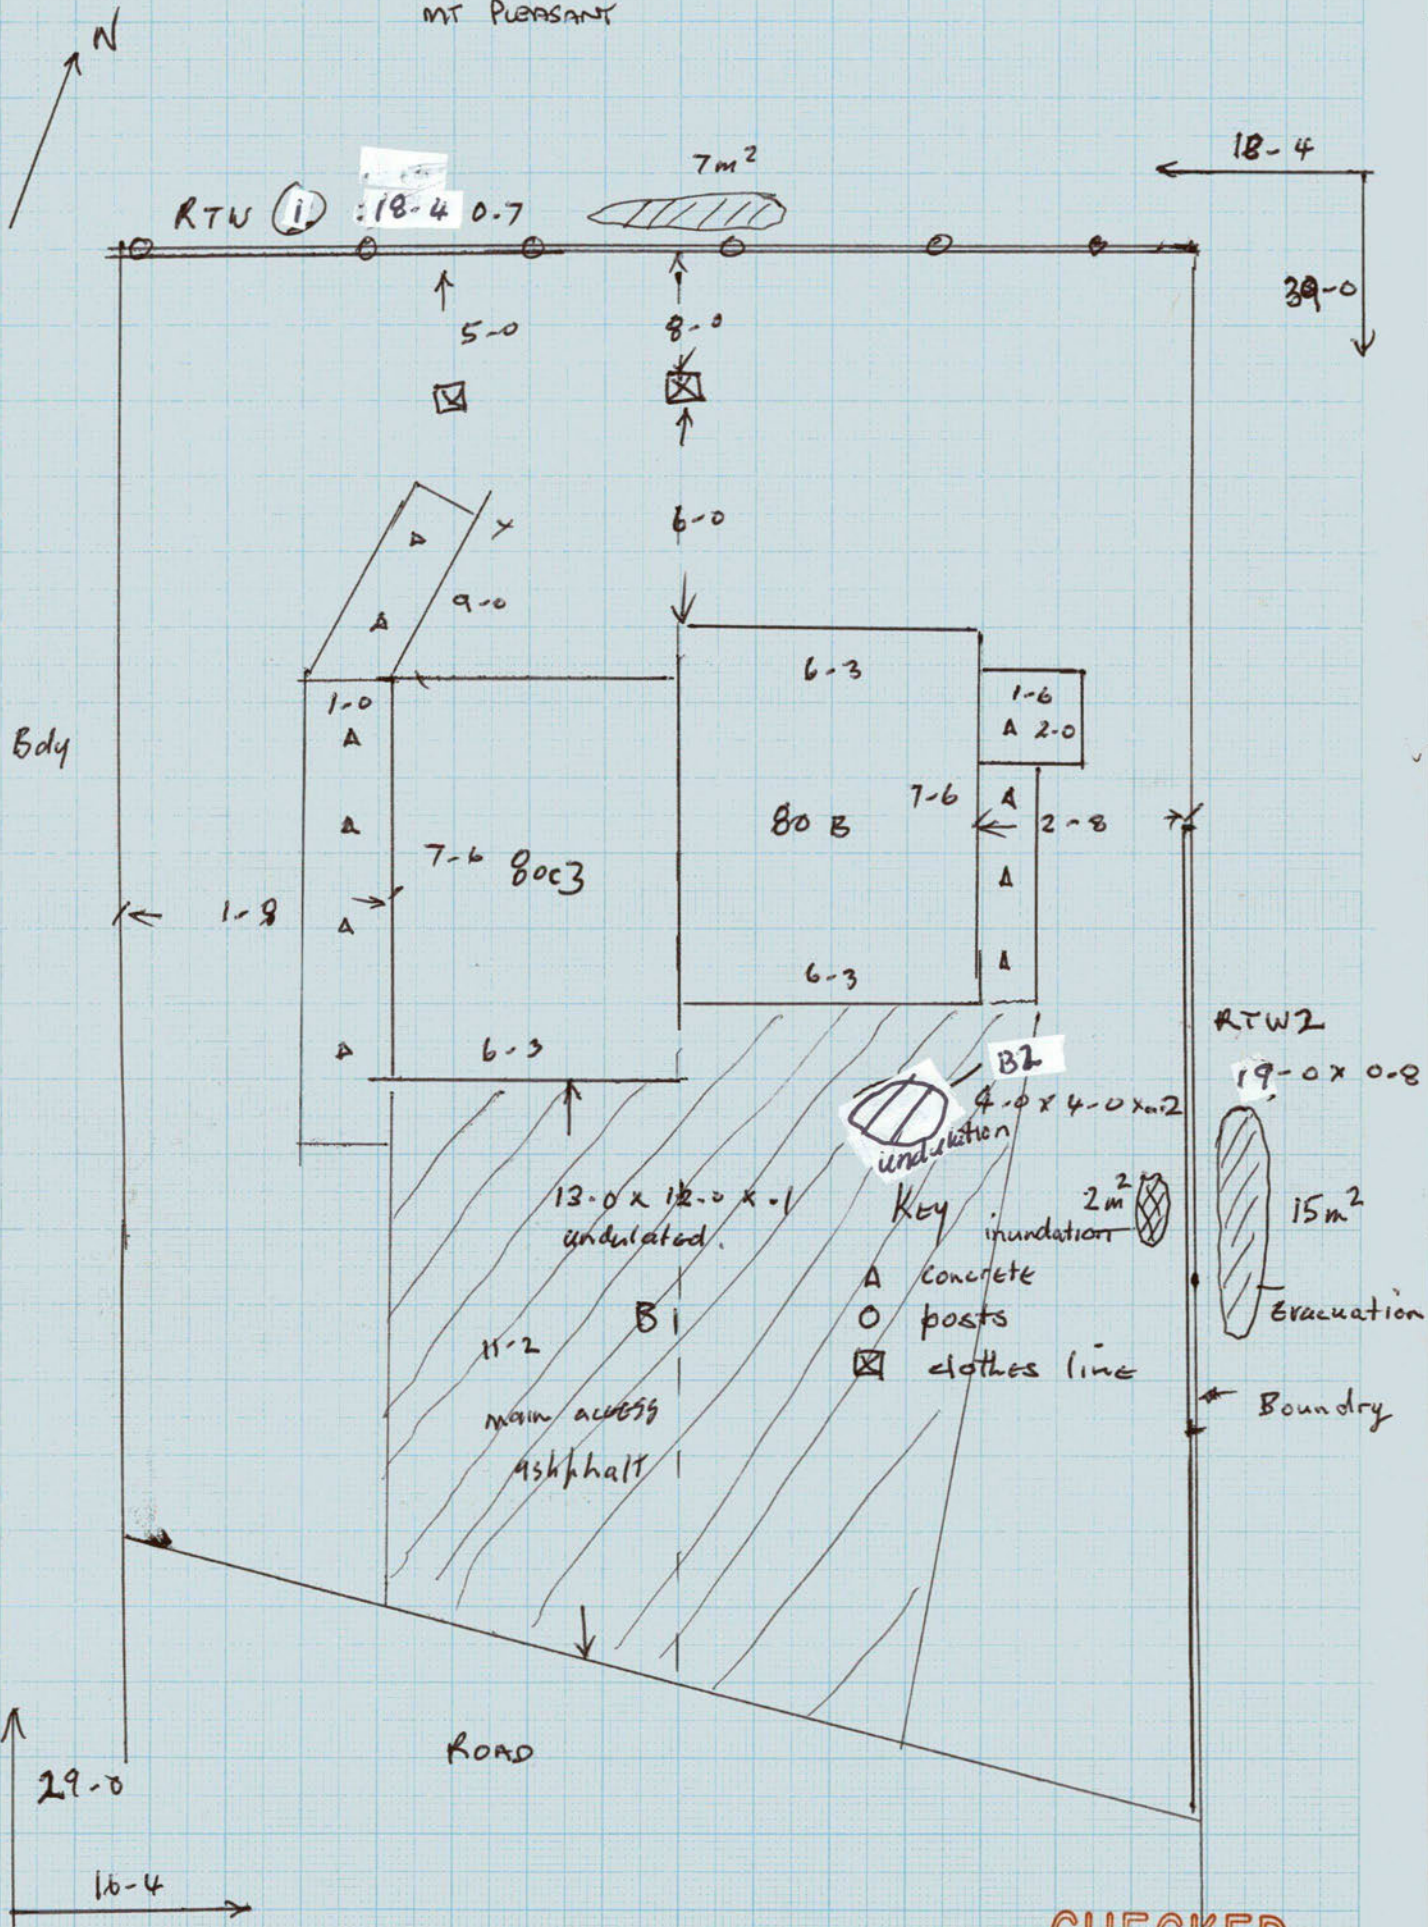
| Exclusive | Common | Legend Ref | Description | Total Area (m2) | Cost | % Allocated | Allocated Area | Allocated Cost |
|---|---|---|---|---|---|---|---|---|
| ✓ | | RTwo2 | Masonry block, Rotated | 15.2 | 10,983-20 | 100 | 15.2 | 10,983-20 ✓ |

| Exclusive | Common | Legend Ref | Description | Total (m3) | Cost | % Allocated | Allocated m3 | Allocated Cost |
|---|---|---|---|---|---|---|---|---|
| ✓ | | RTwo2 | Inundation | 1.0 | 180-00 | 100 | 1.0 | 180-00 ✓ |

| Exclusive | Common | Legend Ref | Description | Total Area (m2) | Cost | % Allocated | Allocated Area | Allocated Cost |
|---|---|---|---|---|---|---|---|---|
| | ✓ | RTwo2 | Timber post & Rail Rotated | 12.88 | 6073-80 | 50 | 6.44 | 3036-90 ✓ |

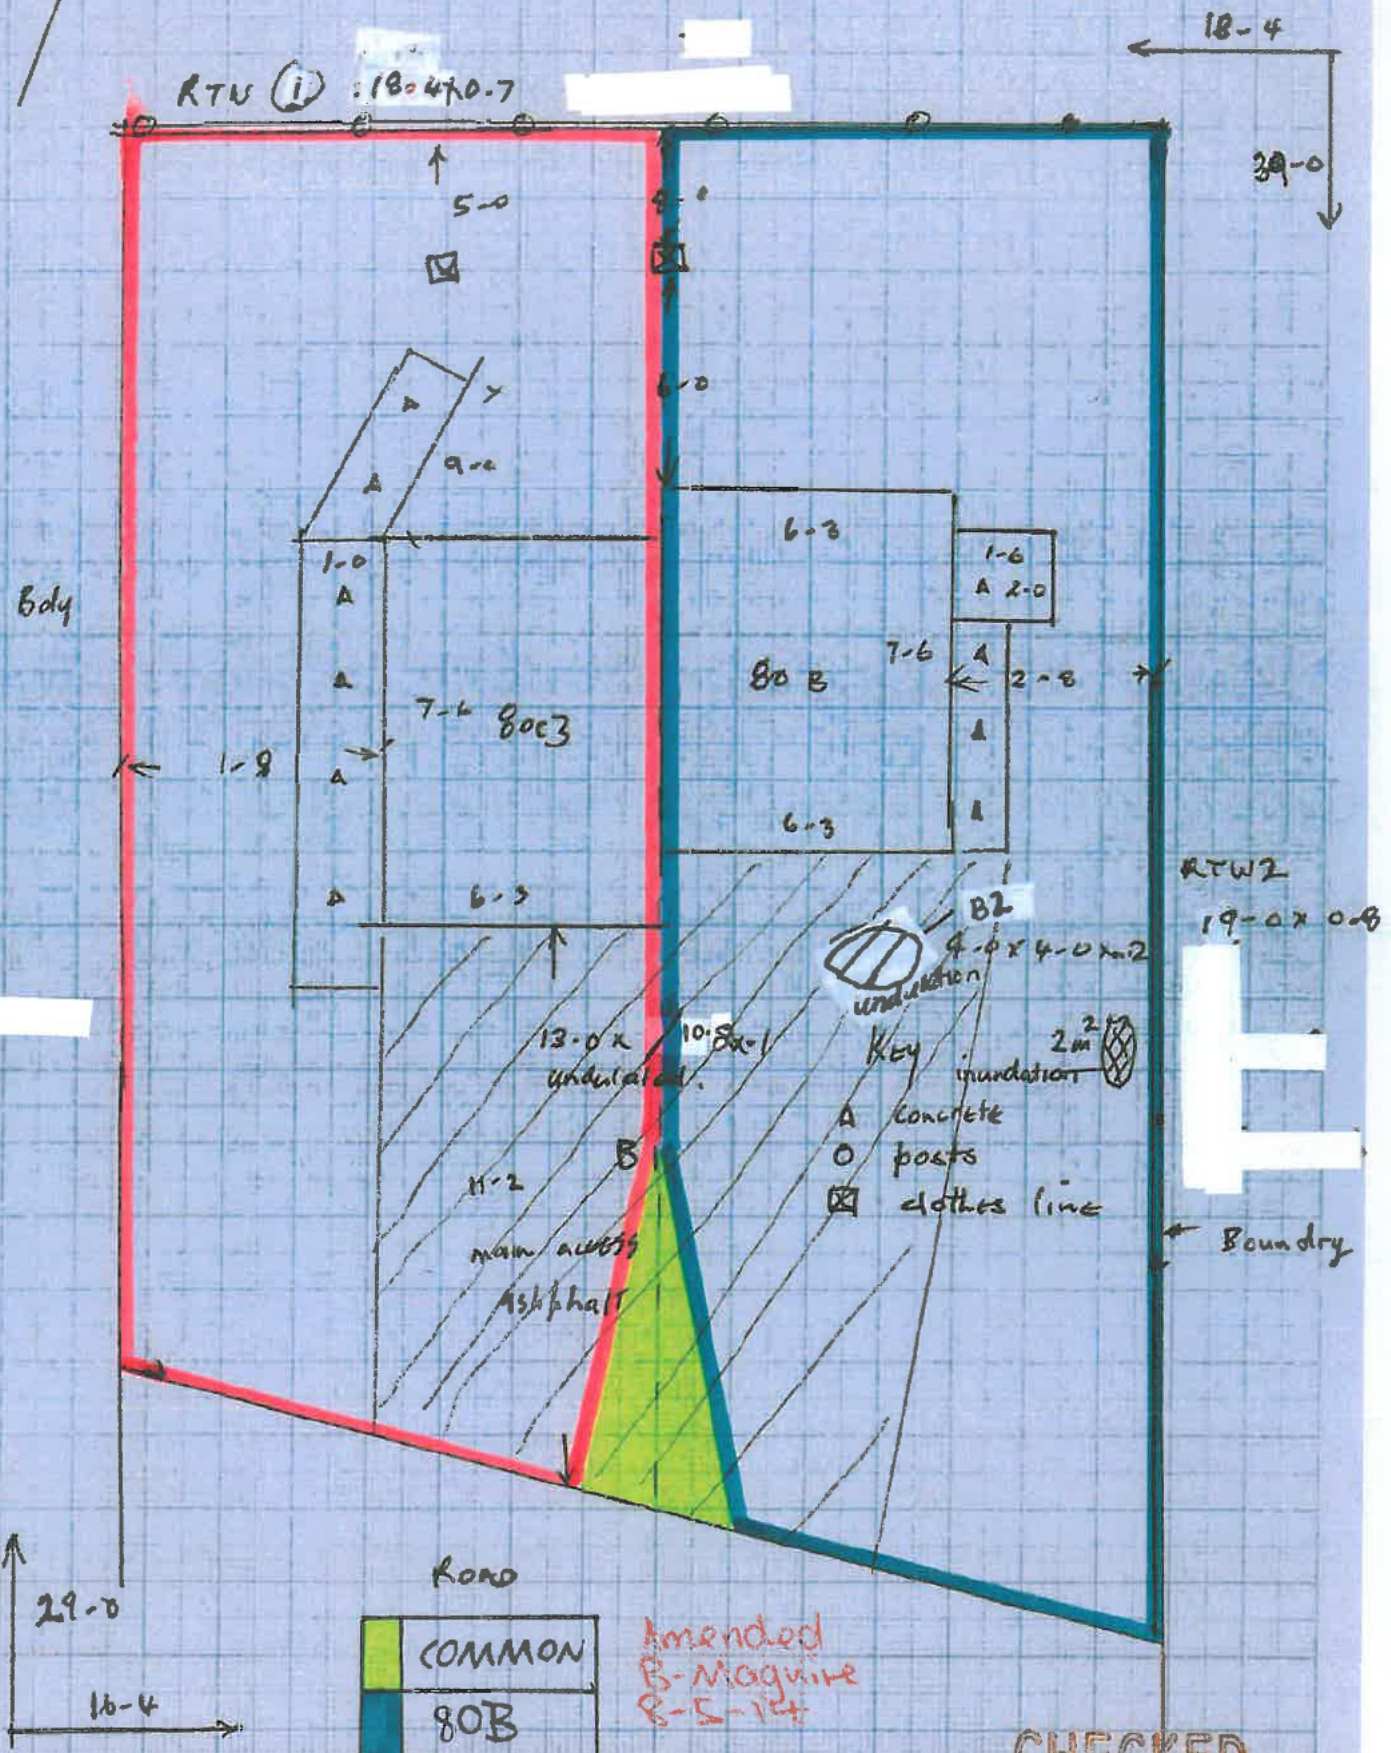
| Item N° | Description/Construction | Length | Height/Width | Depth | Damage | Damaged Area | Evacuated m² | Inundated m² | Debris m³ | Access<br>E D |
|---|---|---|---|---|---|---|---|---|---|---|
| B1 | Asphalt Drive | 13 | 10-8 | 0.1 | Undulated | 140.40 | 140.40 | — | — | E |
| B2 | Asphalt Drive | 4.0 | 4.0 | 0.2 | Undulated | 16 | 16 | — | — | E |
| RTW 01 | Timber Post & Rail | 18.4 | 0.7 | | Rotated | 12.88 | — | — | — | E |
| RTW 02 | Masonry Block 1.40 Series | 19 | 0.8 | | Cracked & Rotated | 15.2 | — | — | 1m³ | E |
