## Geotechnical Investigation Report

280 Taylor Road, Taipa

Lot 1 DP 102703

**November 2019**

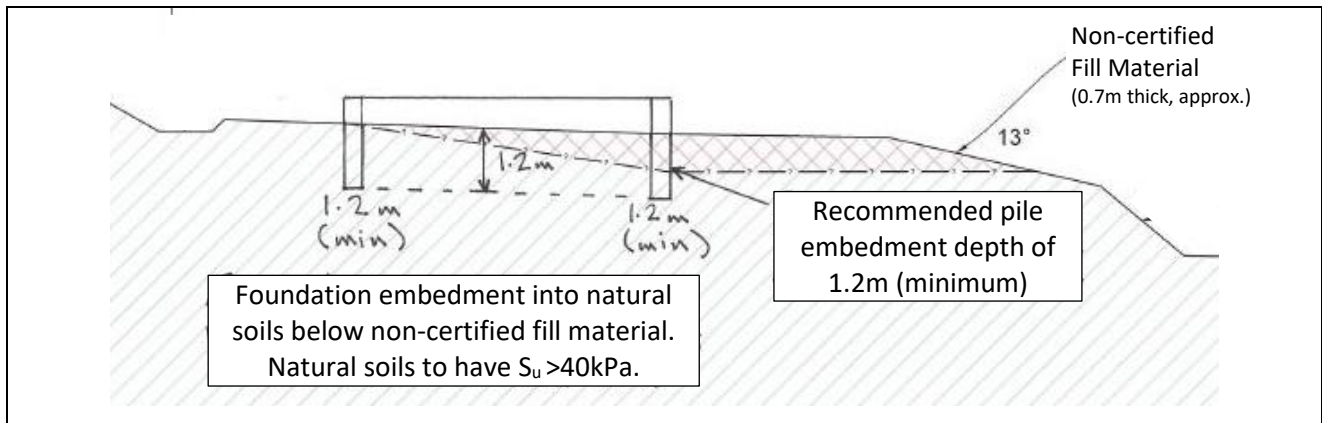
Based on concept drawings provided, we understand that the proposed dwelling will comprise a suspended timber floor supported on concrete encased timber piles embedded into the natural soil. The ground conditions were found to be generally consistent across the proposed development area, with natural soils of the Whangai Formation below a wedge of non-certified fill material in the southwest corner of the proposed building footprint.

**Figure 3 – Potential extent of fill below proposed footprint. Foundations to be embedded below fill material.**

We recommend the proposed dwelling be supported on concrete encased timber piles embedded into the very stiff natural soils. Due to the presence of non-certified fill material below the proposed dwelling footprint, we recommend that piles in the “fill zone” be deepened to have a minimum embedment depth of 1.2m below existing ground level. For consistent foundation performance across the structure, we recommend all foundation piles be founded a minimum of 1.2m below existing ground level into natural soils (with  $S_u > 40\text{kPa}$ ) of the Whangai Formation (refer Figure 3 below).

We recommend all standard and braced piles be embedded a minimum of 1.2m below existing ground level into stiff natural soils below the non-certified fill material. If anchor piles are used, then these piles should be embedded a minimum of 1.5m below existing ground level.

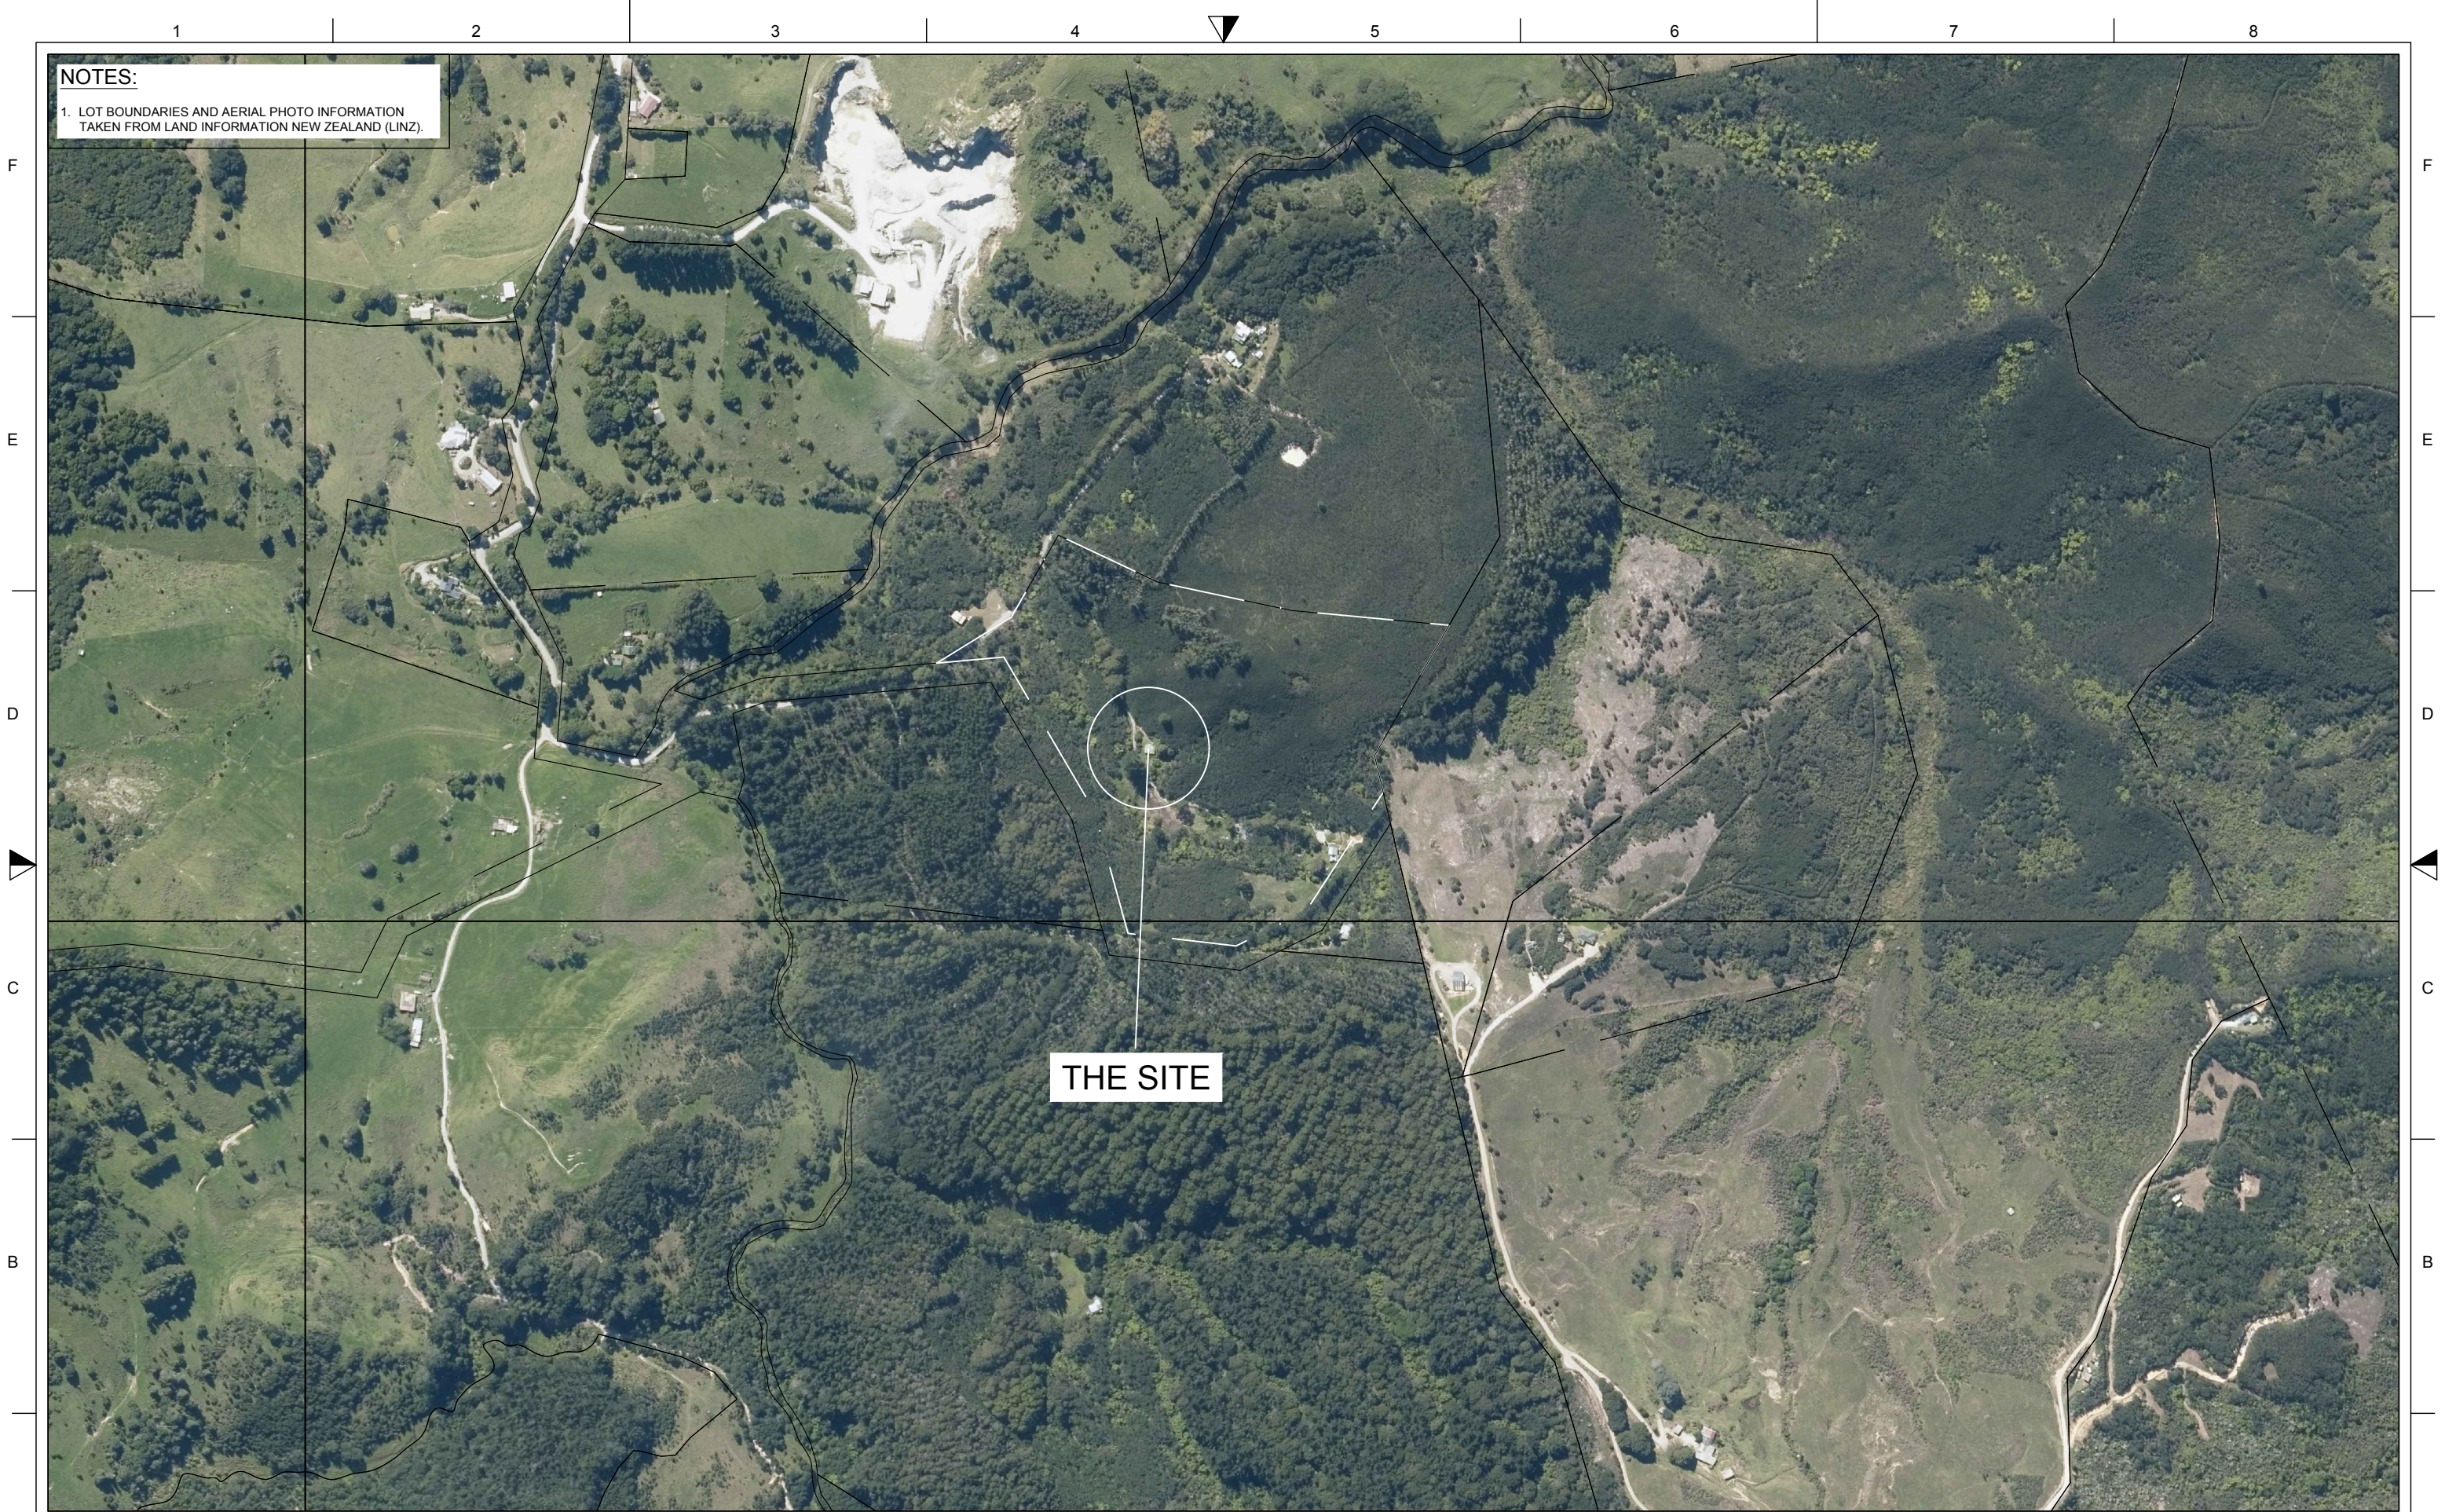
| Drawing No. | Title | Scale |
|---|---|---|
| 19 164/02 | Site Features and Borehole Location Sketch | Not to Scale |

It is considered that the steep west facing cut slope will overtime regress to reach equilibrium of a slope angle at or close to  $16^{\circ}$ . We consider a suitable setback distance from the crest of the cut slope to allow for regression of the cut face should be allowed for in the final dwelling location. We recommend a minimum distance of 2.5m between the dwelling and the crest of the slope be maintained, as shown on, refer Drawing 19 164/02 & 03.

To help reduce continued erosion of the steep cut faces, we recommend protective measures are considered, such as retaining walls or planting of the slopes to protect against erosion and or instability. Provided a suitable setback distance is applied to the dwelling location, the cut faces are not expected to impact the proposed dwelling location.

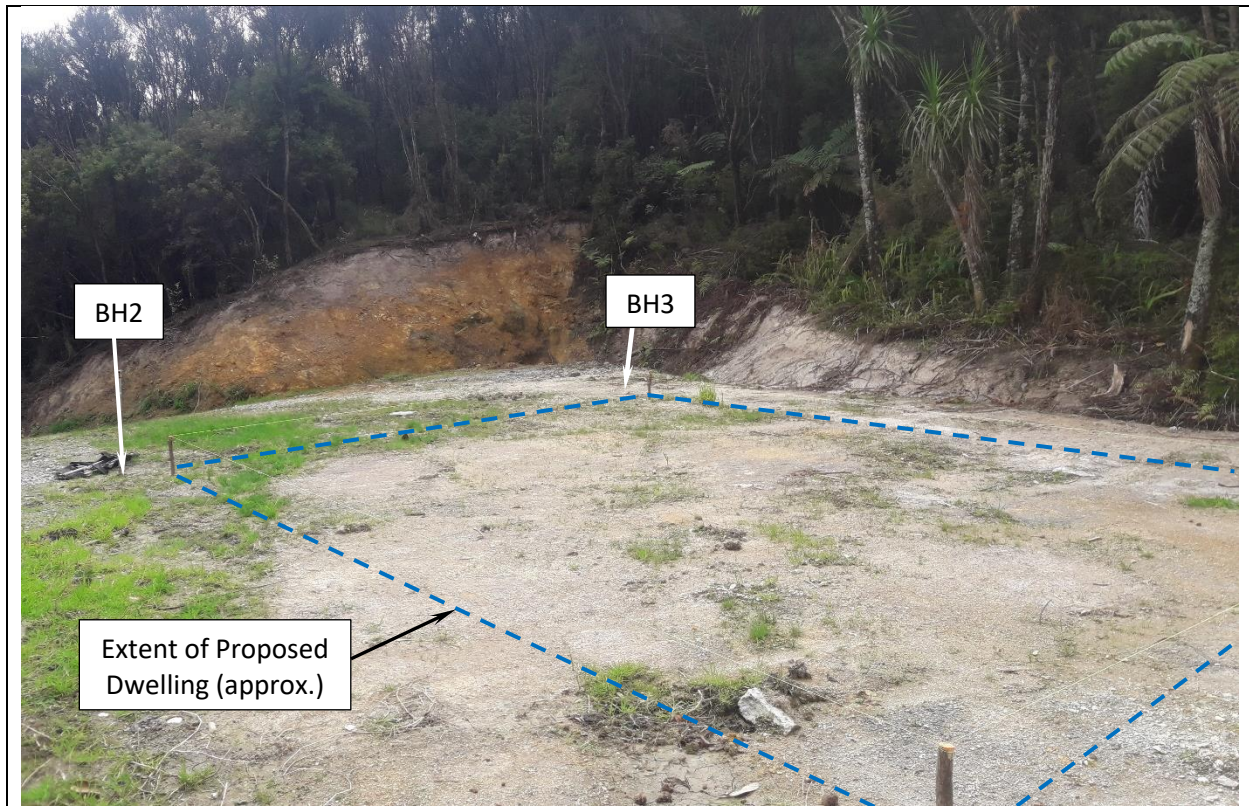
Looking northeast (approx.) across proposed building platform. Pegs denote approximate dwelling location. Note the steep cut bank with exposed soils and open drain at base of slope, top of image.

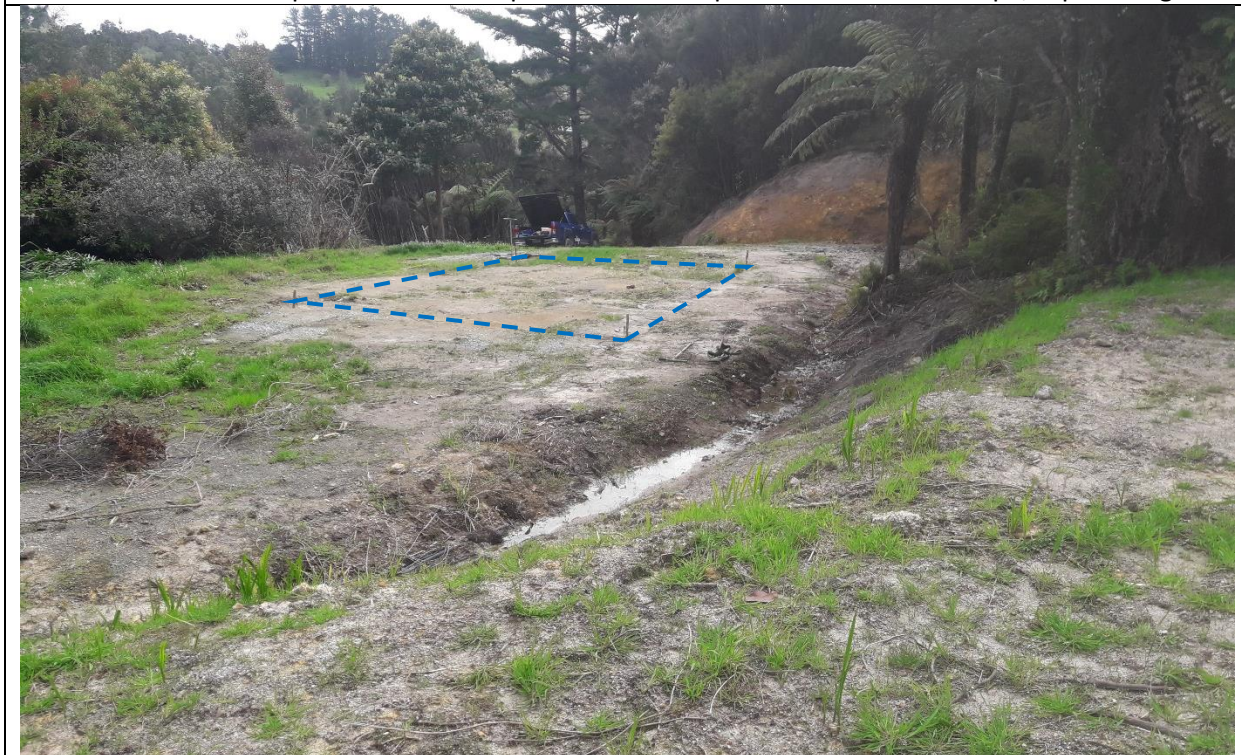
Looking north (approx.) across proposed building platform (dashed line). Note open drain at base of slope that extends around the perimeter of the propose building platform.

We recommend that a stormwater cut-off drain be installed around the perimeter of the building platform and that stormwater be collected and channeled to be disposed of in a controlled, dispersive manner. Careful consideration should be given to the grading of the site surface to channel any stormwater runoff away from the dwelling and towards a suitable discharge point.

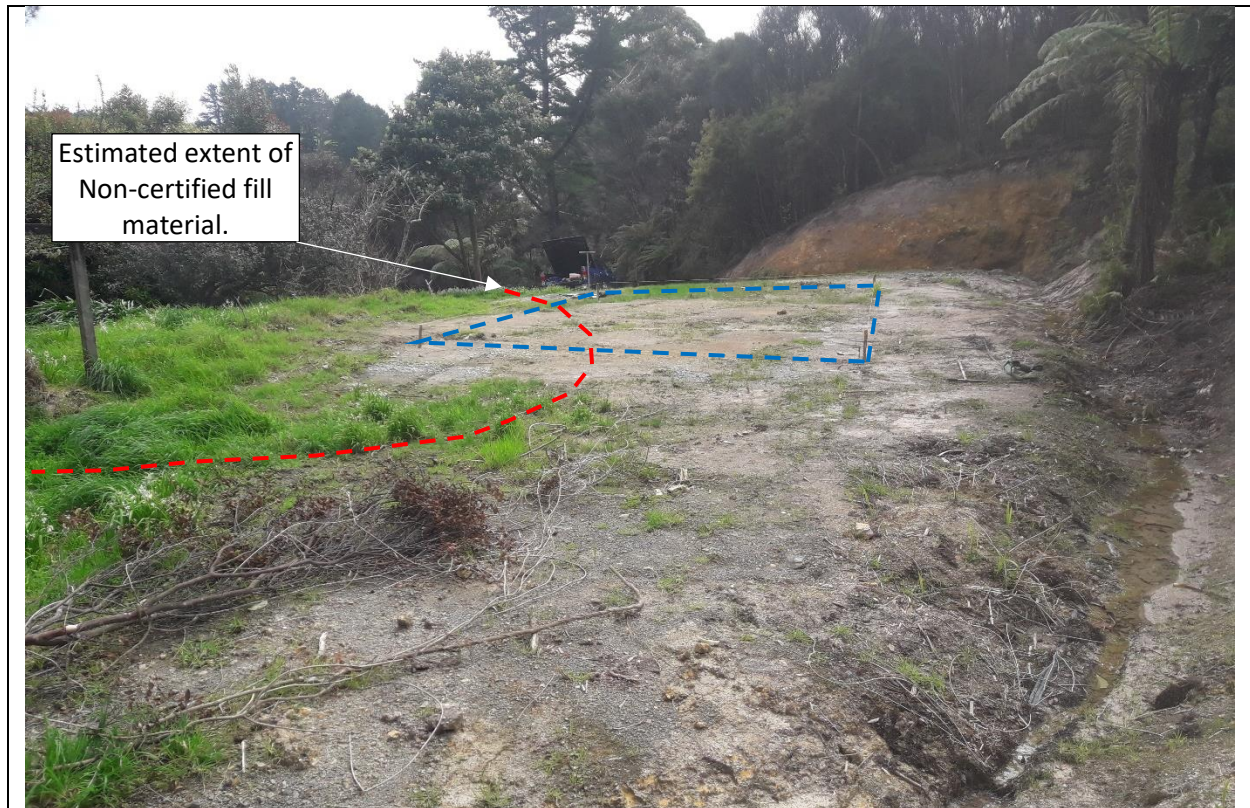
Fill material was encountered within borehole BH1 to a maximum encountered depth of 0.7mbgl and is considered as non-certified fill for the purposes of reporting. The fill material comprised intermixed light brown, brown, light orange and grey clayey silt with some fine to medium gravel that was described as very stiff, moist to wet and of low plasticity. The placed fill material encountered is considered to be comprised of re-worked Whangai Formation soils.

Looking north (approx.) across proposed building platform, centre of image. Non-certified fill material encountered at western (left) side of build platform.

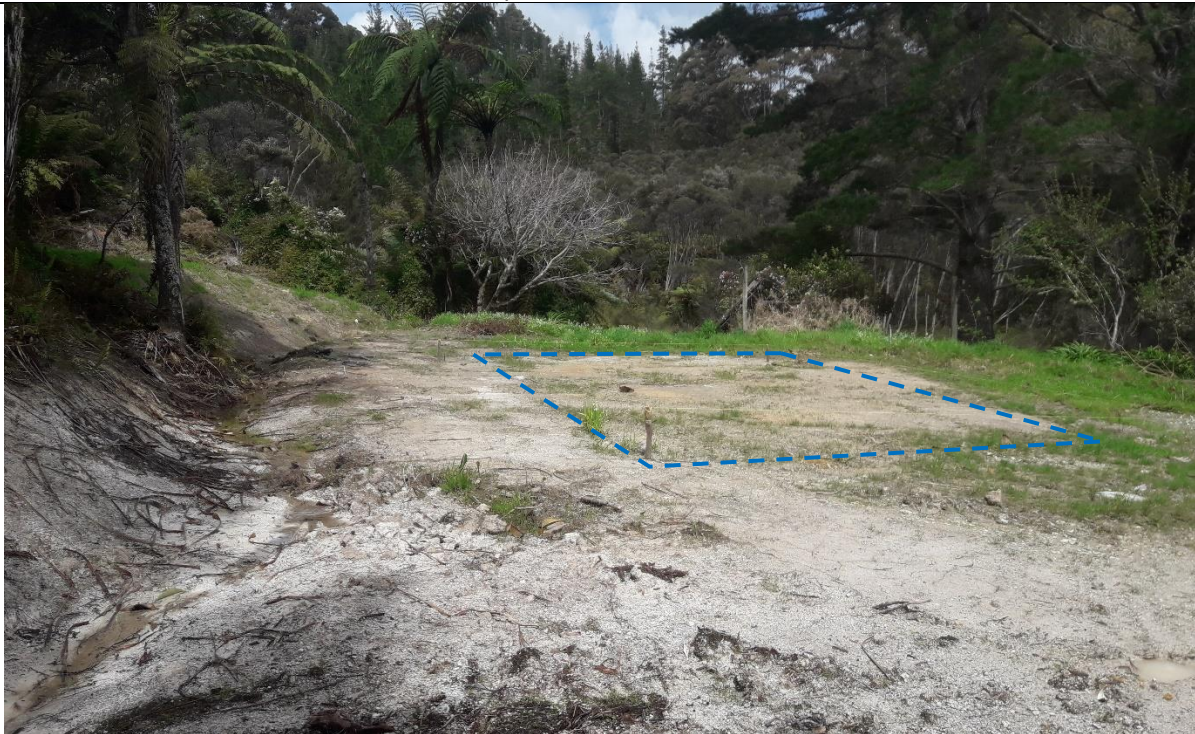
Looking south (approx.) across proposed building platform. Bank below building platform to top right of image (grassed area). Non-certified fill material encountered at far corner of build platform.
