# **Tony Head**

127 Onga Onga Road, Waipawa, 4272

Preliminary Geotechnical Investigation Report

210418  
4 November 2021

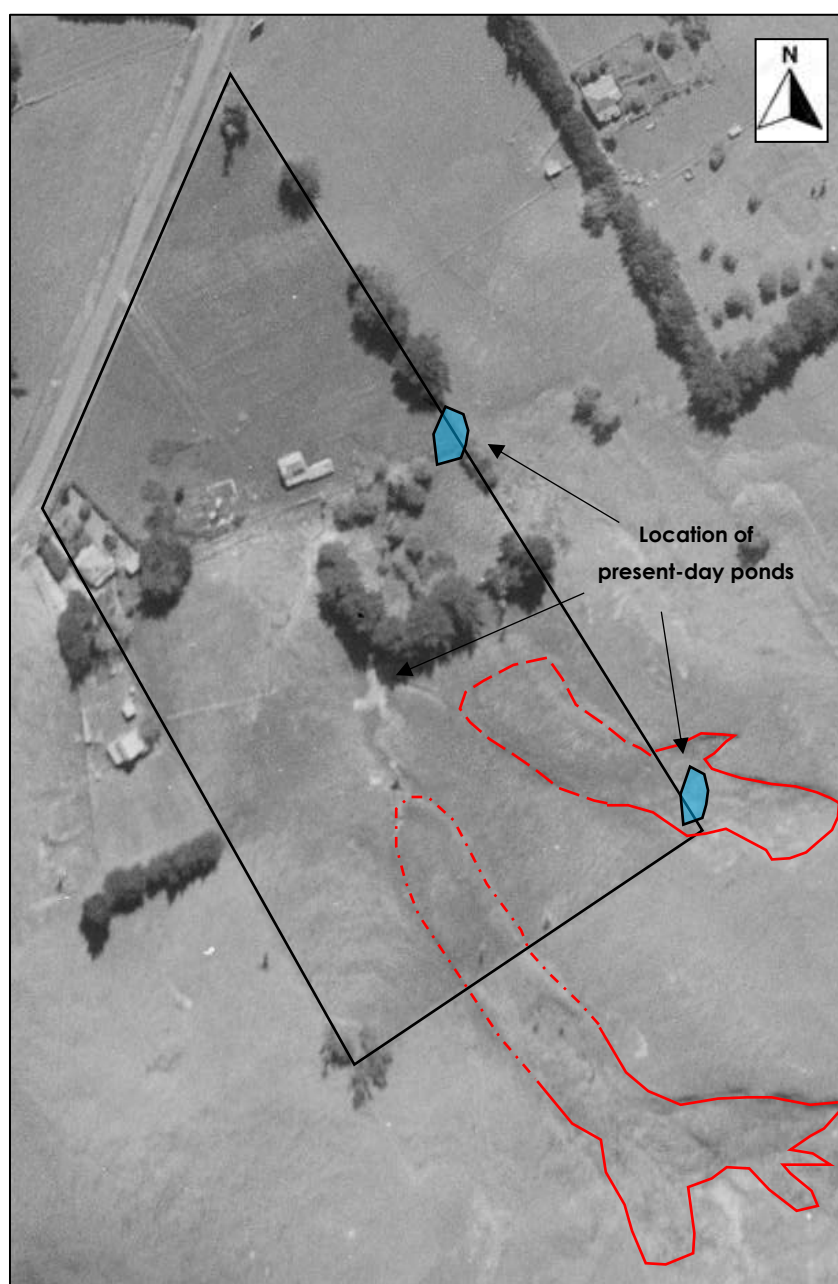
Figure 4: 1943 aerial photography (Retrolens.nz)

We have reviewed historical aerial photography from retrolens.nz, and Figure 4 is a photo flown in 1943 (cropped). We have identified two landslide features affecting the site, but the photo shows these features pre-date 1943. These areas are indicated in red on Figure 4. Recent aerial photographs (i.e., Figure 2) show that there has been no significant change to the landslide features, but a pond has been developed at the top of one of the debris lobes.

We recommend that no residential development is carried out on the large historic landslide features identified at the site.

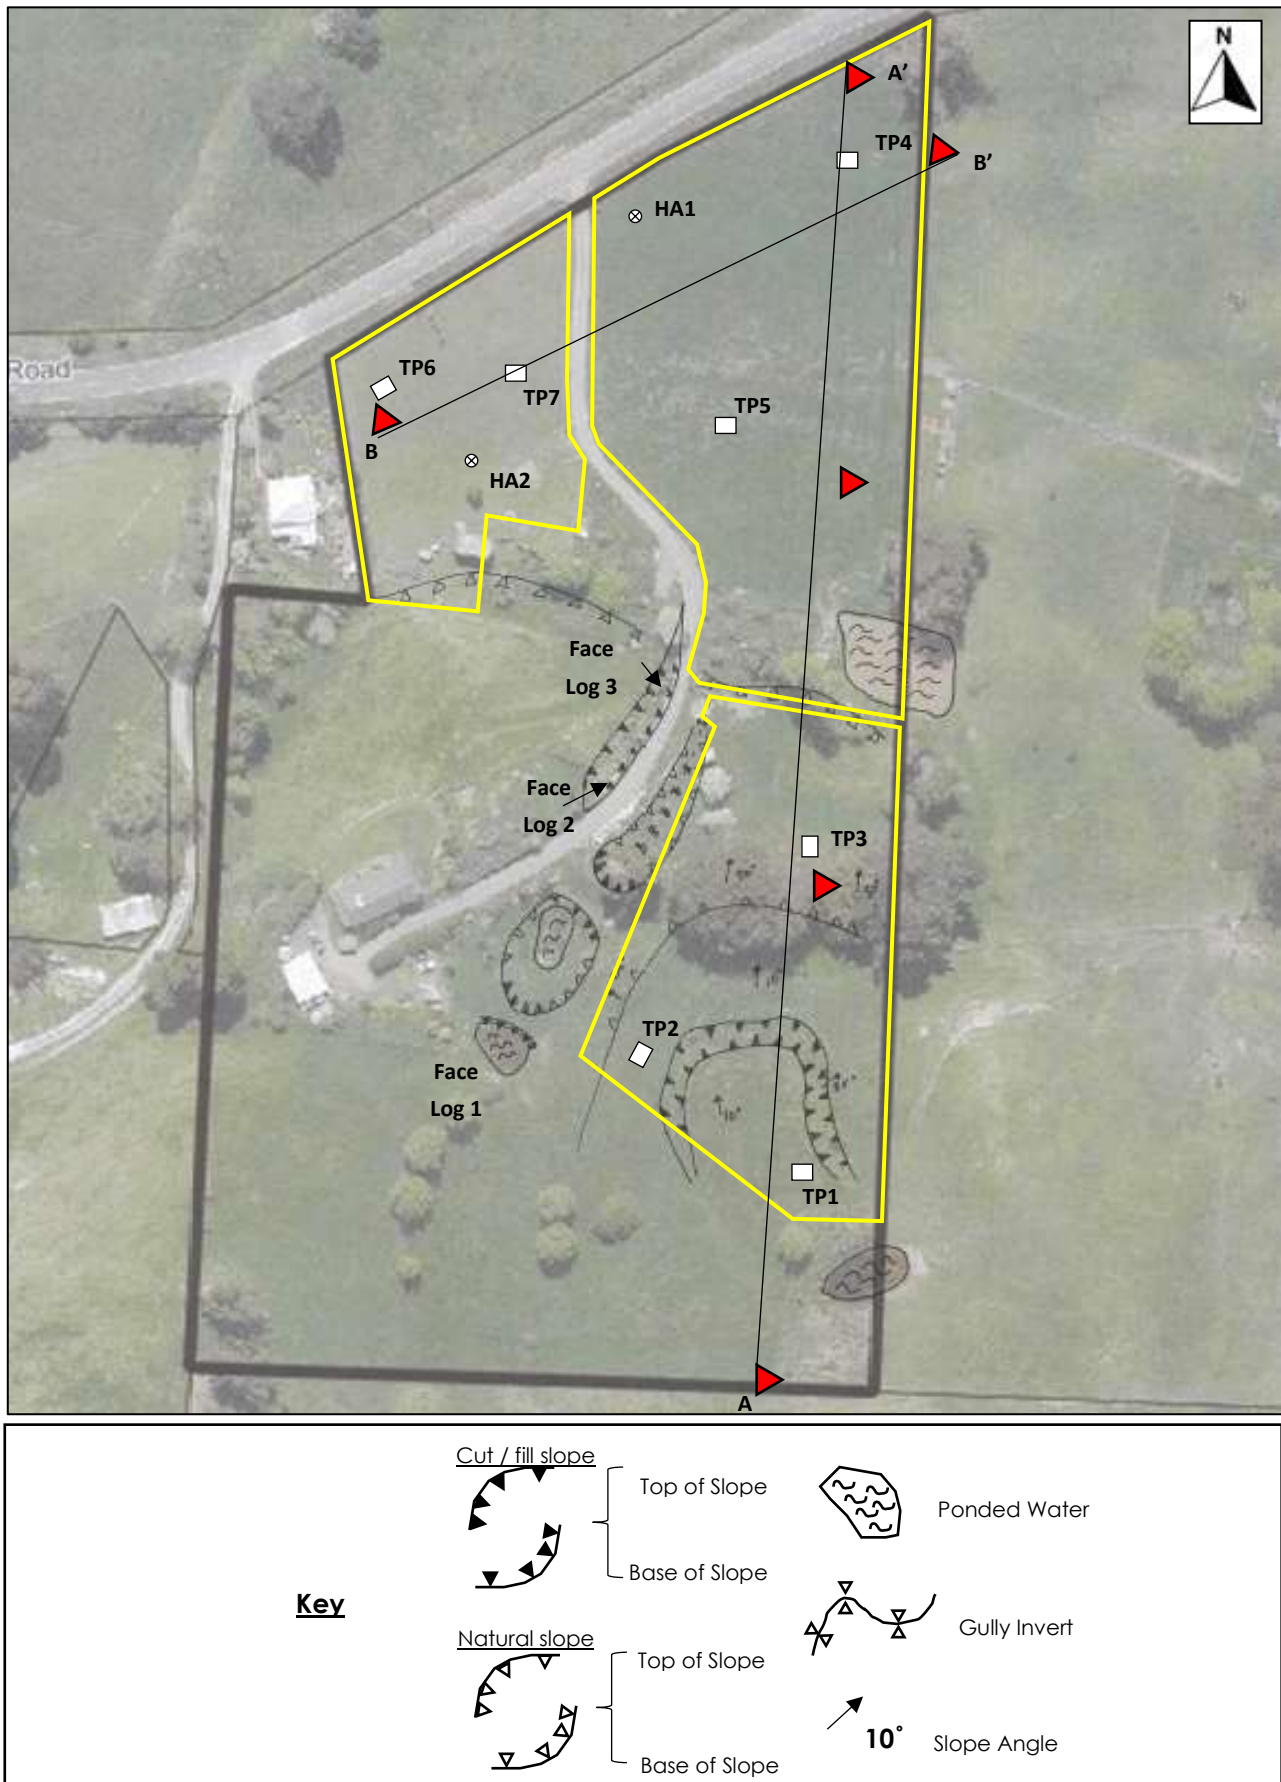
Figure 5: Geotechnical plan

Test locations are indicated on the Geotechnical Plan (Figure 5) and investigation logs are included in Appendix 1.

Geomorphic mapping was carried out by the Engineering Geologist and the main geomorphic features are include on the Geotechnical Plan using standard symbols (see Key). Typical slope angles were measured using a smart level. Natural exposures of soils were logged, and the location of 3 FLs are shown on the plan. The FLs are included in Appendix 1.

Unit 3 is the moderately weathered rock mass of the Wanstead and/or Whangai Formations. Relatively unweathered materials are exposed in areas across the site (see Figure 5) and were descriptions range from hard low plastic sandy silt (Unit 3a), to extremely weak highly fractured mudstone (Unit 3b).

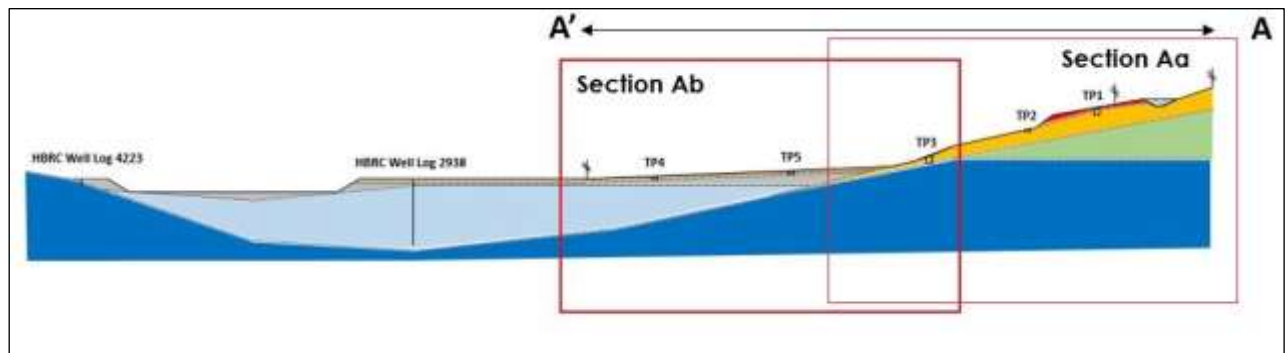
**Figure 6: Geotechnical Section A'A**

Based on our field investigation and background geological study, we have developed a ground model for the site, and this is shown in a series of Geotechnical Sections. Figure 6 is a section subparallel to the eastern subdivision boundary that has been extended through the riverbed to give the wider context of the ground conditions. Figures 6a and 6b are smaller scale sections (Section Aa & Section Ab) to show the more detailed ground conditions through the subdivision.

In general, the northern (flat) part of the site has been built up with alluvial deposits that would have on-lapped the hill slopes that form the main area of the subdivision. The alluvial deposits would tend to become thicker towards the centre of the valley and river channel. Alluvial deposits typically consist of clays and gravel, although a silty hardpan was encountered nearer to the surface. The hill slopes generally consist of clays and include areas where mobilised landslide material has been identified.

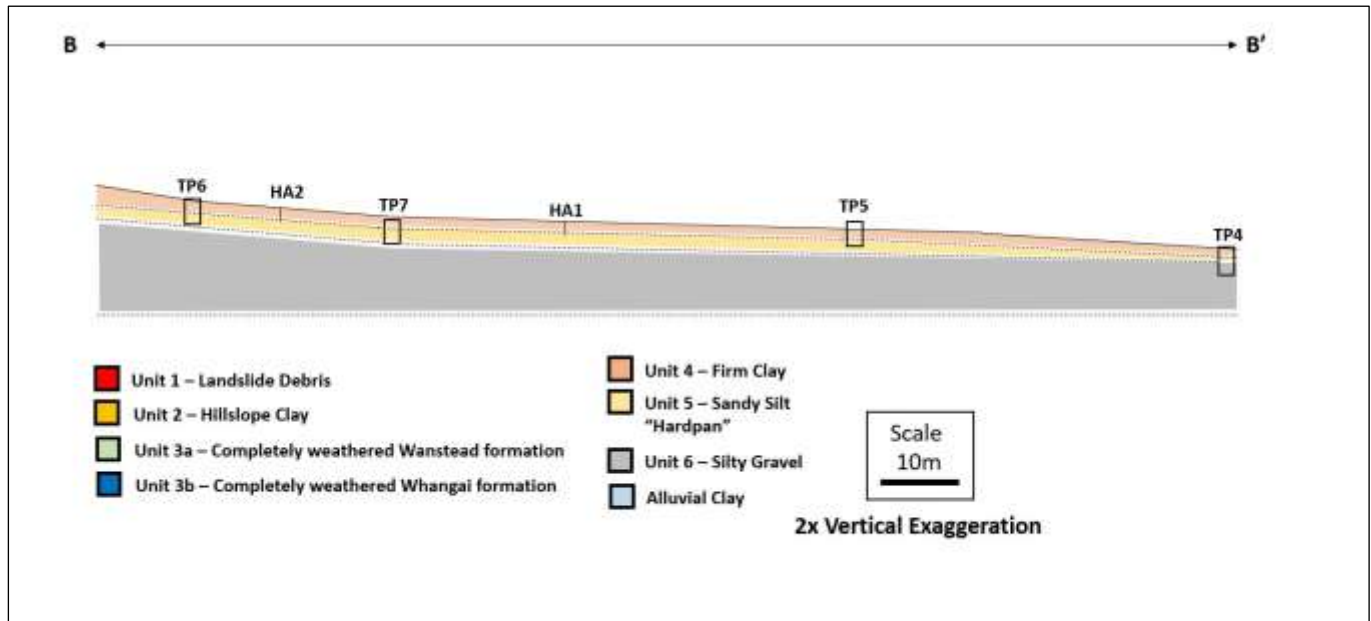
Figure 7: Geotechnical Section B'B

Figure 7 cuts across the flat ground at the northern end of the subdivision subparallel to Onga Onga Road. This section only shows the upper 5m of the soil profile, as this is likely to represent the depth of influence from foundation loads.

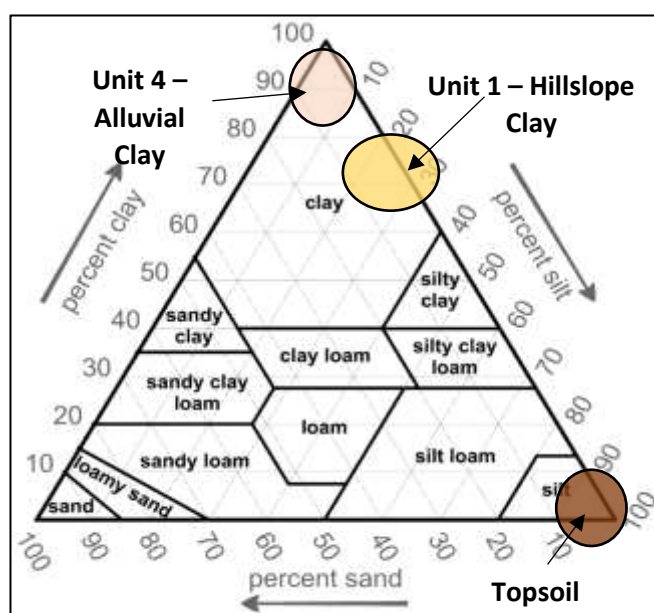
Figure 8: Soil Textural categorisation

The underlying soil units plot as 'Clay' and are likely to be Soil Category 6 – Medium to Heavy Clays. For preliminary design we recommend an indicative permeability ( $k_{sat}$ ) of 0.06 m/day, but this should be verified with field testing once the location of any disposal field are determined.

Based on local experience the risk of shrink/swell behaviour for the clays is low.
