# EARTHQUAKE RECOVERY (EQR) DOCUMENTATION

# EQR Property Overview Report

| EQC Property ID | Property Address | Vulnerable? | Property F Status | Property Finalisation Indicator | | |
|---|---|---|---|---|---|---|
| 2010065050 | 18 DOWNING STREET, HOON HAY | | F3 - Complete & Finalised | Some Finalisation has taken place | | |

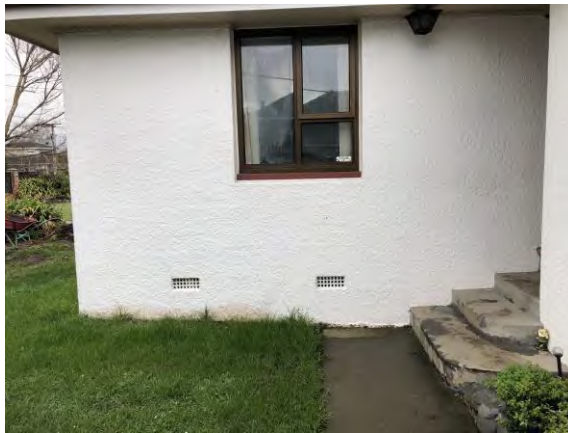
The exterior of the perimeter concrete foundation could not be observed, as it was covered by stucco plaster at the time of our site inspection.

Photo 4. Perimeter concrete foundation covered by stucco plaster.

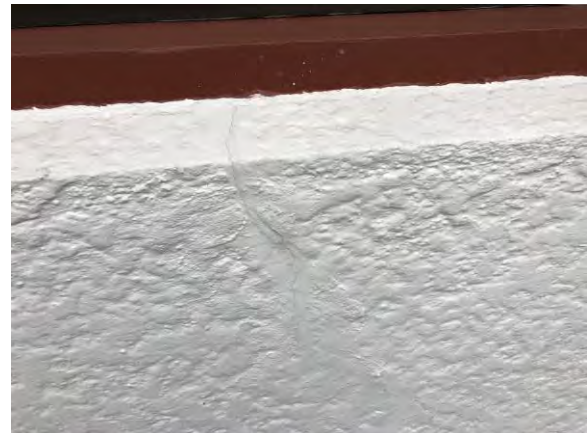
The repair works to the external cladding had been carried out prior to our site inspection. Evidence of the repair works was identified on site. Some of the repaired cracks were observed to have re-opened.

Photo 5. Crack repaired then re-opened.

- The non-structural elements, such as cracking damage to the external cladding, internal linings and driveway, shall be repaired by a suitably qualified person as per manufacturer's specifications.

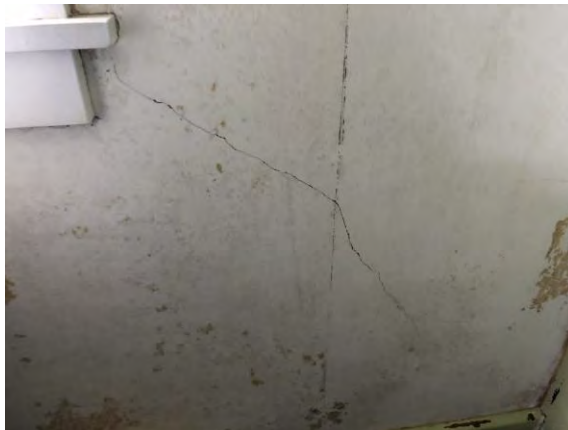
- Minor to moderate cracking damage to the plasterboards. Some of these cracks were around the window and door openings.
- Vertical, horizontal and diagonal cracking damage to the wall linings around the window and door openings.
- Door misalignment identified at one location.
- Cracking damage to the scotia.
- Minor separation at the juncture between the scotia and ceiling, and scotia and wall.
- Minor separation at the juncture between the skirting board and timber floor.
- Cracking damage along the window frames.

Photo 6. Cracking damage to the plasterboard.

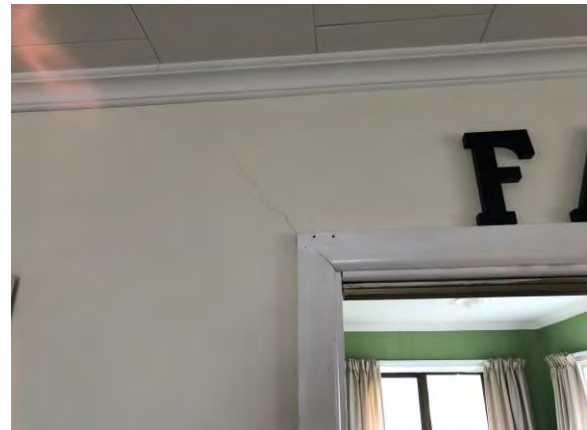
Photo 7. Cracking damage to the wall lining around the door opening.

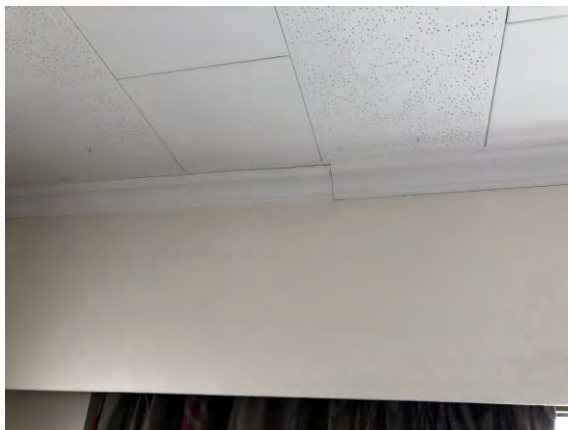
Photo 8. Movement and cracking damage to the scotia.

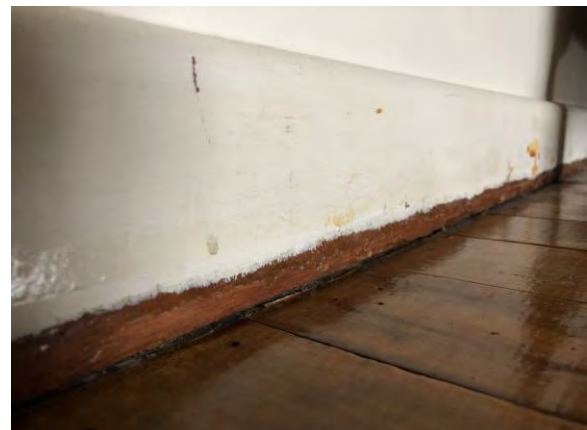
The floor levels measured across the timber floor of the dwelling, showed maximum floor level variations of 50mm (+14, -36), achieving the 50mm suggested threshold of “no foundation re-level is necessary” set out in Table 2.3 of the MBIE Guidance. The floor slopes exceeding 1:200 (0.5%) were identified along the northwest wall in the lounge. The general trend of the floor level variations appeared to be relatively minor, except the northwest wall in the lounge, where significant floor sagging was noted.

Photo 9. Separation between the skirting board and sagging floor.

- The timber subfloor framing shall be disconnected from the concrete base, and new timber bearer and floor joists can be installed if required. New piles shall be installed to support the subfloor framing. The soil bearing capacity shall be confirmed by a suitably qualified engineer.
- The timber floor around the sagging area can be re-levelled by jacking and packing pile methodology as per the MBIE Guidance if necessary. Adequate bearer-to-pile and packer-to-bearer connections shall be installed. DPC sheets between the timber packers and concrete piles are required.
- The vertical offset along the construction joint of the garage slab can be remediated by partial replacement of the garage slab along the construction joint. The slab partial replacement details are shown below:

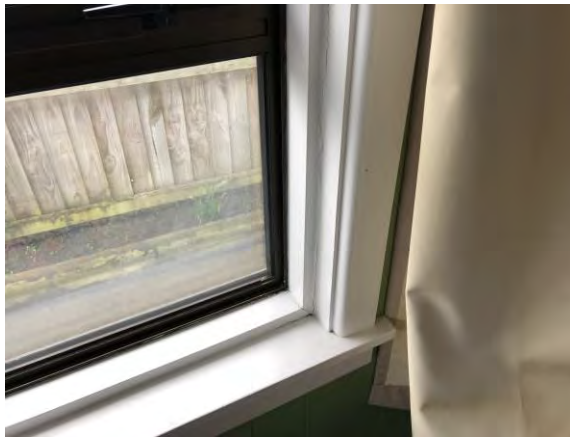
Photo 10. Cracking damage along the window frame.

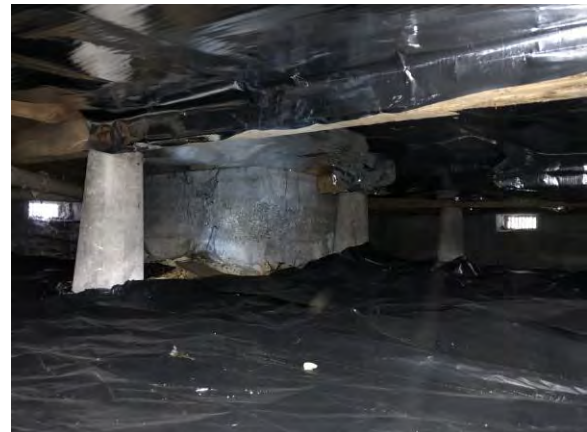
There was a concrete base observed under the northwest lounge wall, where the significant floor sagging was identified. This appeared to be a historical chimney base. The slopes along the door frames were measured around this area, and the results showed a consistency between the localised floor slopes and door frame slopes. Considering the damage observed in this area, such as the diagonal crack to the wall linings around the door opening and the movement to the scotia, Cephas Rock is of the opinion that the floor level variations in this area is, more likely than not, attributed to the settlement of the concrete base, and the earthquake-related exacerbation to the concrete base settlement cannot be ruled out.

Photo 13. Concrete base observed underneath the sagging floor.

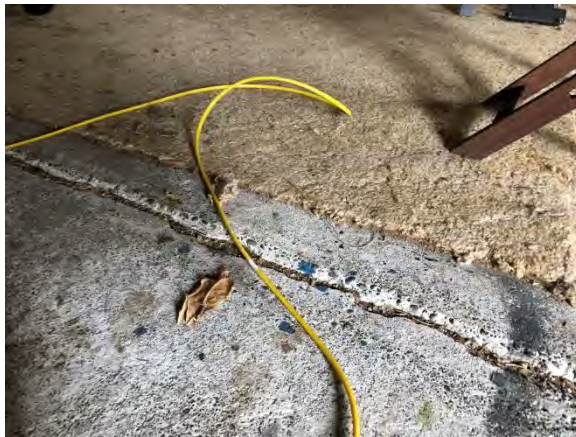
- Maximum floor level variation of 22mm (+22, 0) was recorded.
- No floor slope exceeding 0.5% was identified.
- The floor slab appeared to have settled differently along the construction joint. Vertical offset was observed across the construction joint.
- Garage door misalignment was noted.
- Cracking damage to the driveway outside of the garage entry was observed.

Photo 16. Vertical offset along the construction joint of the garage slab.

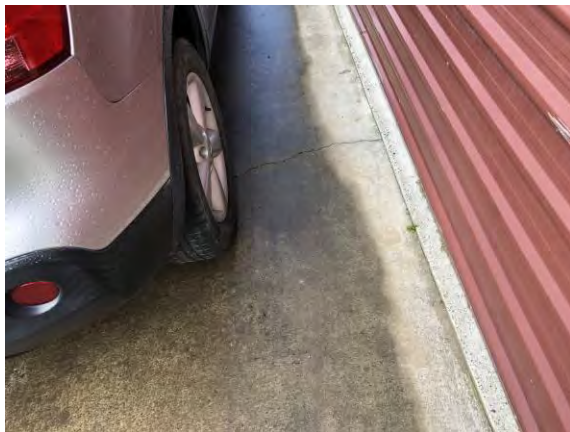
Photo 18. Cracking damage to the driveway by the garage entry.
