## Statement of Professional Opinion – Floor Re-levelling and Associated Repairs

**Project:** 18 Downing Street, Hoon Hay, Christchurch

Prepared by: Frankie Chen

**Date:** 27/07/2026

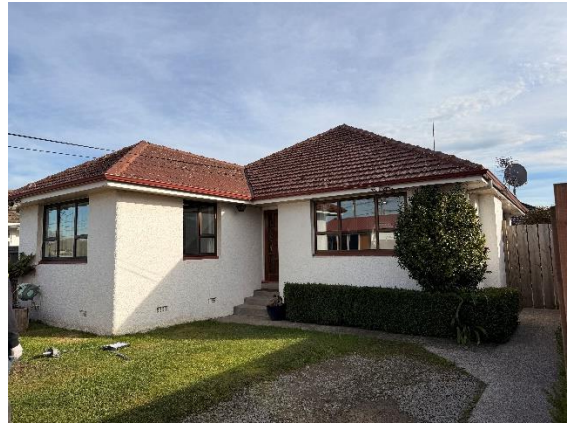
Photo 2. View of the dwelling from the driveway.

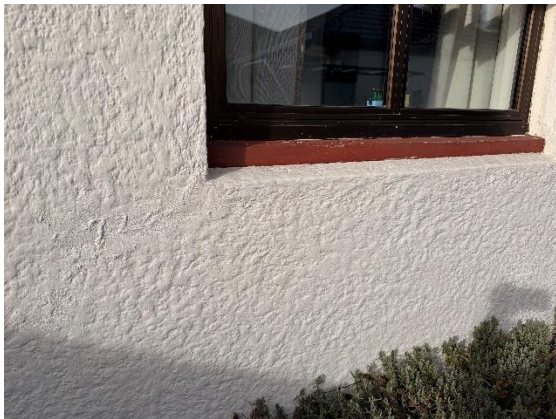
Photo 3. View of repaired cladding.

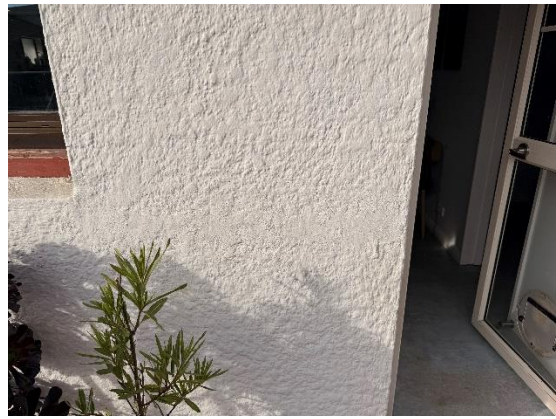
Photo 4. View of repaired cladding.

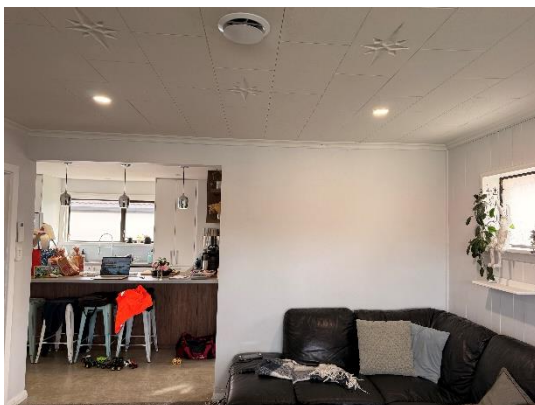
Photo 5. Internal lining has been repaired

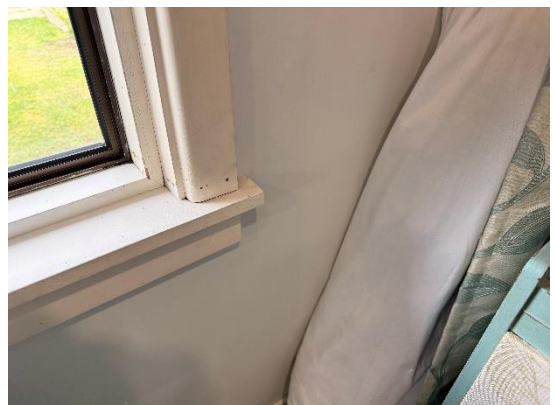
Photo 6. Internal lining has been repaired

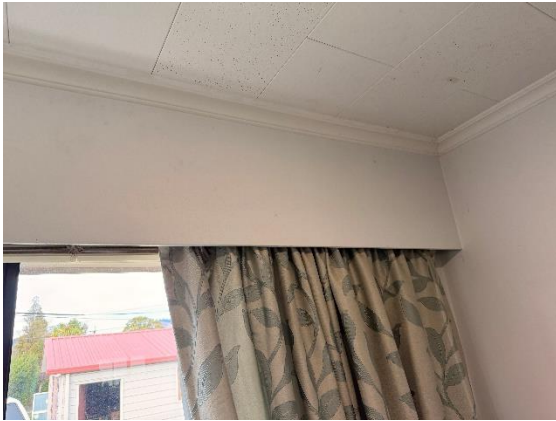
Photo 7. Internal lining has been repaired.

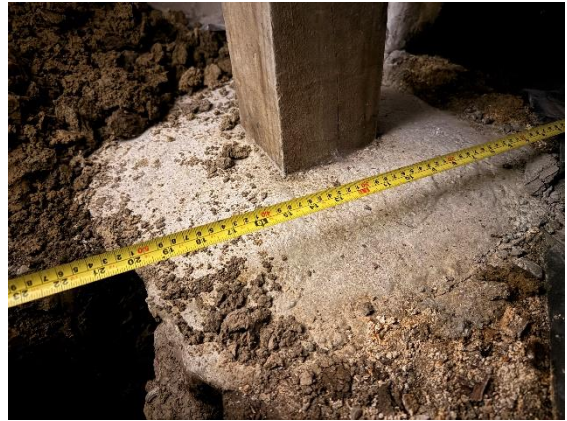
3. **New Timber Piles and Footings:** Exposed excavations confirmed that the new timber piles are supported by concrete footings measuring 500 mm  $\times$  500 mm  $\times$  500 mm deep. The observed bearer-to-pile connection details appear to comply with the requirements of NZS 3604:2011.

Photo 8. Internal pile footing size.

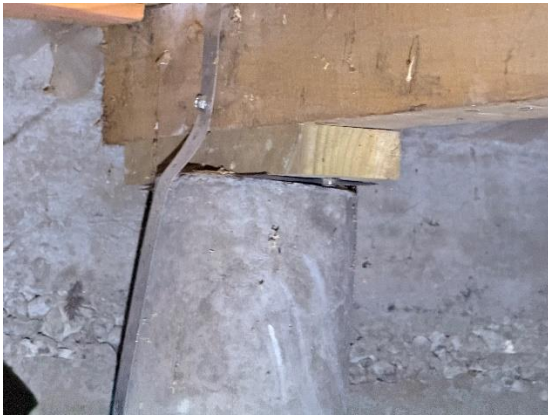
2. **Subfloor Works:** Visible subfloor packers, DPC placement, bearer-to-pile connections, and bracing details are generally consistent with the repair recommendations in our 2018 report. Timber packers appear to be solid H3.2 treated sections, with DPC installed between the packers and concrete piles.

Photo 9. View of internal pile packer.

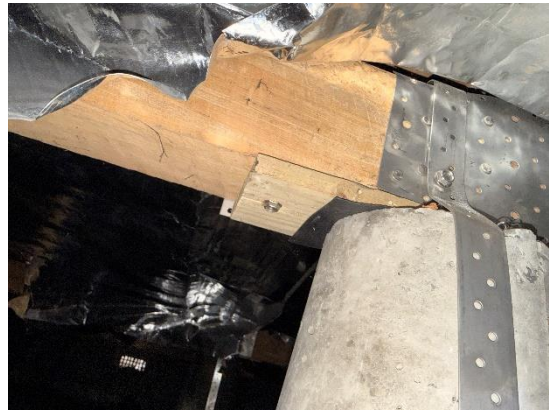
Photo 10. View of internal pile packer.

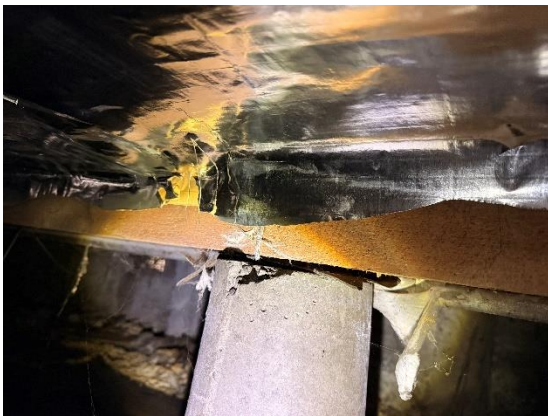
Photo 11. View of internal pile.

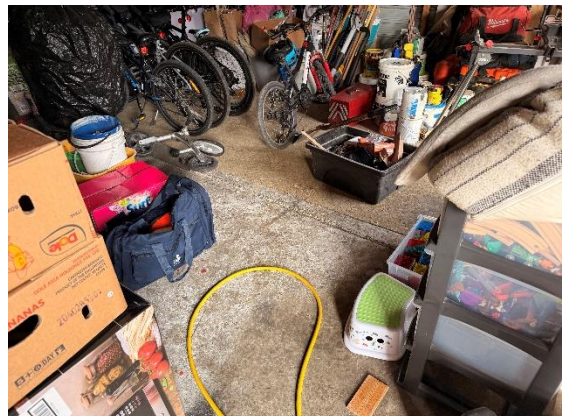
6. **Detached Garage:** No remediation works have been carried out to the garage. A 10 mm vertical offset remains observable along the concrete slab construction joint. Our recommended remediation for the garage remains consistent with the advice provided in our 2018 report.

Photo 12. View of garage slab control joint.

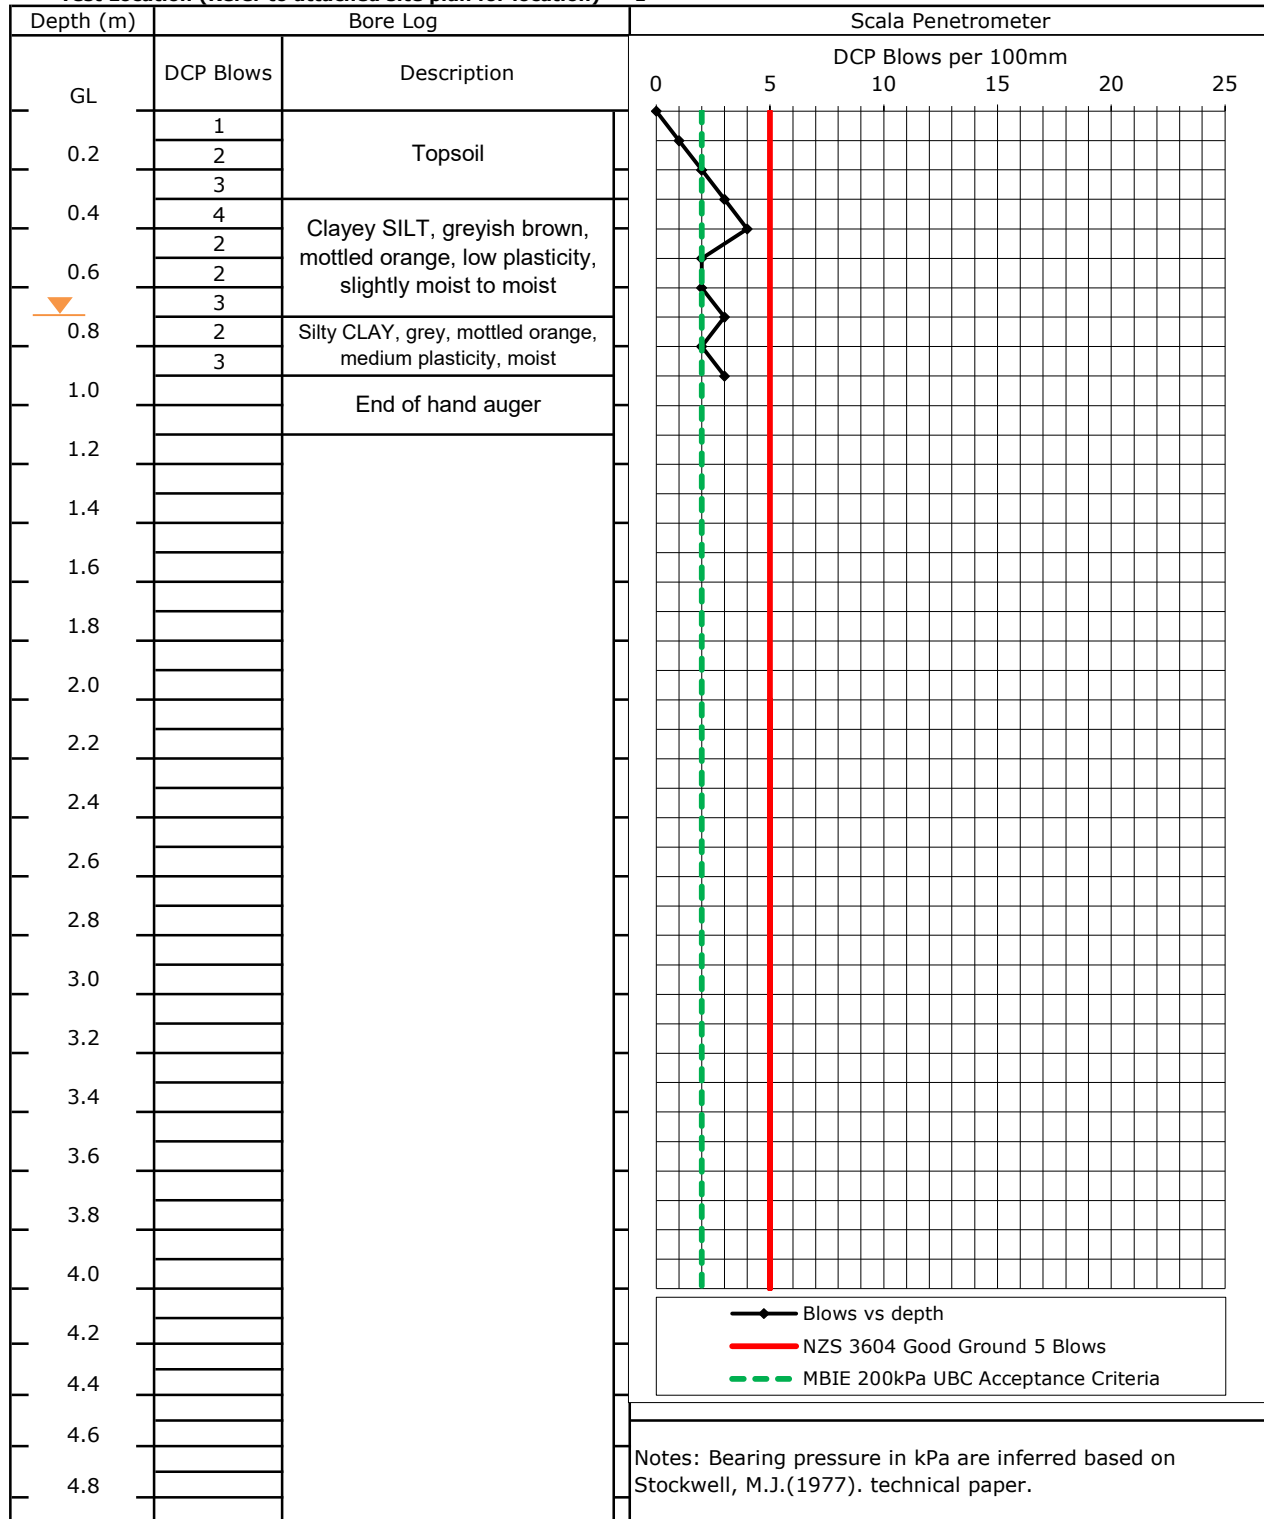
**Test Location (Refer to attached site plan for location) 1**

4. **Geotechnical Capacity:** Supplementary soil testing confirmed a minimum bearing capacity of 200 kPa at 500 mm below ground level. This capacity is considered sufficient to support the design loads for the new timber piles.
