## Unauthorised building work report for **Certificate of Acceptance application.**

3113-21

Address 113 King Edward Street  
94/141 Pt Sec 3 Sec 177 Motueka DIST  
1956041600

Date of inspection: 13 October 2021

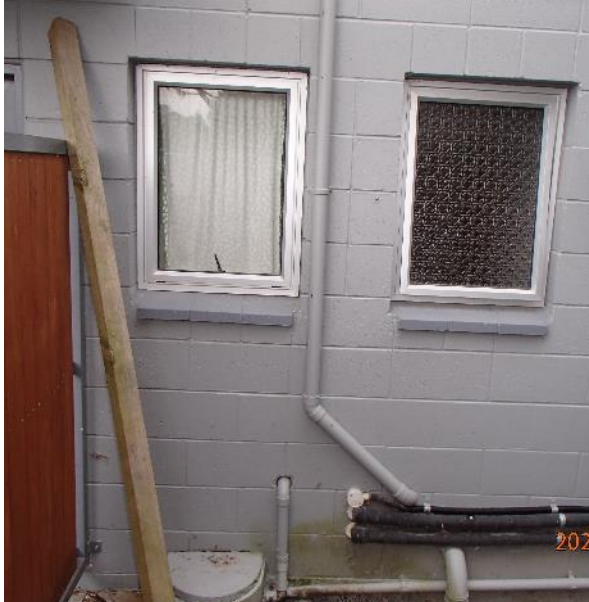
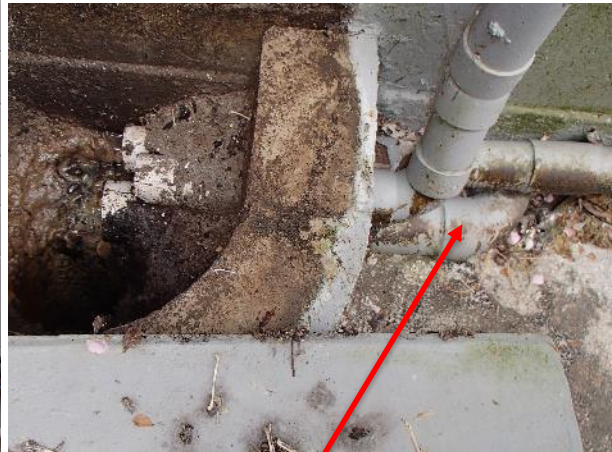
Waste from the laundry tub goes to gully on the outside wall.

This gully now receives the waste from the shower and basin.

*Basin waste through the wall, shower direct to gully. shower waste into side of gully*

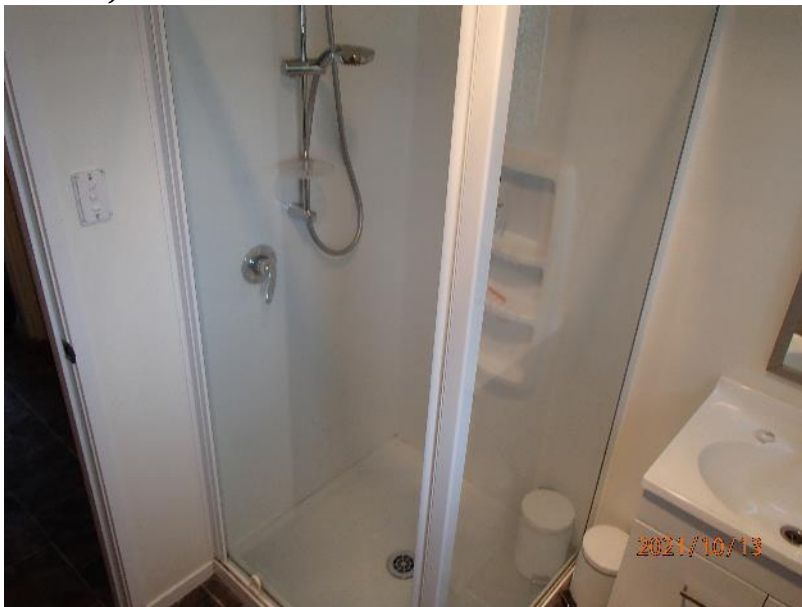
**Shower;**

The shower is a proprietary 2 sided acrylic unit with safety glass screen and door. Plumbing is within a new timber framed wall that separates the new bathroom. It has a mixer, flexile hose and shower rose.

A chase was cut through the concrete floor for the waste which goes to the gully trap outside.

We found no elevated moisture readings outside the shower at either corner or in the timber framed walls on two sides.

We believe this shower meets the performance requirements of the relevant clauses of the code.

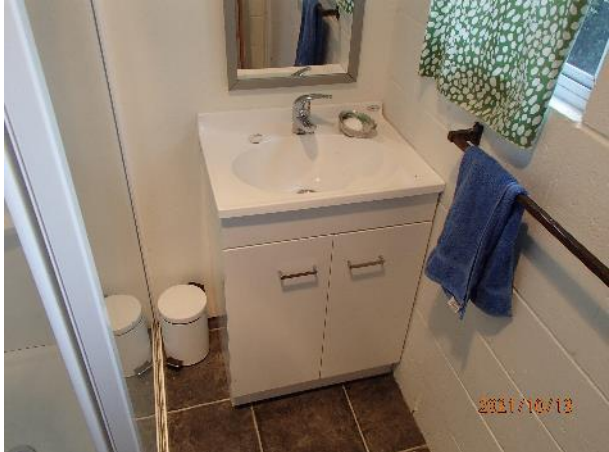
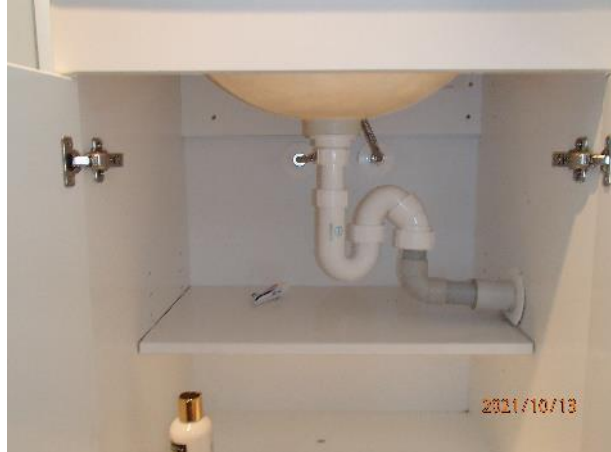
## Vanity;

The vanity has been installed where the laundry was previously located using the same plumbing. It has an acrylic top and is sealed to the painted walls.

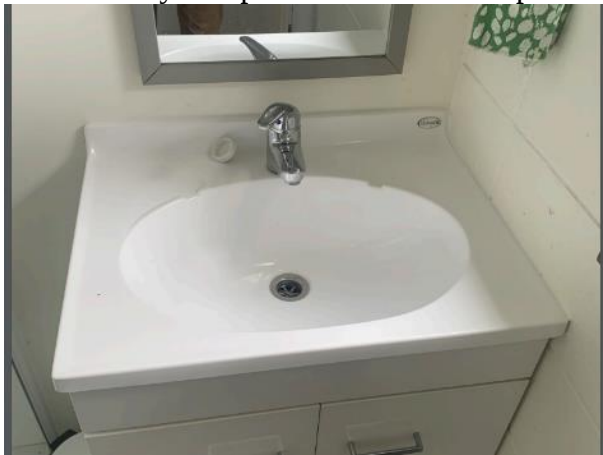
*Vanity sealed to both walls*
