# EARTHQUAKE RECOVERY (EQR) DOCUMENTATION

# EQR Property Overview Report

| EQC Property ID | Property Address | Vulnerable? | Property F Status | Property Finalisation Indicator | | |
|---|---|---|---|---|---|---|
| 2010124453 | 67 JACKSONS ROAD, OHOKA | | F3 - Complete & Finalised | Some Finalisation has taken place | | |

67 Jackson's Rd., Ohoka, Kaiapoi

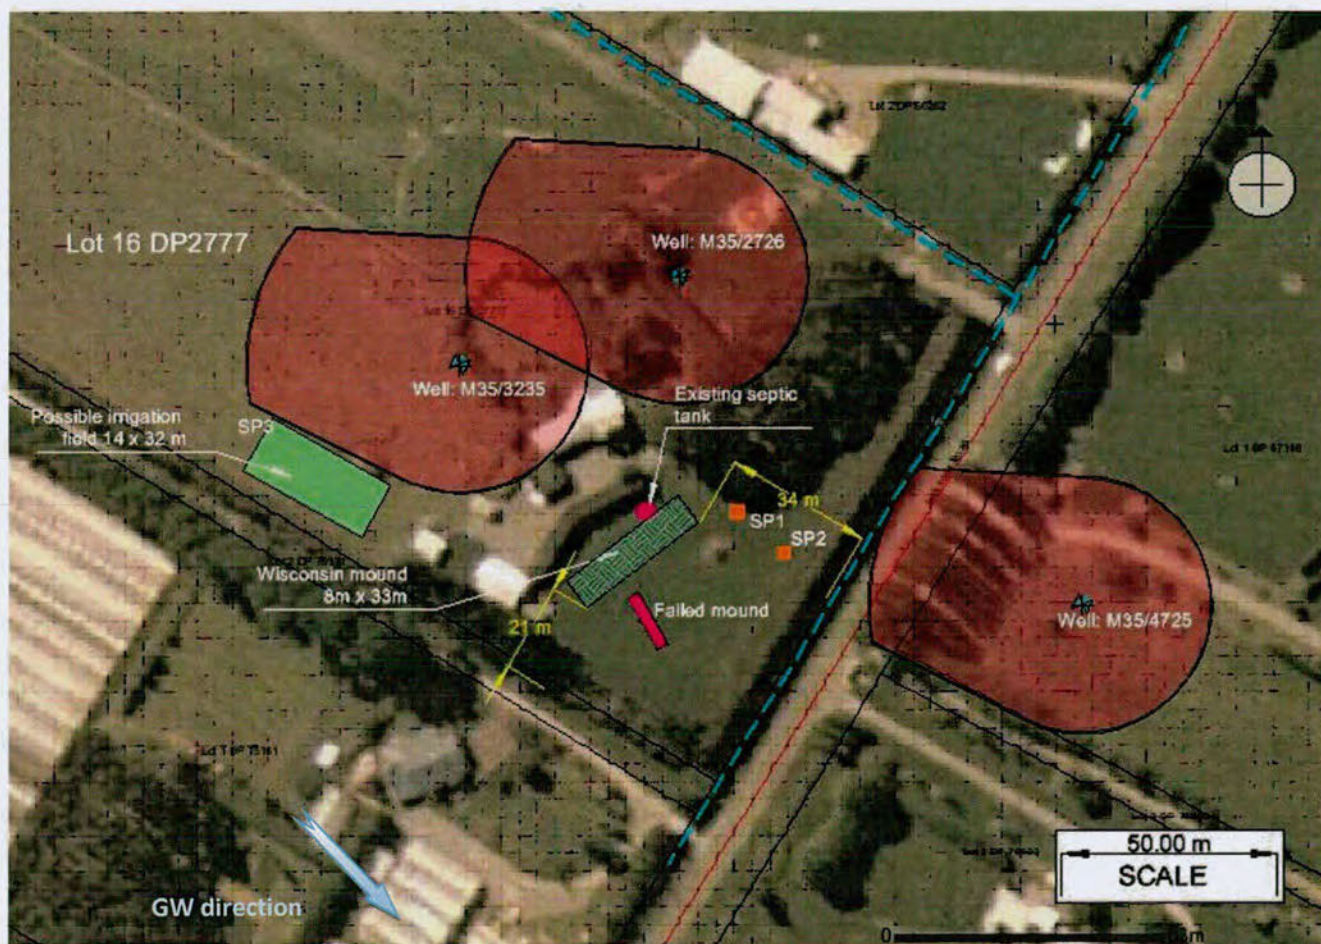
Photo 1. Aerial view showing location of septic tank (ST), well and failed soakage field

| Recommendations /comments | <p>The septic tank and pump are operating normally.</p> <p>The mound needs to be replaced.</p> <p>ecoEng designed a septic tank to mound system for this site and a quote was obtained from Hansen Contractors Ltd (Rangiora) (\$31,994+gst). This included a new septic tank system. ecoEng was not initially made aware that there existing system comprised of two septic tanks in series. The first septic tank is buried and hidden under trees and the owner alerted ecoEng of its existence on the 15 July. It now appears that existing septic tank capacity will meet code requirements and a new septic tank system is unnecessary.</p> <p>Repair work required is replacement of the mound only. The cost to repair the damage will now be less than originally expected.</p> <p>For this site it is clear that the mound has failed. The mound dimension are under code (AS/NZS1547) causing it to be saturated and vulnerable to earthquake induced liquefaction and consequent mound failure.</p> <p>Any upgrade of the system will be required to meet the current Canterbury Regional Council Rules, NRRP and in particular WQL9 which makes reference to AS/NZS1547:2000.</p> |

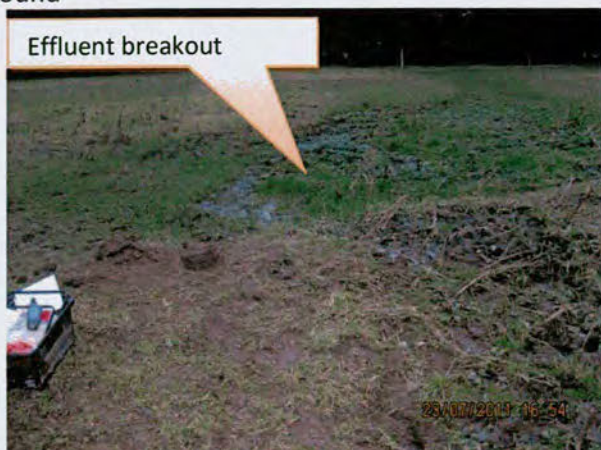
**Photo 2** Mound showing effluent breakout at east of mound

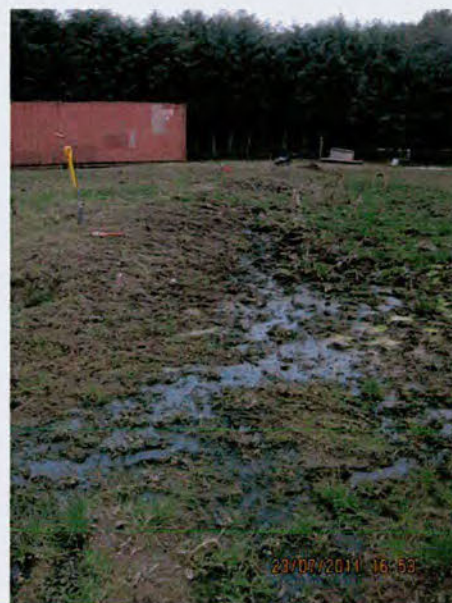
**Photo 3** Mound showing effluent breakout at the far end of the mound

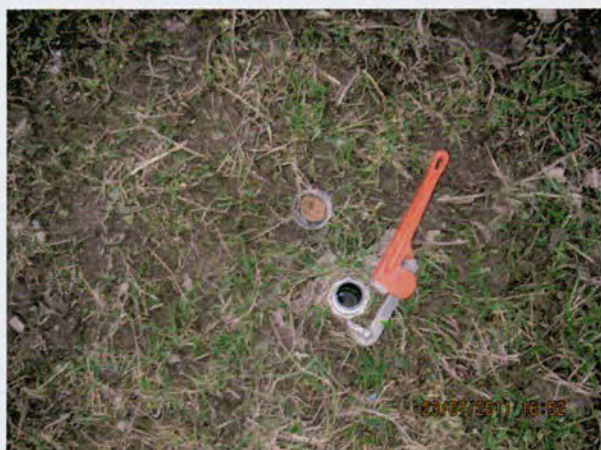
| Description of mode of failure | <p>The septic tank, filter and pump are all operational (Refer to Fig 7).</p> <p>ecoEng opened the flush-out port at the end of the mound (Photo 4) and activated the pump. Wastewater flow was strong out of the flush-out port (Photo 5) indicating that the distribution manifold along the length of the mound was operational.</p> <p>The mound has clearly failed as surface ponding of the septic tank effluent is evident. See Photos 2 and 3. Excess of weed growth on and around the mound was evident on a previous site visit (10 Feb 11) and indicates wet soil conditions have persisted for some time. According to the owners surface ponding prior to the earth quake was not evident.</p> <p>The property owner commented that he thought that the height of the mound had reduced in recent months.</p> <p>In an attempt to assesses any damage/failure within the mound a soil pit was dug across the top of the mound (Photo 6). At a depth of about 250mm a geofabric mat was exposed. It would have been a major disruptive exercise to dig below this so digging was stopped.</p> |

**Photo 4.** Distribution pipe flush-out port at end of line

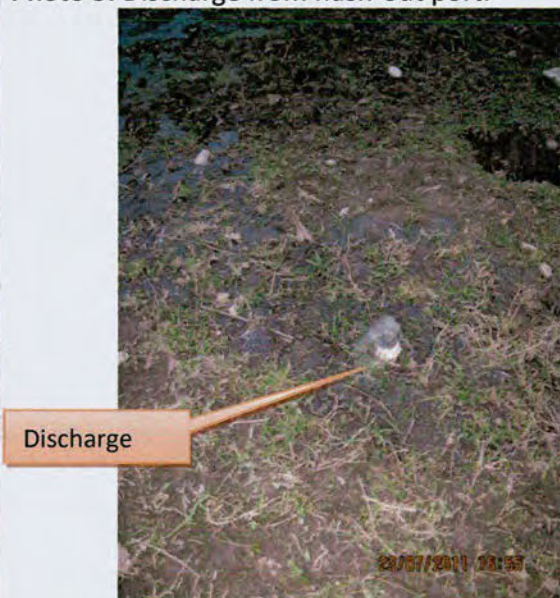
**Photo 5.** Discharge from flush-out port.

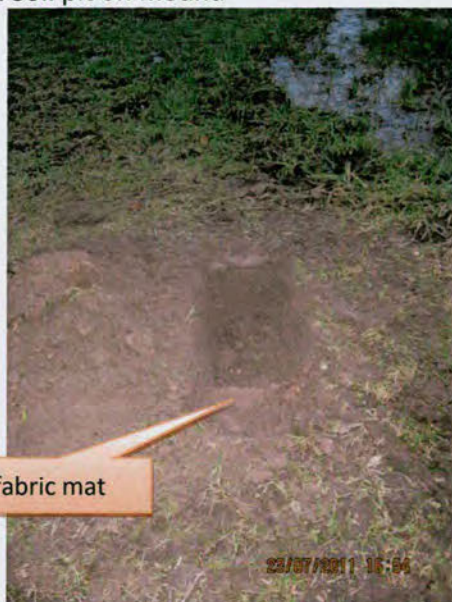
| | <p>view of the fact that a Geofabric mat has been installed under about 250mm of topsoil, this would suggest that it has not been designed as an ETS bed and that there is a more permeable fill such as sand or stone chips overlaying the mound base. The soil type at the mound base will depend on depth. At about 350mm below ground level the soil profile is a sandy clay loam with moderate to imperfect drainage capacity, i.e. category 3 to 4 as in AS/NZS1547. The recommended hydraulic loading rate to this soil type is about 16 L/m<sup>2</sup>/day. For a 4 bedroom dwelling the daily design loading is 1400L/day, requiring a mound soakage base area of at least 88 m<sup>2</sup>. The existing mound base area is about 35m<sup>2</sup> (2.5 x 14). The current number occupants is 6 and the expected daily wastewater load (excluding kitchen wastewater) could be about 1000L/day. The corresponding loading rate on the existing mound would be about 28 L/m<sup>2</sup>. The implication of this is that the mound is too small for the hydraulic load it is being subjected to. Hydraulic overloading of the mound will result in saturation of the mound.</p> <p>With sand in the mound bed and likely saturated conditions, the earth quake activity could have liquified the sand in the mound<sup>1</sup>. This would account for the observed consolidation of the mound and reduction in its height. A reduced hydraulic conductivity within the mound due to this compaction may have aggravated breakout drainage to the outer edges of the bed and the obvious surface ponding.</p> |

**Photo 6. Soil pit on mound**

Geofabric mat

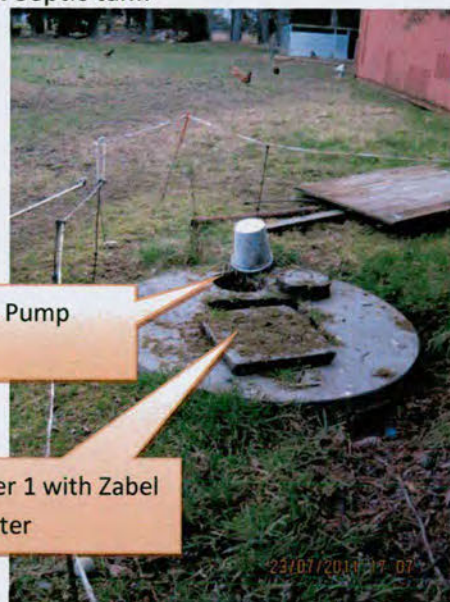
**Photo 7. Septic tank**

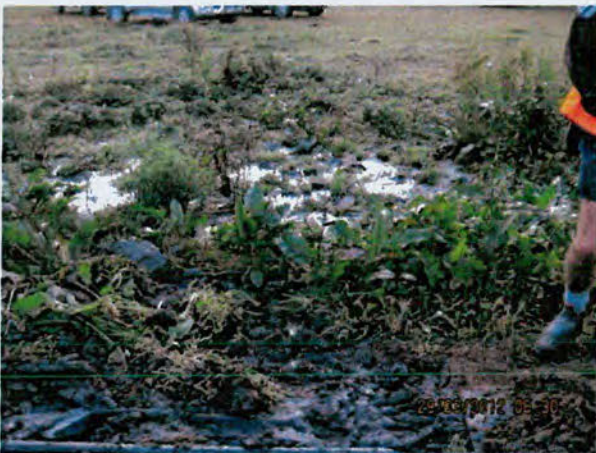
On arrival it was very clear that the mound had failed. There was a significant area of surface ponding of septic tank effluent mostly on the North side of the mound (see **photo 1**).

**Photo 1** showing surface ponding on the north-east side of the mound.

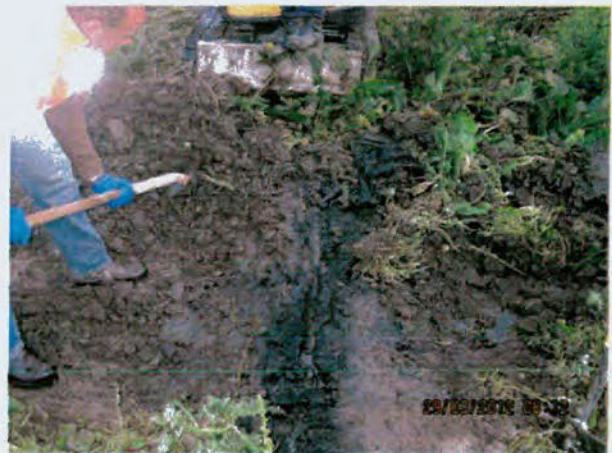
**Photo 2.** Distribution pipe (40mm) showing gravel pack blocked with black biomat.

It was concluded that the cause of hydraulic failure of this mound was primarily due to the following factors:

- a. High hydraulic and organic loading rate into the gravel pack around the single 14m long 40mm distribution pipe and as a consequence;
- b. buildup of dense anaerobic biomat preventing even and adequate infiltration into the sand mound.

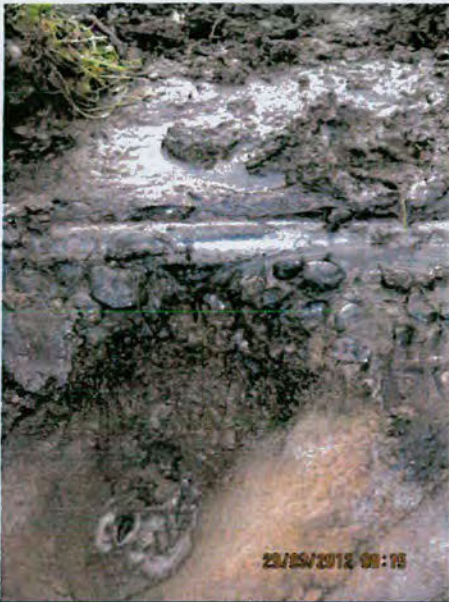
**Photo 3.** Relatively free draining, normal density mound sand below the biomat layer

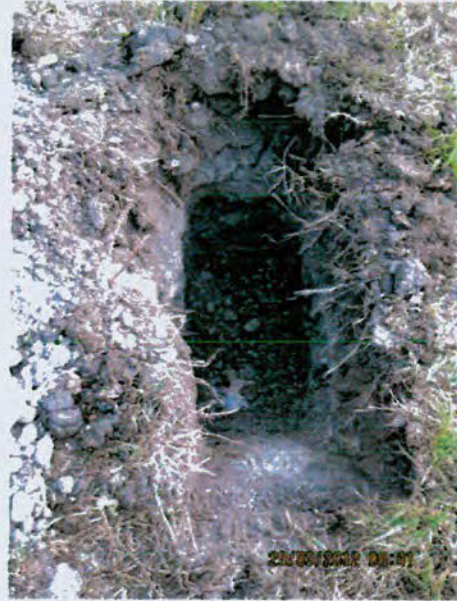
The depth of sand in the mound was about 1 m and below the sand was parent soil (stony layer as in **Photo 4**)

**Photo 4.** Soil pit adjacent to and on the south-west side of the mound,
