**GEOTECHNICAL REPORT – BUILDING FOUNDATION SOILS**

116 Richard Street  
OPOTIKI

Project Ref. 2630-1  
20 September 2024

## BUILDING CONDITION REPORT FOR RELOCATION

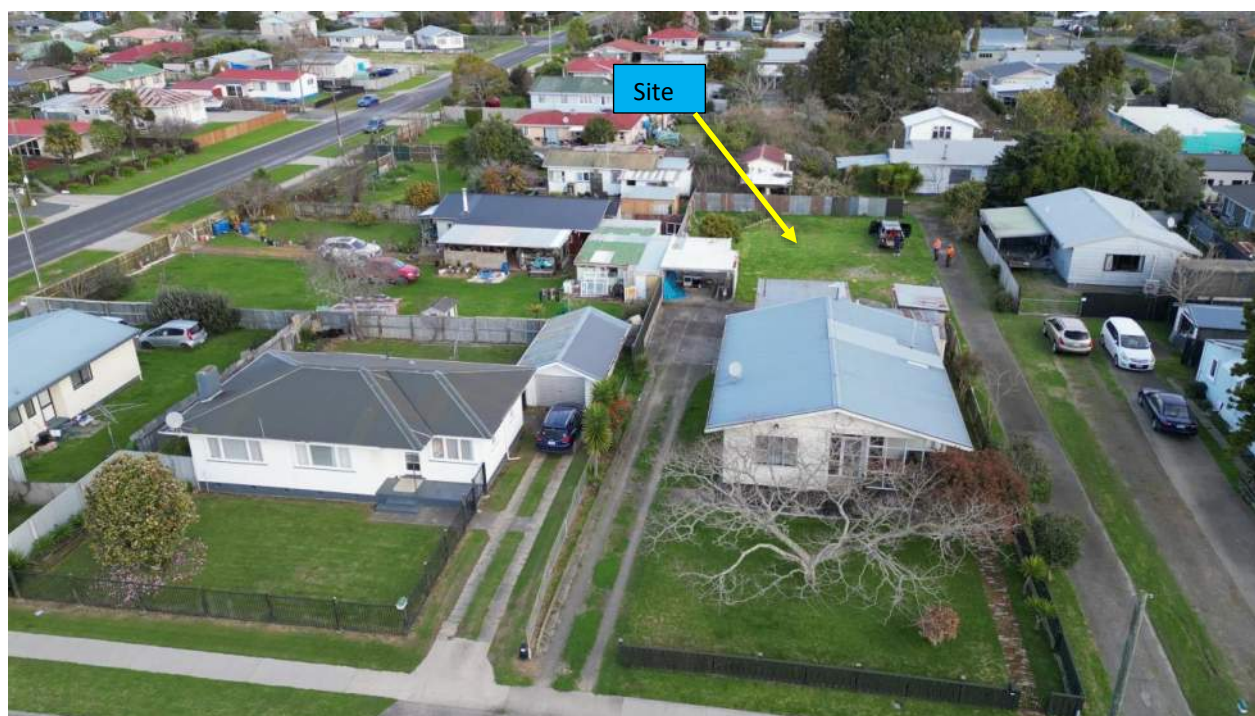
Figure 9: view looking south at site (drone)

A raised garden is in the southeastern corner of the site. This will be within the building platform.

A raised vegetable garden and existing landscaping features are located within the building area. These should be removed. The excavation must be cut level and exposed natural organic free soil and be backfilled per New Zealand Standard *NZS 4431:2022: Engineered fill construction for lightweight structures*. Any filling greater than 0.6m depth or that will support a building foundation must be performed under supervision of a Chartered Engineer who is familiar with this report.

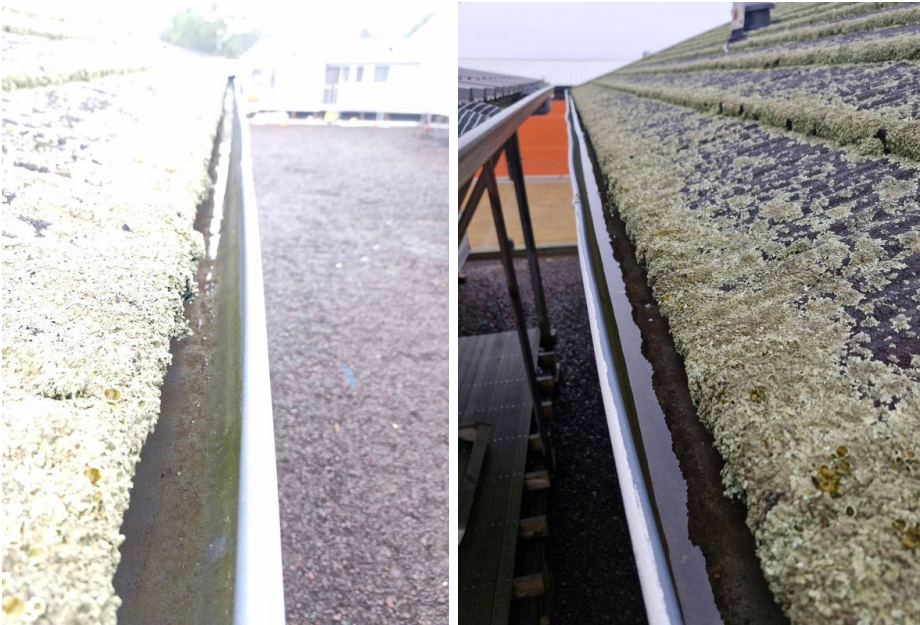
**Coverings: Material**

Metal, Tile

The roofing system is a modern-style texture coated pressed metal tile in relatively good condition with significant lichen growth visible that treatment may be required for.

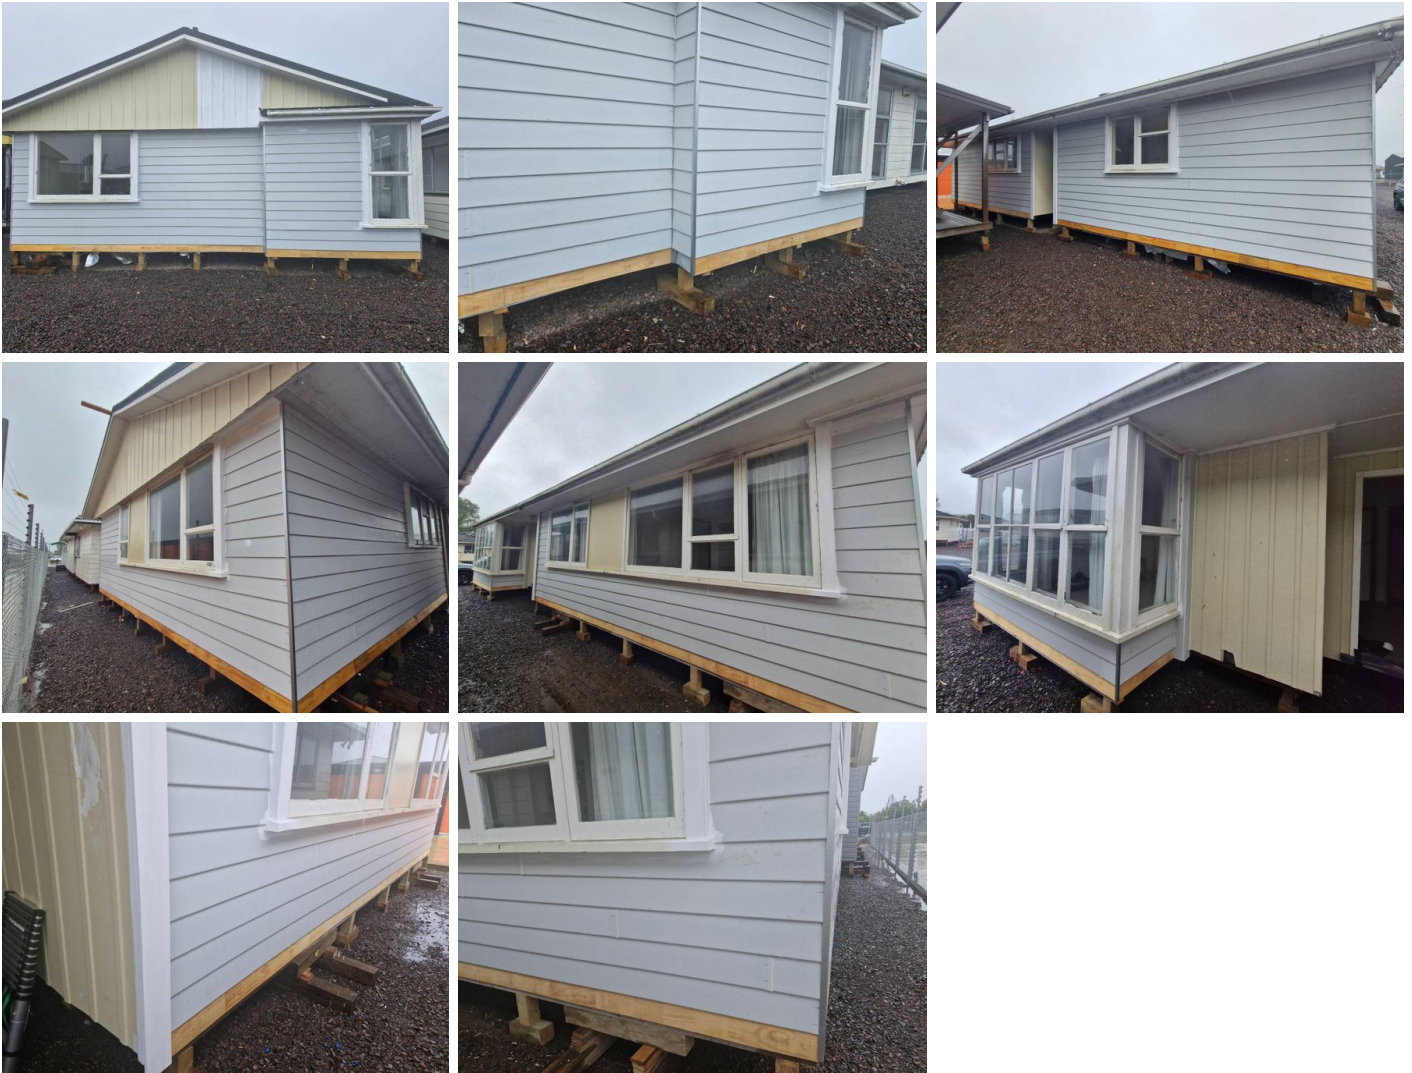
**Cladding, Flashing & Trim: Structure and Exterior Cladding System/s**  
Multiple systems

The building is a timber frame structure on a suspended timber floor structure.

Secondary cladding system in use on the gable ends and around the entrance way is a direct fixed vertical profile overlapping joint fibre cement sheet with a painted finish in servicable condition, with some transportation damage visible that may require repair upon relocation.

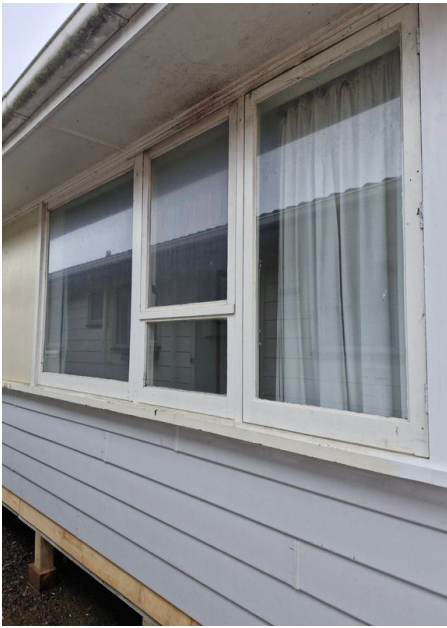
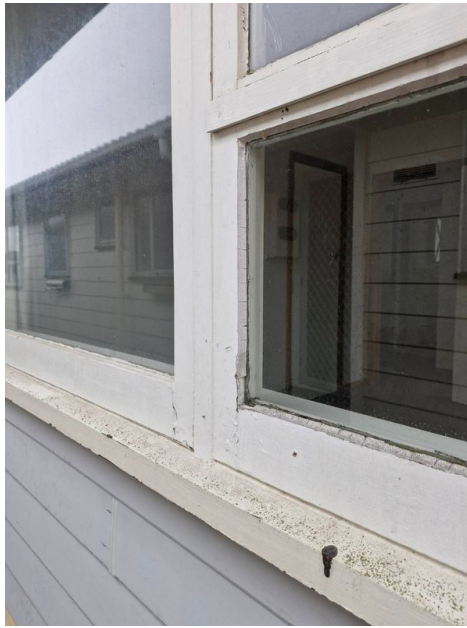
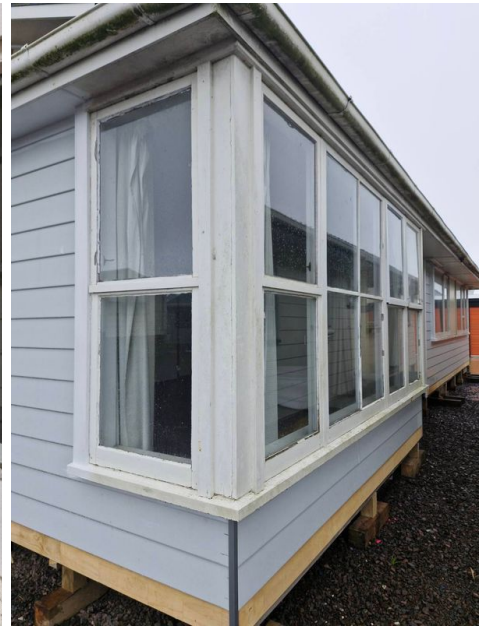
### Exterior Doors & Windows : Window Frames

Older style aged but serviceable timber joinery

Paint is flaking and generally poor condition on timber joinery.

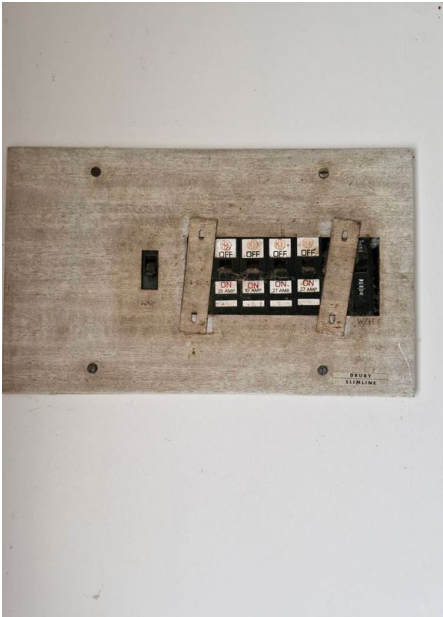
**Electrical: Fuse Box Type**

Circuit Breaker, Older Style  
Board, No RCD fittings

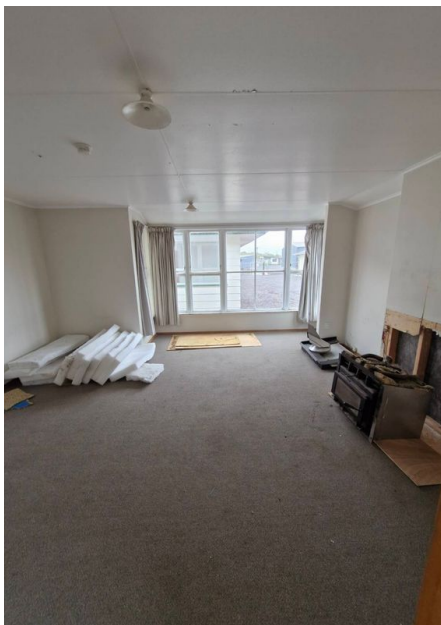
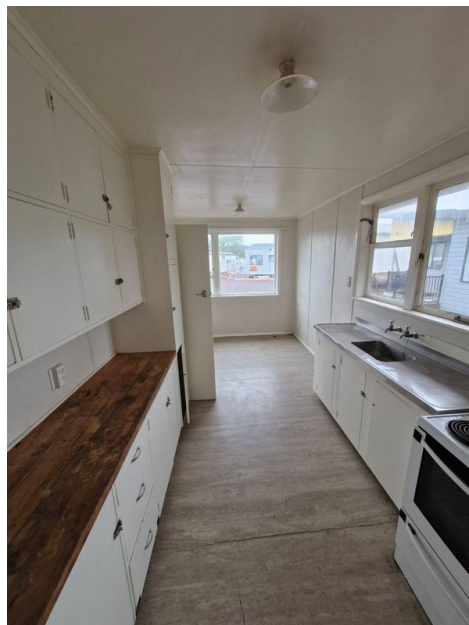
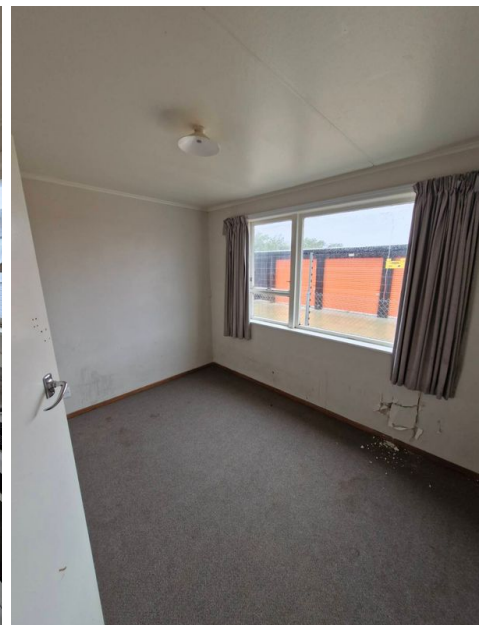
Brick, Plasterboard, Walls in serviceable condition, Some flaking and damaged paint visible

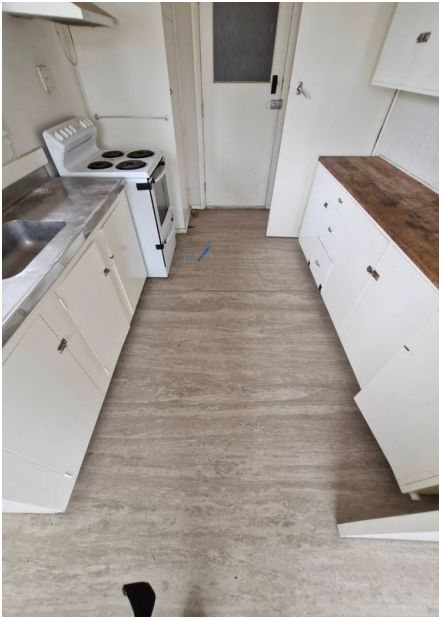
#### Floors: Floor Coverings

Vinyl, Poor condition
