# Thermal Imaging Inspection Report

## VISUAL NON-INVASIVE THERMAL IMAGING PROPERTY CHECK

### 10 Thomas Lane, Rangiora

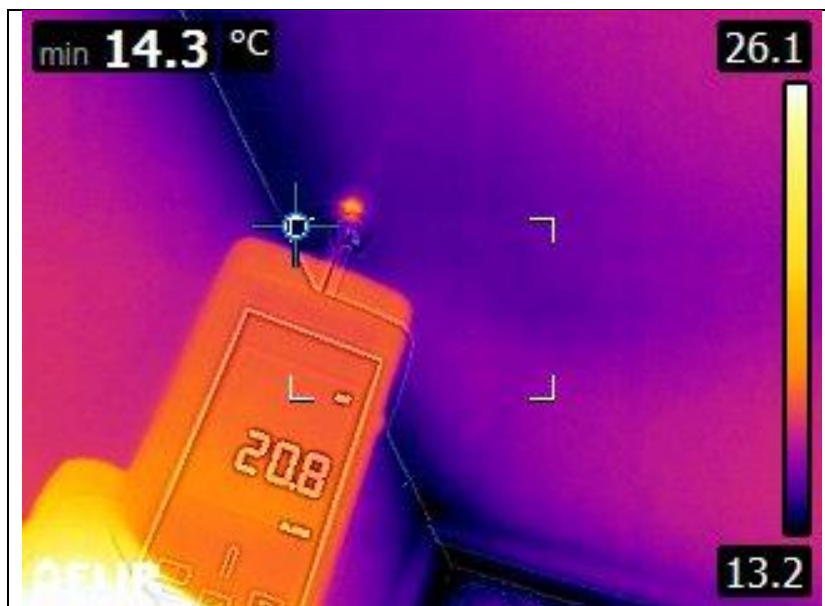
Image 5 - All accessible suspicious darker areas identified on thermal images were double checked with our moisture meter to ensure they were not returning elevated readings.
