## RED LBP PRE-PURCHASE REPORT

# CERTIFICATE OF INSPECTION IN ACCORDANCE WITH NZS 4306:2005

**Company:** GDDC Ltd trading as RedLBP NC.  
**Client:** Simon Ensor  
**Date of Inspection:** 17th June 2026  
**Site Address:** 10 Thomas Lane, Rangiora 7400  
**Inspector:** Gary Cassidy  
**Qualifications:** Advanced Trade Certificate Carpentry & Joinery. Licenced Building Practitioner.

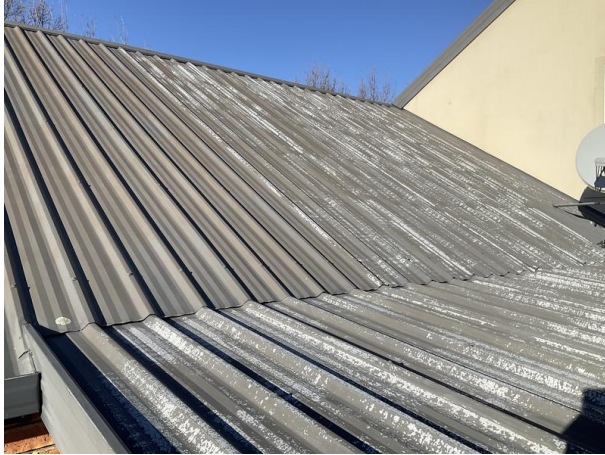
Condition of roofing material coating - Areas of deterioration to the coating, refer to the photos below.

**Photo 4**  
West elevation of roof. Coating  
deterioration visible.

Considering the age of the roof, it appears to be in a maintainable condition. To preserve its condition and extend its lifespan, it is recommended to prioritise the maintenance of the paint coating and replacement of some fixings. This should be undertaken in the near future.

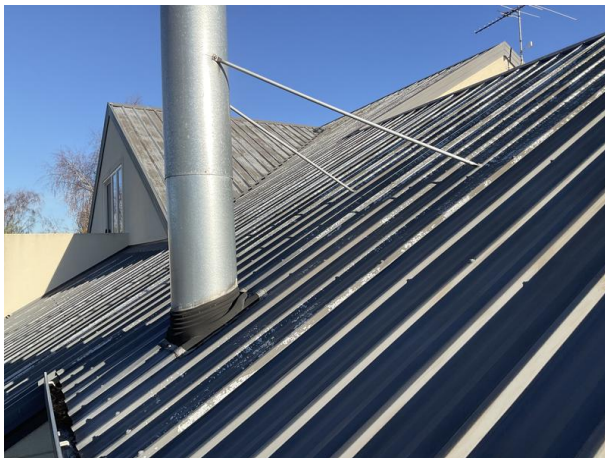
**Photo 5**  
East elevation of roof. Coating  
deterioration visible.

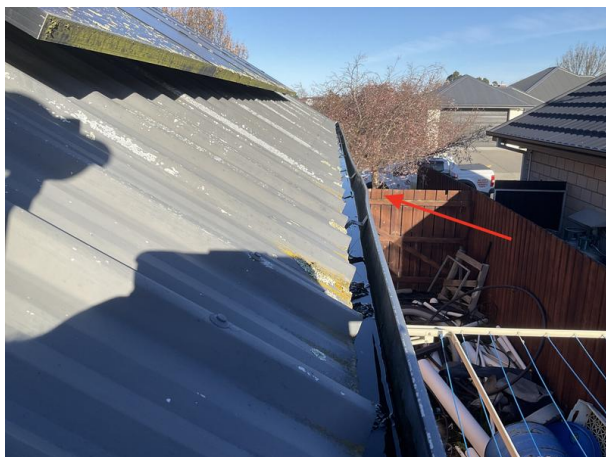
**Photo 9**

Deflection in gutter line visible on west elevation.

It is recommended to clear the gutters regularly to ensure proper drainage and prevent potential issues. When gutters become clogged with debris such as leaves and twigs, water can overflow and accumulate on the roof or other parts of the building. This can lead to water damage and leaks. Keeping the gutters clean ensures efficient water flow away from the roof, protecting the property from moisture-related damage.

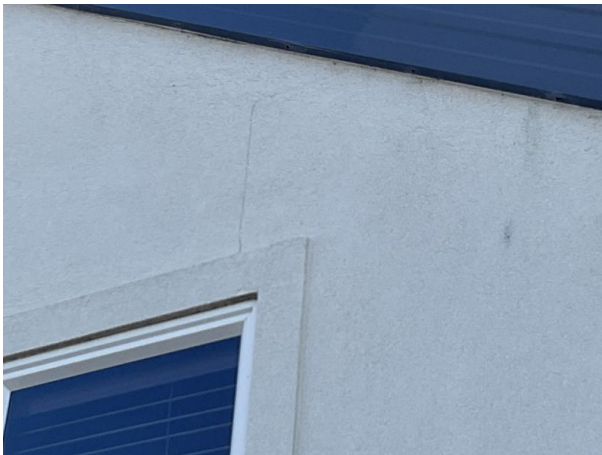
**Photo 14**  
Sheet cracking visible on south gable.  
Seal, monitor and maintain.

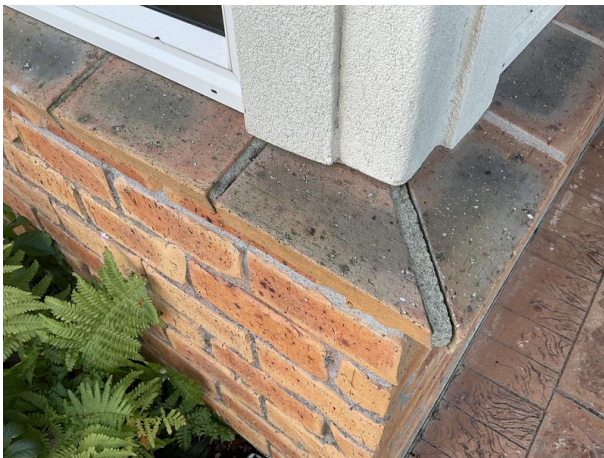
**Photo 17**

Mortar cracking visible on window sill.

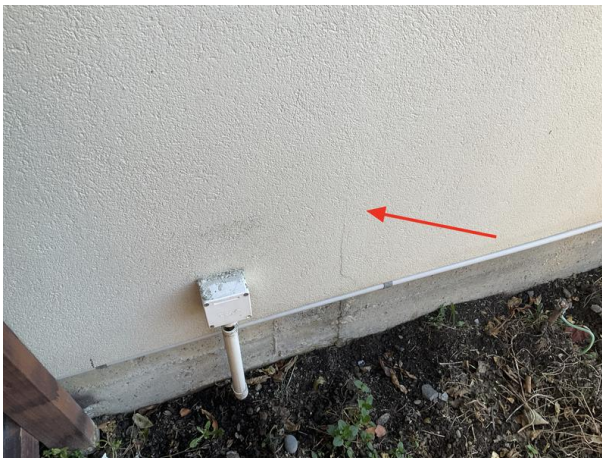
**Photo 20**  
Sheet cracking visible below meter box.

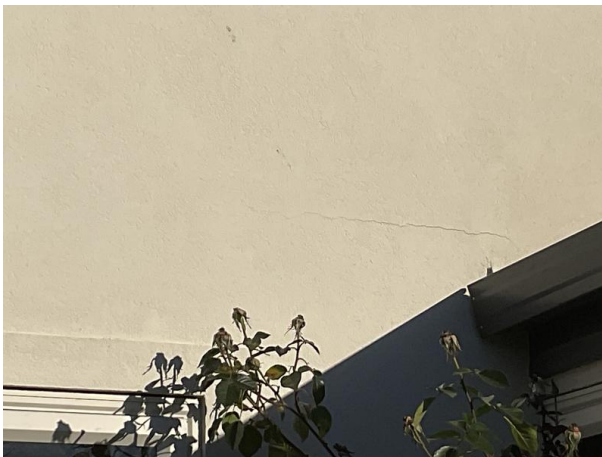
**Photo 21**  
Sheet cracking visible on north gable.  
Seal, monitor and maintain.

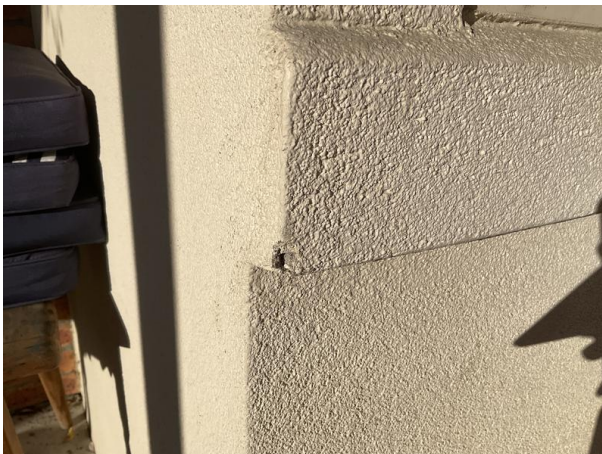
**Photo 24**  
Seal any chips or cracks  
recommended.

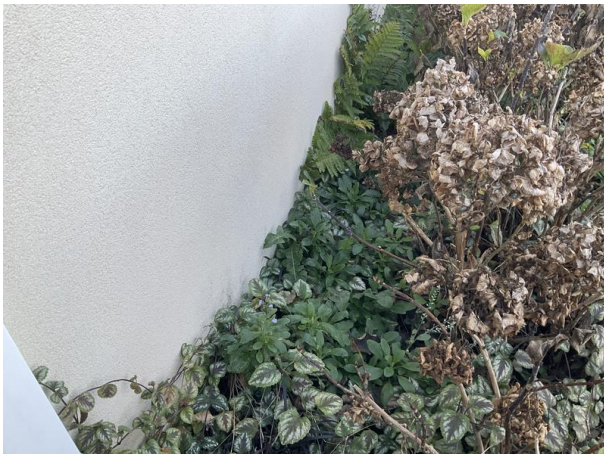
**Photo 25**

Keep garden beds and vegetation clear of the exterior cladding. Remedial work recommended.

It is recommended to keep garden vegetation clear of the exterior cladding. Adequate clearance is essential for the cladding system to function properly and to prevent moisture intrusion through capillary action. Maintaining this separation helps protect the cladding's integrity and reduces the risk of water damage.

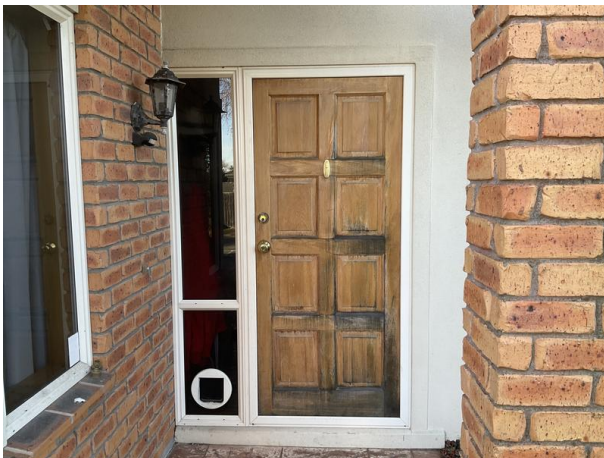
**Photo 29**  
Entrance door and frame. Weathering to timber door visible, maintenance recommended.

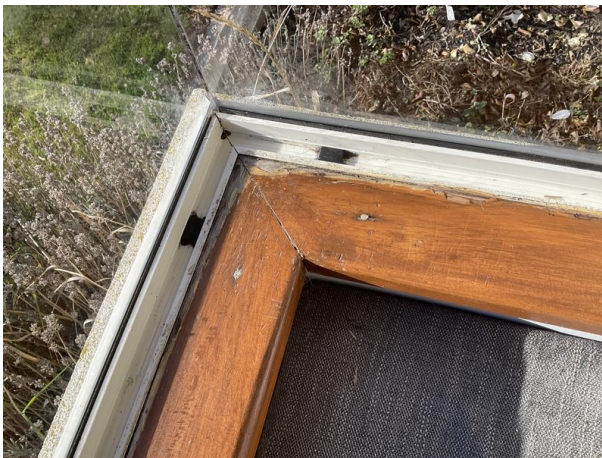
**Photo 45**  
Window reveal maintenance recommended.

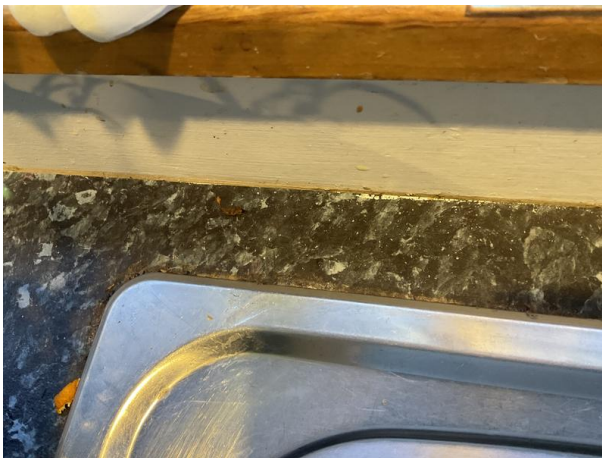
The junction between the kitchen benchtop and the adjoining wall is not sealed. Without proper sealing, water from regular use may track into concealed areas, leading to deterioration of wall linings, cabinetry, and adjacent floor finishes. To mitigate this risk, it is recommended that a durable, flexible sealant be applied and maintained at this junction to provide a watertight seal and protect the surrounding materials from moisture damage.

**Photo 48**  
Sealant recommended between  
benchtop and wall.

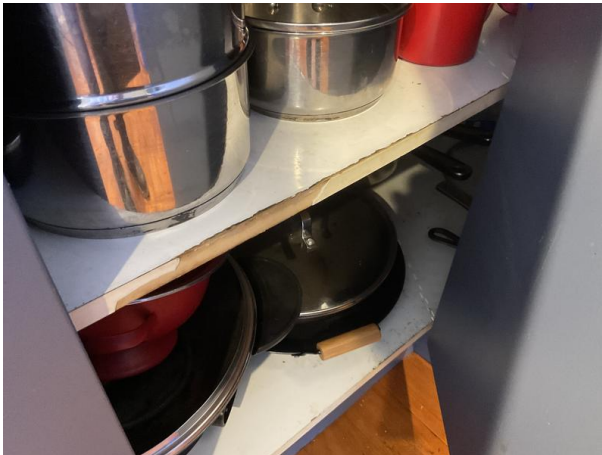
**Photo 49**  
Edging tape damage visible in sink  
cupboard.

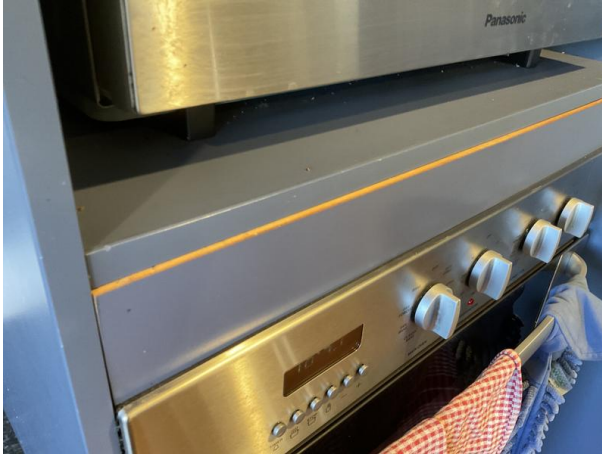
**Photo 50**

Panel above oven is loose,  
maintenance recommended.

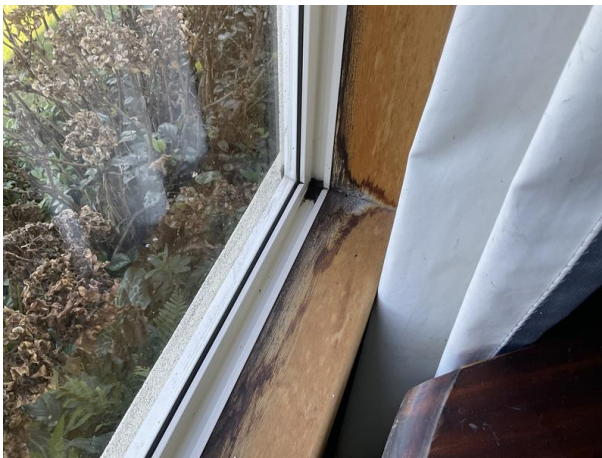
**Photo 53**  
Window reveal maintenance recommended.

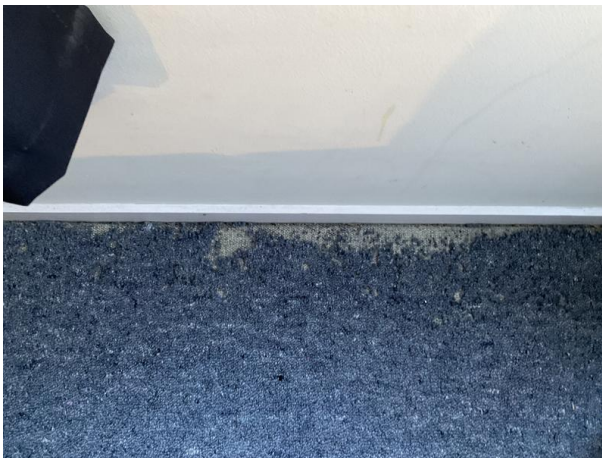
**Photo 55**  
Carpet deterioration visible.

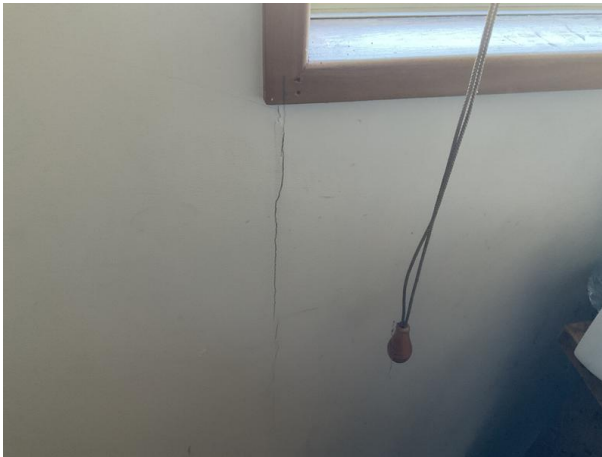
**Photo 60**  
Sheet cracking below window visible.

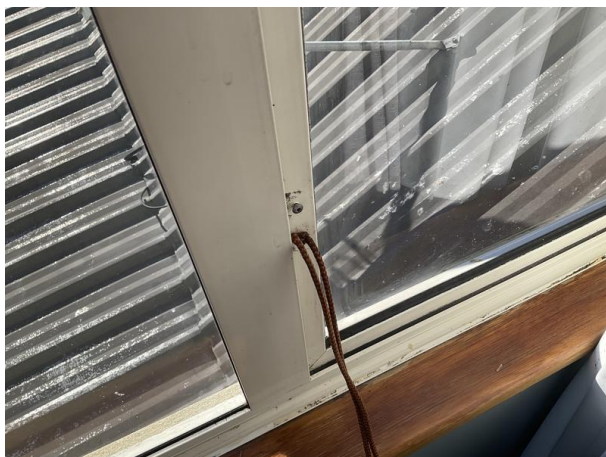
**Photo 63**  
Window latch is missing.

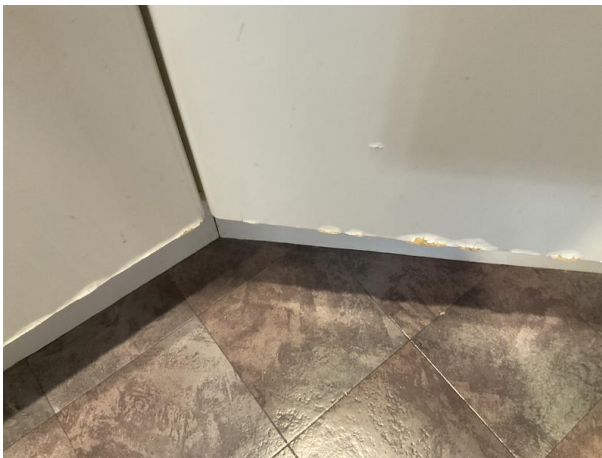
**Photo 65**  
Moisture damage to vanity fronts visible.

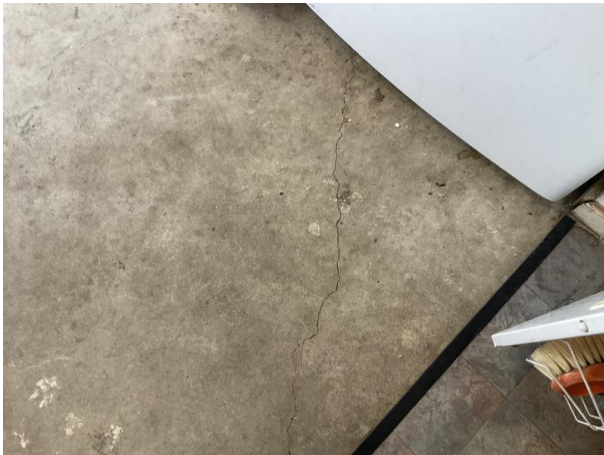
Cracking - As observed in the garage.

**Photo 68**  
Crack visible in garage floor.

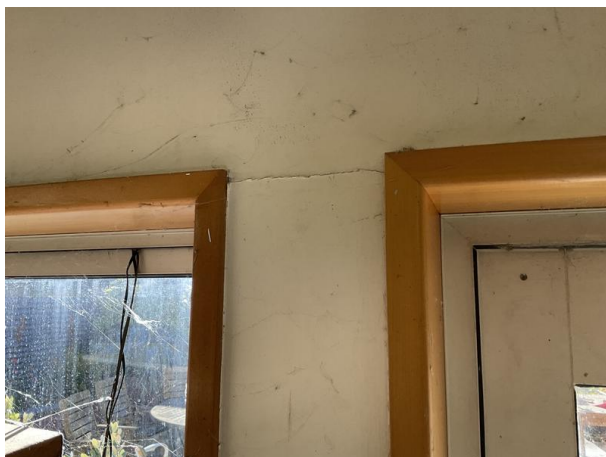
**Photo 69**  
Sheet cracking between window and door visible.

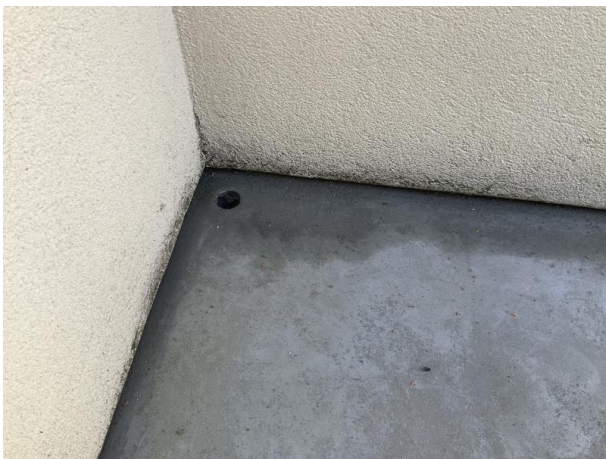
**Photo 71**

Minimal clearance between cladding and membrane and minimal - sized drain visible.

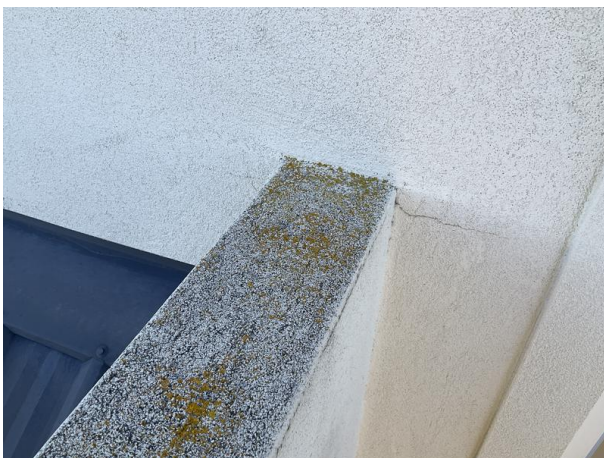
**Photo 73**

Cracking visible around balustrade. Seal, monitor and maintain.
