# Canterbury Claims – Assessment Report

**Claim Number:** 2011/122912

**Property Address:** 427 Armagh Street,  
Linwood,  
Christchurch, 8011

**Date:** 02.12.2024

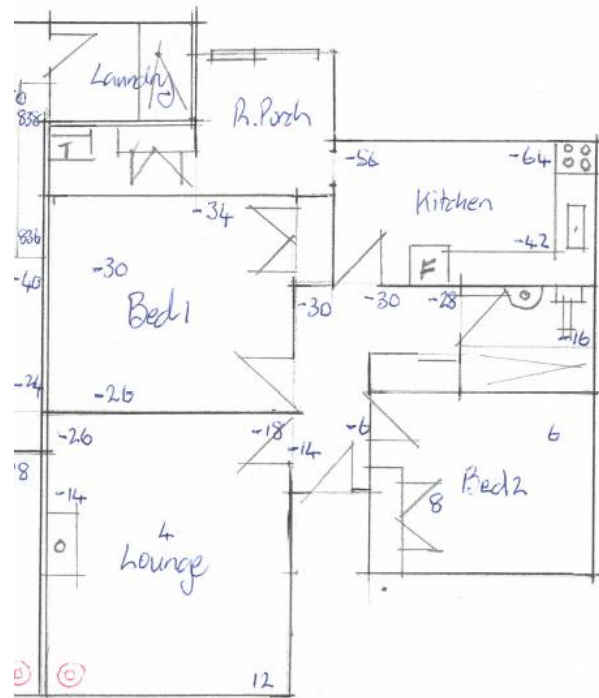
The plan records global dislevelment of 76mm with the high point on the floor locating in the SE corner of the lounge and low point in the NE corner of the Kitchen.

This dislevelment exceeds MBIE guidance tolerance recommendations for releveling (50mm).

The building presents a general tilt to the North (N) and the floor also falls towards the party/fire wall between the two flats.

Similarly, localised slopes are shown to exceed MBIE's guidance tolerances in some areas, this issue presenting similarly in both flats. 425 Armagh Street additionally presents a similar global tilt albeit recording a lesser variance.

| | <p>the tilt measured is entirely pre-existing. Additionally, a similar pattern of dislevelment is noted to the adjoining flat.</p> <p>It is thus recommended that the home be referred for an Engineering assessment to confirm the cause of the dislevelment measured - <b>Possible EQ.</b></p> <p>Given the adjoining nature of this unit &amp; 425 Armagh Street, the Engineering review &amp; assessment will need to consider the performance of the entire building.</p> <p>(Note: Pending the outcome of the recommended Engineering assessment, the following remains outstanding:</p> <ol style="list-style-type: none"> <li>1) Drainage</li> <li>2) Ring crack remediation)</li> </ol> |
